Phase I Environmental Site Assessment

1550 Park Avenue
Emeryville, California

Prepared for
1550 Park LLC
June 9, 2015
Adanta, Inc. Project A1293-1

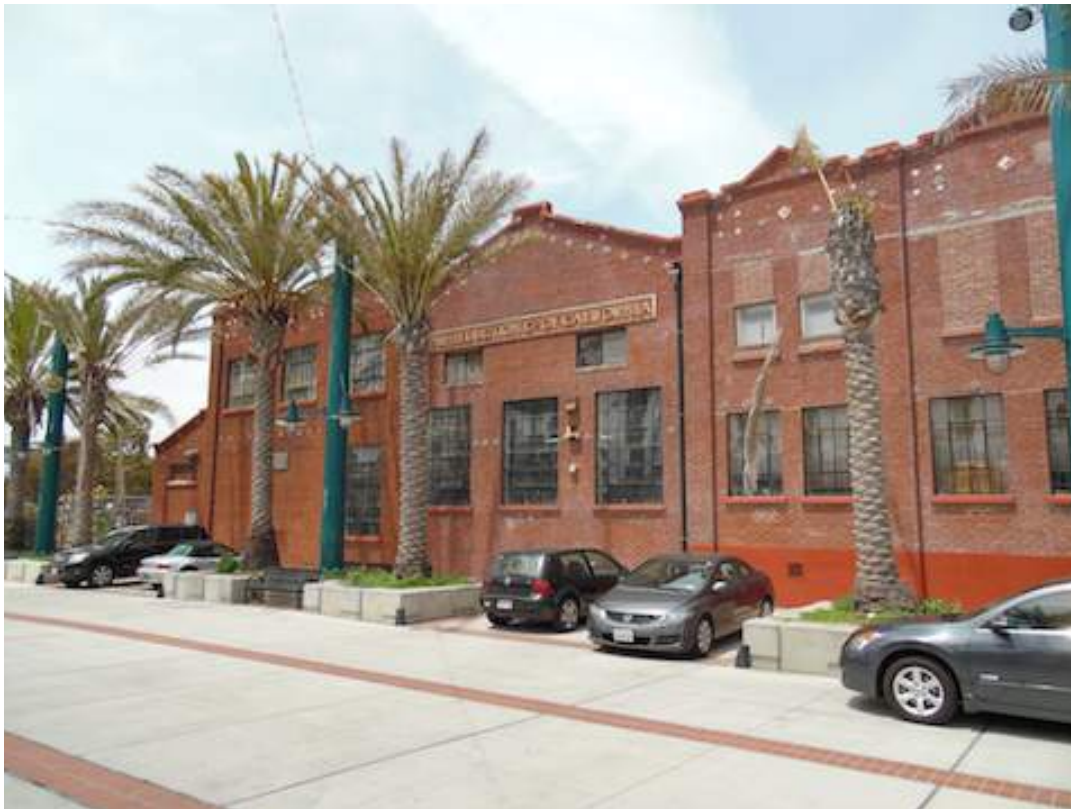
Photograph 2 - Southern wall of Property building.

- An environmental assessment should be conducted to determine if soil or groundwater has been affected beneath the Property building. Soil and groundwater sampling should be conducted inside the building, near the southern wall to find if contamination from the former UST beneath the sidewalk of Park Street has affected environmental conditions beneath the Property building. In addition, soil borings should be advanced in the northern portion of the Property collecting grab groundwater samples to assess the potential that the PCE contamination at the adjacent site has affected environmental conditions at the Property.

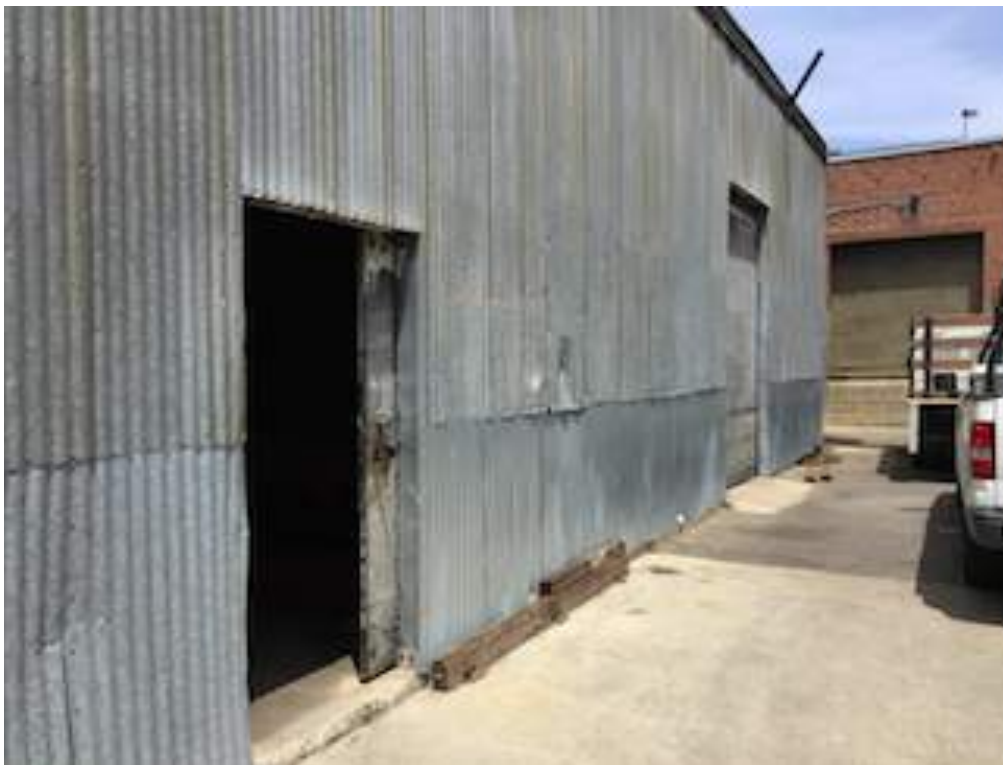
In the approximate center of the Property is a corrugated metal building that is apparently used for storage only, at this time. Inside the building are some lubricating chemicals, waste oil, and propane canisters. The surface of the building is concrete. Staining was noted on the concrete floor through out the building. One roll-up door allows vehicles inside. The yard to the north and south of the corrugated metal building is concrete. To the north of the building is an additional concrete pad, on top of the yard concrete pad, that is octagonal and may have been a base for a large oxygen tank, based on information obtained from Sanborn Fire Insurance Maps.

Photograph 6 – Corrugated metal maintenance shed in central portion of Property.

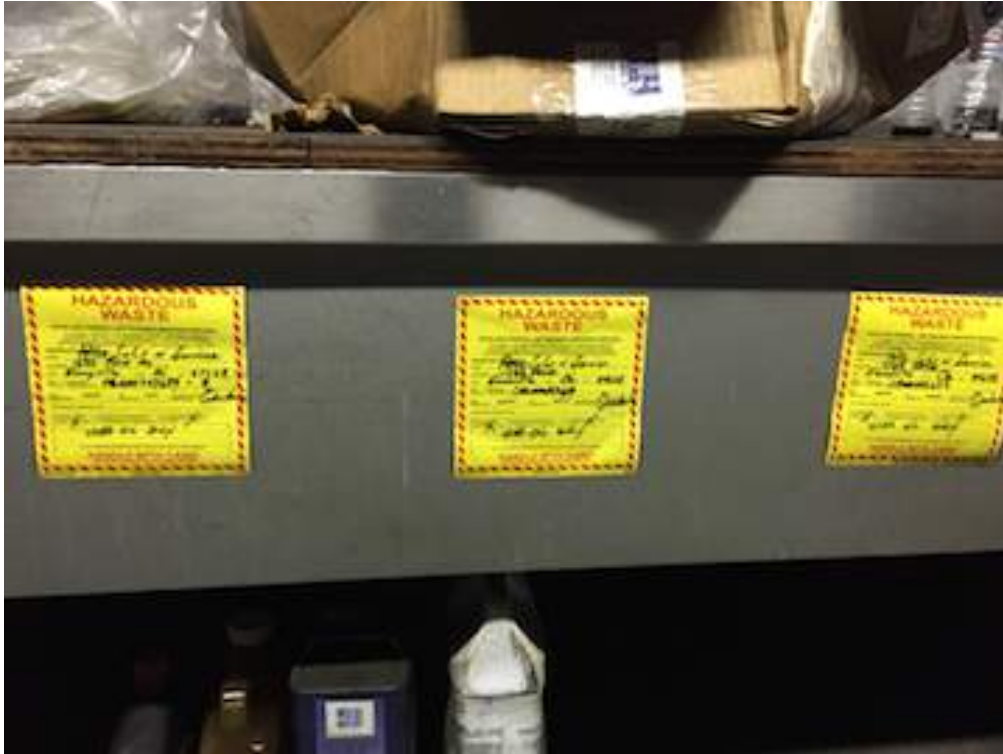
Photograph 7 – Used oil storage tank in corrugate metal building.

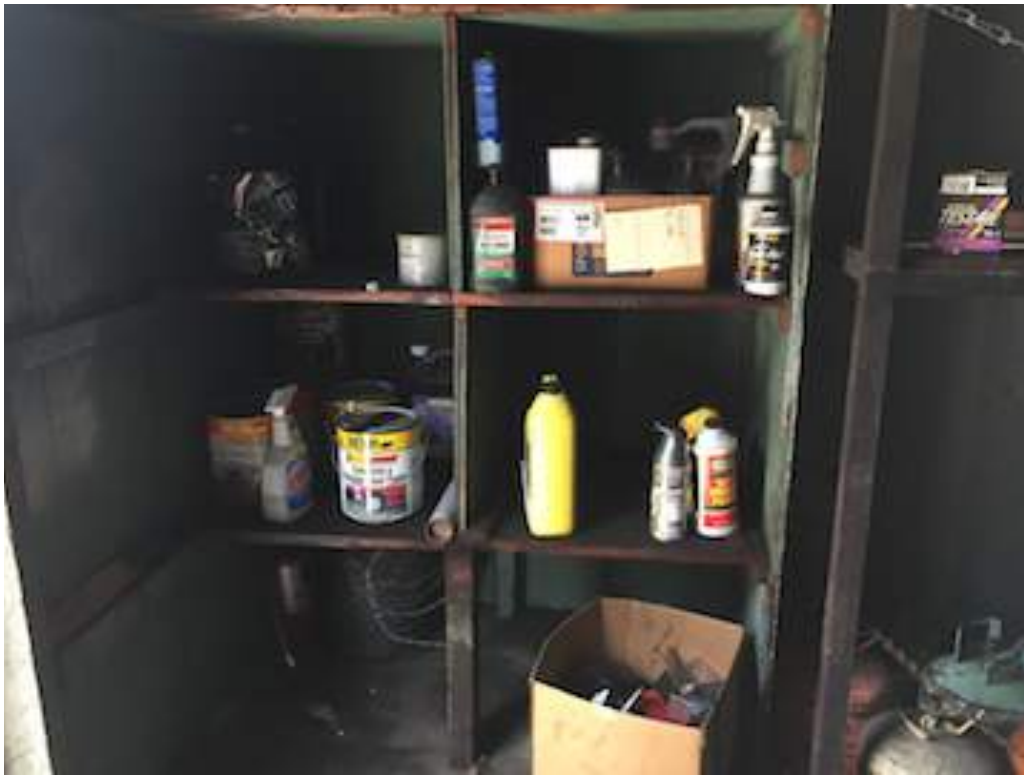
During the Property Survey, Adanta observed common cleaning and maintenance liquids. In addition, the facility maintains a propane-powered forklift. The metal building contained numerous propane canisters. However, the Property does not have a large propane tank. Adanta was shown the locations of two former USTs. One UST was used for fueling onsite vehicles was located in the yard on the north side of the building. There were also remnants of a former fueling pump. The other UST was on the south side of the building, and was apparently used as a heating oil tank for the building. Both tanks have been removed.

Photograph 8 – Maintenance chemicals and lubricants with propane canisters in bottom right.

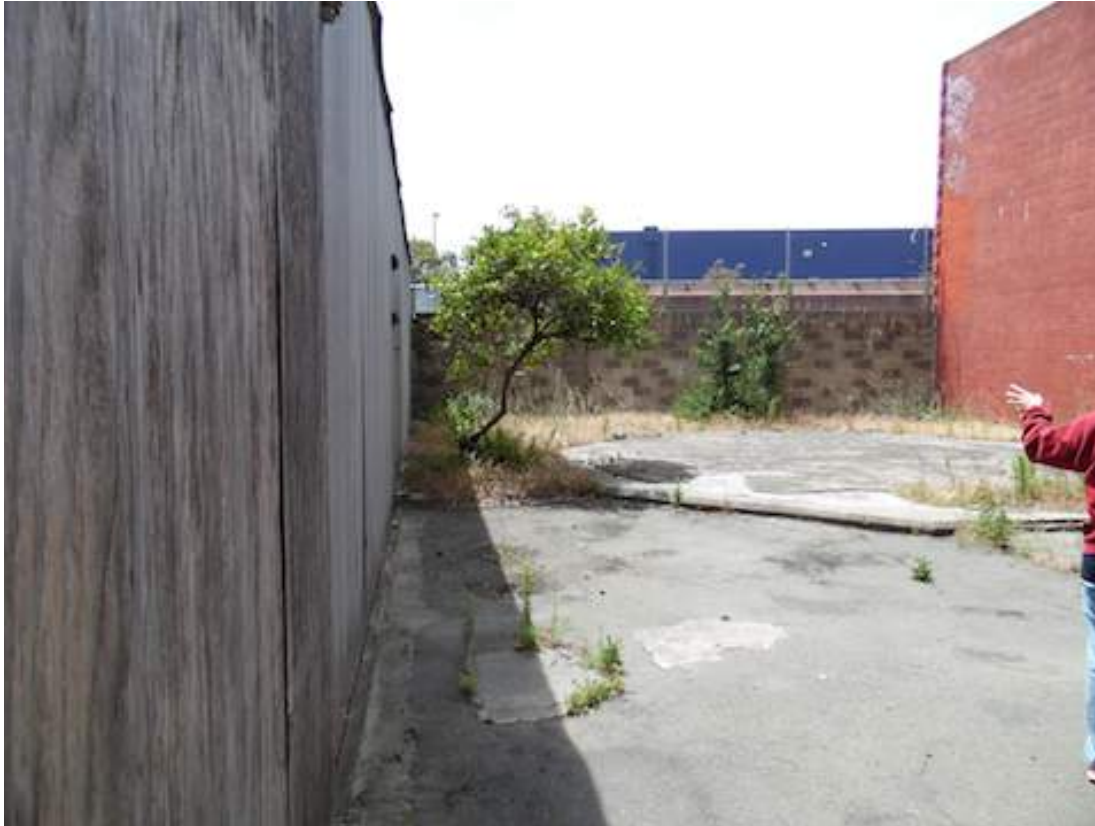
Photograph 9 – Former location of elevated oxygen tank.

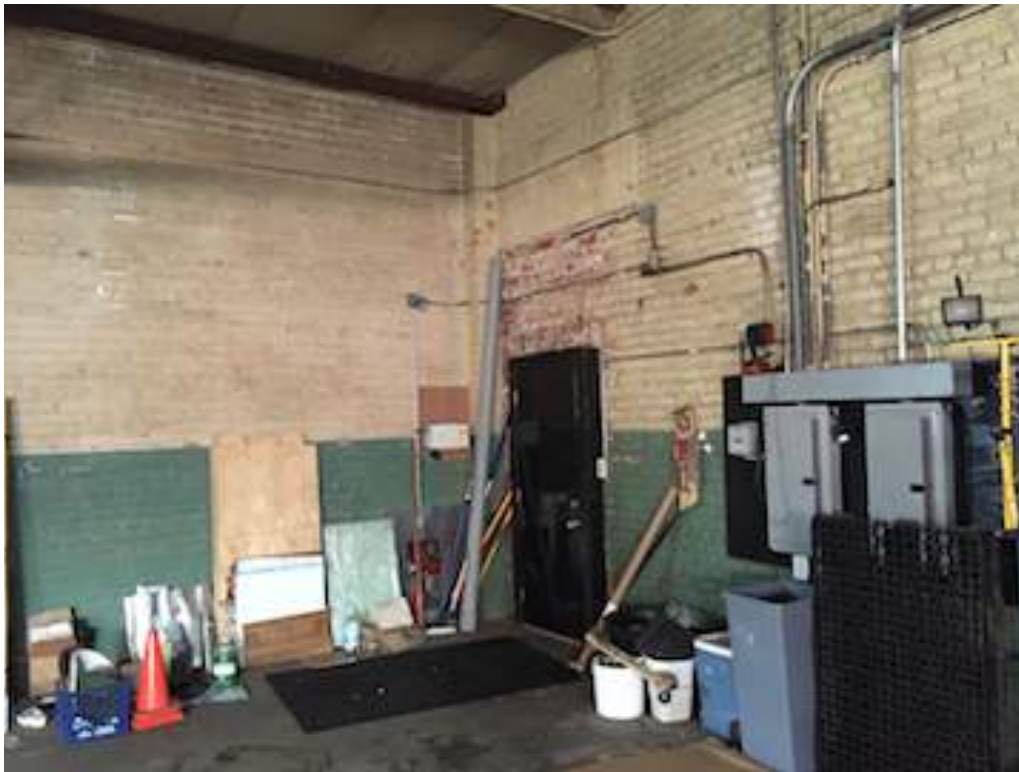
Photograph 14 – Northeast corner of main building with 5-gallon buckets of cleaners.

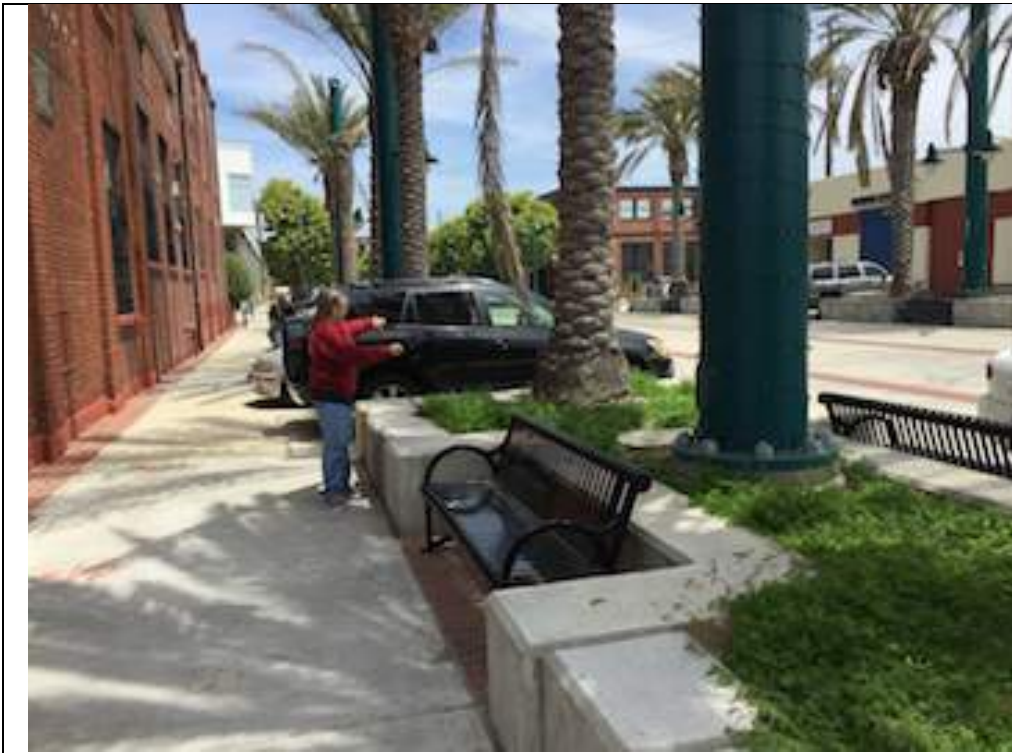
There is known soil and groundwater contamination adjacent to the south of the Property due to a leaking underground storage tank that was apparently used as a heating oil tank for the Property building. It is not known, if the soil and groundwater contamination originating from leaks in this tank has migrated to the Property.

Photograph 15 – Pennie Barger is pointing to former location of UST responsible for current open regulatory case.

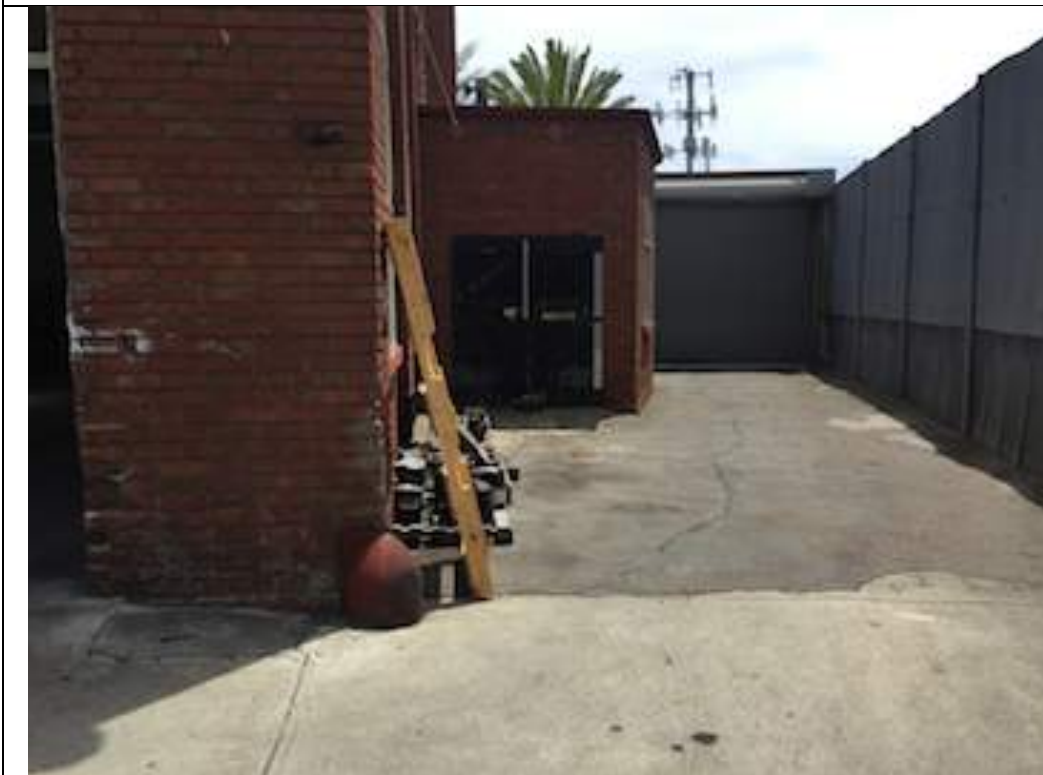
A 1,500-gallon UST used to store gasoline was removed from the central portion of the Property in 1994. Soil contamination was limited to the upper five feet of soil (20 cubic yards), which was removed and properly disposed. 110 gallons of groundwater was removed from the excavation. When groundwater recharged and was re-sampled it was found that concentrations of contaminants were much lower than initial sampling. One groundwater monitoring well was installed in an assumed downgradient flow direction. Although groundwater was encountered in the boring completed as a monitoring well at a depth of four feet, the monitoring well was not screened until a depth of five feet. Soil samples collected during well installation were reported to not have detected concentrations of contaminants, and water samples collected following well installation were also reported to not have concentrations of contaminants.

Photograph 16 – Adjacent to the wall on the left is the former pump and in the center is the former location of the closed UST.
