Subject: Soil and Groundwater Investigation Report  
Main Street Property  
927 Main Street  
Pleasanton, California 94566  
ACDEH Fuel Leak Case No. RO0003199  
GeoTracker Global ID No. T10000008158

## Soil and Groundwater Investigation Report

Main Street Property  
927 Main Street  
Pleasanton, California 94566

ERA Project No. 01-2016-1300-001

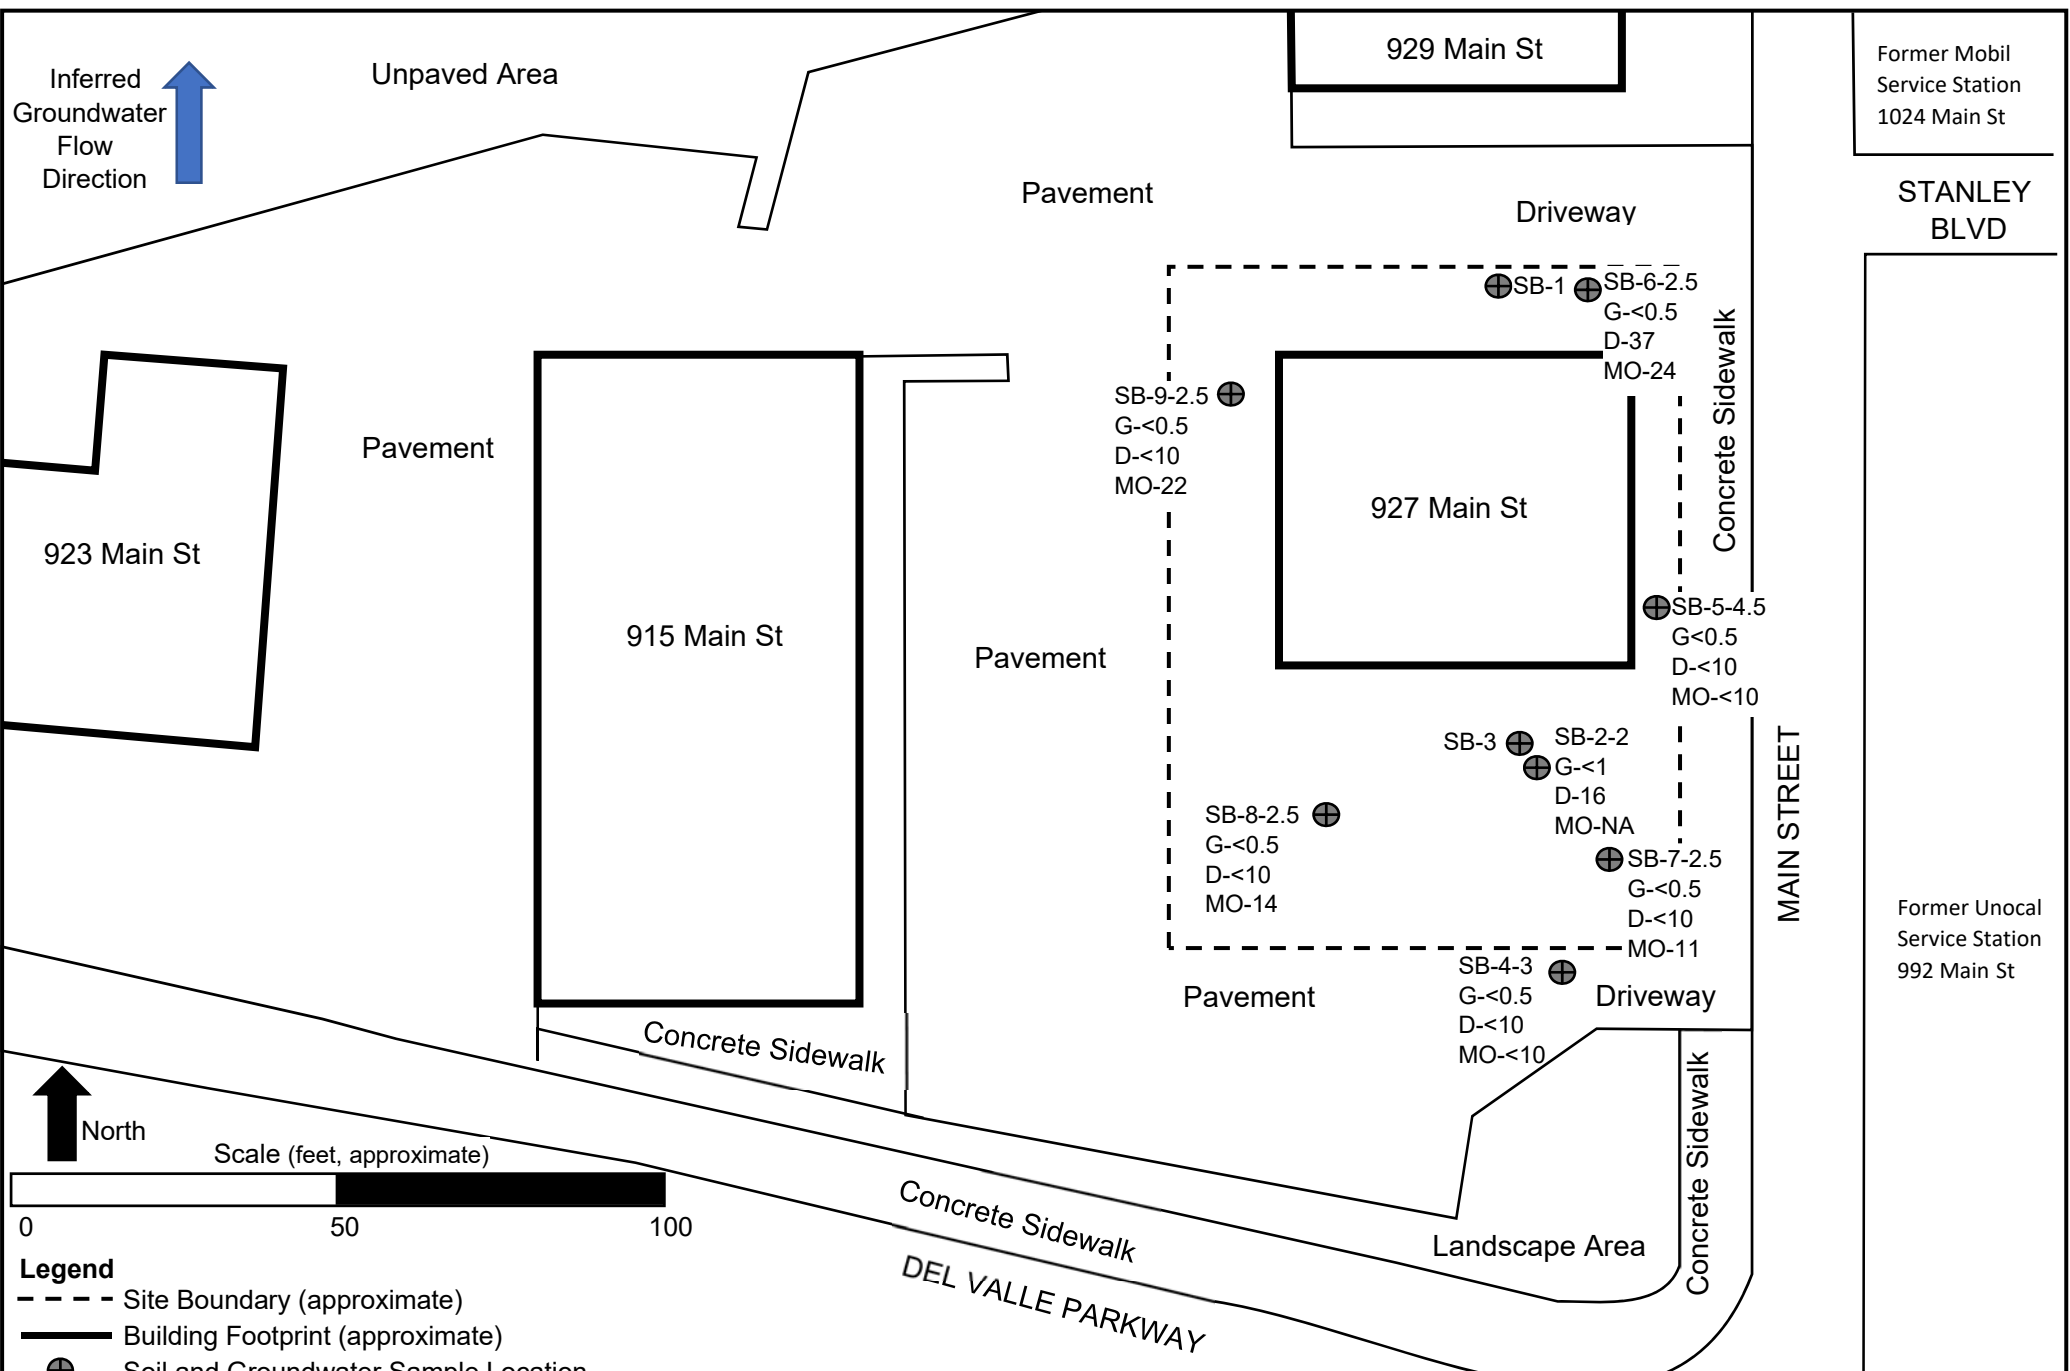
<b>Soil Results: Hydrocarbons, 0- to 5-Foot Depth Interval</b>	PN: 01-2016-1300-001
	Date: June 26, 2017
<b>Soil and Groundwater Investigation Report</b>	EP: Lita Freeman
927 Main Street, Pleasanton, Alameda County, California	<b>Figure 5</b>

- Legend**
- - - - Site Boundary (approximate)
  - ▭ Building Footprint (approximate)
  - ⊕ Soil and Groundwater Sample Location
  - SB-2-2 Sample ID: Boring and Sample Depth (1.5- to 2-foot depth)
  - G Total Petroleum Hydrocarbons (TPH) Quantified as Gasoline, Diesel, Motor Oil; units=milligrams per kilogram (mg/kg); NA=Not Analyzed for noted compound
  - D
  - MO

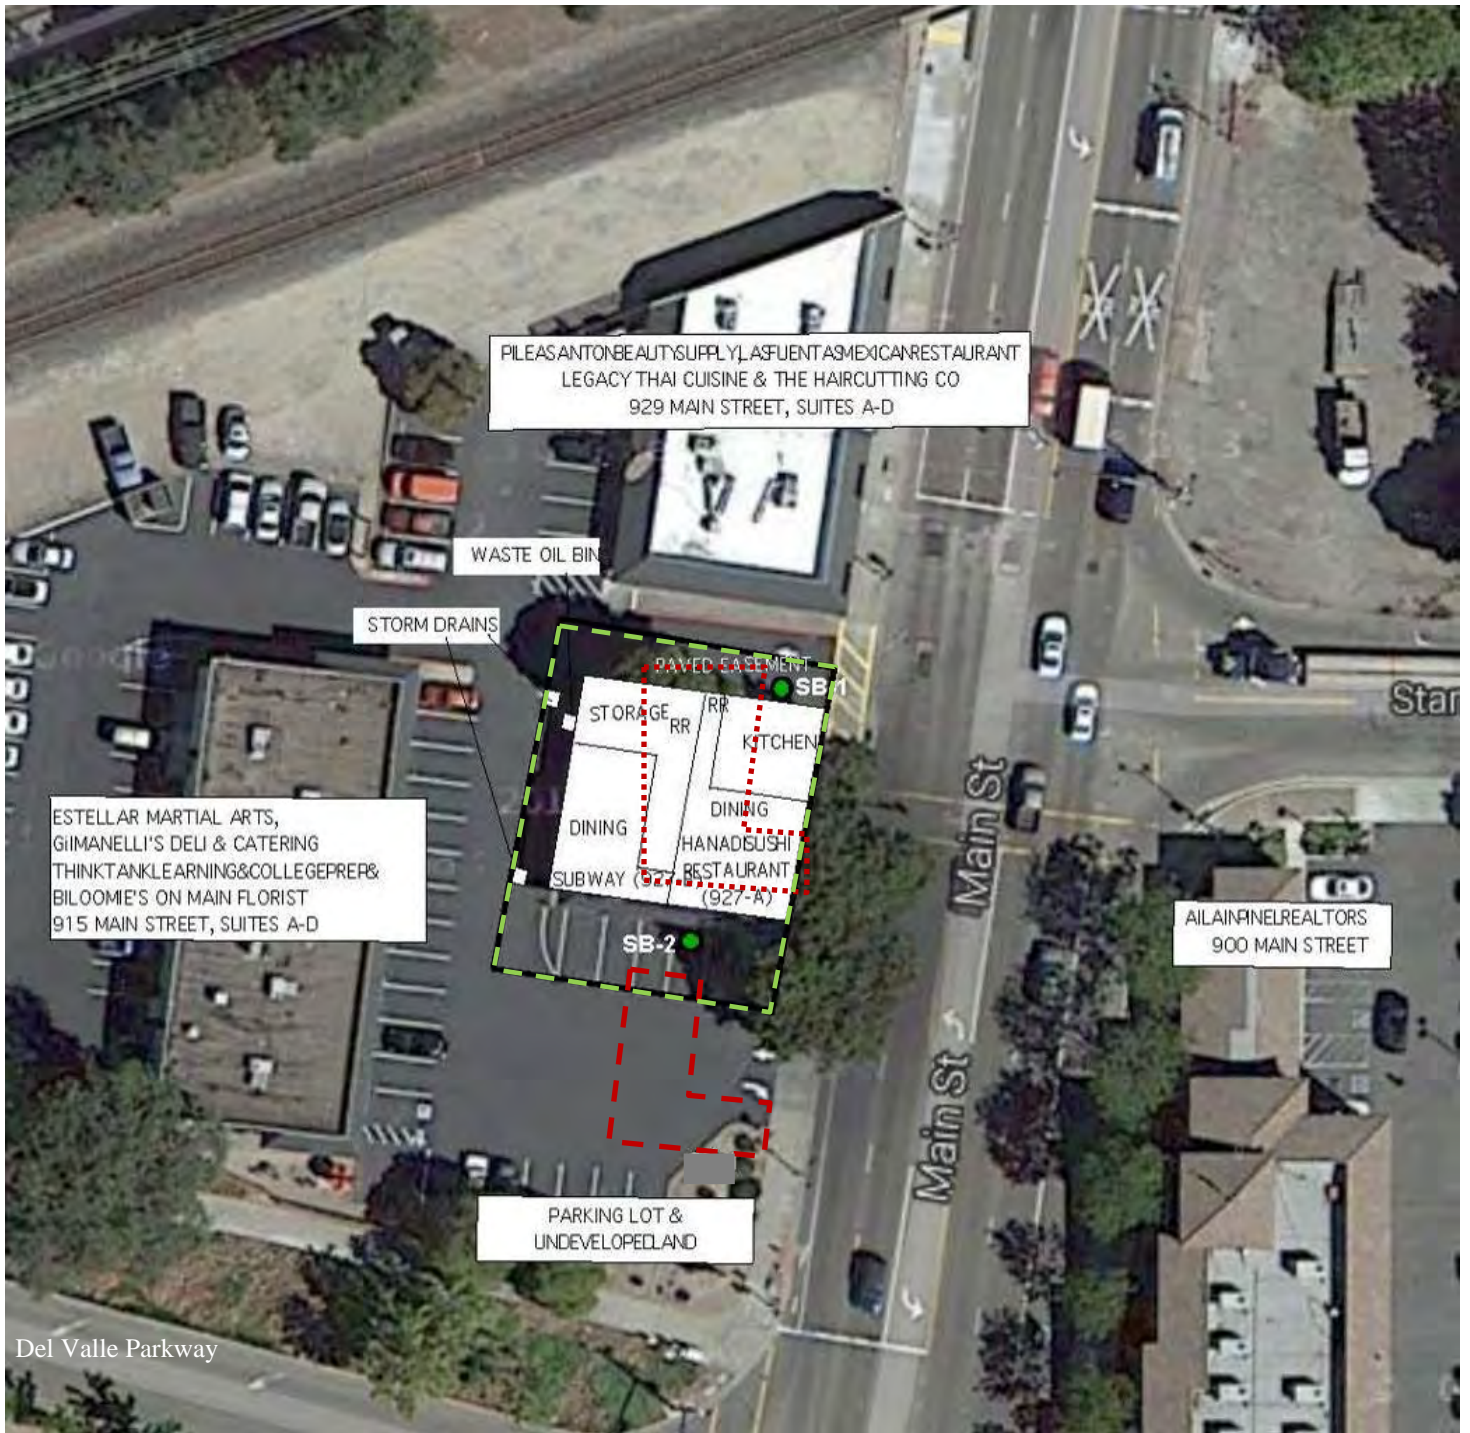
**Figure 1**

<ul style="list-style-type: none"> <li><span style="color: green;">- - - -</span> Approximate Property Boundary</li> <li><span style="color: red;">. . . . .</span> Former Gas Station Building</li> <li><span style="color: red;">- - -</span> Former Canopy Over Dispensers</li> <li><span style="color: green;">●</span> Sampling Location</li> </ul>	<p>↑ North</p> <p>0 _____ 75</p> <p>Scale (feet, approximate)</p>
--	---

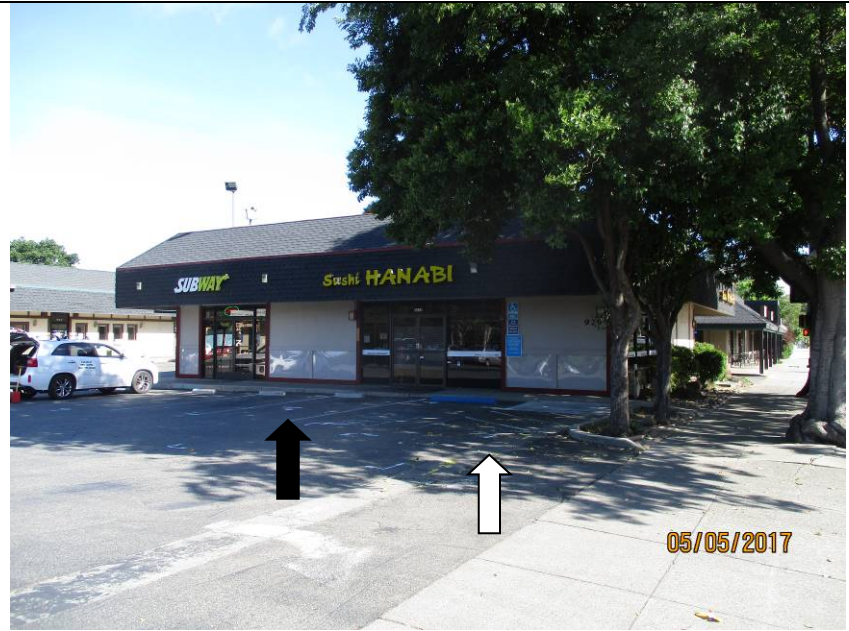
**Photograph: 2**

Photo depicts the south (on right) and west (on left) elevations of the on-site building. View to the northeast with Main Street in background. Proposed locations of boring SB-8 at black arrow and boring SB-9 at white arrow.

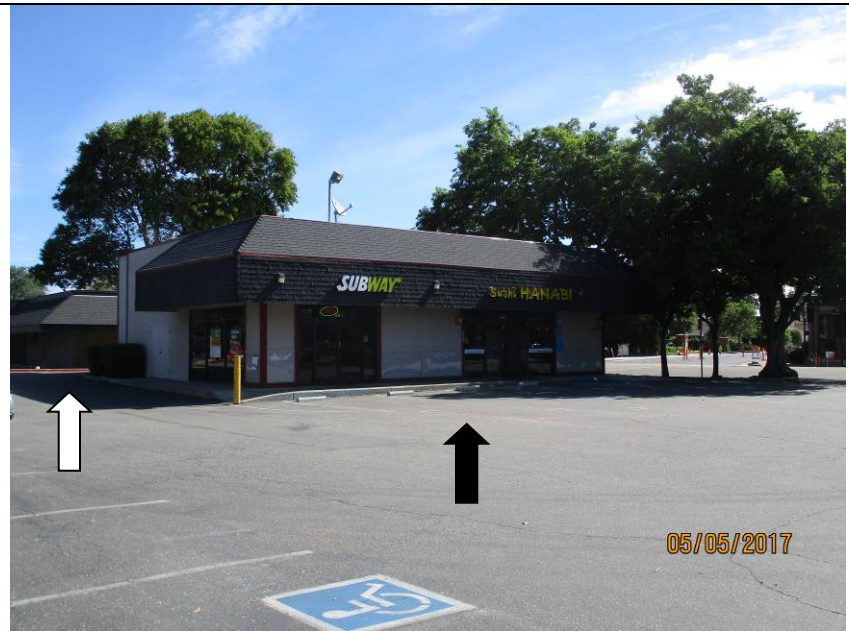
**Photograph: 3**

Photo depicts the east (on left facing sidewalk) and north (on right) elevations of the on-site building. View to the south from across northern driveway. Proposed locations of boring SB-5A at black arrow and boring SB-6 at white arrow.

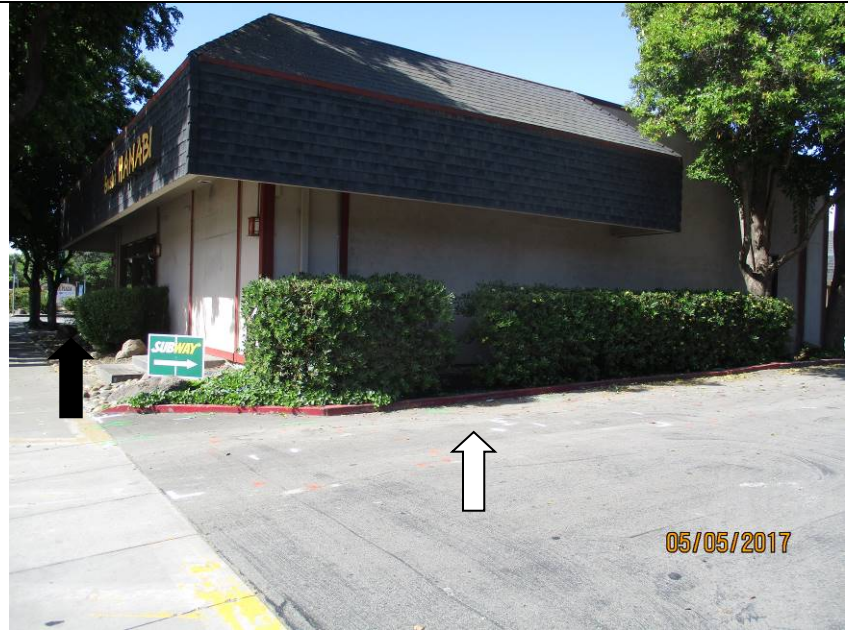
**Photograph: 4**

Photo depicts drilling rig set up on boring SB-2A. Proposed location of boring SB-7 at black arrow. View to northwest.

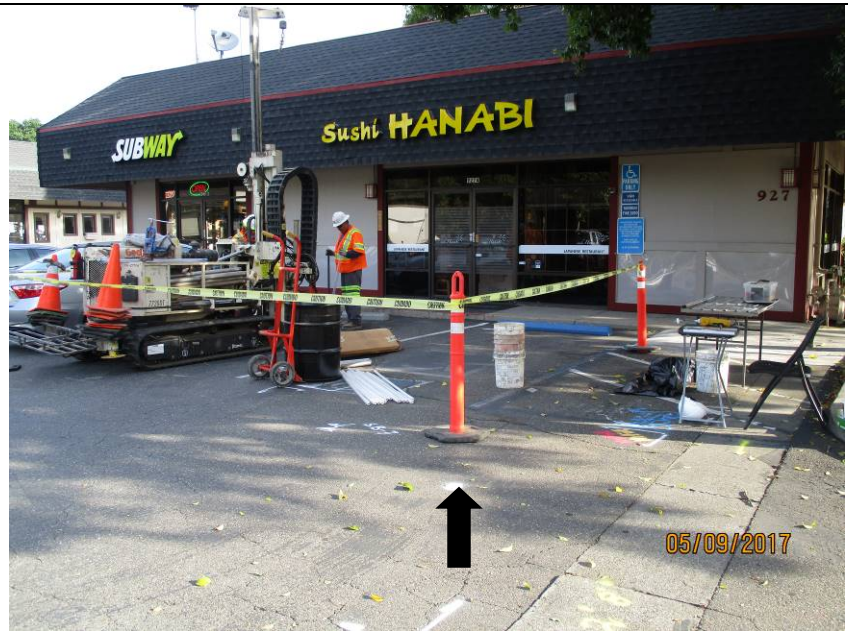
**Photograph: 5**

Photo depicts drilling rig set up on boring SB-6. View to south-southeast.

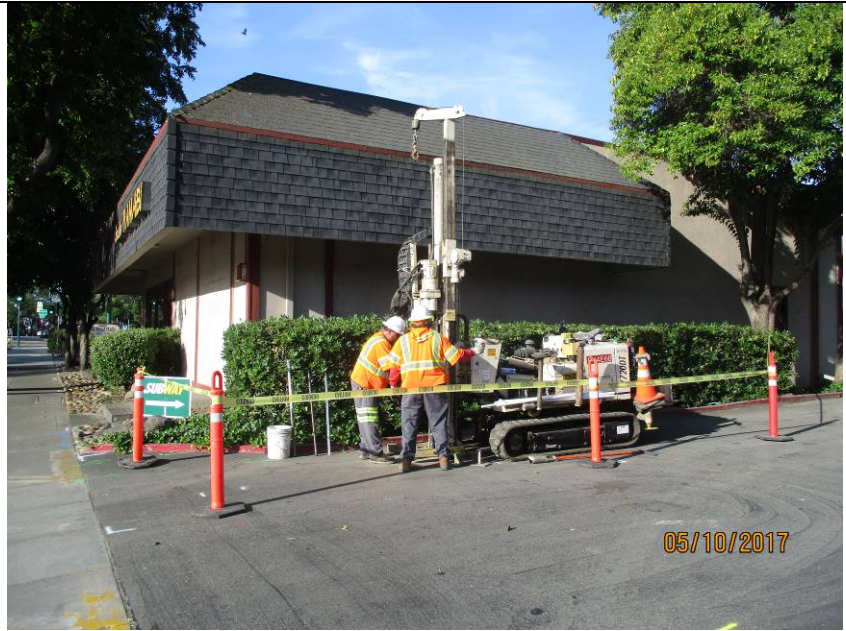
**Photograph: 6**

Photo depicts drilling rig set up on boring SB-8. View to the southeast.

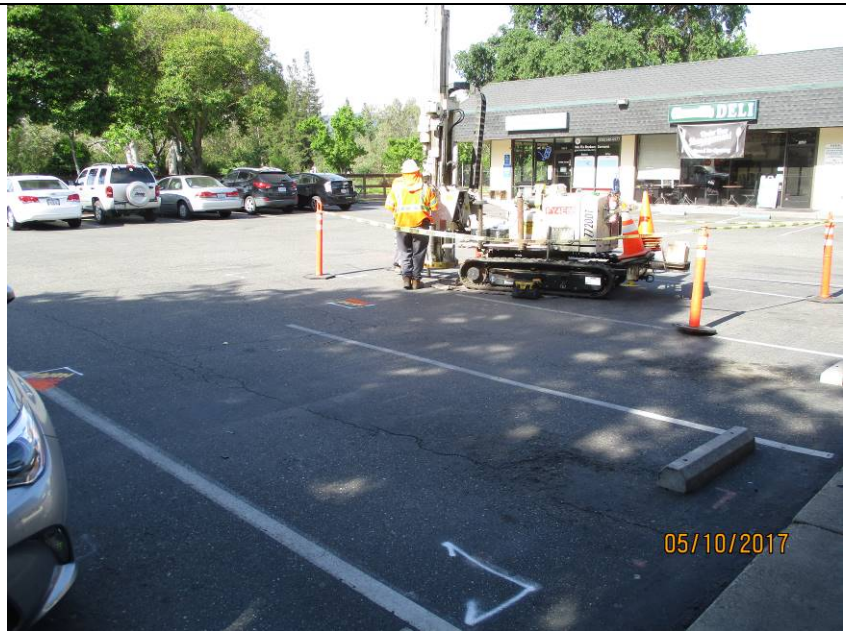
**Photograph: 7**

Photo depicts drilling rig set up on boring SB-9. View to the north.

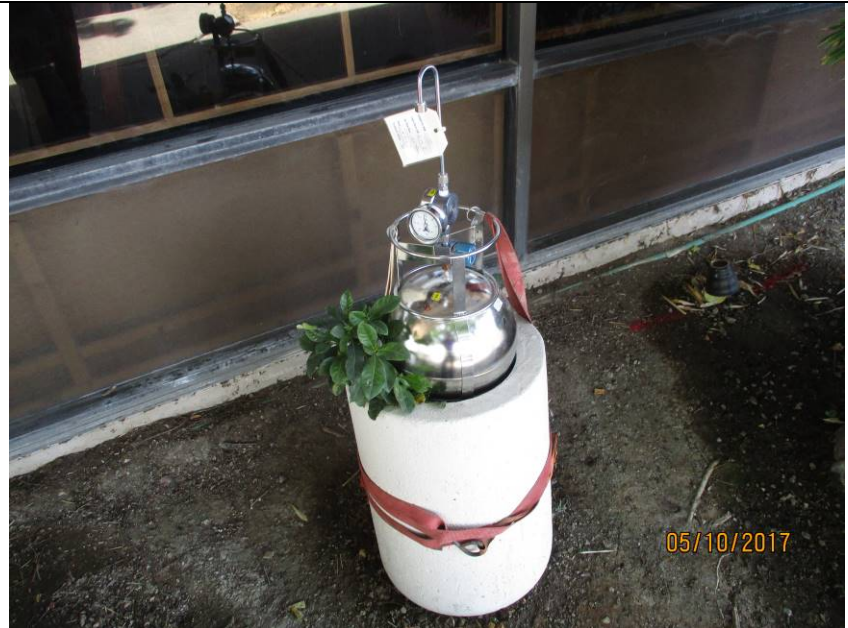
**Photograph: 12**

Photo depicts setting soil gas probe at sampling location SB-5A.

On May 17, 2017, a soil gas sample was collected from a temporary soil gas probe advanced at sampling location SB-5A to a depth of approximately 5 feet below the bottom of the on-site building foundation. The soil gas probe was placed outside the building footprint rather than inside the building because of access constraints. The soil gas sample was collected approximately 2 hours after installing the soil gas probe. The soil gas probe installation method and equilibration time was recorded in the field log book.

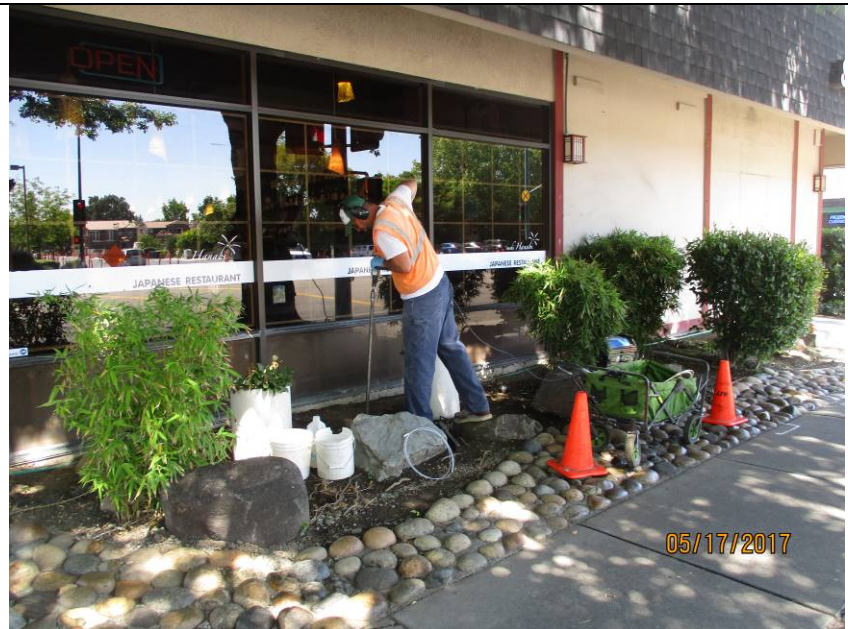
**Photograph: 13**

Photo depicts soil gas sample collection set up with Summa canister at sampling location SB-5A.

Soil gas was collected in an evacuated 1-liter stainless steel Summa canister for TO-15 analysis and in a tube using a syringe for TO-17 analysis. The Summa canister, regulator to control sample collection flow rate into the Summa canister, and tube were provided by McCampbell Analytical, Inc. (McCampbell Analytical) of Pittsburg, California. Beginning and ending vacuum readings for the Summa canister were recorded for the canister as shown in Table 2.

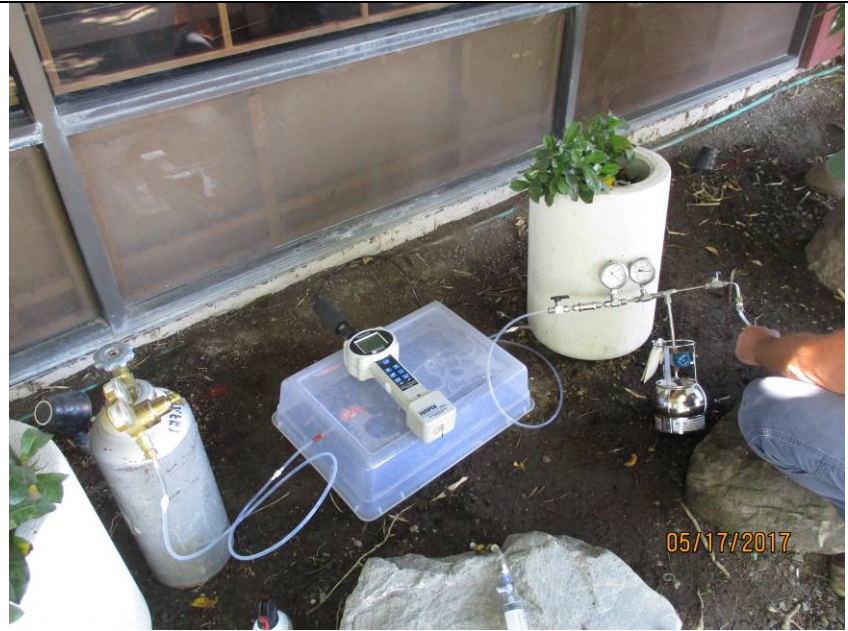
**Photograph: 14**

Photo depicts soil gas sample collection using syringe and tube at sampling location SB-5A.
