REMEDIAL ACTION PLAN FOR LEAD EXCAVATION

9400-9500 International Boulevard

Case #: RO0003202

RPS IRIS ENVIRONMENTAL
1438 Webster Street, Suite 302
Oakland, California 94612

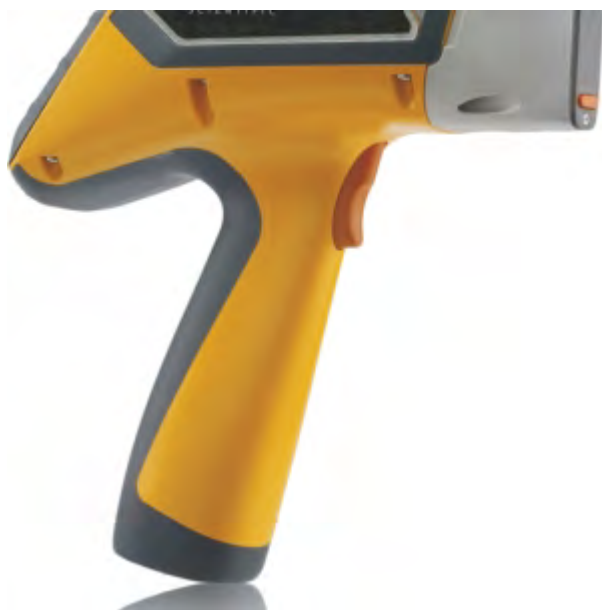
Thermo Scientific Niton XL2 980 GOLDD XRF Analyzer

- Niton XL2 analyzer - High-performance semiconductor detector
- Niton XL2 GOLDD analyzer - Geometrically optimized large area drift detector
- Fixed-angle, color, touch-screen display
- USB and Bluetooth™ communications
- 45 kV miniaturized x-ray tube

To reduce the extent uncertainty of soil impacts, and expedite remediation in case additional impacts are observed, soils will be field screened for lead utilizing an x-ray fluorescence (XRF) analyzer to help determine the excavation limits. An XRF analyzer is capable of measuring real-time lead concentrations in soils. RPS Iris Environmental proposes to use a Thermo Scientific Niton XL2 GOLDD Series Environmental Analyzer, or equivalent. This XRF model is reported to have a lower lead detection limit between 7 and 12 mg/kg depending on soil composition. These specifications are provided in Appendix B. There is precedence in the San Francisco Bay Region to use XRF technology ancillary to confirmation soil sampling for excavation of lead impacted soil to assist in confirmation sampling for lead excavation (Harding 2002) and an Oregon based study has shown excellent correlations for lead (Clark 1999). Additional XRF references include an initiative to identify lead impacts in Berkeley City homes using XRF's (Ridley 2015), screening for toxic metals in packaging recognized by DTSC, screening for lead in soils recognized by the California Department of Public Health (CDPH) (State of California 2016). The reported detection limit is well below the residential ESL of 80 mg/kg for lead. This will provide immediate approximations for lead in soils during excavation, and lend confidence that the RAO has been accomplished before laboratory confirmation sampling results are returned. The approach is designed to avoid or minimize iterative RUSH sampling and analysis events (and corresponding iterative over-excavations) that delay redevelopment activities.
