PHASE I
ENVIRONMENTAL
SITE ASSESSMENT

295 139th Avenue
San Leandro
California

Subject: Phase I Environmental Site Assessment Report
295 139th Avenue
San Leandro, California 94578

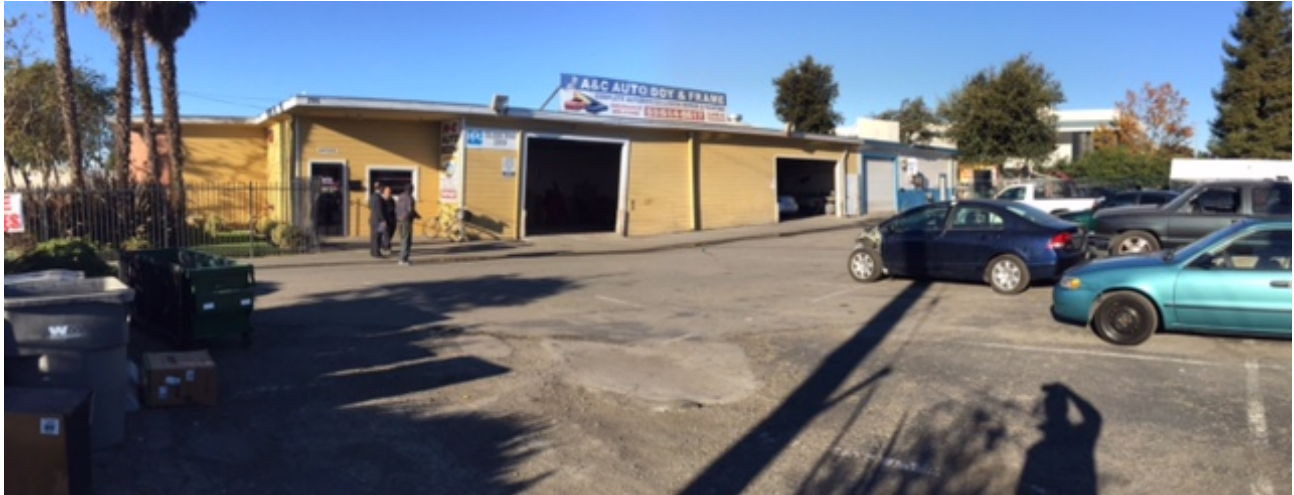
Photo 1: Subject Site (Facing Northwest)
One-Story Commercial Garage Building and Associated Paved and Landscaped Areas
at the Northwest Corner of 139th Avenue and Washington Avenue

The subject site is located within the City of San Leandro at the northwest corner of 139th Avenue and Washington Avenue and approximately three miles east of the San Francisco Bay (See Drawings 1 and 2). The subject site consists of an approximately 0.76-acre “rectangular” shaped parcel of land improved with an approximately 16,154-square foot one-story multi-tenant commercial garage building and associated paved and landscaped areas (See Photos 1 – 4).

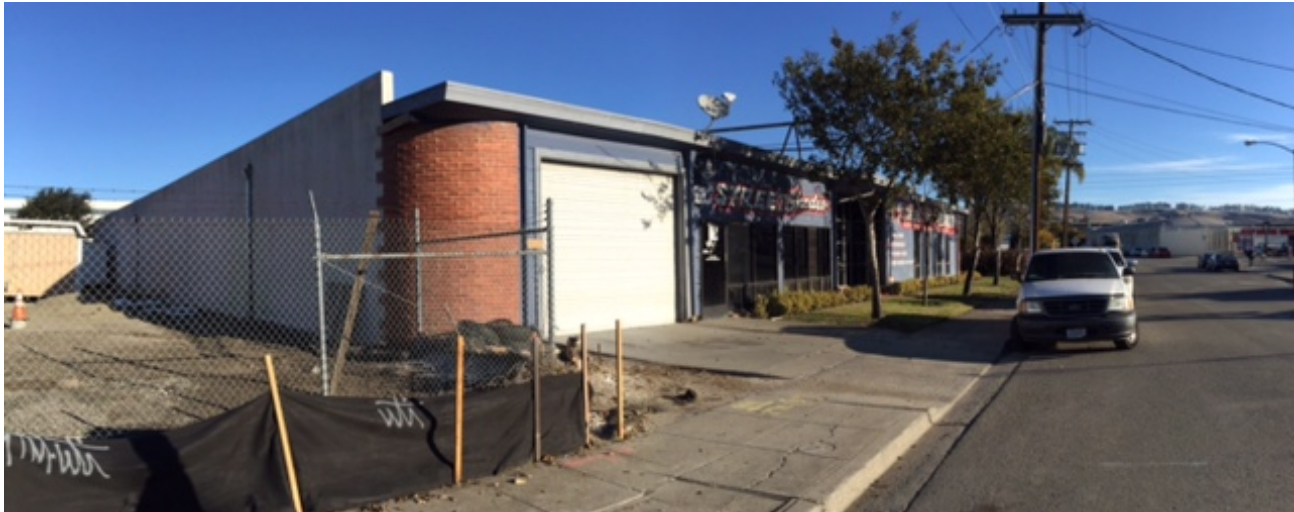
Photo 2: Subject Site (Facing Northeast)
One-Story Commercial Garage Building and Associated Paved and Landscaped Areas
at the Northwest Corner of 139th Avenue and Washington Avenue

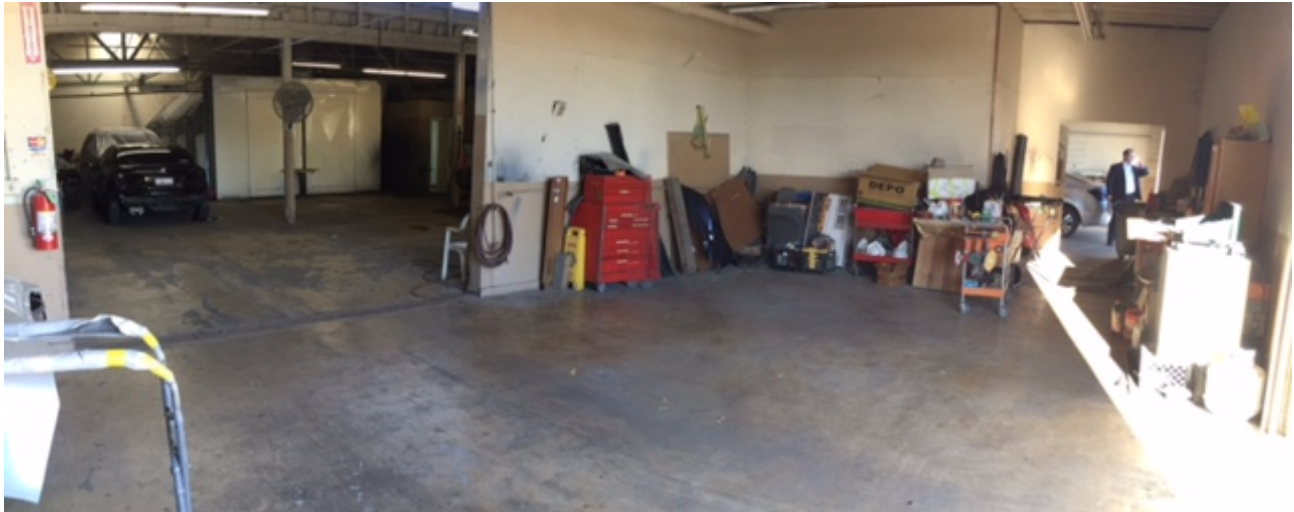
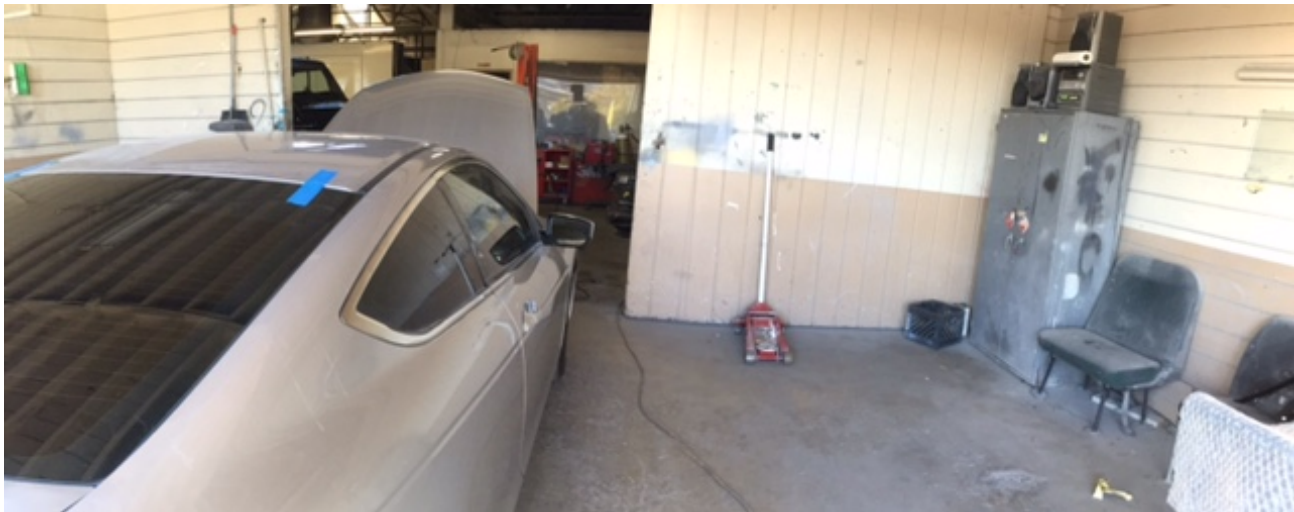
The east warehouse area is located on the east portion of the business unit and consists of an open garage/shop area utilized to receive automobiles (See Photos 3 – 4). During the time of the site inspection, the east warehouse area appeared neat and clean. A metal storage cabinet is located along the north wall. Discussions with a site representative indicated the cabinet is utilized to hold small amounts of car wash and cleaners. Visual observations of the east warehouse area and concrete surface below did not reveal any obvious evidence of hazardous materials, stains or spills. Visual observations of the bare concrete within this area did not reveal any drains, sumps, major cracks or other conduits to the subsurface.

Photo 3: Subject Site (Facing Northwest)
One-Story Commercial Garage Building
(East Warehouse Area of A&C Auto Body & Frame Unit A)

Photo 4: Subject Site (Facing Southwest)
One-Story Commercial Garage Building
(East Warehouse Area of A&C Auto Body & Frame Unit A)

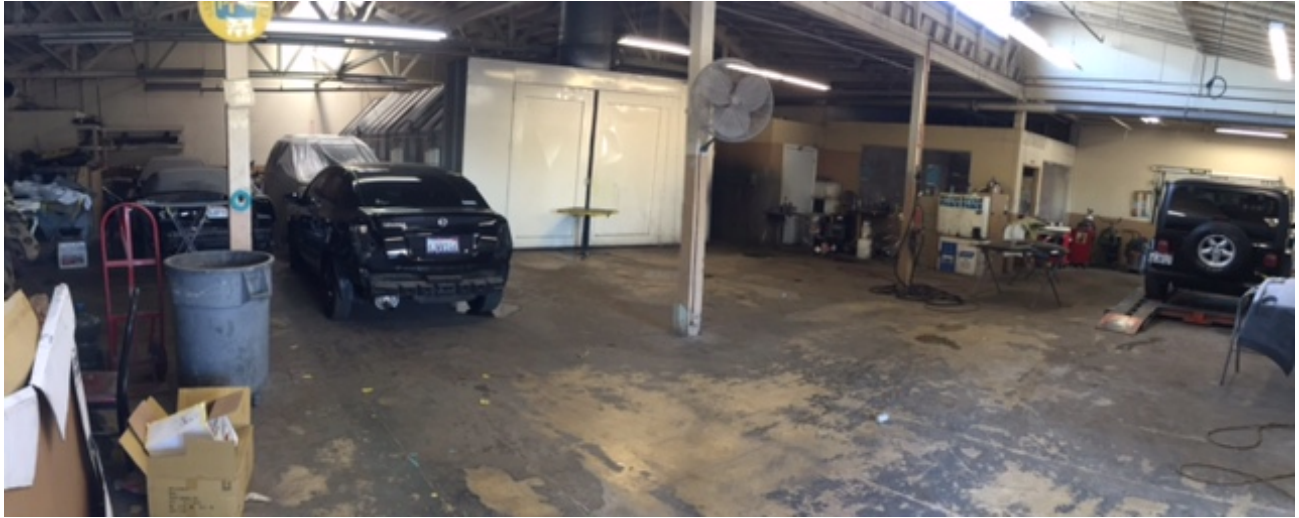
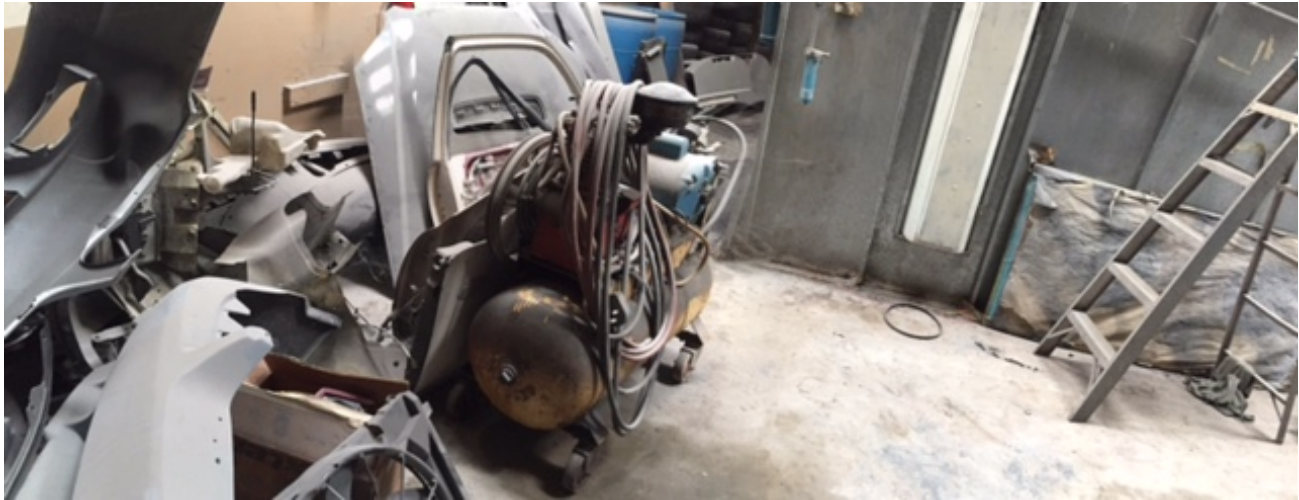
Located on the west portion of the west warehouse area is an enclosed metal spay paint booth connected to an air filtration system (See Photos 5 – 6). Visual observations of the enclosed metal spay paint booth and concrete surface below did not reveal any obvious evidence of hazardous materials, stains or spills. Visual observations of the bare concrete within this area did not reveal any drains, sumps, major cracks or other conduits to the subsurface. Discussions with a site representative of A & C Auto Body & Frame indicated the air vent collects fumes which flows through air filter/scrubber which is permitted with the Bay Area Air Quality Management District. Visual observations of the bare concrete within this area did not reveal any other drains, sumps, major cracks or other conduits to the subsurface.

Photo 5: Subject Site (Facing Northwest)
One-Story Commercial Garage Building
(West Warehouse Area of A&C Auto Body & Frame Unit A)

Photo 6: Subject Site (Facing North)
One-Story Commercial Garage Building
(Paint Booth in West Warehouse Area of A&C Auto Body & Frame Unit A)

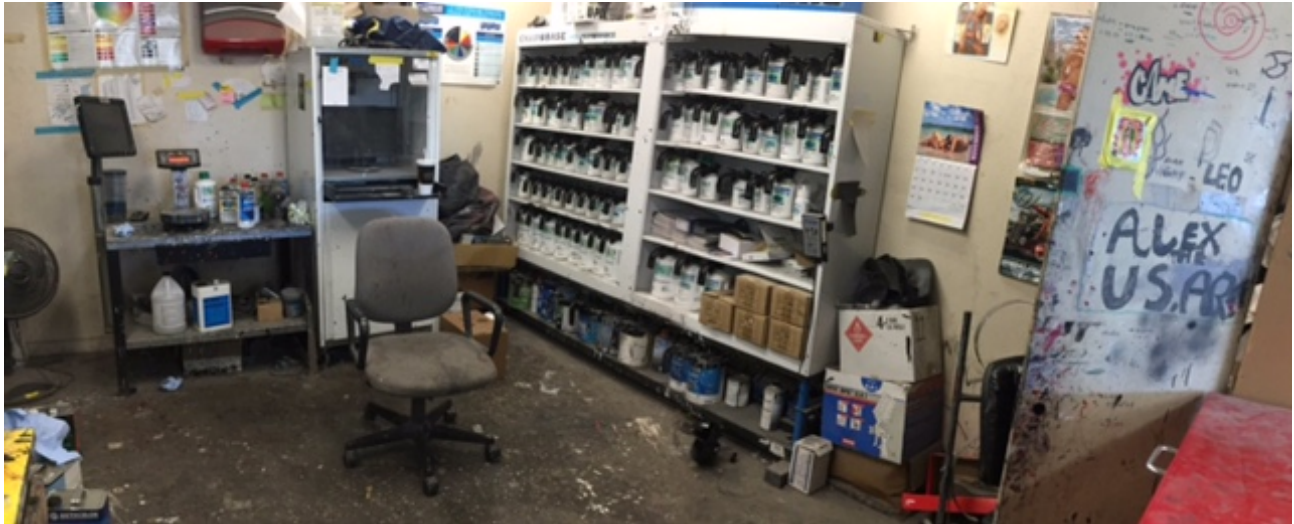
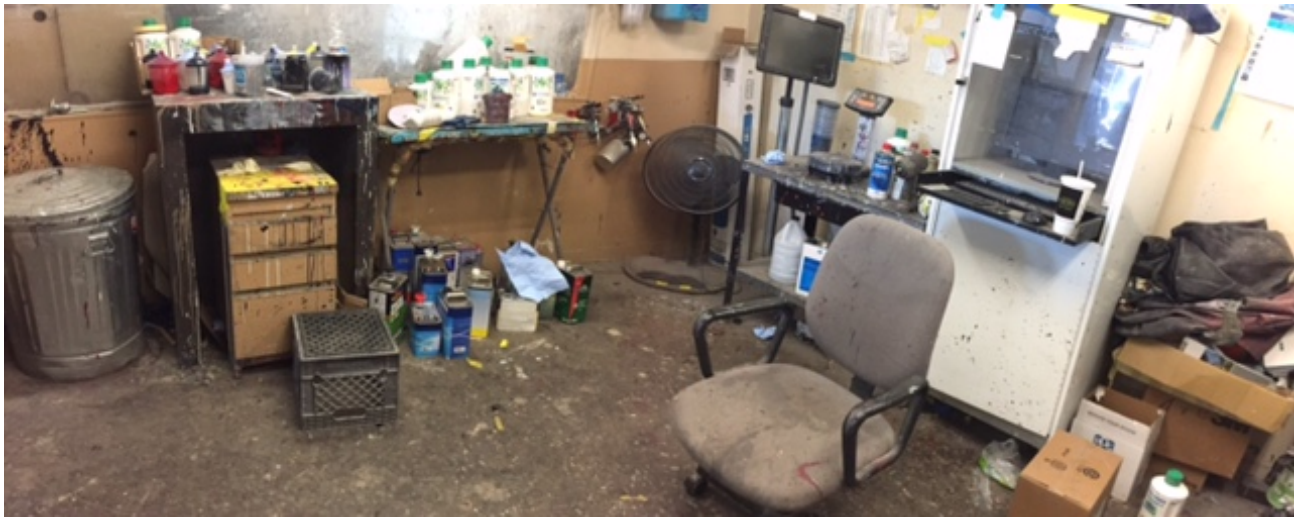
The paint storage room is located on the northwest portion of the west warehouse area and utilized to store paints and thinners. Located within the paint storage room are shelves of small containers (1 pint and 1 gallon containers) of miscellaneous auto body paints and lacquers (See Photos 7 – 8). Discussions with a site representative of A & C Auto Body & Frame indicated paint mixing occurs in this area with small amounts of paints and thinners. Visual observations of the miscellaneous auto body paints, thinners and concrete surface below revealed only minor evidence of paint stains and splatters. Visual observations of the bare concrete within this area did not reveal any drains, sumps, major cracks or other conduits to the subsurface.

Photo 7: Subject Site (Facing Northwest)
One-Story Commercial Garage Building
(Paint Mixing Room in West Warehouse Area of A&C Auto Body & Frame Unit A)

Photo 8: Subject Site (Facing Southwest)
One-Story Commercial Garage Building
(Paint Mixing Room in West Warehouse Area of A&C Auto Body & Frame Unit A)

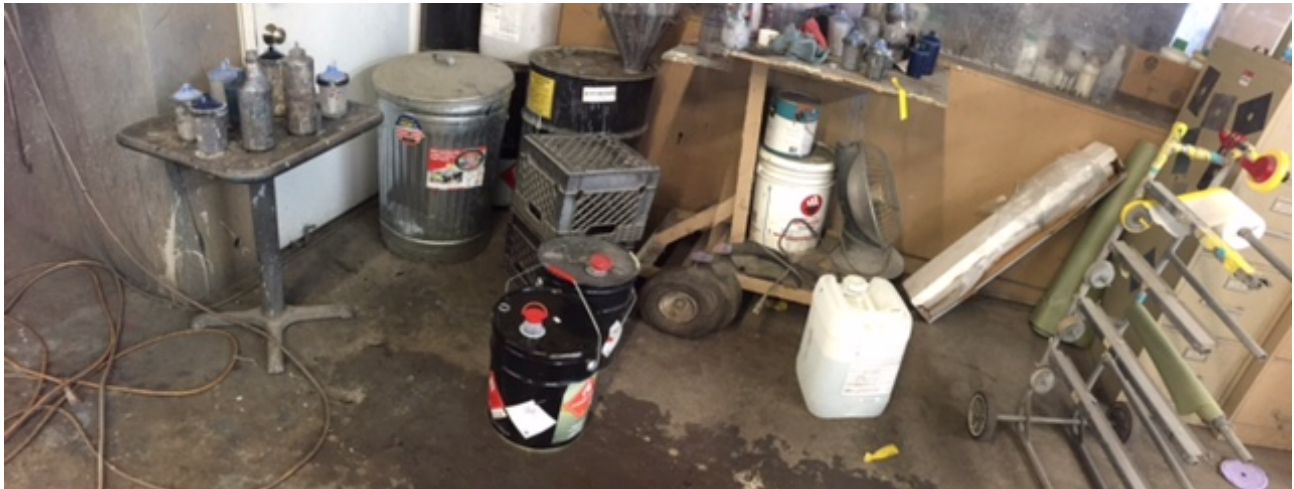
Located just east of the paint storage room is one 55-gallon steel drum container utilized to hold waste paint/thinner (See Photo 9). No secondary containment was noted below the drum. Additional small containers (1 pint and 1 gallon containers) of miscellaneous auto body paints and 5-gallon containers of lacquers are located in this area. Discussions with a site representative of A & C Auto Body & Frame indicated waste paint/thinner is collected, manifested and recycled by a local recycler on a periodic basis (CAL EPA# CAL000288760). Visual observations of the 55-gallon drum of waste paint/thinner, miscellaneous auto body paints, lacquers and concrete surface below revealed only minor evidence of paint stains and splatters. Visual observations of the bare concrete within this area did not reveal any drains, sumps, major cracks or other conduits to the subsurface.

Photo 9: Subject Site (Facing Northwest)
One-Story Commercial Garage Building
(Paint Mixing Room in West Warehouse Area of A&C Auto Body & Frame Unit A)

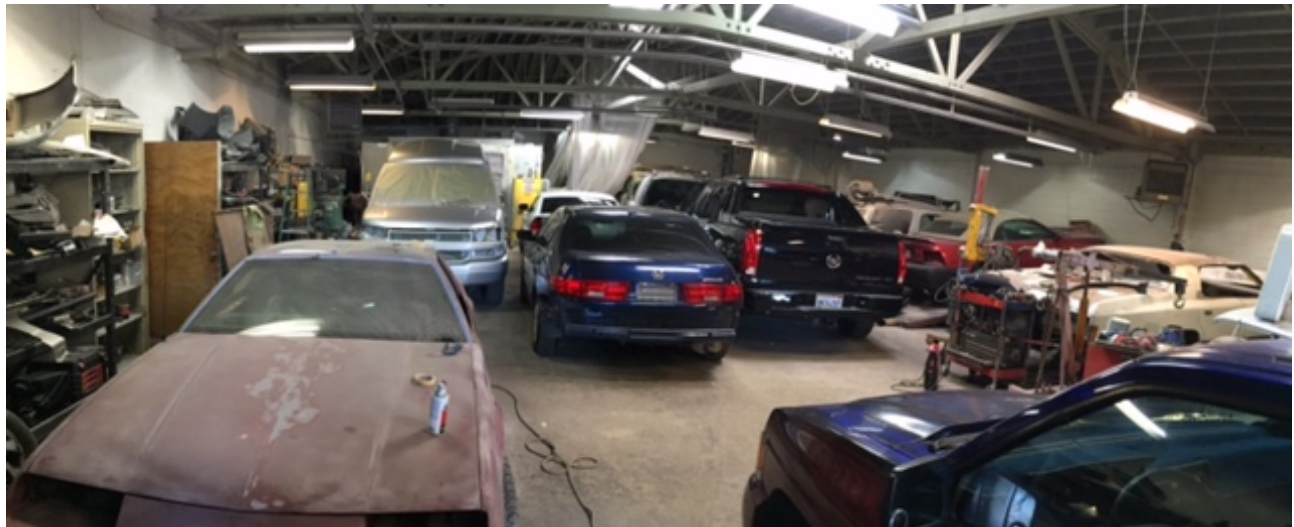
The warehouse area occupies the majority of the business unit and consists of an open garage/shop area utilized to service, sand and paint automobiles (See Photo 10). During the time of the site visit, the warehouse area was occupied by multiple automobiles limiting observations. Discussions with a site representative of JP Auto Body & Paint indicated no underground hydraulic lifts are utilized at the subject site.

Photo 10: Subject Site (Facing West)
One-Story Commercial Garage Building
(Warehouse Area of JP Auto Body & Paint Unit C)

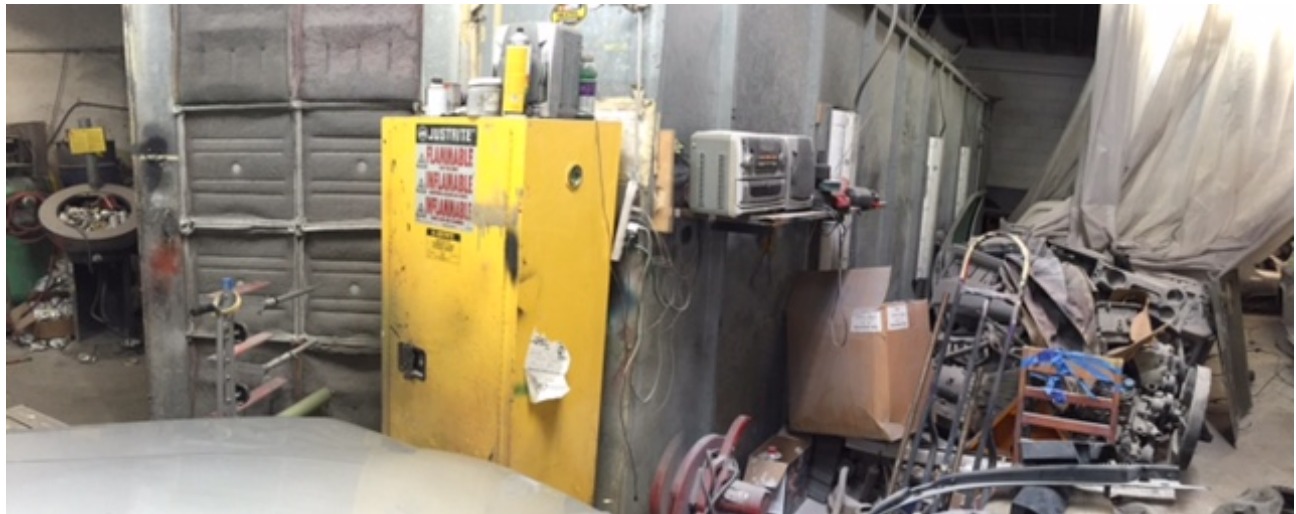
Located on the southwest portion of the warehouse area is an enclosed metal spray paint booth connected to an air filtration system (See Photo 11). Visual observations of the enclosed metal spray paint booth and concrete surface below did not reveal any obvious evidence of hazardous materials, stains or spills. Visual observations of the bare concrete within this area did not reveal any drains, sumps, major cracks or other conduits to the subsurface. Discussions with a site representative of JP Auto Body & Paint indicated the air vent collects fumes which flows through air filter/scrubber which is permitted with the Bay Area Air Quality Management District.

Located just east of the metal spray paint booth is a metal flammable materials cabinet utilized to store small containers (1 pint and 1 gallon containers) of miscellaneous auto body paints and lacquers (See Photo 11). Visual observations of the miscellaneous auto body paints, thinners and concrete surface below revealed only minor evidence of paint stains and splatters. Visual observations of the bare concrete within this area did not reveal any drains, sumps, major cracks or other conduits to the subsurface.

Photo 11: Subject Site (Facing Southwest)
One-Story Commercial Garage Building
(Paint Booth in Warehouse Area of JP Auto Body & Paint Unit C)

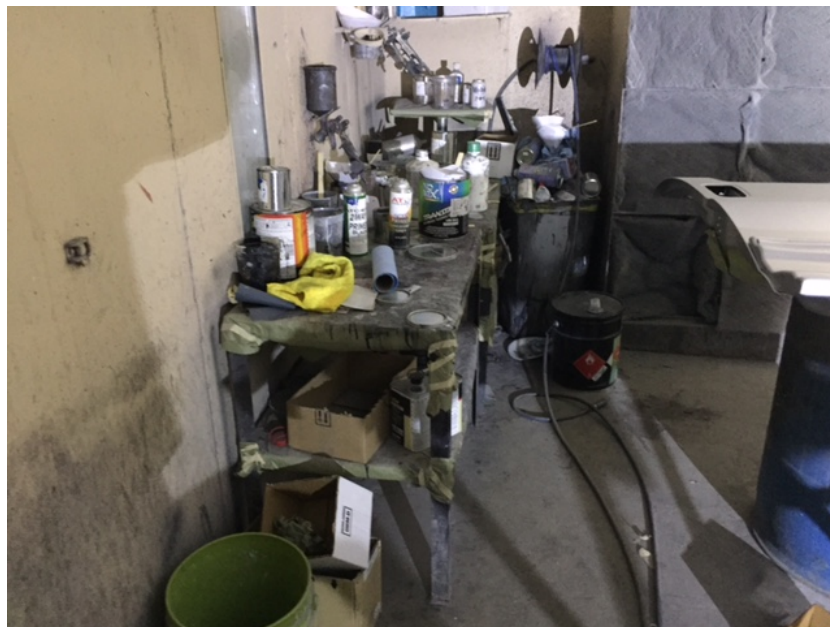
Located on the northeast portion of the warehouse area is a workbench with additional small containers (1 pint and 1 gallon containers) of miscellaneous auto body paints and 5-gallon container of lacquers (See Photo 12). A 30-gallon steel container appears to be utilized to store waste paint/thinner. No secondary containment was noted below the container. Discussions with a site representative JP Auto Body & Paint indicated paint mixing occurs in this area with small amounts of paints and thinners. Waste paint/thinner is collected, manifested and recycled by a local recycler on a periodic basis (CAL EPA# CAL000409321). Visual observations of the 30-gallon container of waste paint/thinner, miscellaneous auto body paints, lacquers and concrete surface below revealed only minor evidence of paint stains and splatters. Visual observations of the bare concrete within this area did not reveal any drains, sumps, major cracks or other conduits to the subsurface.

Photo 12: Subject Site (Facing West)
One-Story Commercial Garage Building
(Paint Mixing Area in Warehouse Area of JP Auto Body & Paint Unit C)

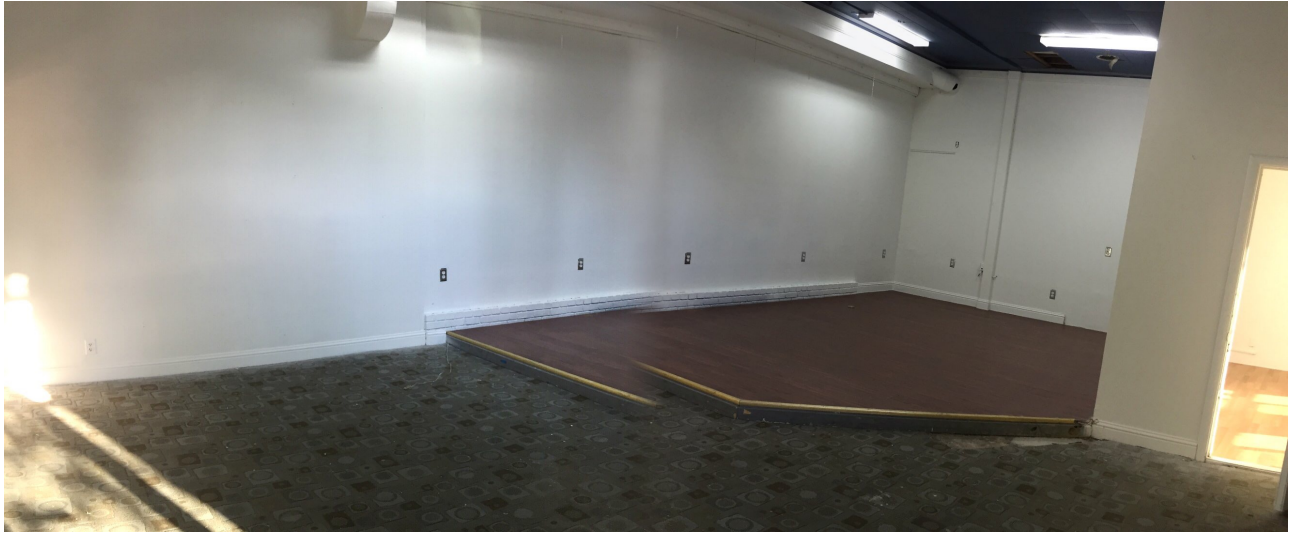
The office area (Units B, D & E) is located on the south portion of the business unit and consists of five individual offices (See Photos 13 & 14). Signage on the exterior doors indicated the two offices on the east portion appear to have been Unit B; the office in the center portion appears to have been Unit D and the office on the west portion appears to have been the office area of Unit E. During the time of the site visit, the office areas were vacant and unoccupied. Visual observations of the office area did not reveal any obvious evidence of hazardous materials, stains or spills. Visual observations of the floor of the office area did not reveal any obvious evidence of collection drains, sumps or other conduits to the subsurface.

Photo 13: Subject Site (Facing Northeast)
One-Story Commercial Garage Building
(Vacant Retail Unit B)

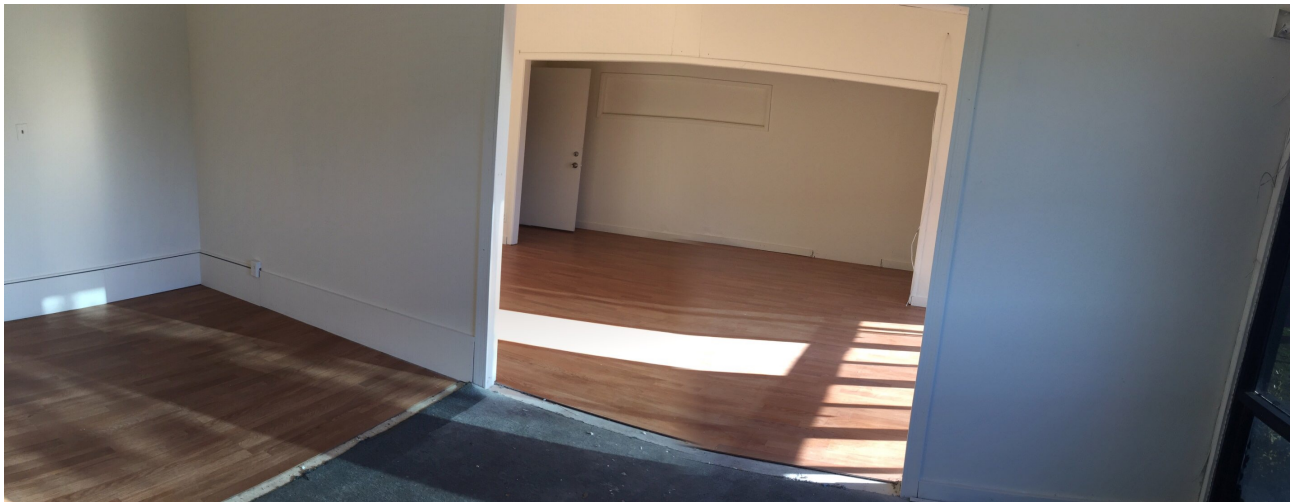
Photo 14: Subject Site (Facing Northeast)
One-Story Commercial Garage Building
(Vacant Retail Unit D)

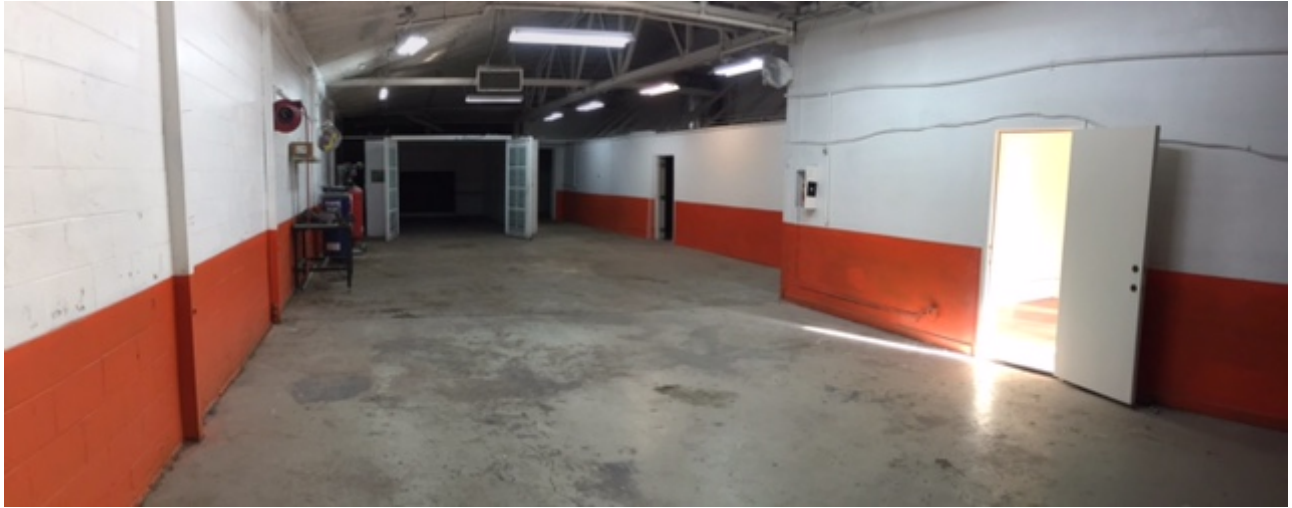
The warehouse area (Unit E) occupies the west portion of the business unit and consists of an open garage/shop area formerly utilized to service, sand and paint automobiles (See Photo 15). During the time of the site visit, the warehouse area was vacant and unoccupied. Located on the northwest portion of the warehouse area is an enclosed metal spay paint booth (See Photo 16). Two air compressors are also located in this area. Visual observations of the enclosed metal spay paint booth, air compressors and concrete surface below did not reveal any obvious evidence of hazardous materials, stains or spills. Visual observations of the bare concrete within this area did not reveal any drains, sumps, major cracks or other conduits to the subsurface.

Photo 15: Subject Site (Facing North)
One-Story Commercial Garage Building
(Vacant Retail Unit E)

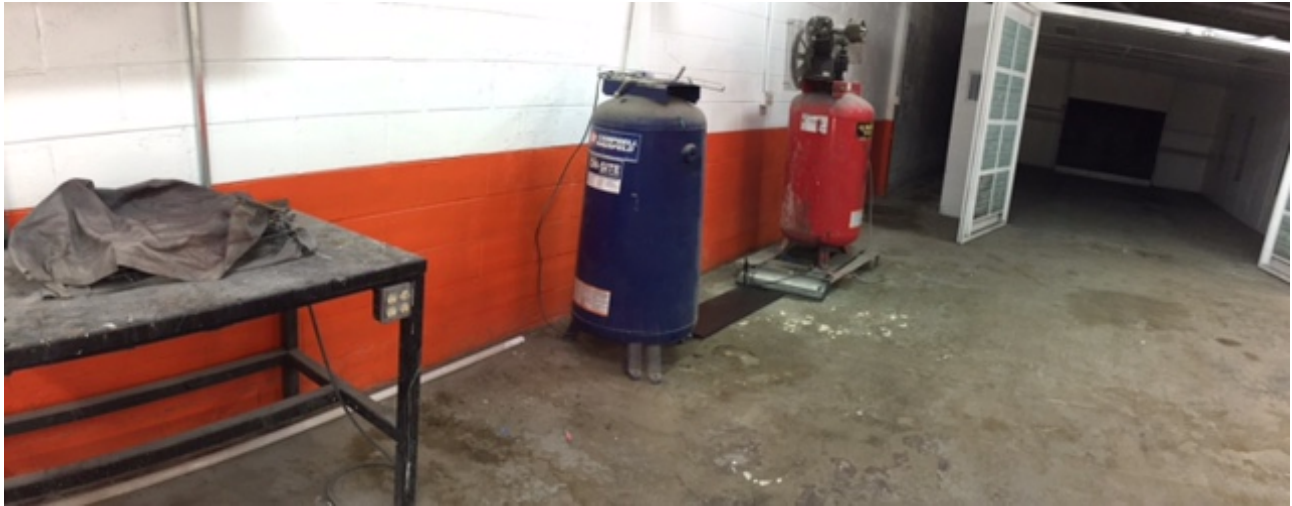
Photo 16: Subject Site (Facing Northwest)
One-Story Commercial Garage Building
(Paint Booth and Air Compressors in Vacant Retail Unit E)

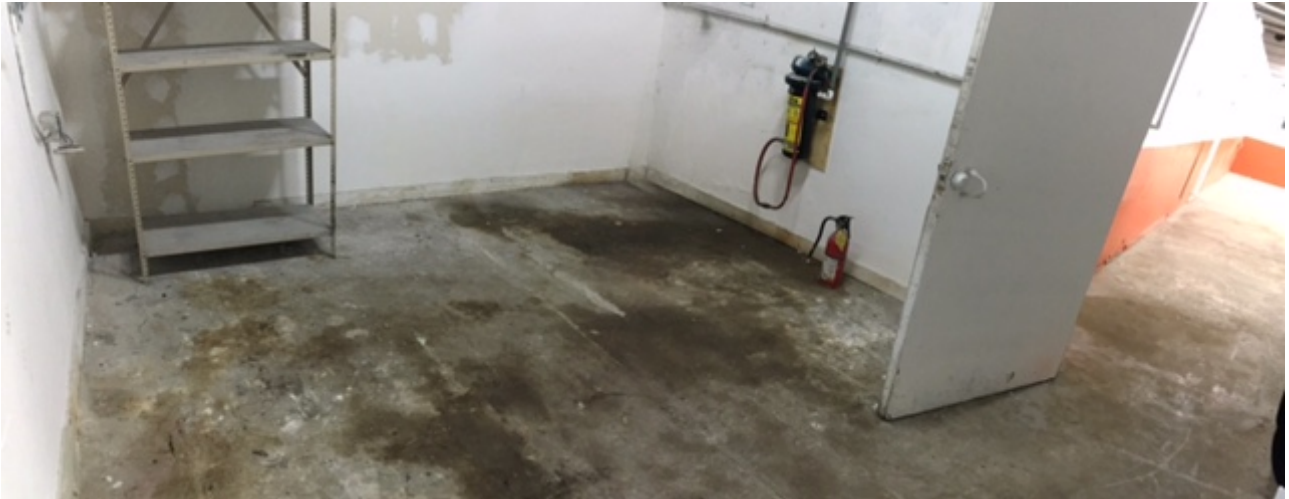
A storage room is located on the northeast portion of the warehouse area (See Photo 17). During the time of the site visit, the storage room was vacant and unoccupied. An air compressor hose connection appears to be located on the wall which extends into the warehouse area. Visual observations of the storage room did not reveal any obvious evidence of hazardous materials, however evidence of oil stains were noted on the concrete floor below the air compressor hose. This may have been from a former air compressor. Visual observations of the bare concrete within this area did not reveal any drains, sumps, major cracks or other conduits to the subsurface.

Photo 17: Subject Site (Facing North)
One-Story Commercial Garage Building
(Former Storage Room in Vacant Retail Unit E)

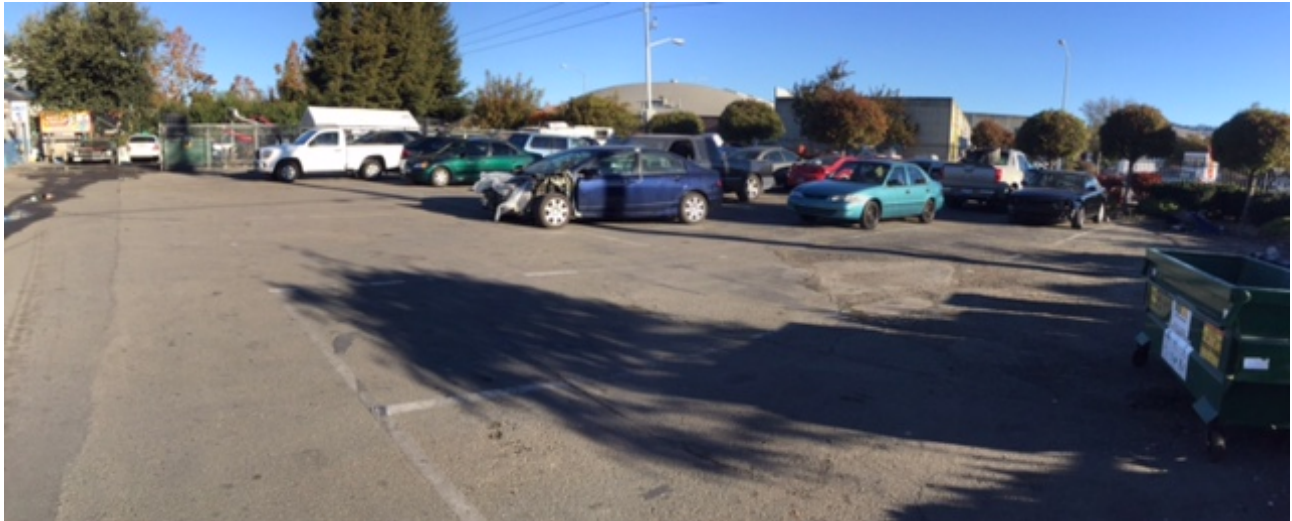
Associated Paved and Landscaped Areas - The associated paved area is located on the east portion of the subject site and is enclosed by a chain link fence and gate (See Photo 18). The associated paved area consists of asphalt and concrete, and is accessible from 139th Avenue to the south. The associated paved parking area is utilized as a common parking/storage zone for the subject site building. The associated landscaped area is located along the south and east perimeters of the subject site and interspersed between the building and sidewalk areas.

Photo 18: Subject Site (Facing Northeast)
Associated Paved Parking Lot

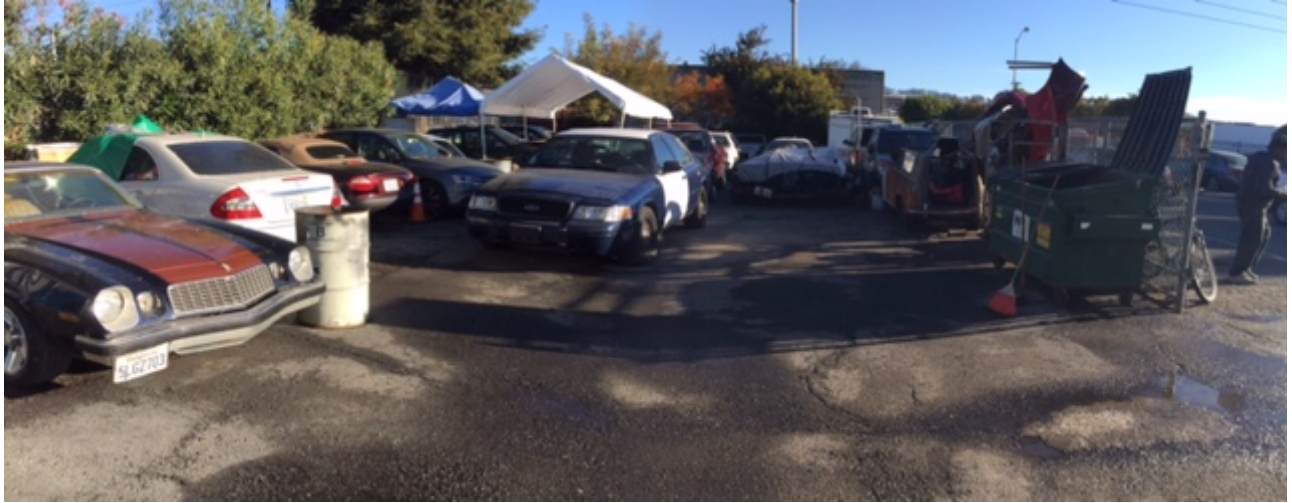
Located within the north portion of the associated paved area are multiple automobiles in disrepair. Two canvas canopies are also located in this area (See Photo 19). Located along the northeast perimeter of this area are various used tires and small 5-gallon plastic buckets of waste oil. General observations of this area revealed poor housekeeping and evidence of minor oil stains or spills. Visual observations of the asphalt in this area did not reveal any obvious evidence of drains, sumps or other conduits to the subsurface.

Photo 19: Subject Site (Facing East)
Associated Paved Parking Lot

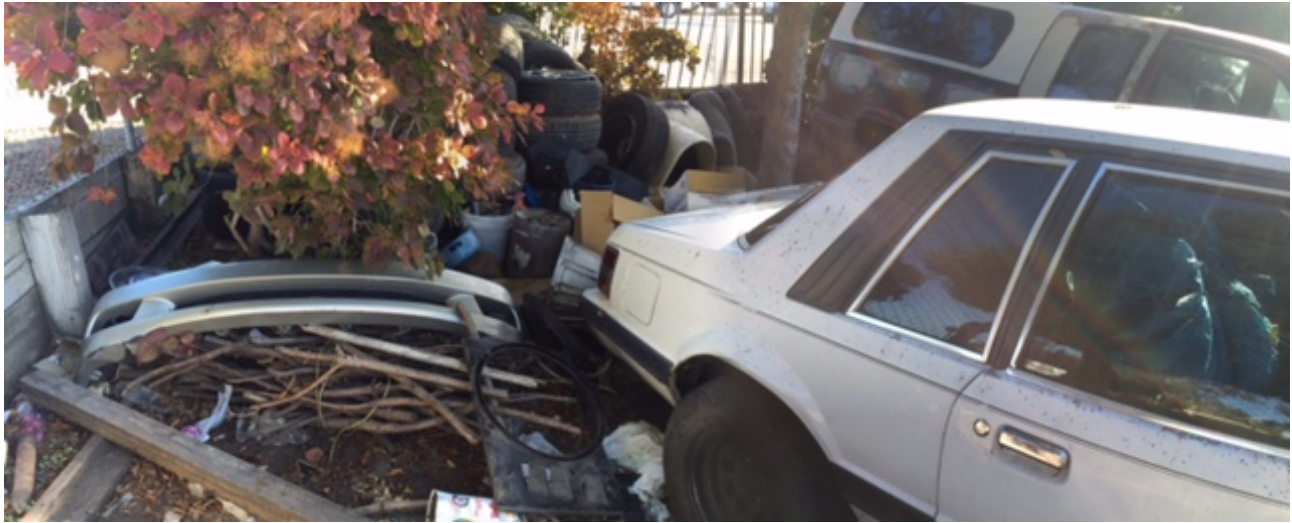
Photo 20: Subject Site (Facing East)
Various Used Tires and Small Containers of Waste Oil in Associated Paved Parking Lot
