December 9, 2016

**Subject: Phase II Limited Soil & Soil Vapor Investigation Report
1228-1236 East 17th Street, Oakland, California
EIS Project # 1652-2**

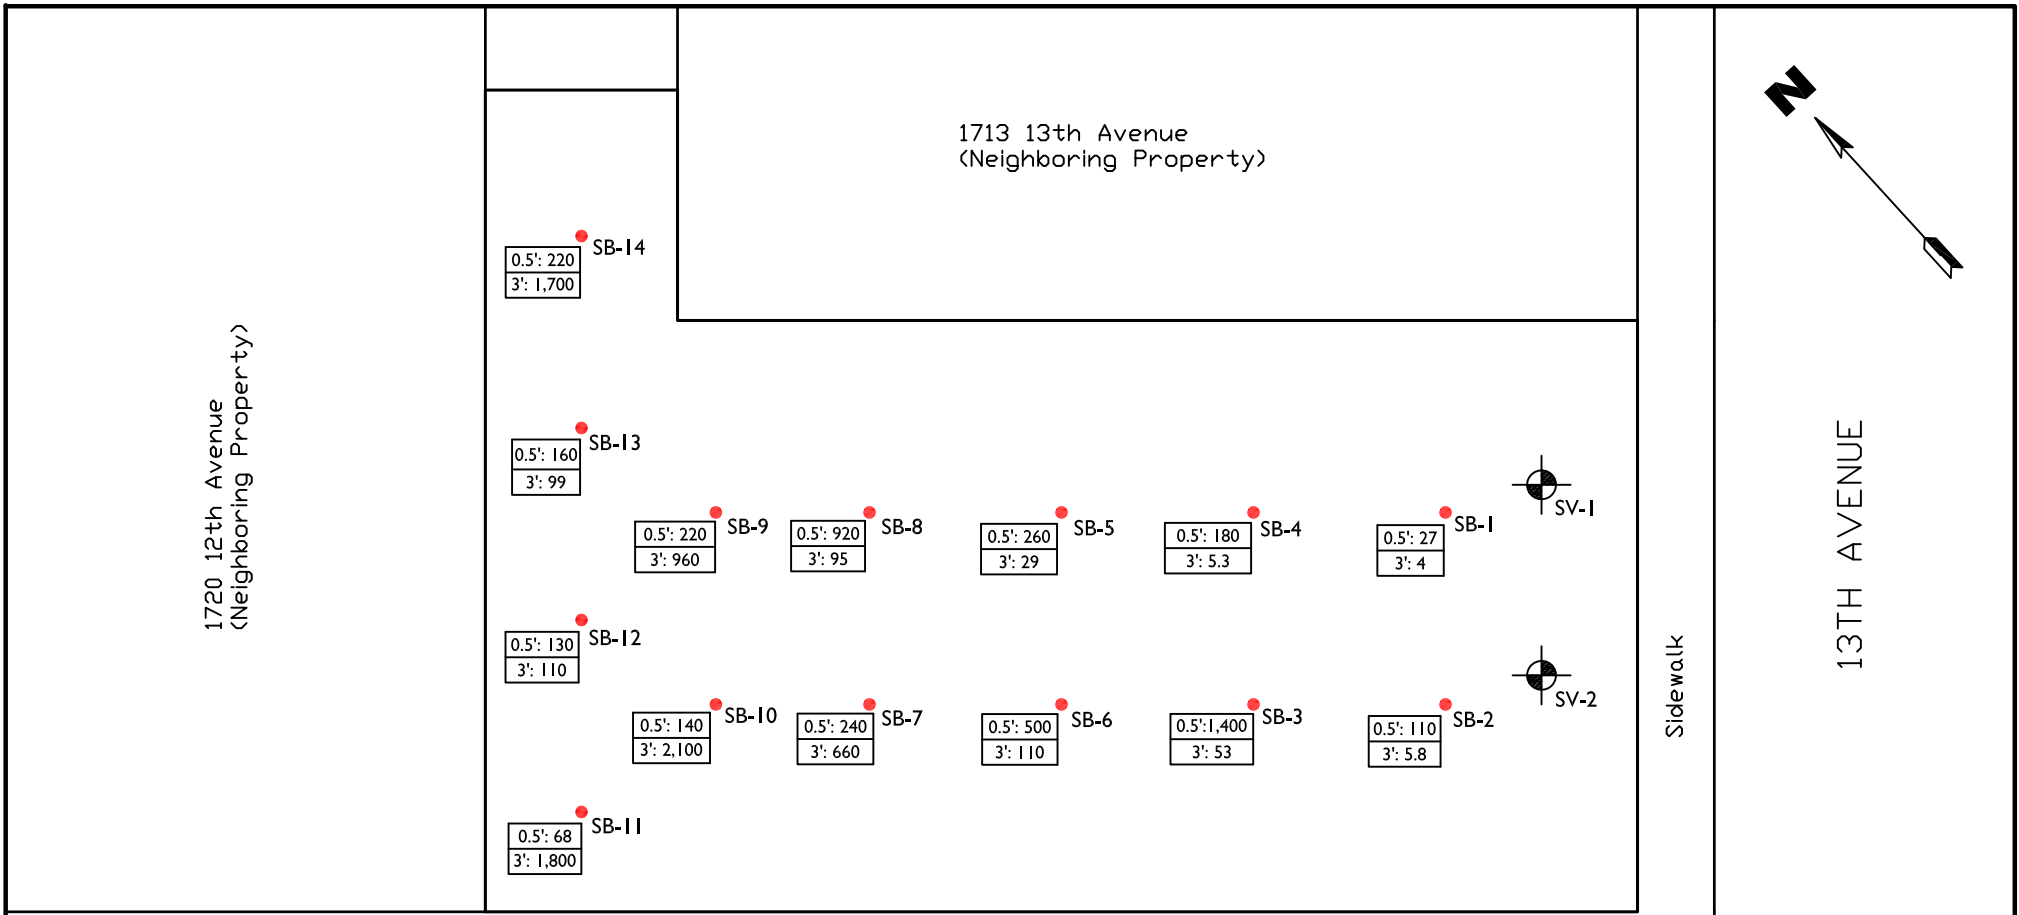
Figure: 2
EIS Project: 1652-2
December 9, 2016

EXPLANATION:

- Temporary Soil Vapor Well location
- Temporary Soil Boring Location

Laboratory analytical results revealed lead concentrations in all soil samples collected from borings SB-1 through SB-14. Soil samples collected from the 0.5 ft. bgs depth interval contained lead concentrations ranging from 27 to 1,400 milligrams per-kilogram (mg/kg), while lead concentrations in soil samples collected from the 3 ft. bgs depth interval ranged from 4 to 2,100 mg/kg.

- Twenty-one of the twenty eight analyzed soil samples contained concentrations of lead that exceeded the Regional Water Quality Control Boards Environmental Screening Level (RWQCB ESL) of 80 mg/kg. Twelve of fourteen soil samples collected from 0.5 ft. depths and nine of fourteen soil samples collected from 3 ft. depths exceed the ESL of 80 mg/kg. Four soil samples revealed lead concentrations over 1,000 mg/kg that exceed the Total Threshold Limit Concentration (TTLC).

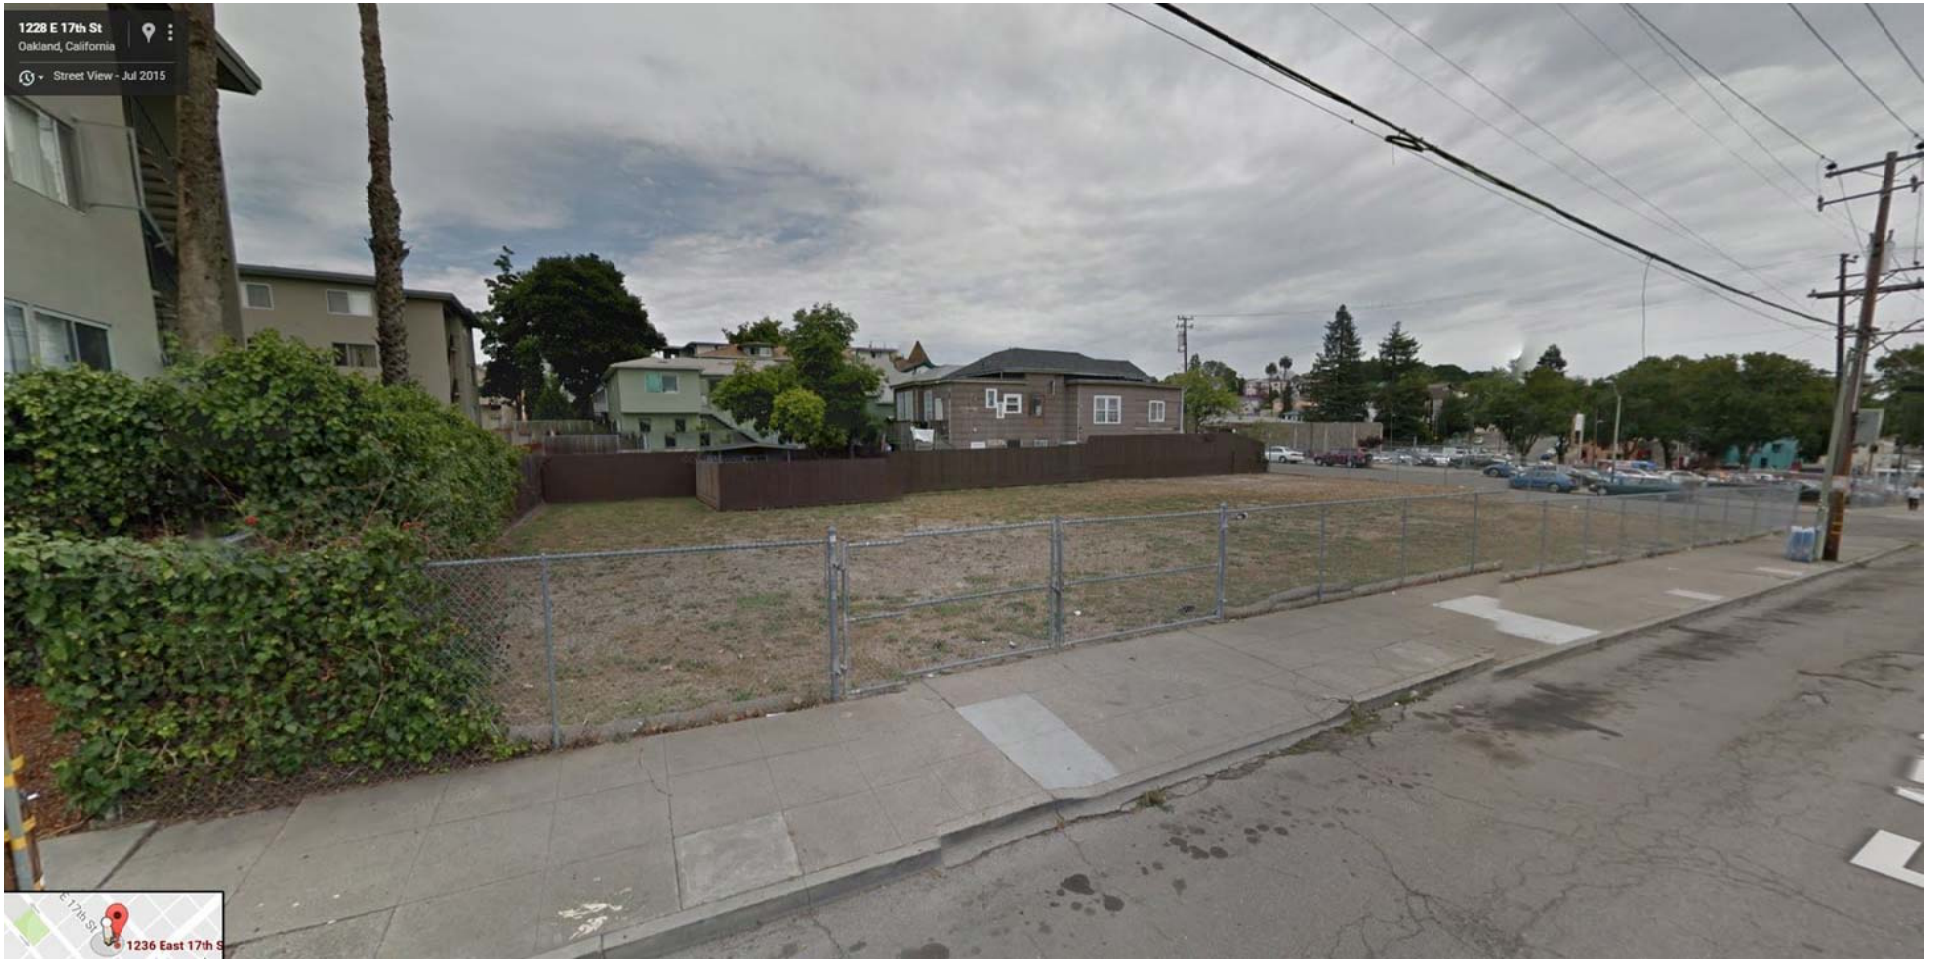
In the next available photograph dated July 2015, the Site appears as it does in present day. The photo depicts the property as a fenced vacant dirt lot vegetated with grass and weeds, as it exists in present day. There are no visible signs of leftover rubble from the former building or parking lot. Images discussed in this section are included in Attachment C of this report.

1. View of the subject property in July 2015 via Googlemaps.

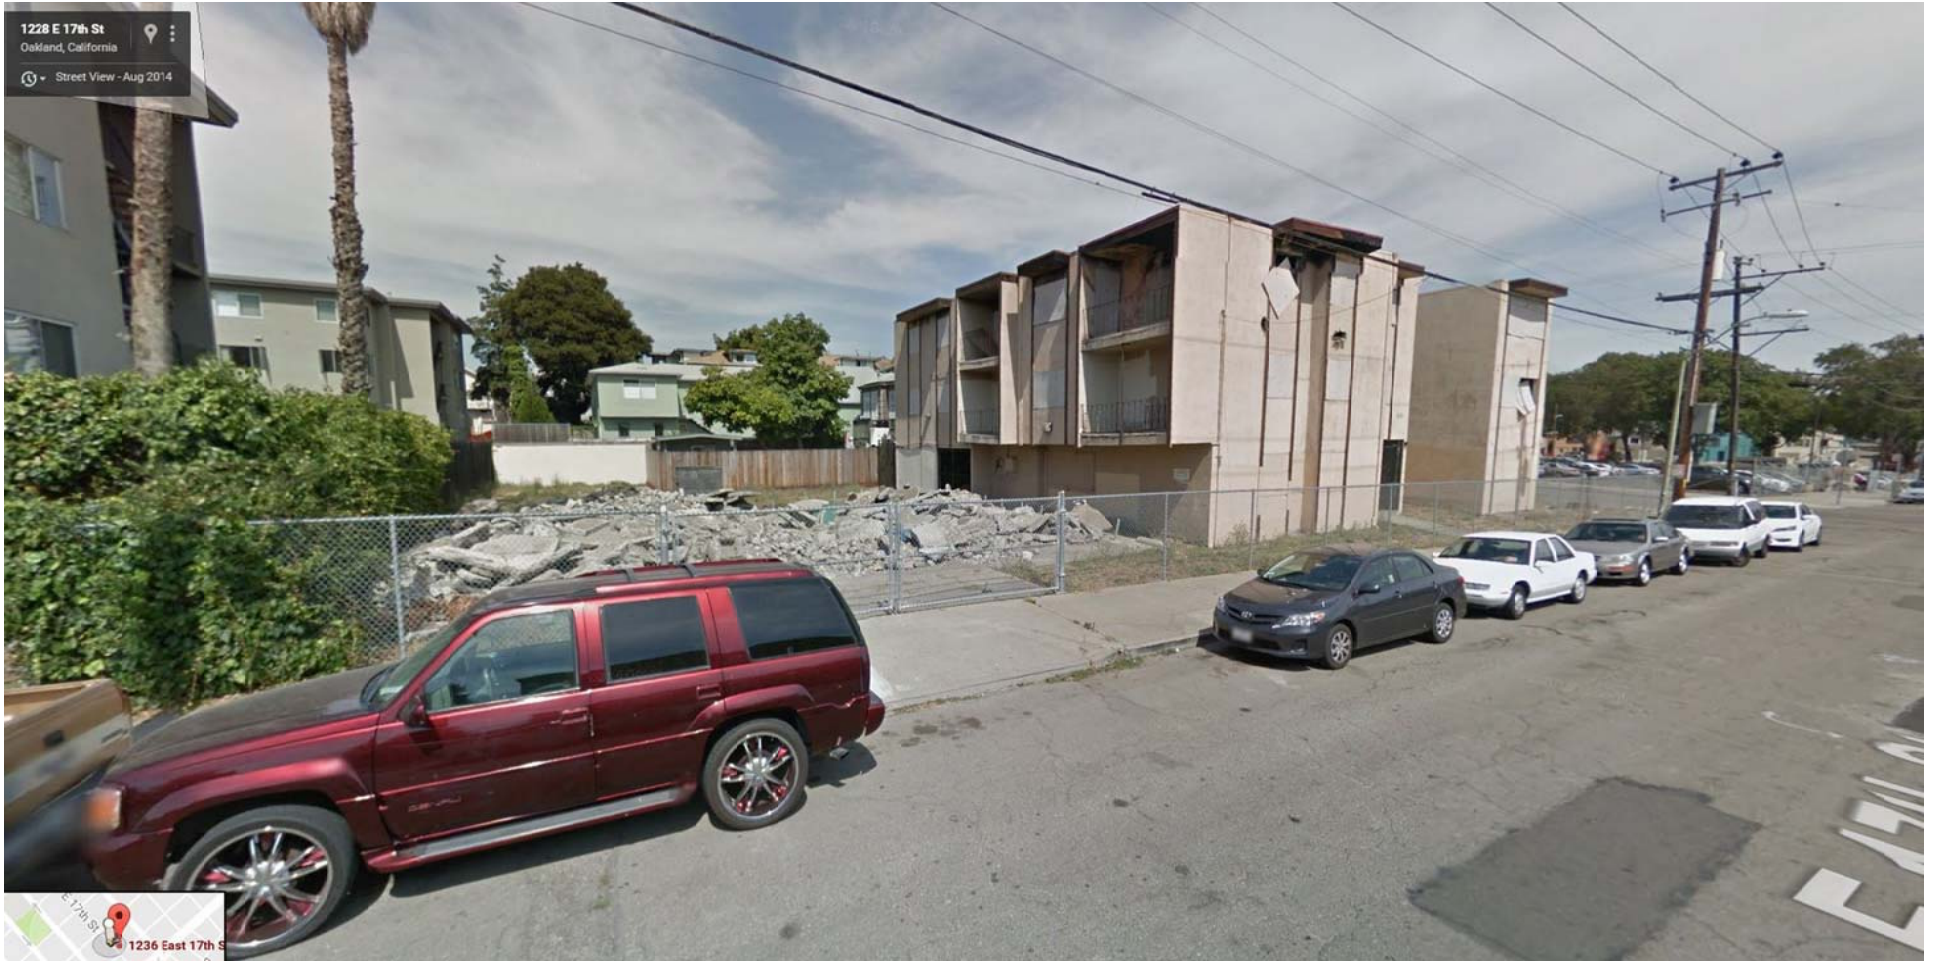
In the next available photograph, dated August 2014, the majority of the cement parking lot is crushed and broken, with the rubble piled on the northwest side of the property. There appear to be no other significant changes from the January 2014 photograph.

2. View of the subject property in August 2014 via Googlemaps.

- Rubble from the previous building and/or parking lot may be buried in the shallow Site subsurface based on historical photos, private utility locator findings, and pieces of building material encountered in soil borings.
