# **REMEDIAL ACTION PLAN - LEAD**

Livermorium Plaza – Mills Square Park Redevelopment 2259 First Street, Livermore, California Site Cleanup Case No. RO0003255

# 307233 REMEDIAL ACTION PLAN - LEAD

Livermorium Plaza – Mills Square Park Redevelopment 2259 First Street Livermore, California

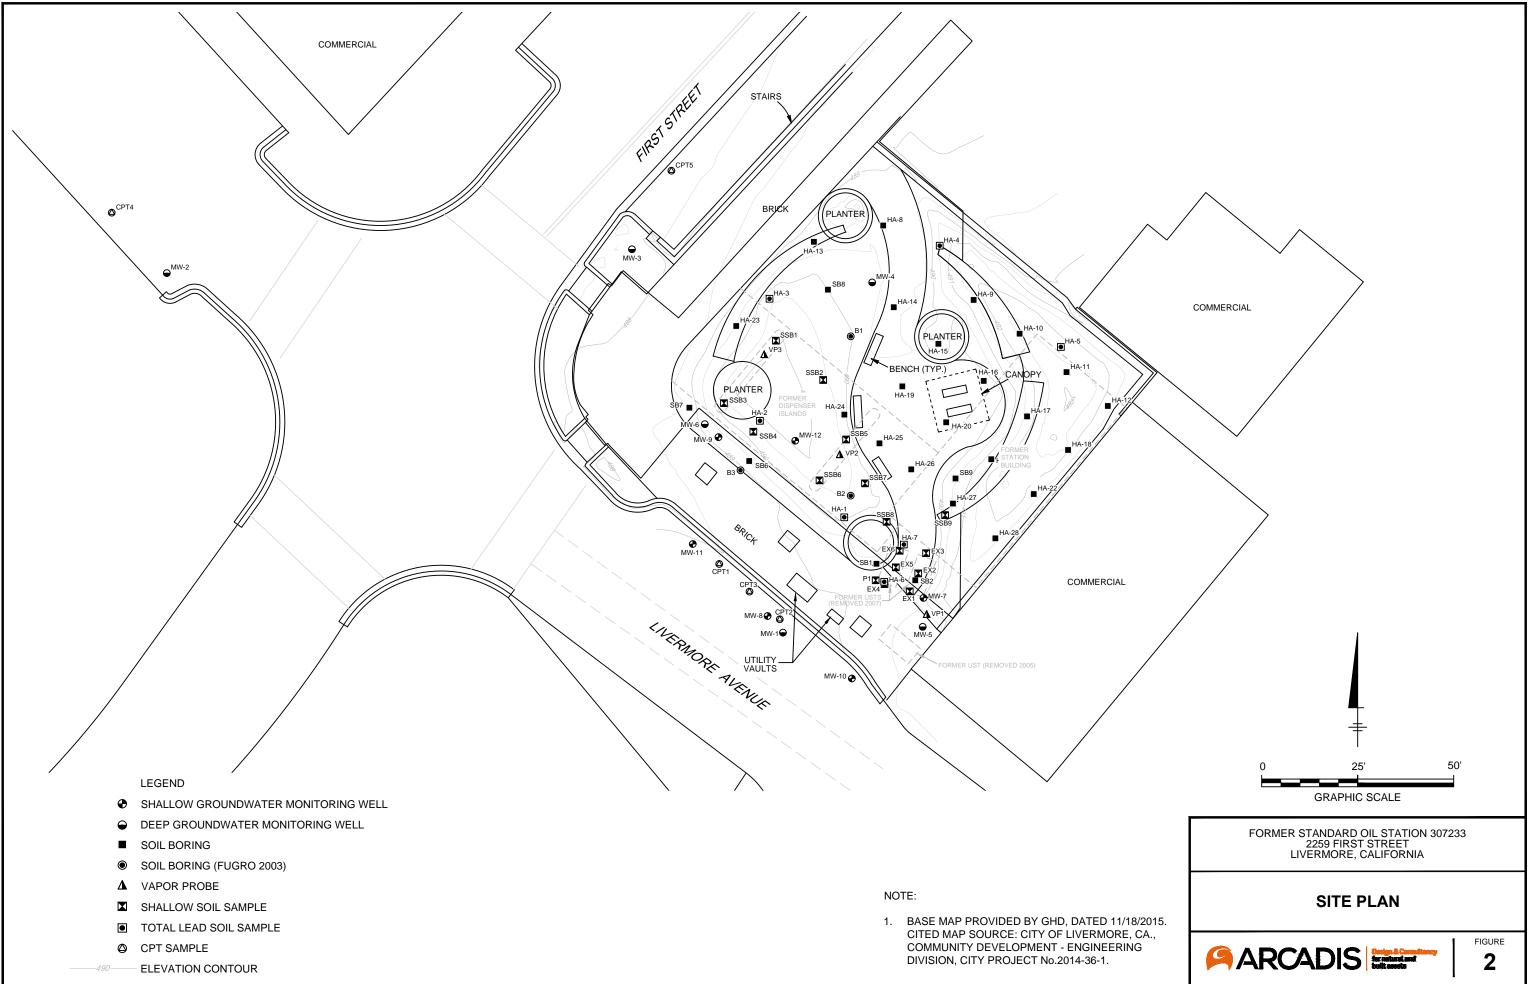
Environmental assessment and remediation has been ongoing since 2003, beginning with an investigation initiated by the City of Livermore Engineering Division to assess soil and groundwater conditions prior to further development to the park. To date, 61 soil borings, 3 dual nested soil vapor probes, 2 single depth soil vapor probes, and 12 wells have been installed. In 2005, one orphaned underground storage tank (UST) was removed. In 2007, two orphaned USTs and associated product piping were removed. A chronological summary of environmental investigation and remediation conducted to date is presented in Appendix C of GHD's Interim Remedial Action Plan (IRAP) (GHD 2016). The locations of all known monitoring wells, soil borings, and former USTs are presented on Figure 2.
