September 17, 1992

RE: SUPPLEMENTAL OBSERVATION LETTER  
UNDERGROUND STORAGE TANK (UST) PROGRAM  
U.S. POSTAL SERVICE VEHICLE MAINTENANCE FACILITY  
1675 7th STREET  
OAKLAND, CALIFORNIA

Geo/Resource Consultants, Inc. (GRC) is pleased to submit this supplemental letter for the observation services performed on June 23, 1992 at the United States Postal Service (USPS) Vehicle Maintenance Facility (VMF) located at 1675 7th Street in Oakland, California. The SCOPE OF WORK performed included the observation and documentation of the removal of one (1) underground storage tank (UST), the transportation off-site of the UST, the sampling of the soil and groundwater in the bottom of the UST excavation, and the extent of the excavation.

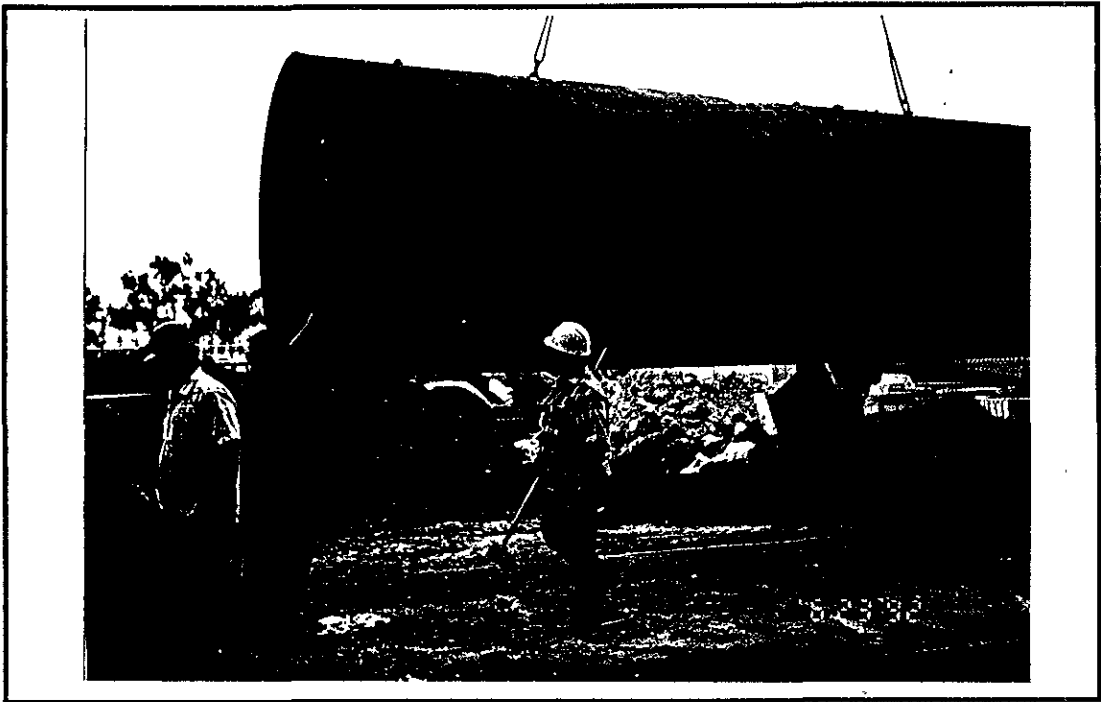
Photo 1: Removal of 10,000-gallon UST with soil piles in background.

Water District (ACWD) and the Oakland Fire Department (OFD) that the UST was deemed safe to transport. The UST appeared to be intact without any pitting or other signs of corrosion. The UST was placed on an H&H flatbed truck for transportation to a disposal and recycling facility (See Appendix A, Photographs 1 through 3).

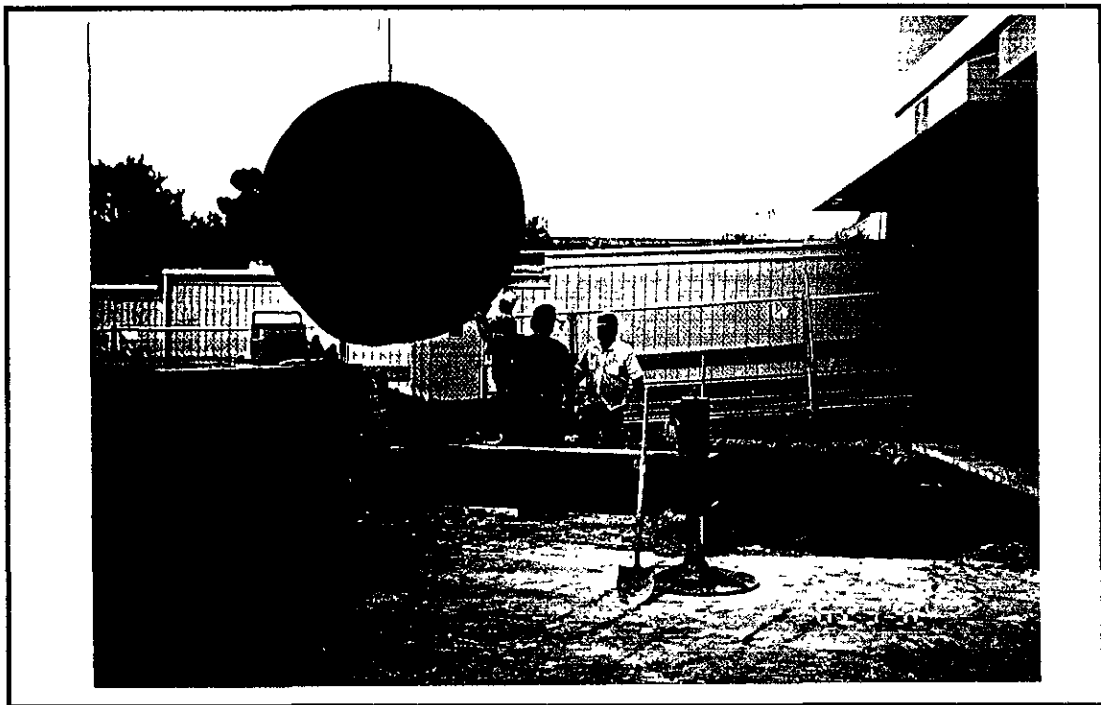
Photo 2: Placement of the UST onto flatbed truck.

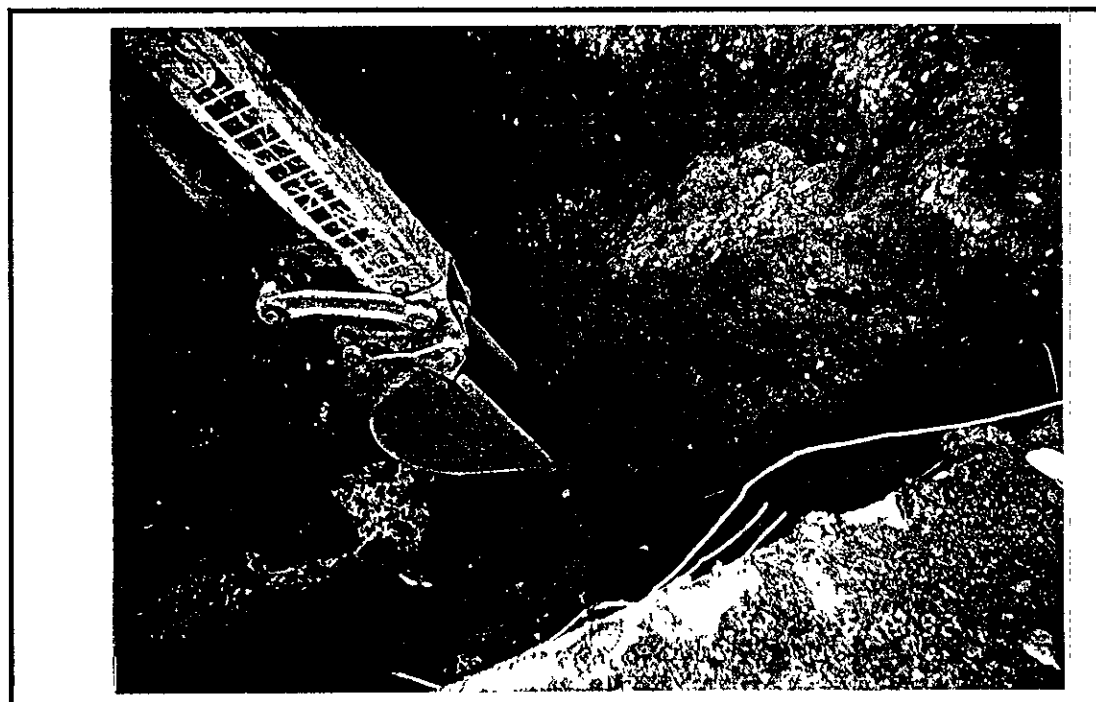
Soil samples were collected by RS EAGAN personnel at the direction of Mr. Dennis Byrnes of the ACWD. Two soil samples were collected from the north and south ends of the UST at approximately 2-feet below the bottom of the excavation (See Appendix A, Photograph 4). Soil samples were also collected from the stockpiled soil generated from the excavation. Visible discoloration of the south sidewall was noted during the excavation process (See Appendix A, Photograph 5). Excavated soil was stockpiled on-site to be later disposed of depending upon the laboratory results.

Photo 4: Sampling of soil from the southern sidewalk of the UST excavation.

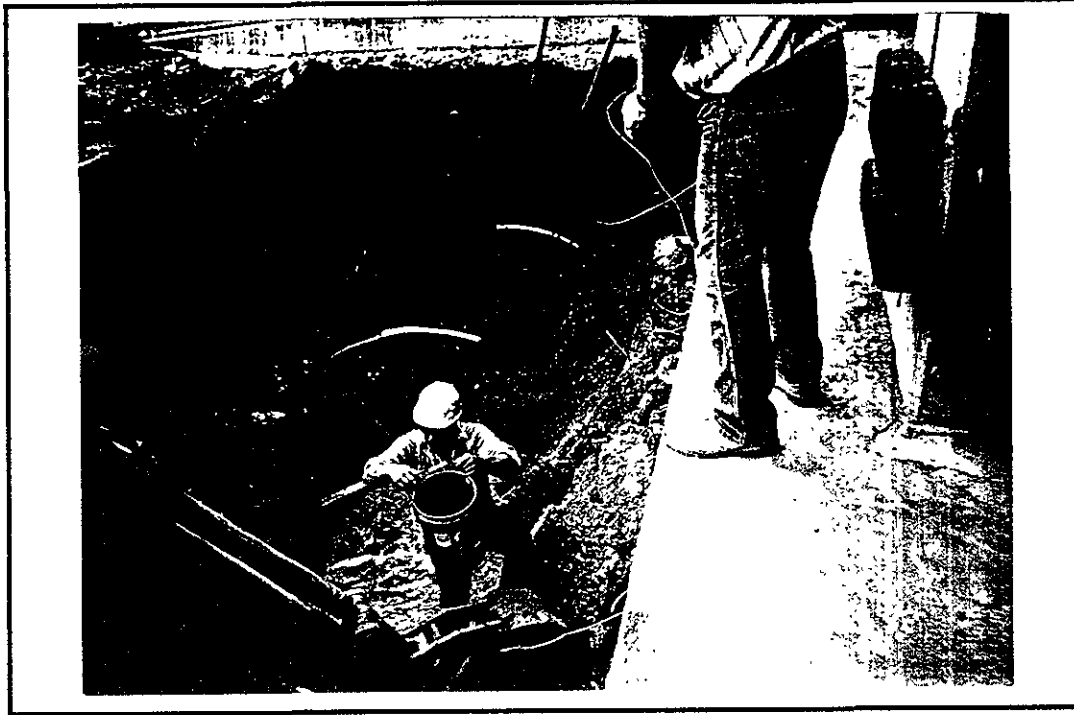
Groundwater was encountered during the excavation at approximately 12-feet below ground surface. A groundwater sample was collected by RS EAGAN personnel using a 5-gallon bucket to extract groundwater from the excavation to facilitate filling the laboratory containers. After reviewing the laboratory data, GRC suspected that the bucket may have contained residual petroleum hydrocarbons. (See Appendix A, Photograph E). A hydrocarbon like sheen was on top of the groundwater noted in the bottom of the excavation. (See Appendix A, Photographs 4 through 6).

Photo 5: Water sampling from the bottom of the UST excavation.
