QUARTERLY MONITORING REPORT BECK ROOFING HAYWARD, CALIFORNIA

LUSH GEOSCIENCES JOB NO. 423-001

NOVEMBER 26, 1996

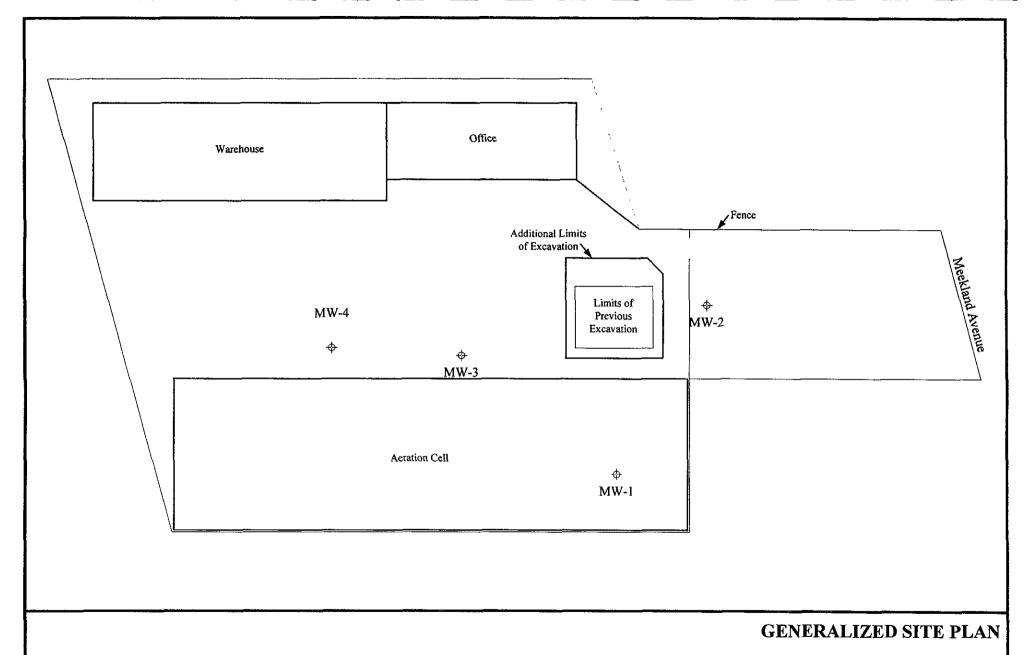
BECK ROOFING FACILTY 21123 MEEKLAND AVENUE HAYWARD, CALIFORNIA

We have attached a Generalized Site Plan (Figure 2), showing the site configuration.

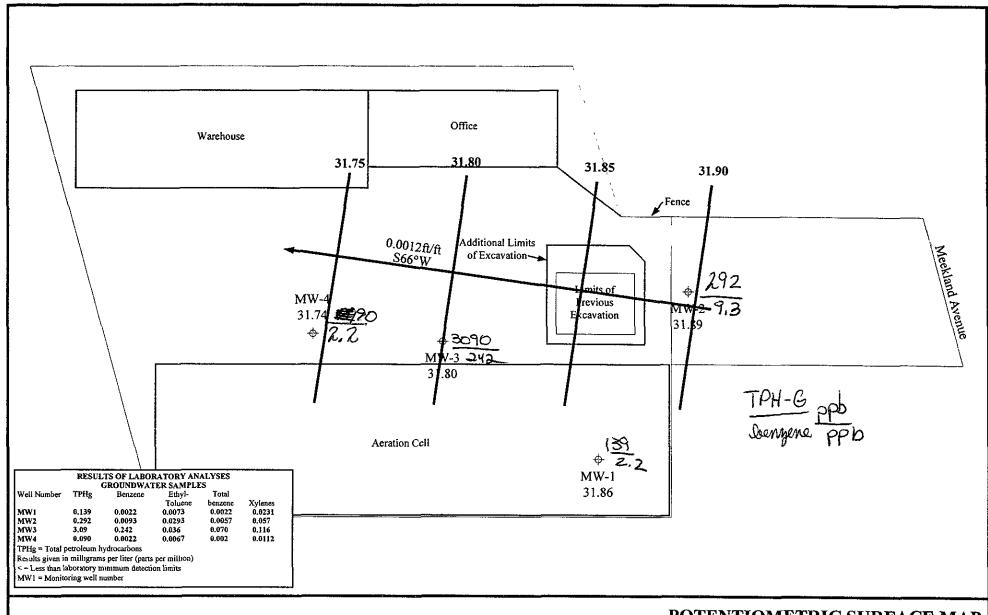
POTENTIOMETRIC SURFACE MAP NOVEMBER 5, 1996 BECK ROOFING FACILTY 21123 MEEKLAND AVENUE

The groundwater gradient was approximated from calculations made using surveyed wellhead elevations and locations in combination with depth to groundwater measurements made on November 5, 1996, (Table 3) (Figures 3 and 4). The data indicate that groundwater flow direction was oriented S66°W. The gradient data is very consistent with data generated during the preceding twelve months indicating a southwesterly flow across the site.
