**REPORT FOR
REMEDIAL INVESTIGATION/FEASIBILITY STUDY**

**ABE Petroleum LLC
17715 Mission Boulevard
Hayward, California 94539**

**Prepared by
Sierra Environmental, Inc.**

**September 29, 2009
Project 09-103.10**

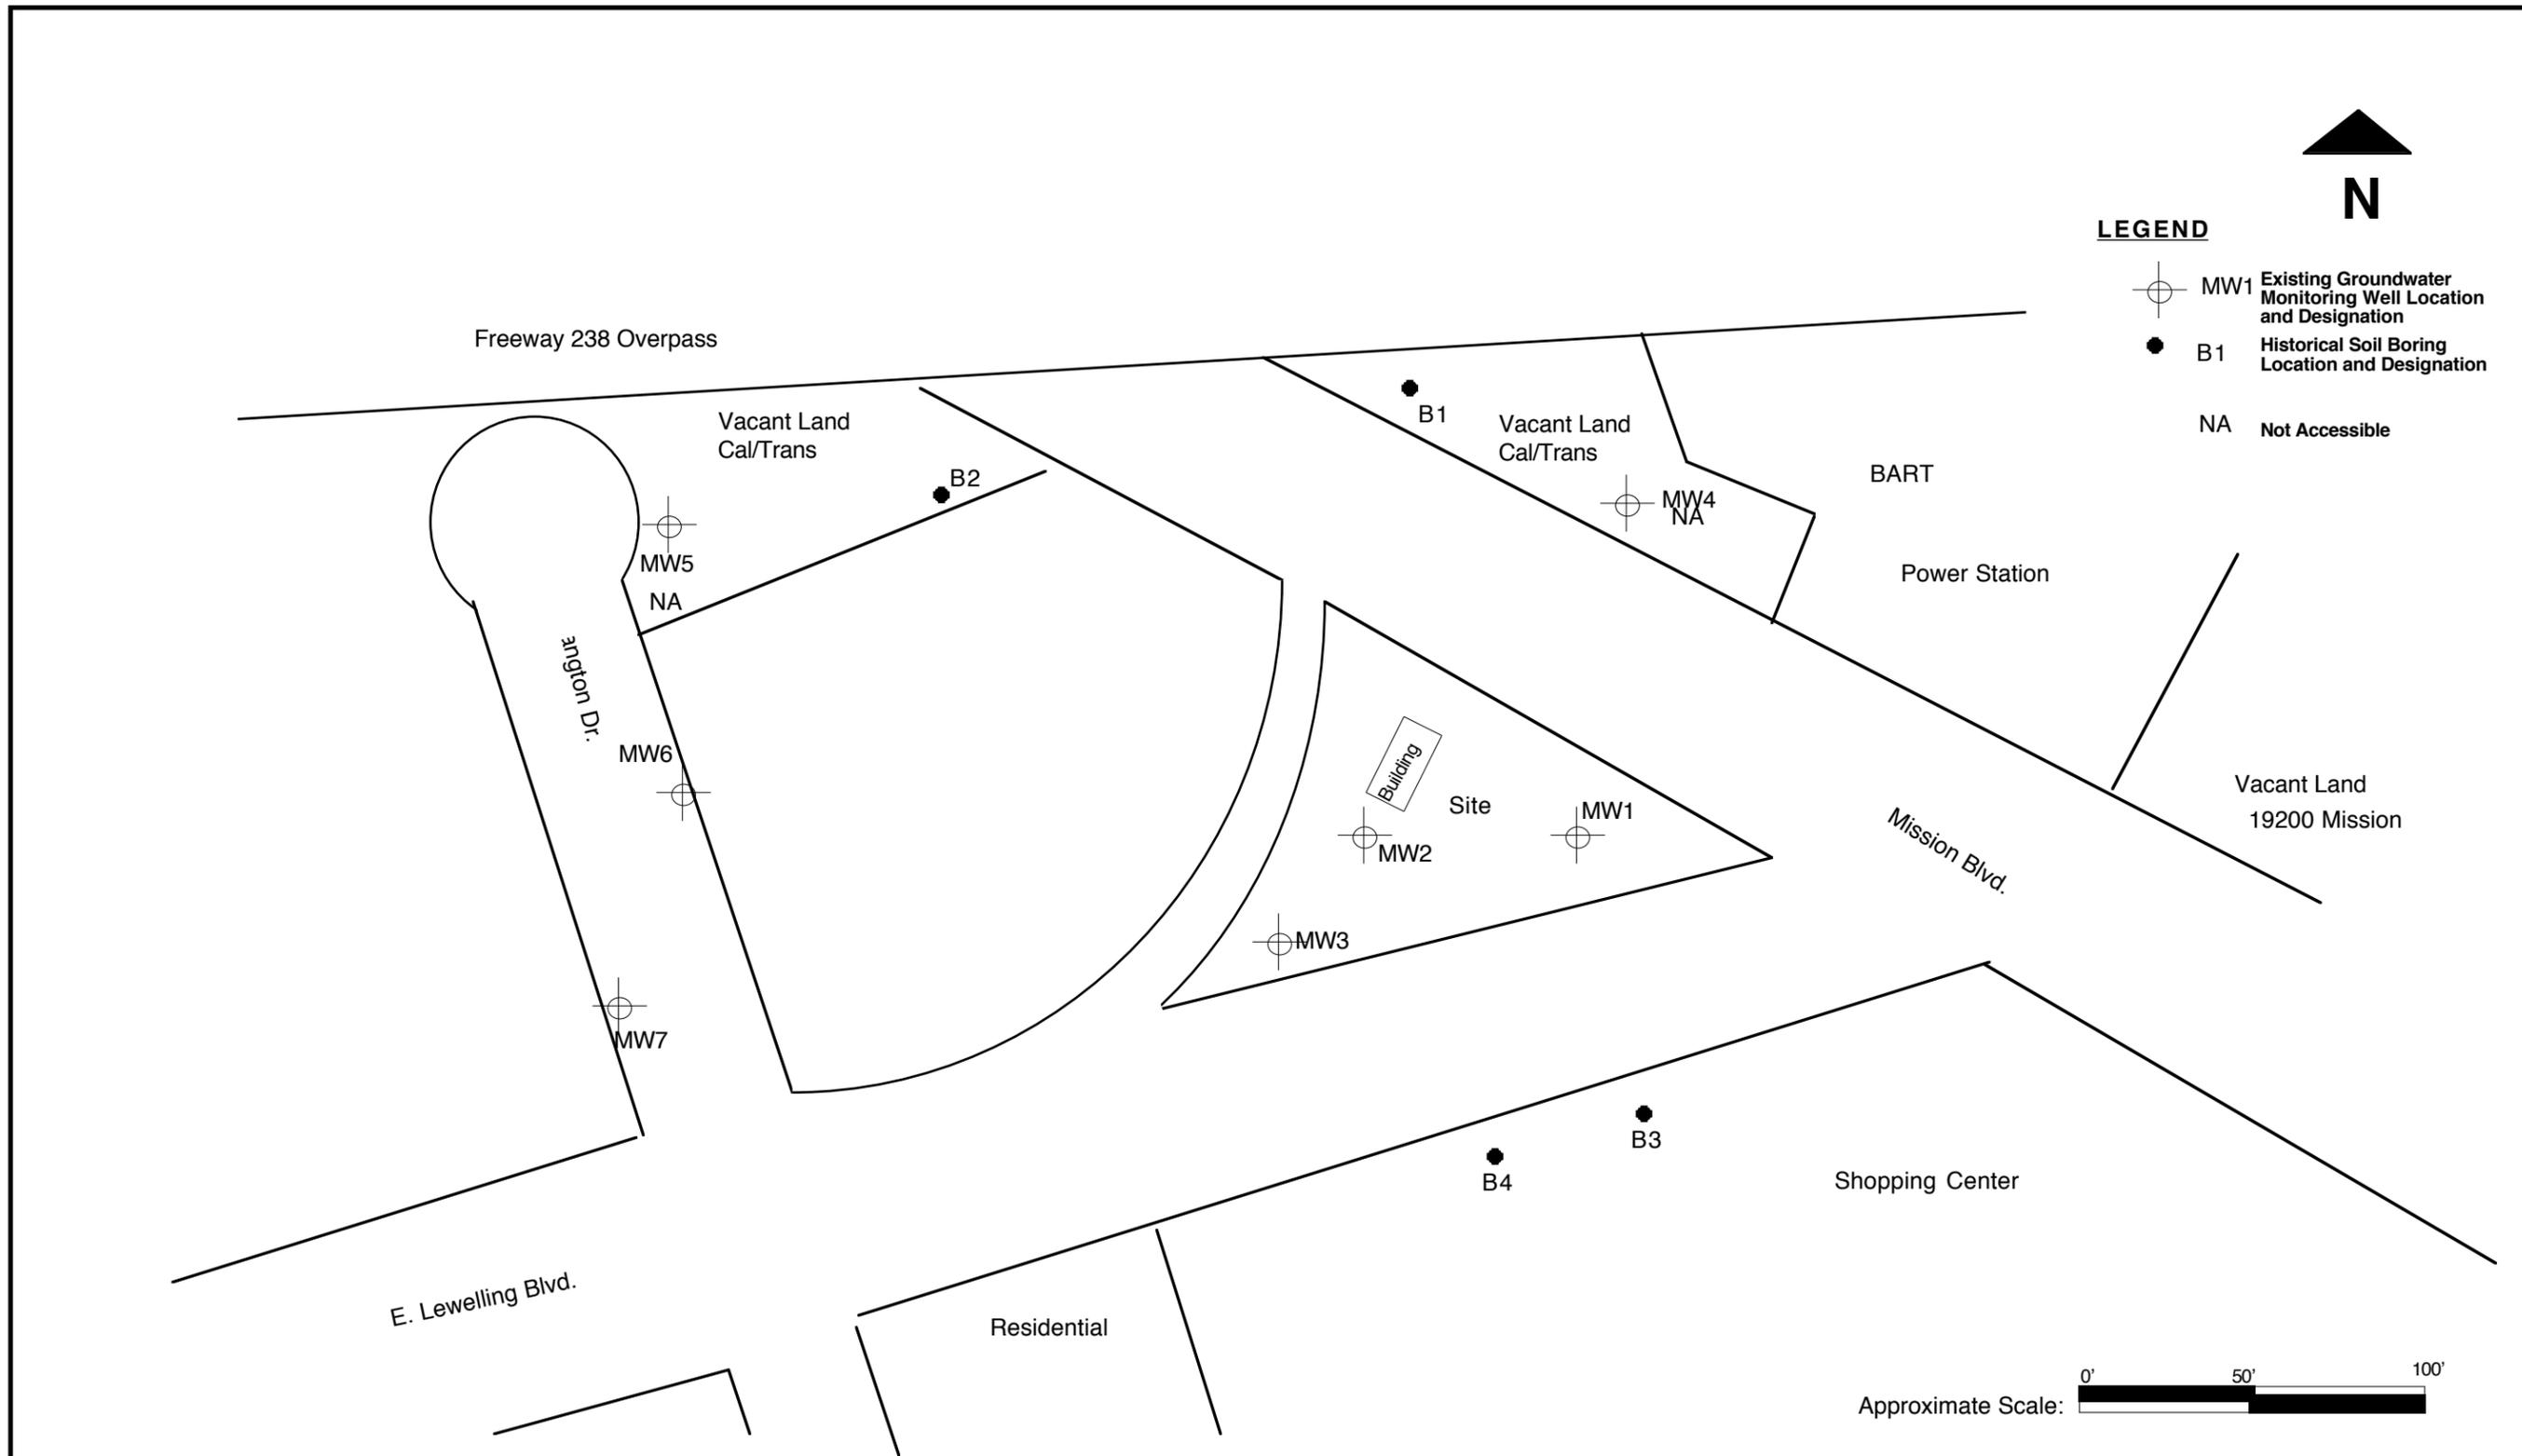
**FIGURE
 4**

On September 16, 1997, Balch Petroleum Contractors & Builders, Inc. (Balch) of Milpitas, California, removed one 2,000-gallon, two 6,000-gallon, one 10,000-gallon single-wall steel gasoline, and one 500-gallon single-wall steel waste oil USTs from the Site. Former UST locations are shown in Figure 4 of Appendix A.

Up to 2,300 mg/kg TPHG was detected in the soil samples collected from beneath the tanks at approximately 14 feet below ground surface bgs. The soil sample locations are shown in Figure 4.

No hole or damage was observed in the tanks. No groundwater was encountered in the tank excavations. After UST removal, Sierra collected soil samples from the tank excavations for chemical analysis.
