Re: Transmittal of Phase I Property Transaction

Environmental Assessment and II Site Investigation Reports - Hanger 9, North Field Oakland Airport

## PHASE II SITE INVESTIGATION HANGAR 9, NORTHFIELD OAKLAND AIRPORT

# PHASE II SITE INVESTIGATION HANGAR 9, NORTH FIELD METROPOLITAN OAKLAND INTERNATIONAL AIRPORT

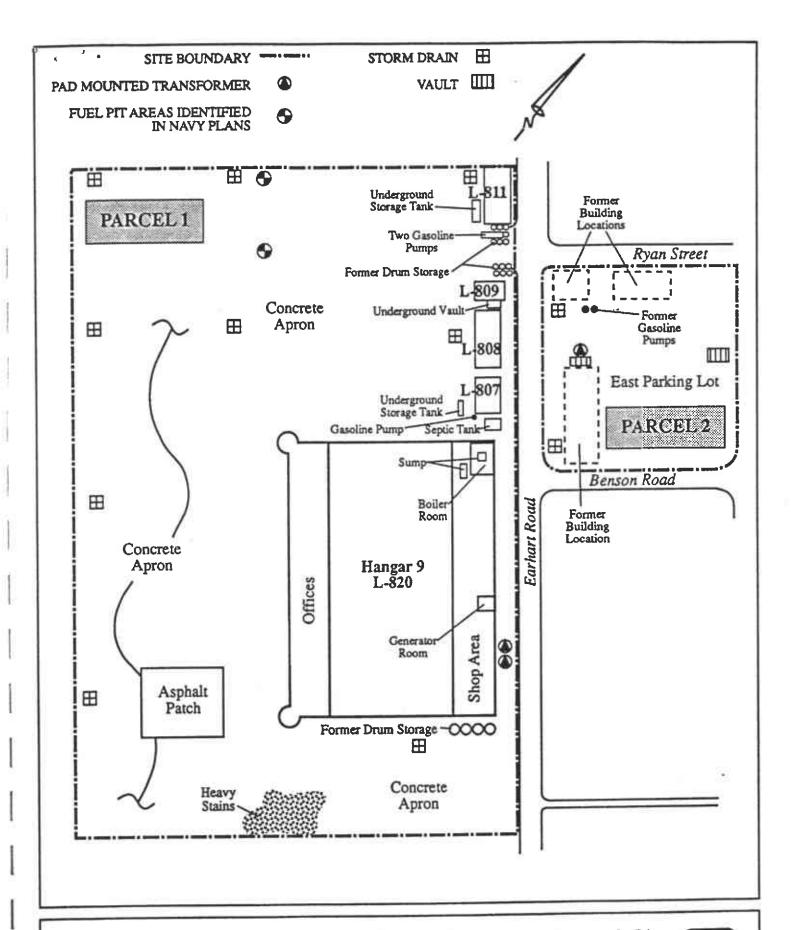
Figure 1 Hangar 9 Site Plan (Parcels 1 and 2)

The Hangar 9 site consists of two parcels: 1) the 6.7 acre Hangar 9 parcel, including Hangar 9 (Building L-820) and nearby service buildings (L-807, L-808, L-809, and L-811); and 2) an approximately 1 acre vacant parking area on the east side of Earhart Road. Both parcels are identified in Figure 1.

Apart from the existing structures, the entire surface area of Parcel 1 is paved with concrete with small patches of asphalt. Parcel 2 is a vacant parking lot covered entirely with asphalt. A transformer is located on a concrete pad and surrounded by a chain-link fence midway along the western edge of Parcel 2. An electrical utility vault with standing water at the bottom is located immediately south of the transformer.

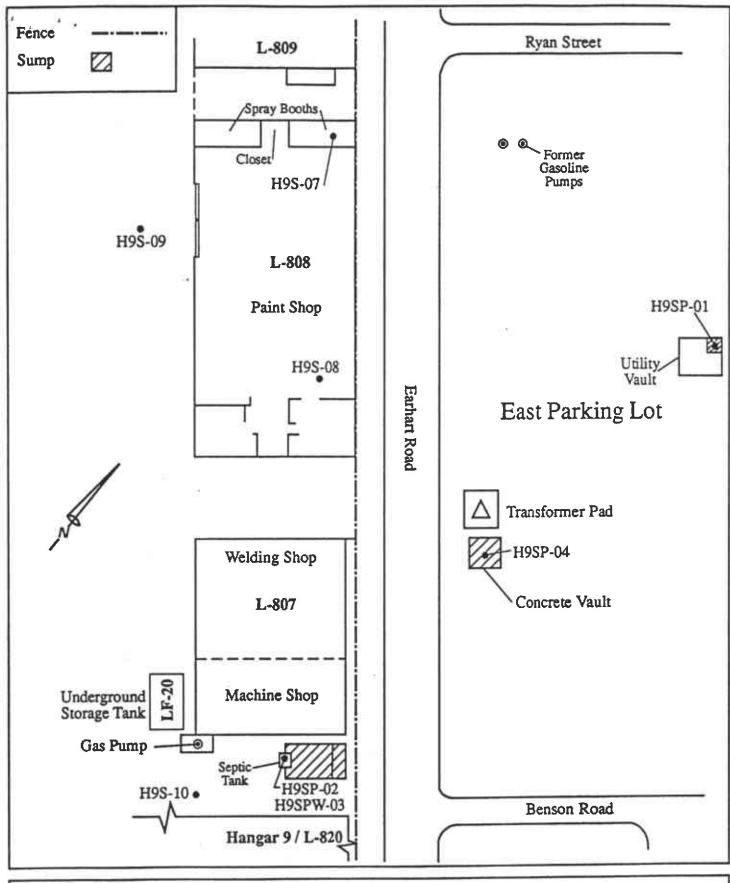
Figure 2 Sample Location Map
Building L-807 and L-808
and East Parking Lot Not to Scale

Sampling locations for Buildings L-807, L-808, and the East Parking Lot are shown in Figure 2; sampling locations for Buildings L-809 and L-811 are shown in Figure 3; and sampling locations for Hangar 9 (Building L-820) are shown in Figure 4. Photographic documentation of sampling activities are presented in Appendix A.

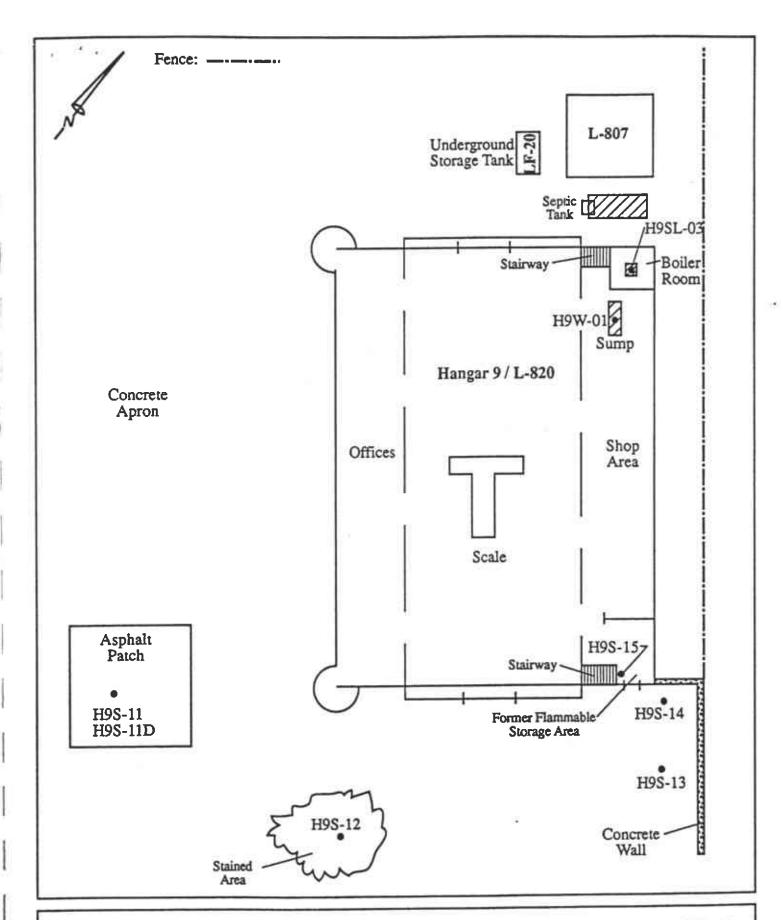
Figure 4 Sample Location Map Hangar 9

Hangar 9 contains 45,000 square feet of hangar space and 60,000 square feet of workshops and offices on two levels, divided evenly along the east and west sides of the building (Figure 4). A boiler room is located at the north end of the work shop area and contains a sump with standing liquid. A larger sump is located inside the work shop area south of the boiler room. A room located at the south end of the workshop area was used to repair aircraft brakes and inside the room flammable materials such as hydraulic fluids and oils were stored on a wooden shelf. Heavy staining was observed on the concrete apron southwest of the hangar door, and asphalt patches are located outside the southeast corner of the building and west of the southwest corner of the

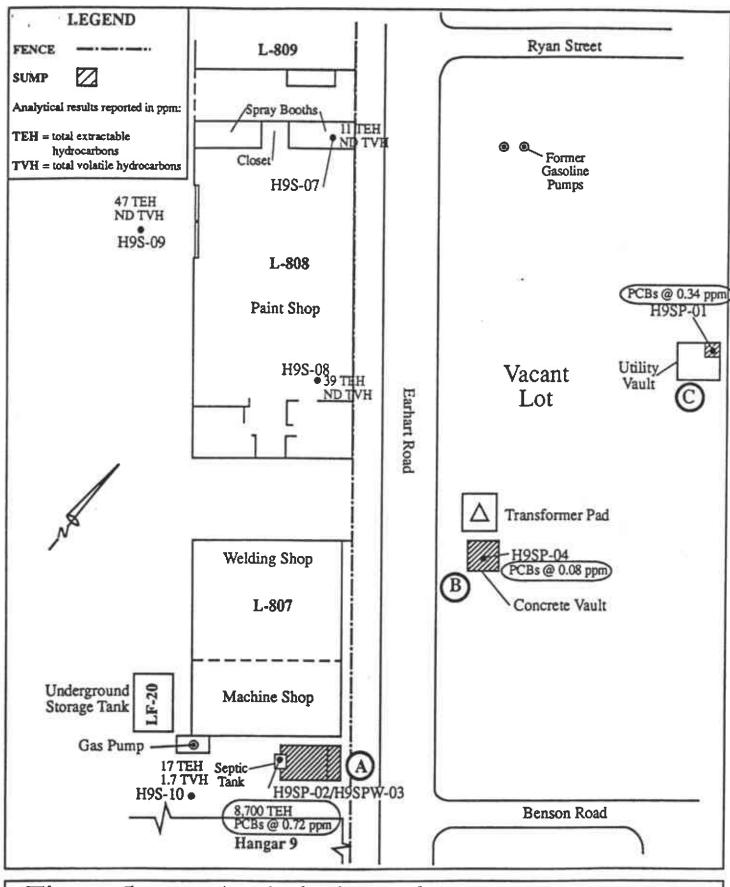
Figure 5 Analytical Results
Building L-807 and L-808
and East Parking Lot Not to Scale

Soil sample H9S-10 contains concentrations of TEH and TVH of 17 and 1.7 ppm respectively with no detectable VOCs. This would not in and of itself suggest that additional site investigation or remedial activity is necessary. Sludge (sediment) samples collected from the nearby septic tank (location A, Figure 5) contains 8,700 ppm TEH (kerosine/jet fuel and/or diesel) and 0.72 ppm Arochlor 1260 PCB.

Soil samples collected from inside the building contain concentrations of fuel hydrocarbons below regulatory action levels. Sample H9S-09 contains TEH at 47 ppm, but no VOCs were identified, indicating aged or weathered fuel.

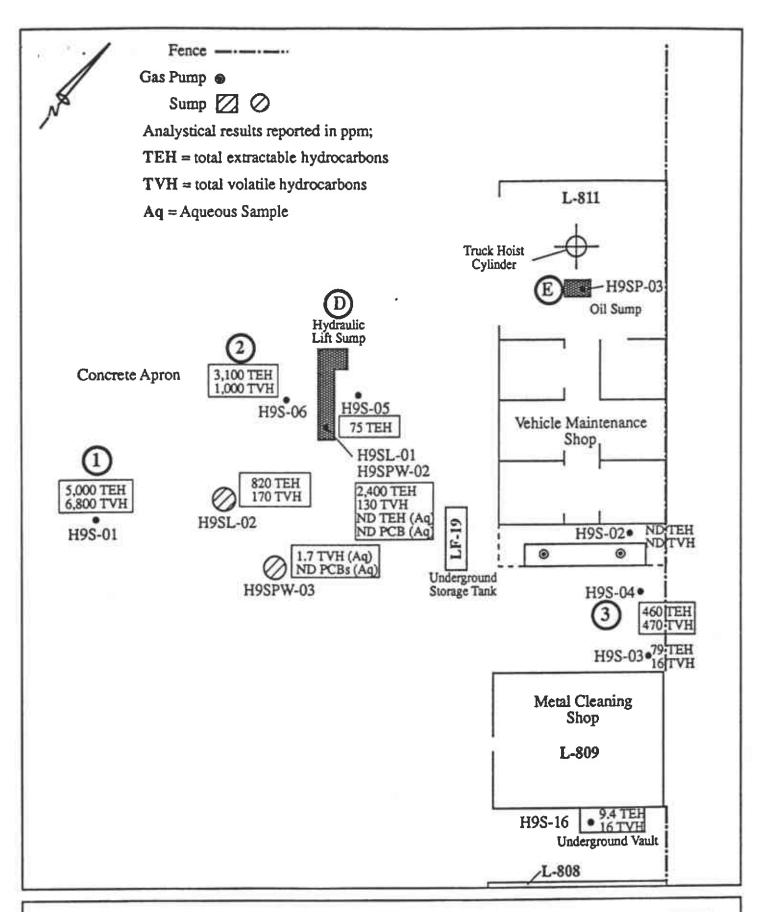
Figure 6

A sump located inside the garage contains waste oil (location E, Figure 6). Analysis of this waste oil did not indicate PCB contamination. Three sumps located west of building L-811 are contaminated with petroleum hydrocarbons. An underground storage tank is located to the southeast of building 811. The sumps and underground storage tank may be a source of soil contamination identified in three soil samples collected west of building L-811. Soil contamination was also identified south of building L-811 (location 3, Figure 6).

Two sumps were identified inside Hangar 9. The sump located inside the boiler room contains waste oil contaminated with PCBs (location F, Figure 6). A sump in an adjacent room is filled with water. Analysis of the contents of this sump did not indicate contamination. Soil samples collected in the apron area southwest of Hangar 9 indicated hydrocarbon contamination.

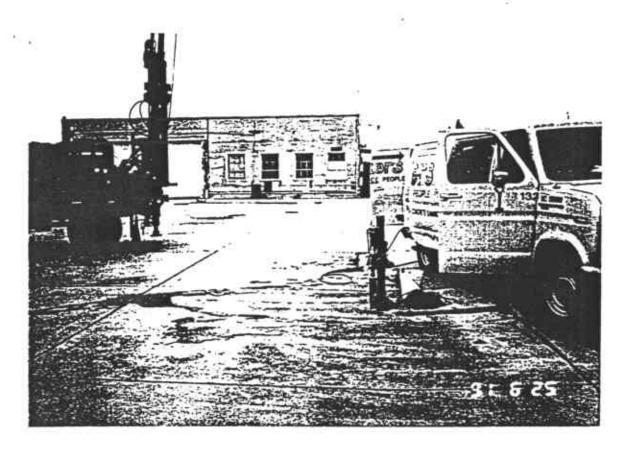
Borehole Sample H9S-01 collected in front of Building L-811

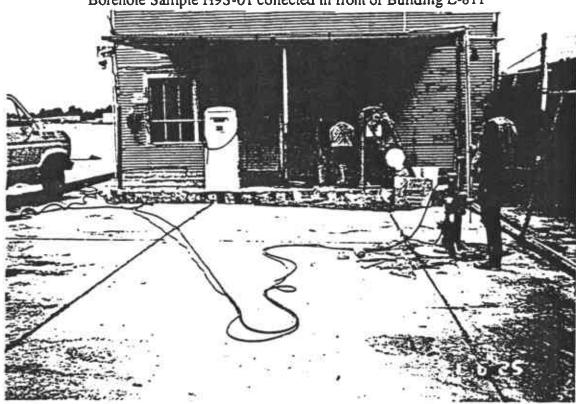
Borehole Samples H9S-04 and H9S-03 collected near gas pumps adjacent to Building L-811

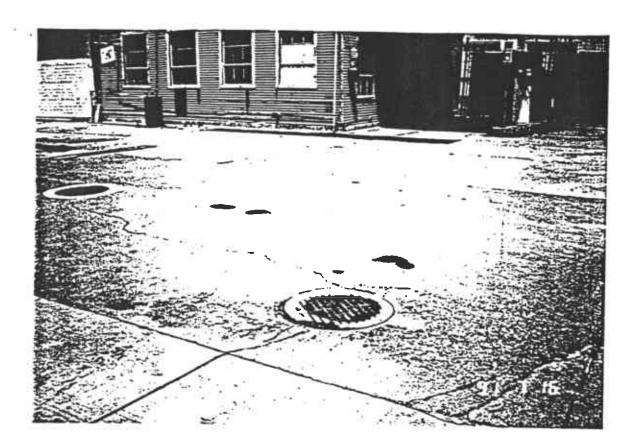
Sediment Sample H9SL-02 collected from sumps southwest of L-811

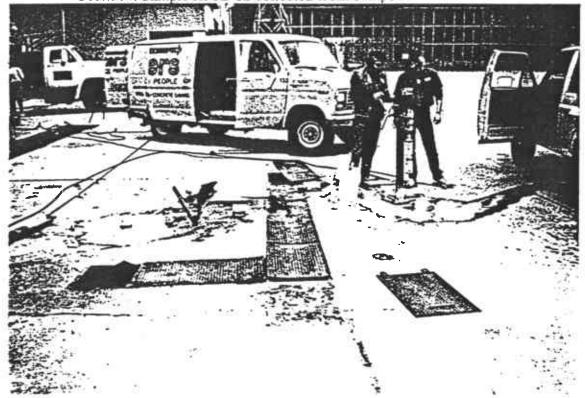
Borehole Samples H9S-05 and H9S-06 collected on eastern and western side of former hydraulic lift

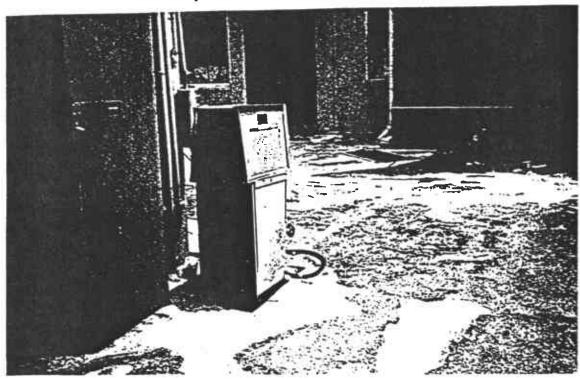
Abandoned gas pump outside southwest corner L-807
Borehole Sample H9S-10 collected outside the northwest corner of Hangar 9

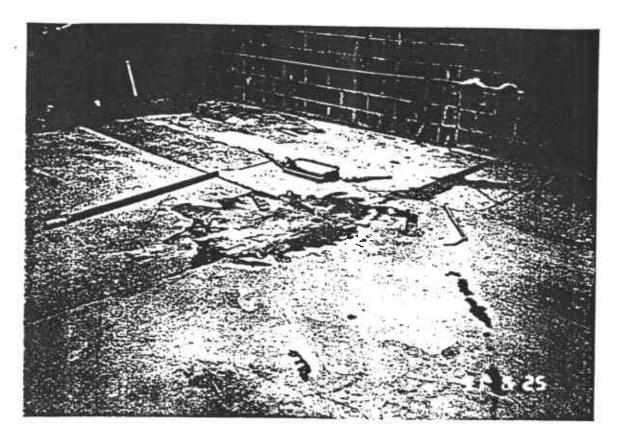
Borehole Sample H9S-13 and H9S-14 collected outside the southeast corner of Hangar 9 in the former drum storage area

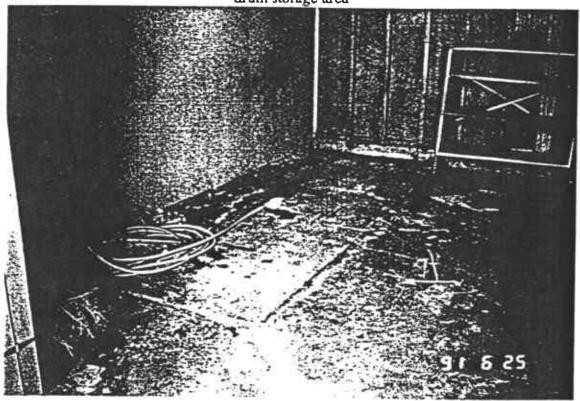
Sample H9S-16, collected from the bottom of the underground vault south of building L-809, contained 10 ppm chlorobenzene. No other volatiles were identified. The vault was used by former tenants to degrease aircraft parts, and it is not known what kind of vault bottom exists, if any.

Sample H9S-16 collected from opening of vault located between Building L-808 and L-809

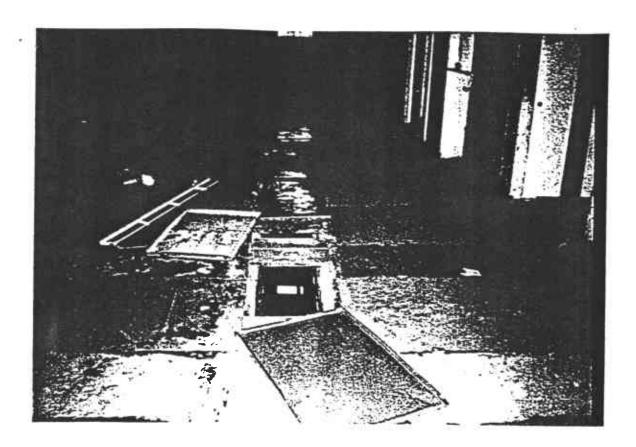
Sump located near Boiler Room of Hangar 9

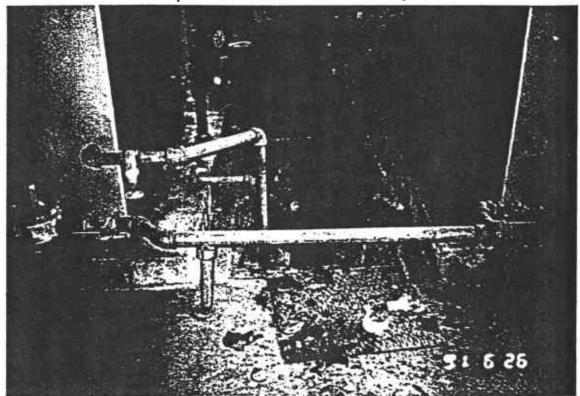
Sump between boilers in Hangar 9 former Boiler Room

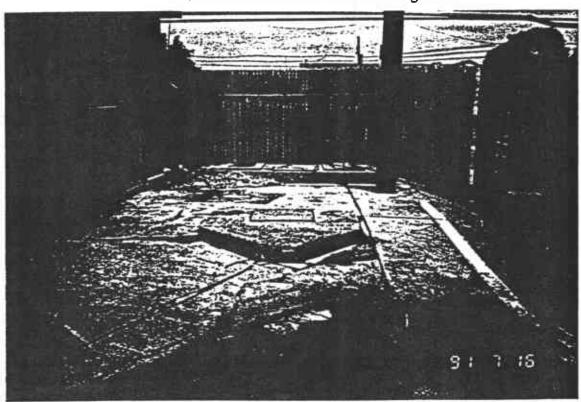
One sediment sample (H9SP-02) consisting of oily sludge was collected from the septic tank located south of building L-807 and was submitted for analysis by DHS LUFT methods for TEH and TVH and by EPA method 8080 for polychlorinated biphenyls (PCBs). A water sample (H9SPW-01) was also collected from the septic tank and submitted for PCB analysis.

Septic Tank located between Hangar 9 and L-807 (H9SP-02)

The Port is currently requesting proposals from environmental consultants to further characterize those locations that yielded samples with elevated hydrocarbons. The future work will be the subject of a work plan that will be submitted to you for your review. This consultant remove the contents of the sumps and dispose of the material properly.
