**RE: UPS- Oakland Hub
Underground Storage Tank Removal Field Activities Observations**

Subject: UPS Facility, 8400 Pardee Drive, Oakland, California

Re: Underground Storage Tank Removal Field Activities Observations

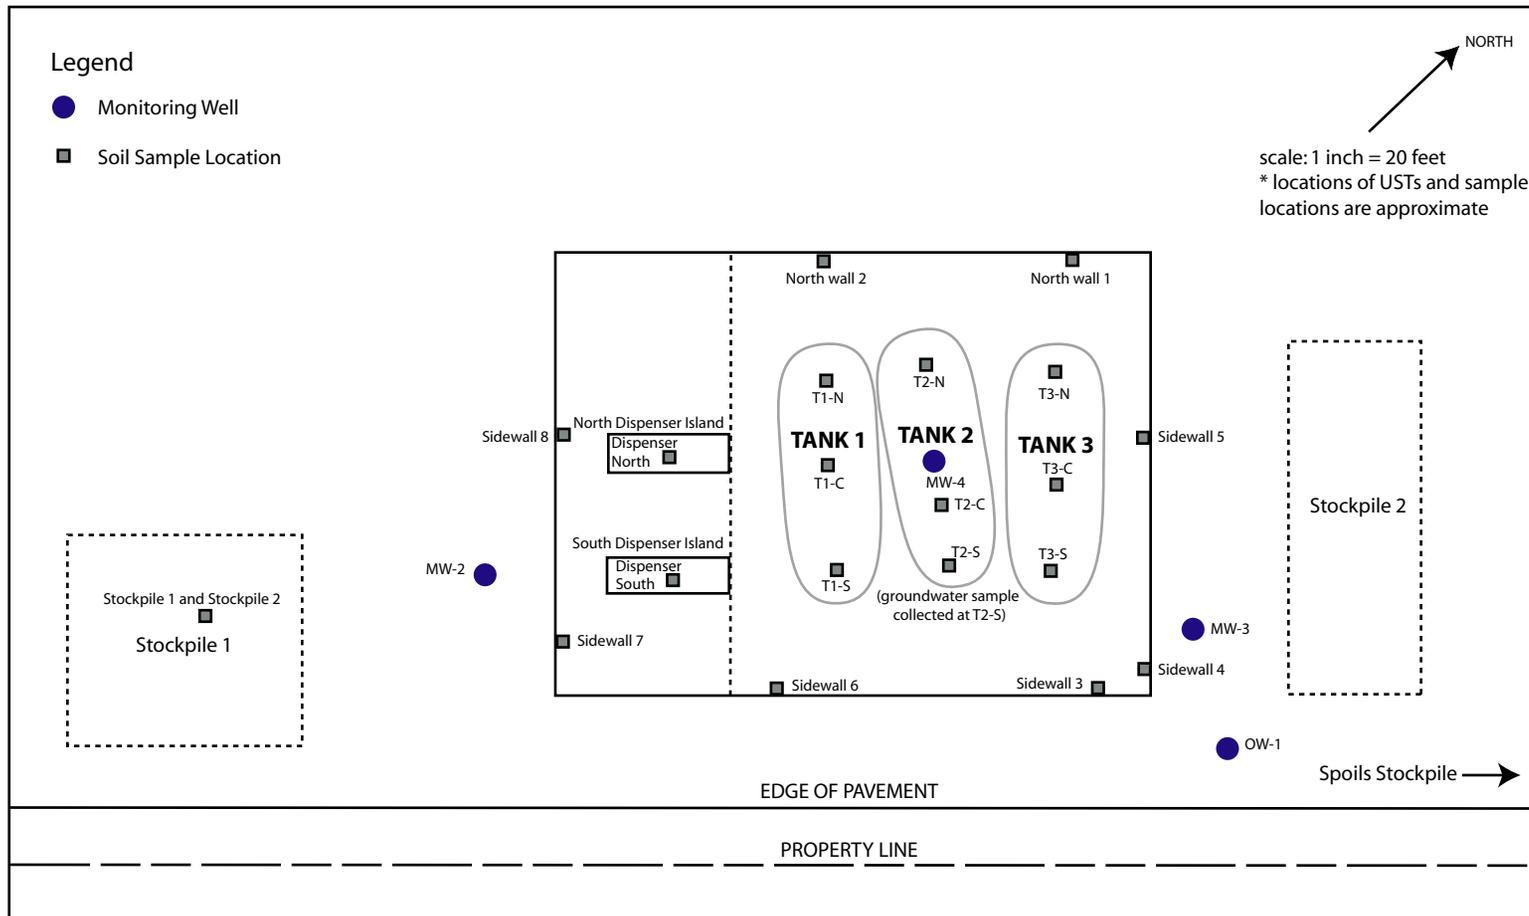
Figure 1: Site Plan

A URS representative observed the removal of three 10,000-gallon, single-walled diesel USTs (Tanks 1 through 3; Figure 1) on April 2, 2009. When URS arrived on site, the tanks had been almost completely exposed in an approximately 60-foot-long by 45-foot-wide by 8-foot-deep excavation. Piping was observed at the tops of the tanks, and two dispenser islands and associated piping (North Dispenser Island and South Dispenser Island; Figure 1) were observed south of the tanks. The concrete pad to the south, east, and west of the dispenser islands was observed to be intact. Tanks 1 and 3 were not observed to have any holes. Tank 2 had been lifted from its original location in the excavation, and a rectangular hole was observed at its eastern end. According to an on-site ARCADIS representative, the hole originally was smaller and triangular, and was speculated to have been created during initial excavation activities. The hole was subsequently enlarged to accommodate removal of material from within the tank (i.e., water and gravel). These activities were conducted prior to URS' arrival on site. Stained soil was observed around all three tanks and groundwater with a sheen was observed beneath Tank 2. Stockpile 1 was observed south of the excavation (Figure 1). URS was informed by ARCADIS that the stockpile consisted of soil removed from on top of the tanks. URS estimated the volume of Stockpile 1 on April 2 to be approximately 60 to 80 cubic yards.

Following removal of the USTs, on April 3, 2009, URS observed additional soil removal from the bottom of the existing excavation. The soil was stockpiled to the north of the excavation (Stockpile 2; Figure 1). URS estimated the volume of Stockpile 2 to be approximately 40 to 60 cubic yards.

A URS representative observed the collection of 29 soil samples and one groundwater sample by ARCADIS on April 2 and 3, 2009. Sampling locations for samples observed by URS are presented on Figure 1. Soil samples were collected from the following locations:

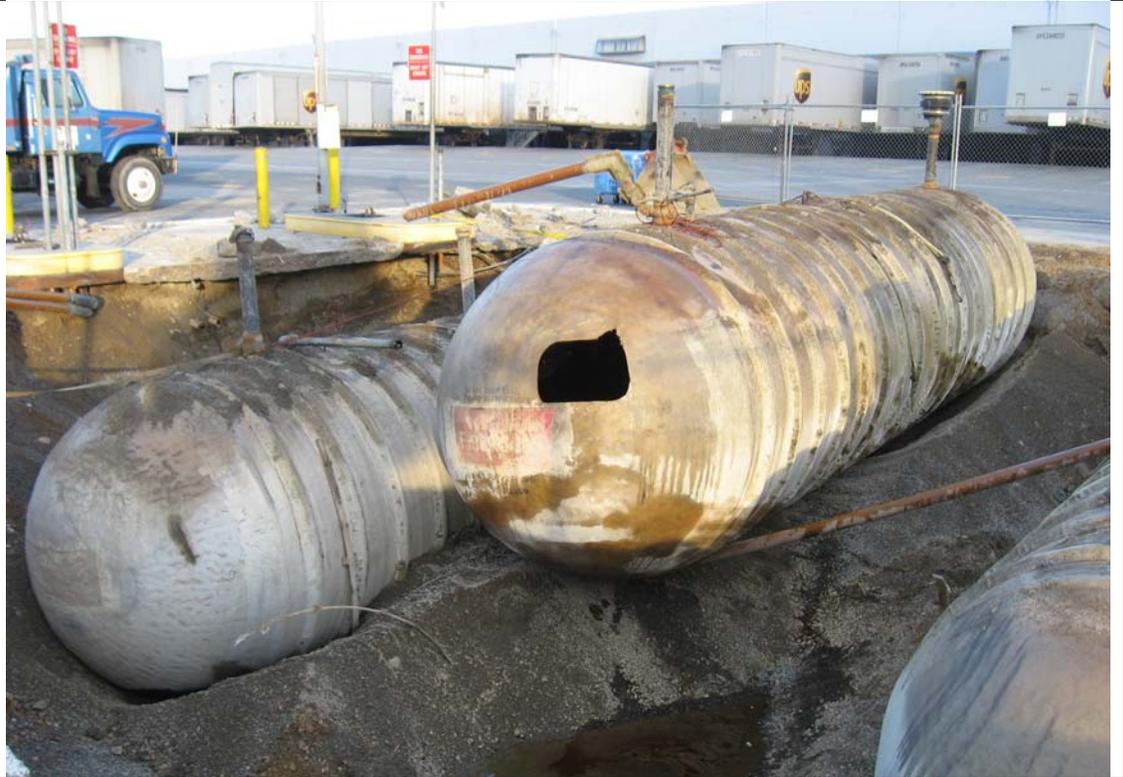
745 to 755	<p>Gina (Arcadis) briefs me on yesterday's site activities. She shows me the location of a triangular hole located on the east end of tank 2. According to Gina, it is unclear how the hole was formed. However, Arcadis believes it was formed during excavation activities for this project. Because water and gravel fill were observed within the tank, a larger square hole was cut below the triangular hole to remove the water and gravel from the tank. The pumped water was disposed at Evergreen Oil, Inc. in Newark, CA and classified as oil and water. The gravel was shoveled back into the excavation. Gina also shows the location of Stockpile 1, located south of the excavation. The material, comprised of gravel fill removed from above the tanks, has not been tested yet, but is assumed to be clean. If the lab results support that assumption, the fill will be reused as backfill in the current excavation.</p>

View of tanks 1 and 2.
Note hole in the eastern
end of tank 2.

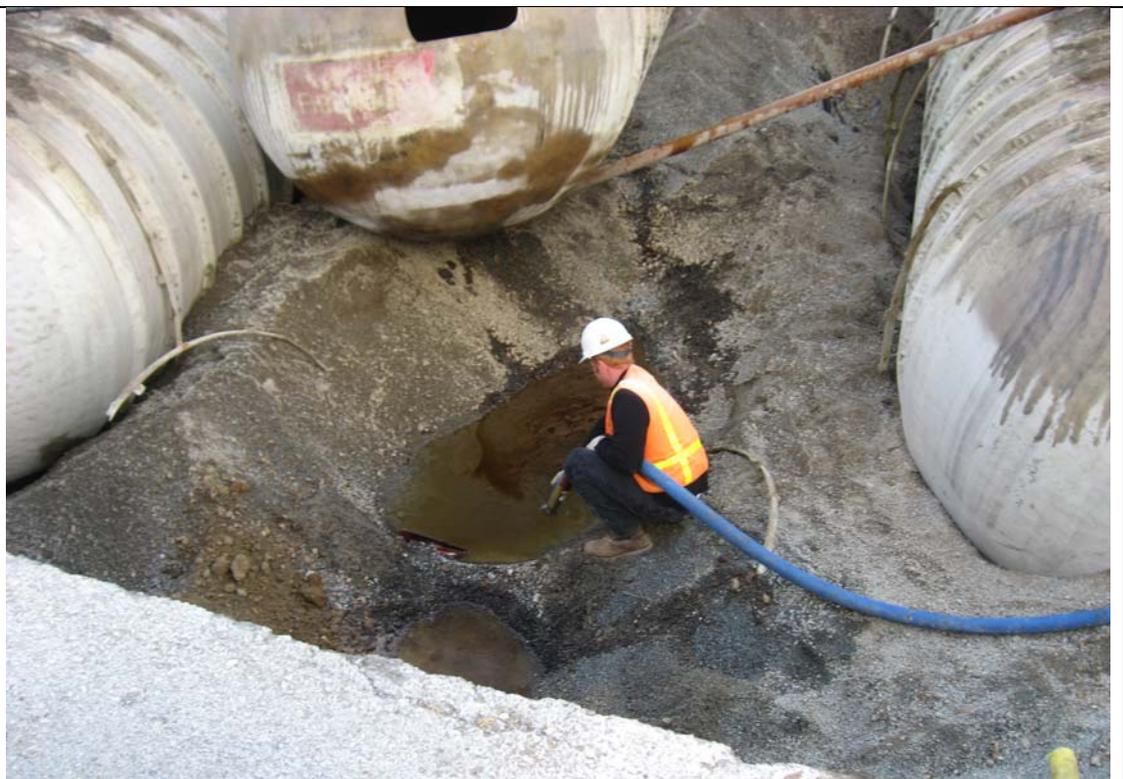
Balch Petroleum crew
member pumping water
from beneath tank 2. Note
the presence of product
on the surface of the
water.

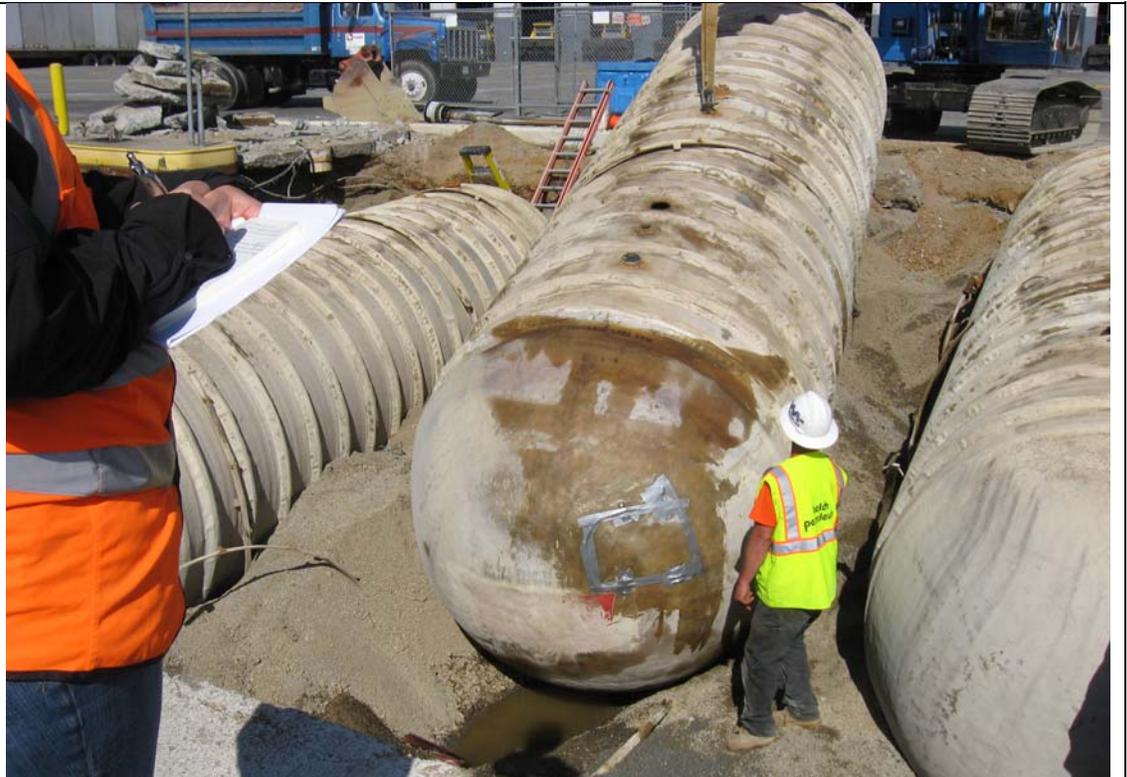
Balch Petroleum crew repositioning tank 2 within the excavation. Note duct tape seal around the cut section and over the original triangular hole.

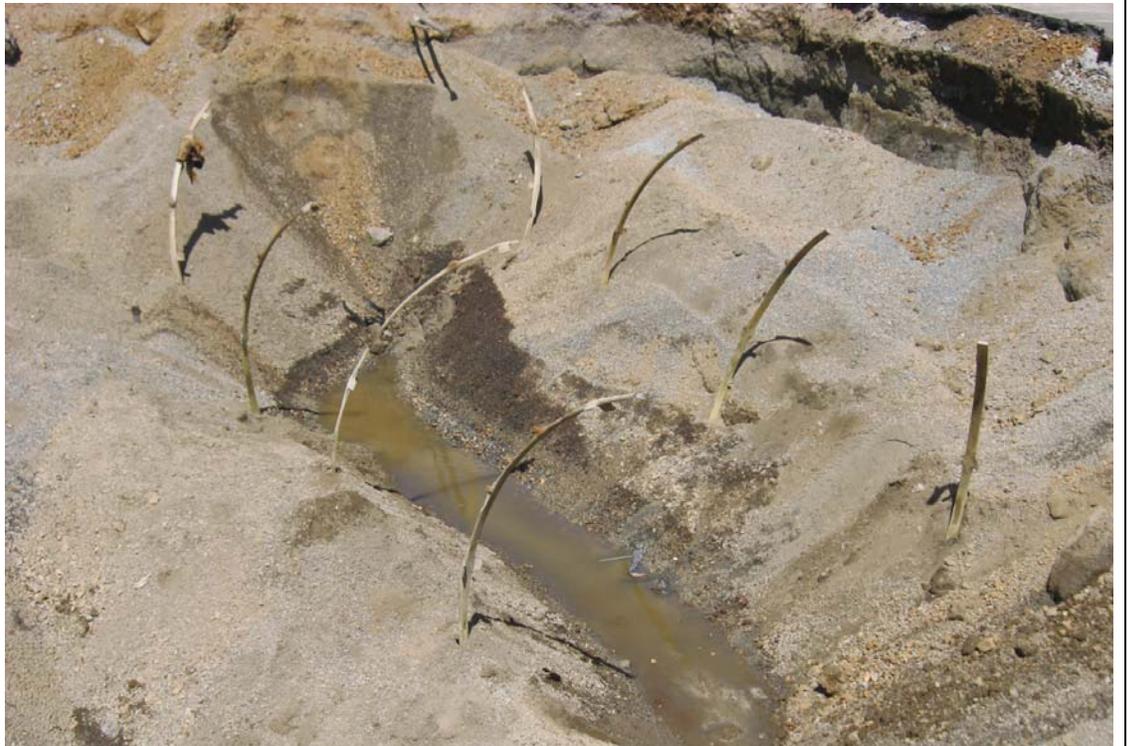
View of tank 3 footprint. Note the presence of product in the underlying groundwater and staining of the fill near the groundwater interface.

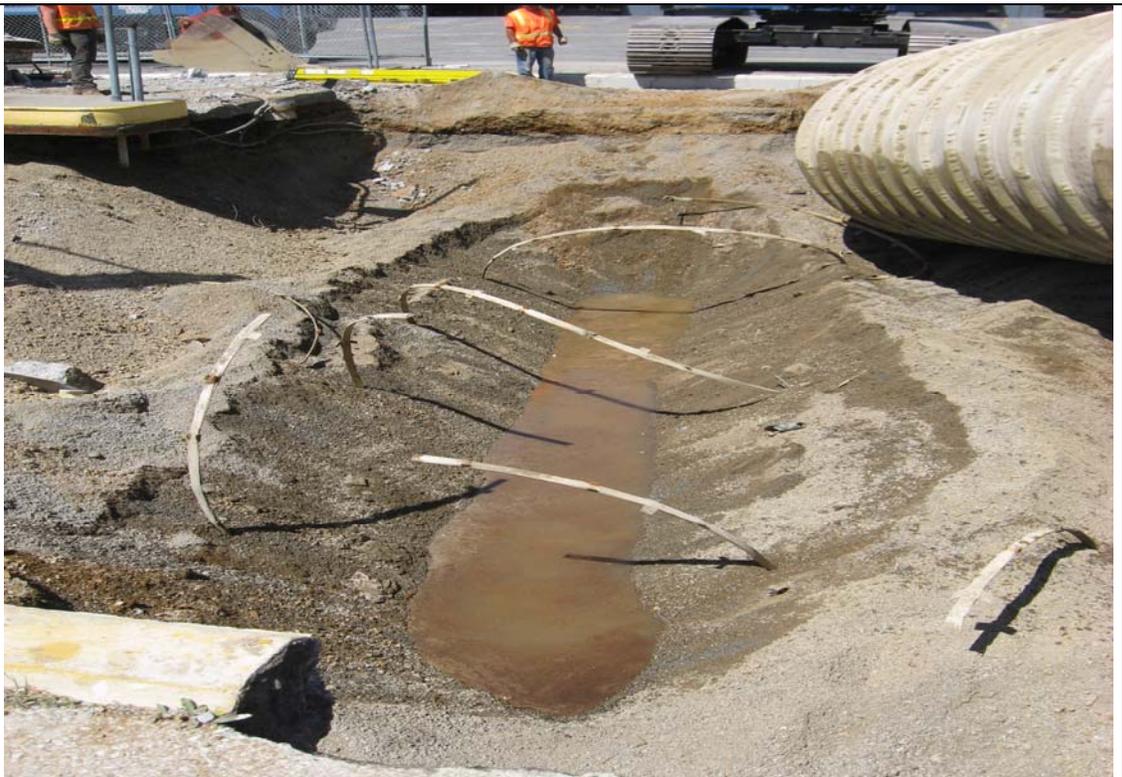
View of the footprint beneath tank 1. Note that the photo is stretched (artifact from placement into this photolog) and the presence of product in the groundwater.

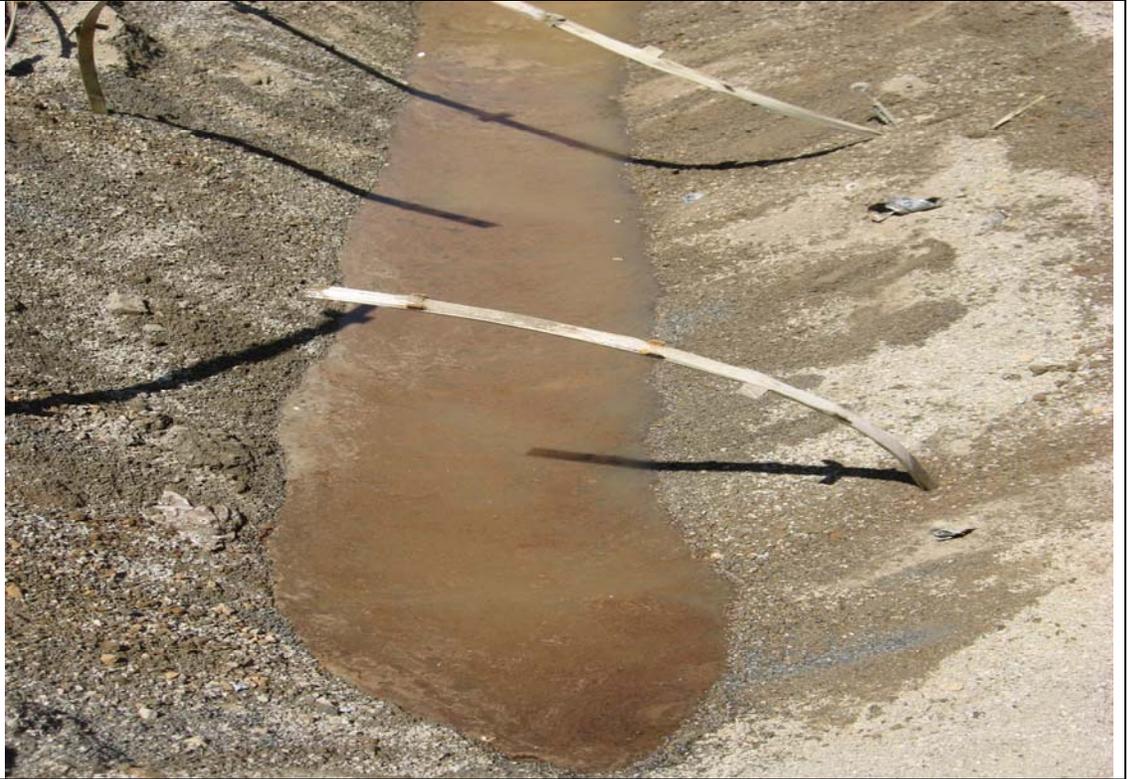
Close-up of product in groundwater beneath tank 1. Note that the photo is stretched (artifact from placement into this photolog).

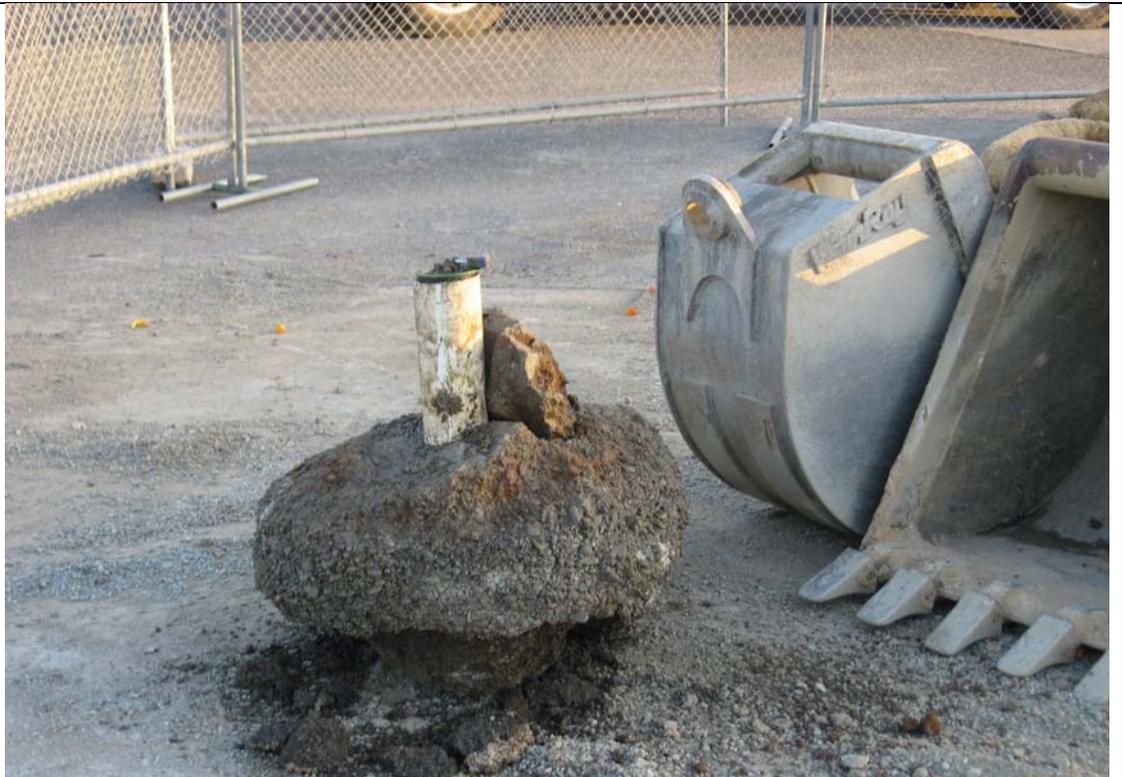
Casing for monitoring well
MW-1 destroyed during
excavation.

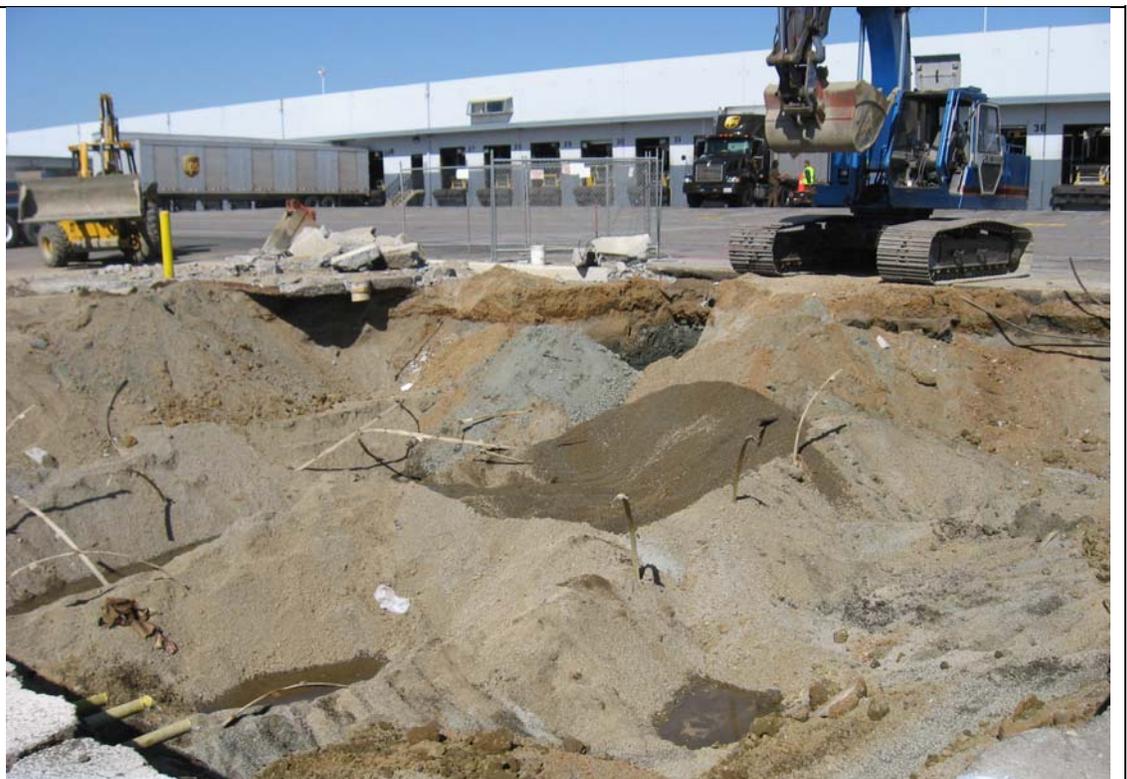
View of excavation looking southwest. Note the presence of groundwater in the foreground.

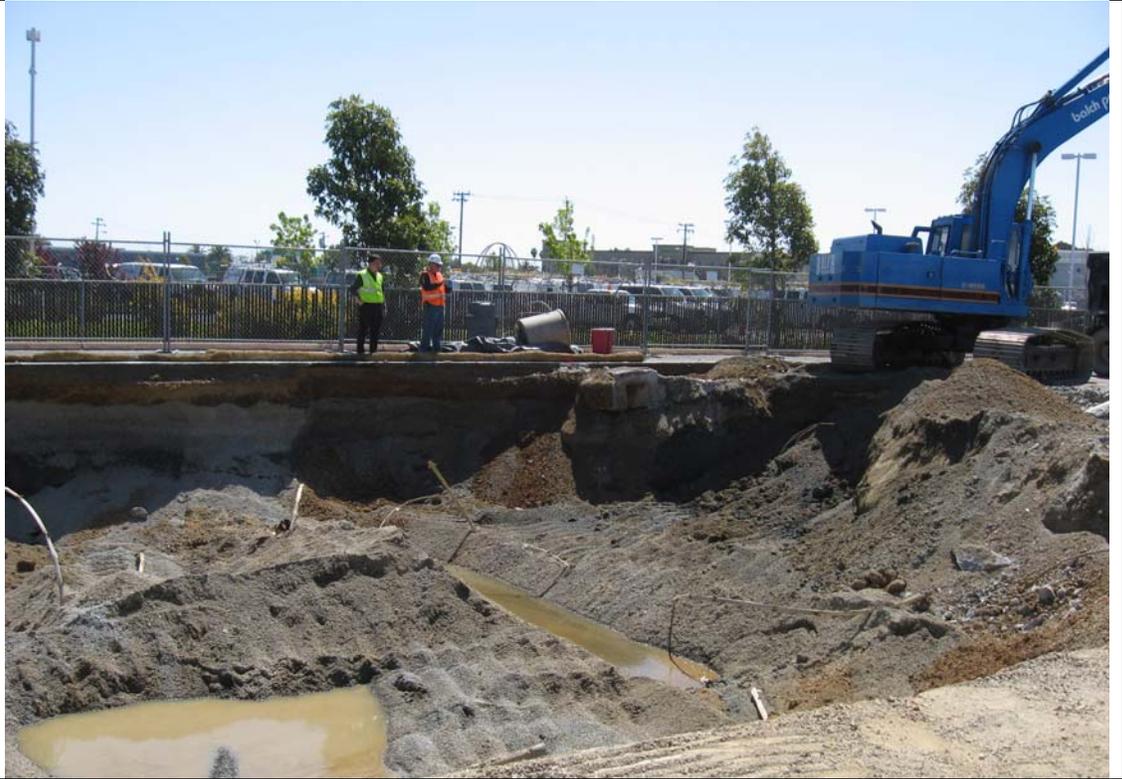
View of the eastern wall of the excavation. Note the groundwater in the foreground. Nelson Ye (UPS) and Hugh Devry (Arcadis) in the background.

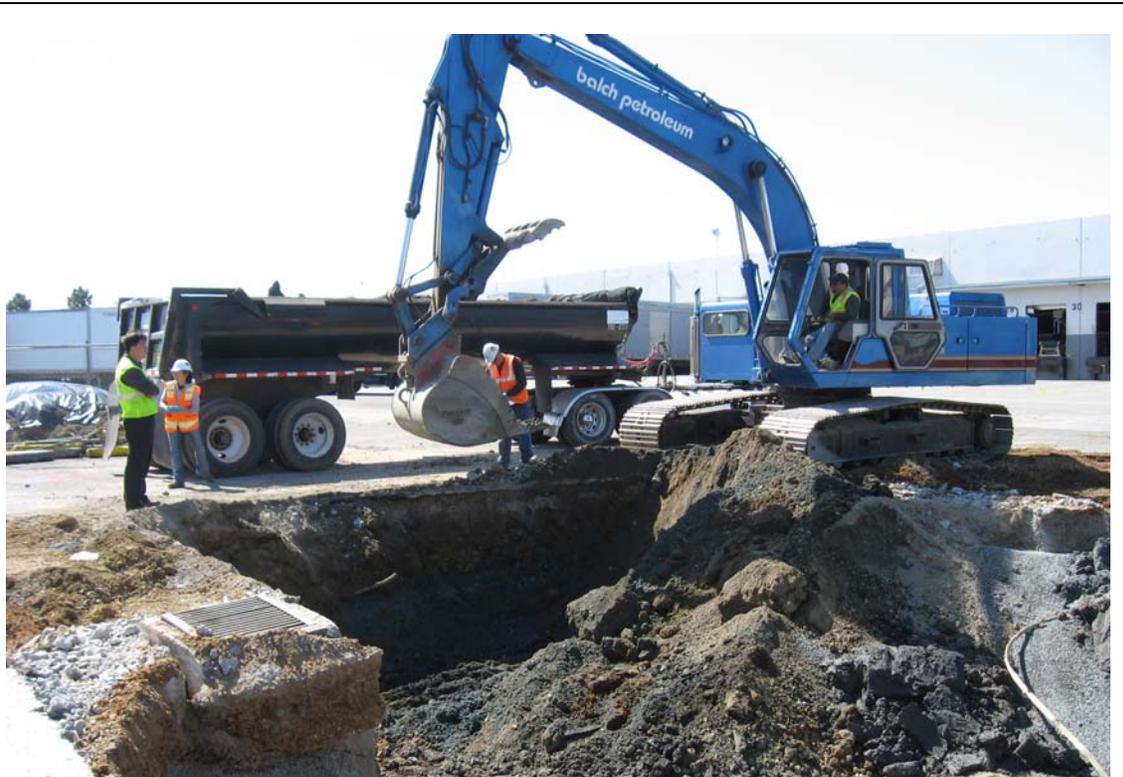
URS observed soil sample collection by ARCADIS. Soil samples were collected in sealable plastic bags. Soil samples collected from within the excavation were collected directly from the excavator bucket. ARCADIS then used a photoionization detector to collect a reading from inside the plastic bag. Soil was then transferred from the plastic bag into a glass jar, which was then sealed, labeled, and placed in an ice-chilled sample cooler. Sample handling such as what

Hugh Devry (Arcadis) collecting sample Sidewall 8 from the excavator bucket.

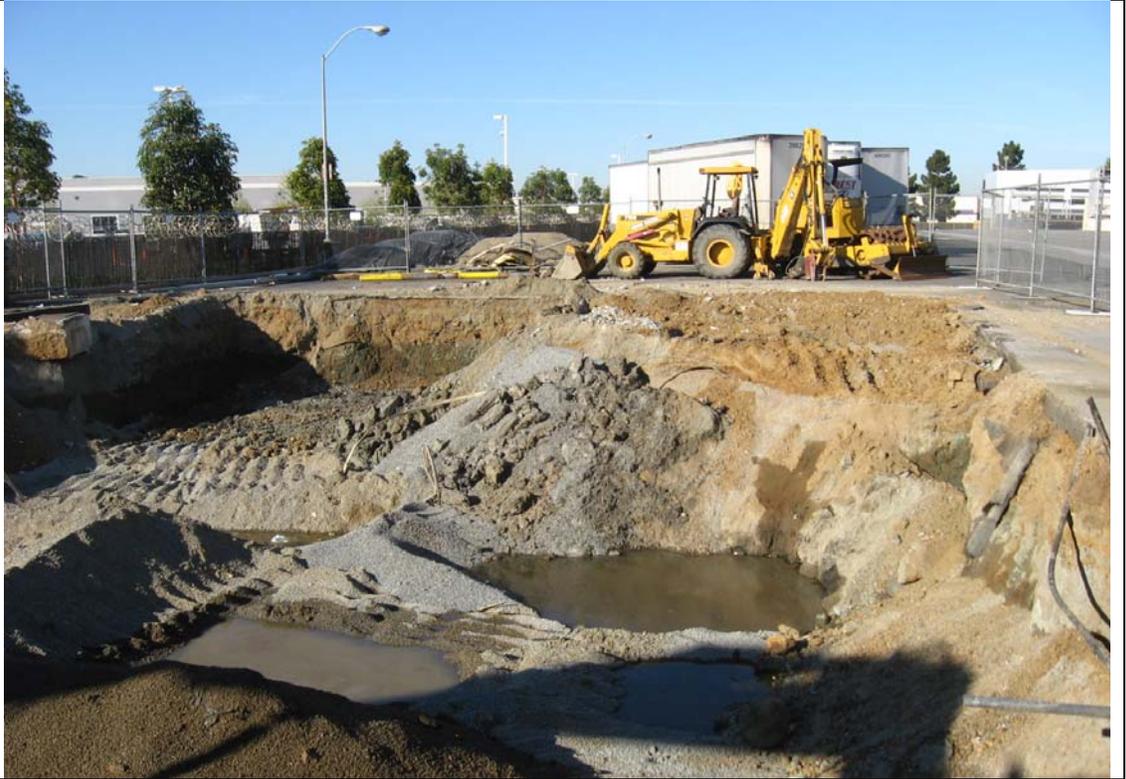
URS representatives observed backfill of the excavation on April 20 to 23, 2009. Prior to placement of backfill, URS observed that the sidewalls and base of the excavation contained stained material that had not been overexcavated. Backfill consisted of a lower zone, a middle zone, and an upper zone. The lower zone was backfilled with material from Stockpile 1 and pea gravel imported from the Balch yard. Stockpile 1 had been sampled and analyzed prior to its placement within the excavation and was evaluated to be clean based on analytical results (Table 1). The pea gravel imported from the Balch yard was sampled and analyzed after being placed in the excavation and was evaluated to be clean based on analytical results. Material from Stockpile 2 was to comprise a portion of the backfill in the lower zone according to a Balch representative; however, it is unclear whether this material was sampled, analyzed, and placed within the excavation. Filter fabric was placed on top of the pea gravel. The middle zone was backfilled with spoils stockpiled near the southeastern corner of the UPS property. The spoils originated from an excavation unrelated to the tank removal field program, which was conducted in conjunction with the installation of footings for an aboveground storage tank. It is unclear whether the footing spoils were sampled and analyzed prior to being used as backfill. The upper zone was backfilled with Class II recycled asphalt. The recycled asphalt was sampled and analyzed after being placed in the excavation and was determined to have detectable concentration of TPH-DRO, polynuclear aromatic hydrocarbons, and arsenic, as stated previously.

View of the southern half of the excavation. Note the in-place material located along the southwestern corner of the excavation in the vicinity of former dispenser island north.
