# Report on Second Sub-slab Vapor, Indoor Air, and Outdoor Air Sampling and Vapor Intrusion Evaluation for the Oakland Veterinary Hospital Located at 4258 MacArthur Boulevard, Oakland, California

76 Service Station No. 1156 (351645)  
4276 MacArthur Boulevard  
Oakland, California

Prepared by:  
AECOM  
Camarillo, California  
February 2015

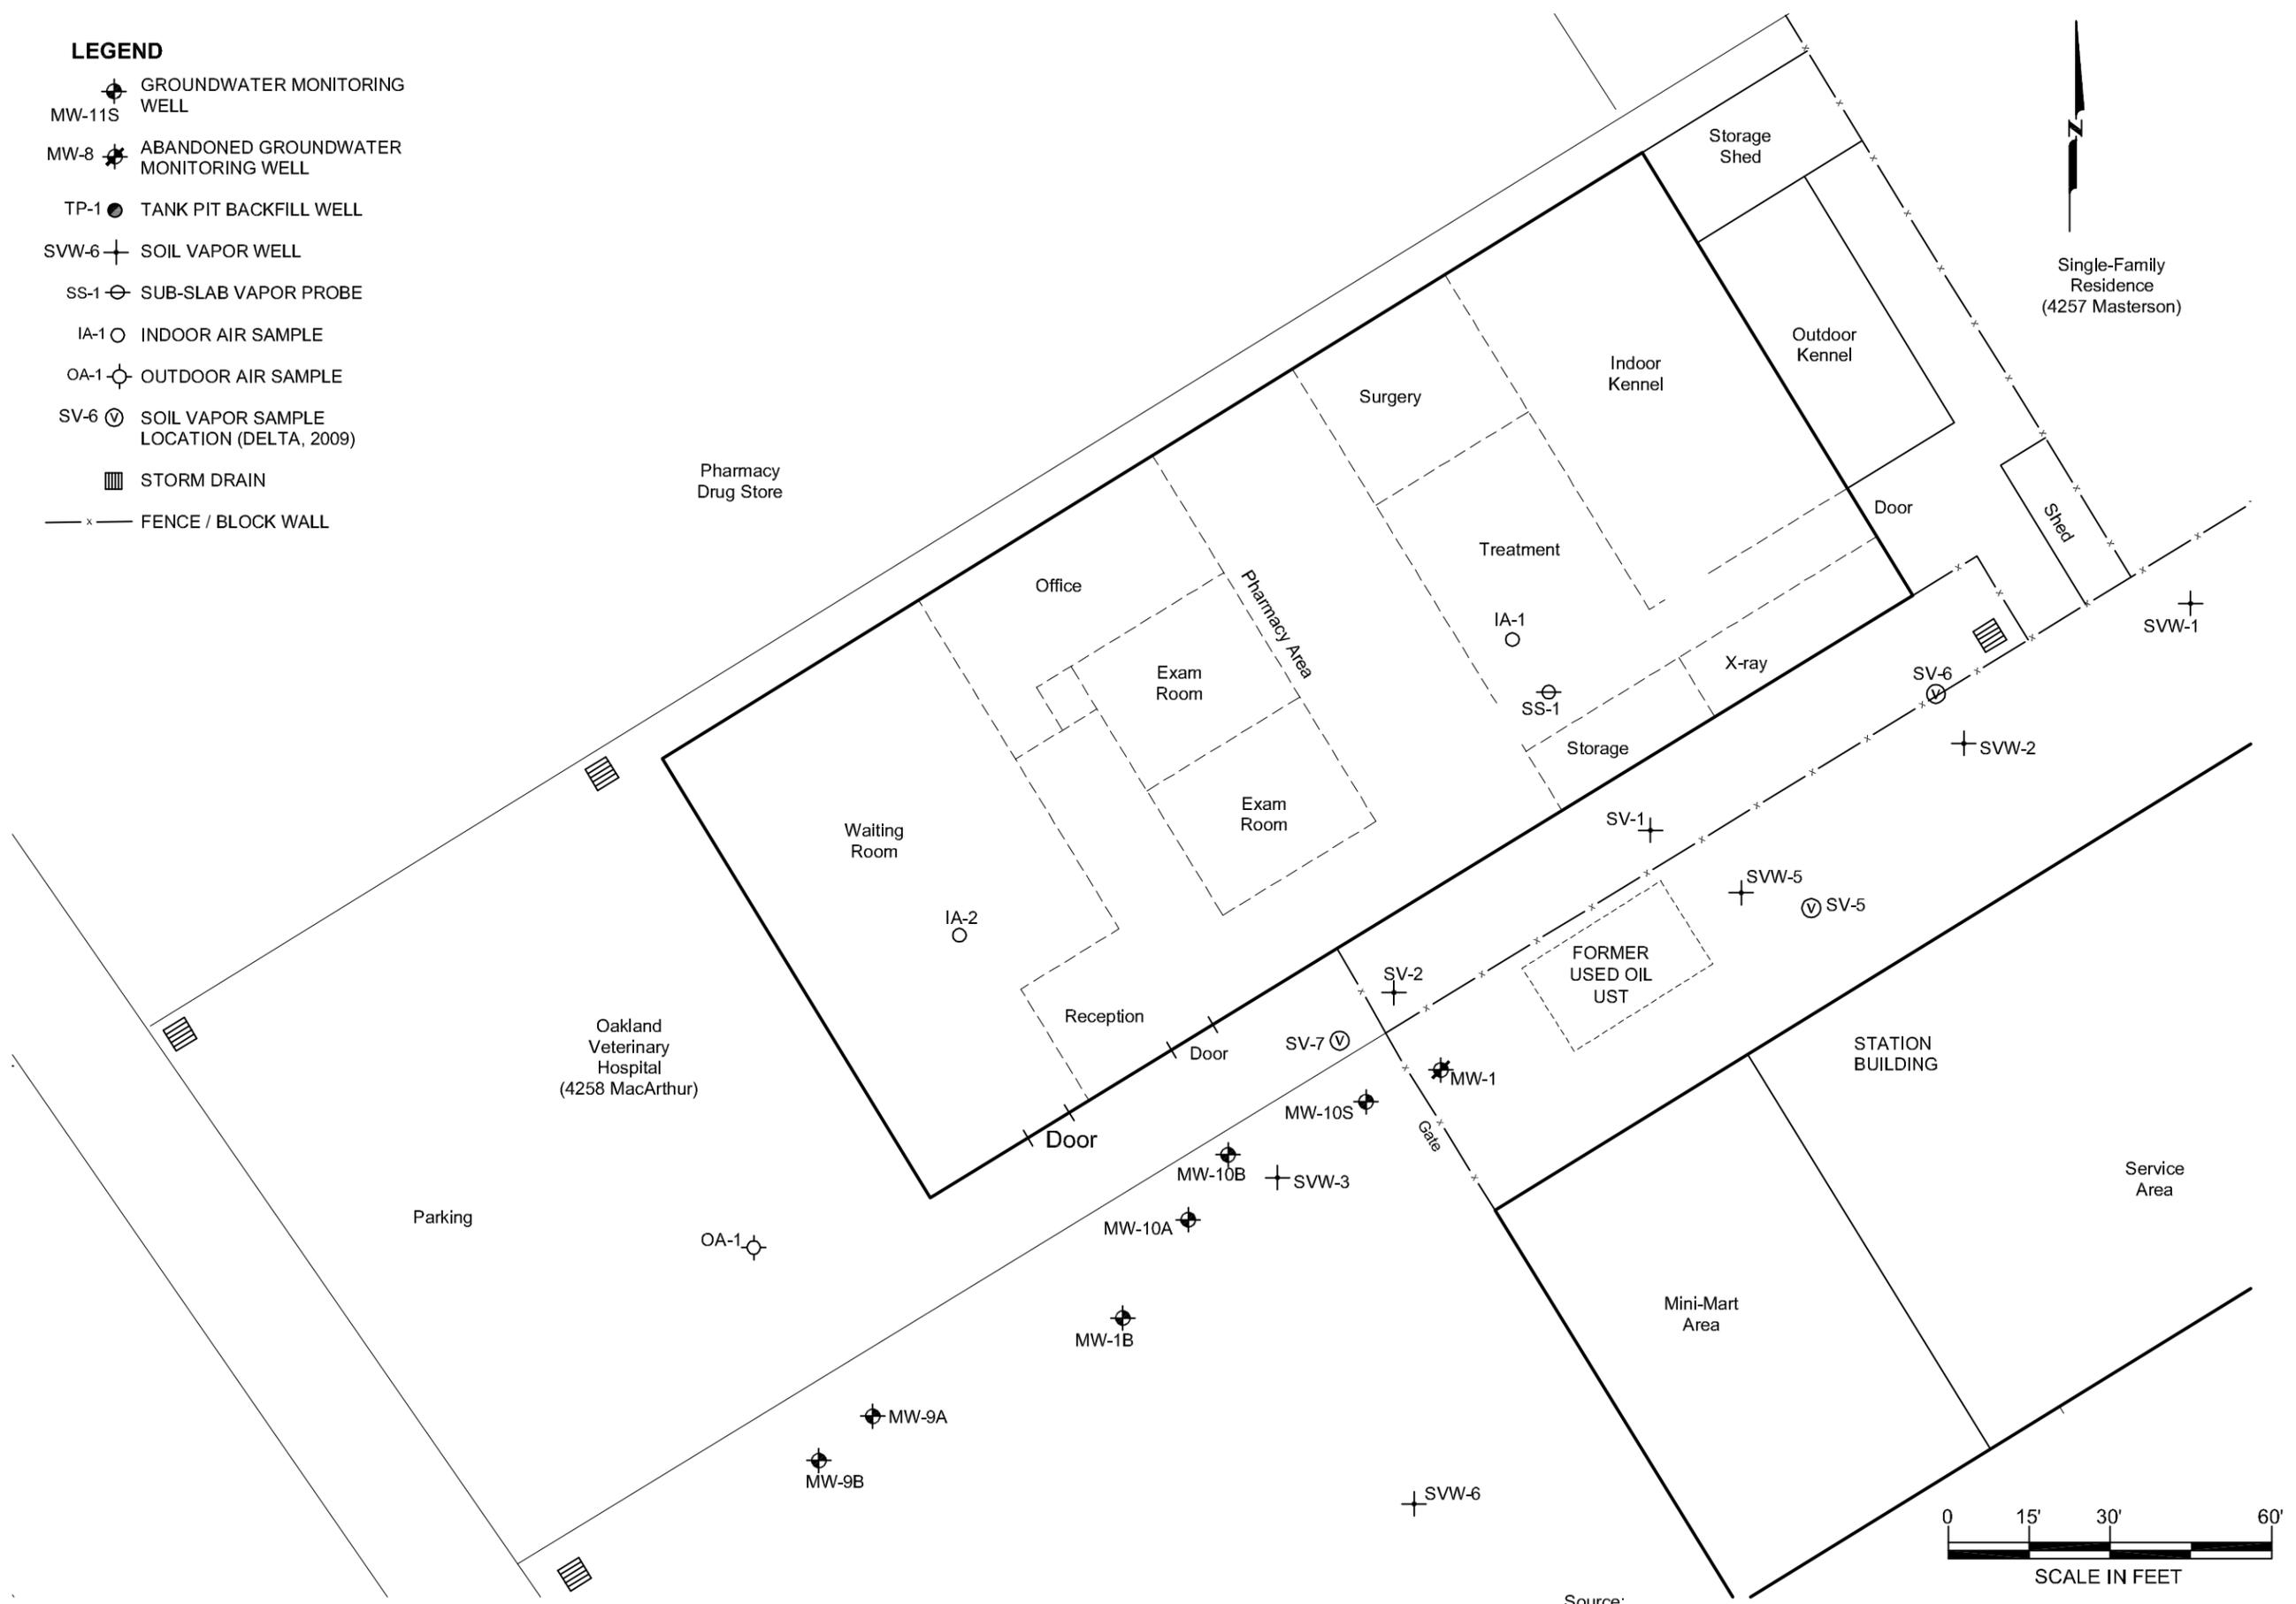
FIGURE NUMBER: <b>2</b>
SHEET NUMBER: X

Each sampling event collected samples from the following locations: one sub-slab vapor probe (SS-1), two indoor air locations (IA-1 and IA-2), and one ambient outdoor air locations (OA-1). The sample locations are shown on **Figure 2**.

As with the first sampling event, two indoor air samples (IA-1 and IA-2) were collected. IA-1 was collected from the same vicinity as the sub-slab sample, while IA-2 was collected over the raised foundation portion of the building. One outdoor air sample (OA-1) was collected for laboratory analysis from outside of the OVH building. The sample locations are shown on **Figure 2**.

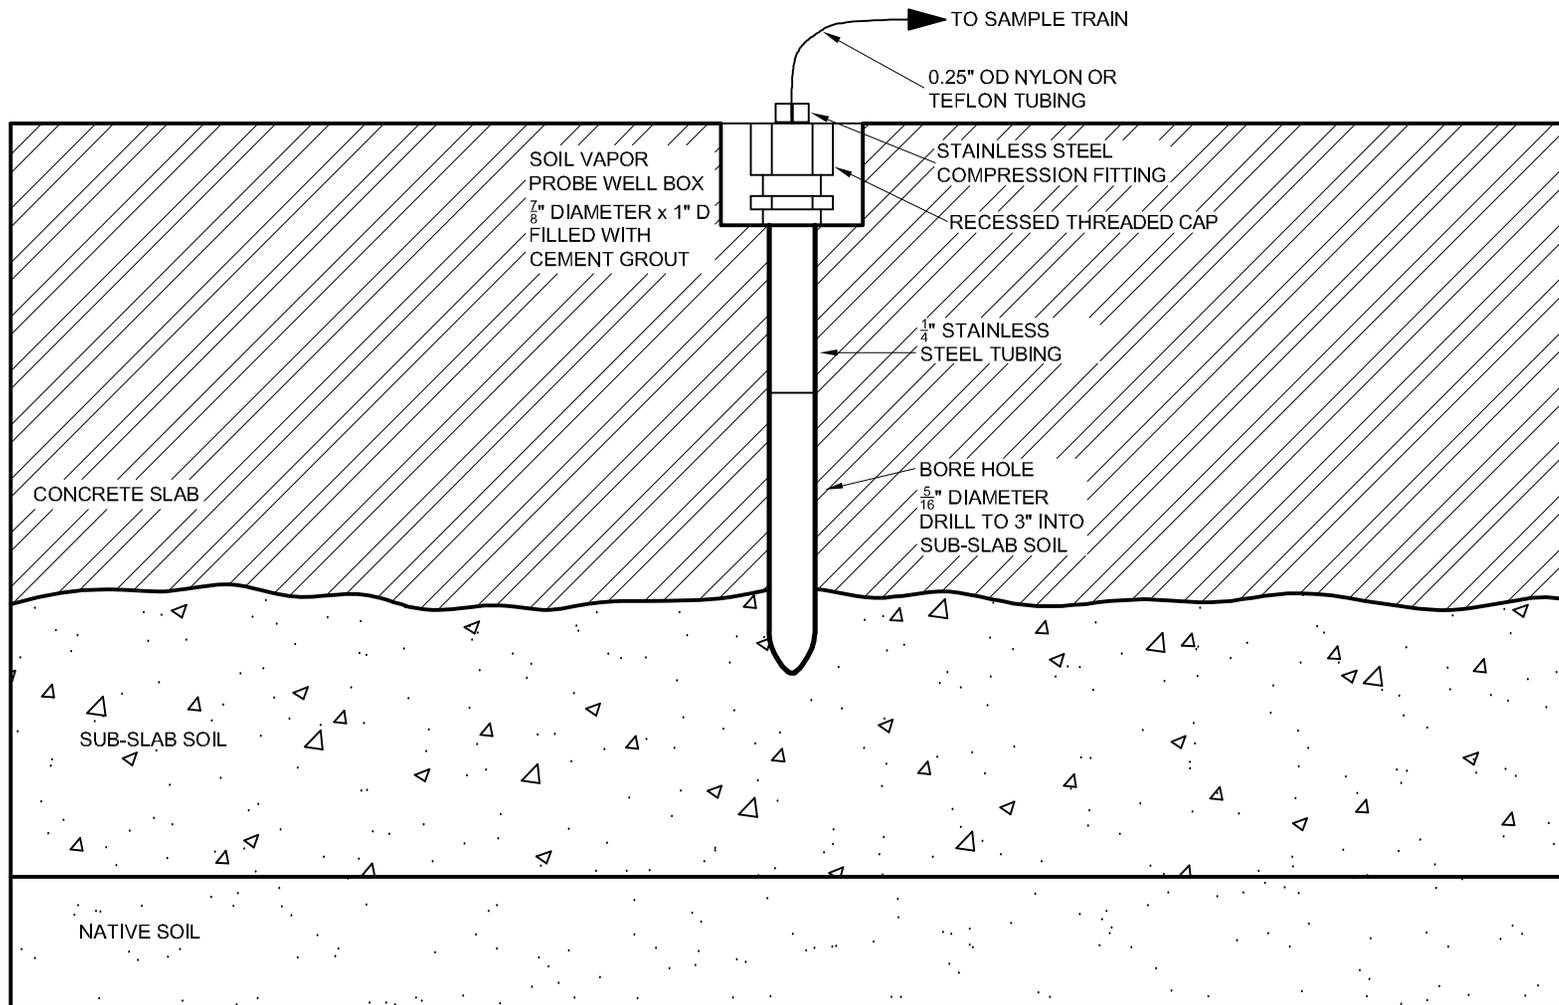
The following subsections provide general information regarding the procedures followed during collection of the soil vapor probe samples. **Figure 3** provides an illustration of the sub-slab vapor probe construction detail. Sampling methods followed the procedures recommended by CalEPA (CalEPA 2011a; 2012). Sub-slab vapor was sampled on January 18, 2015.

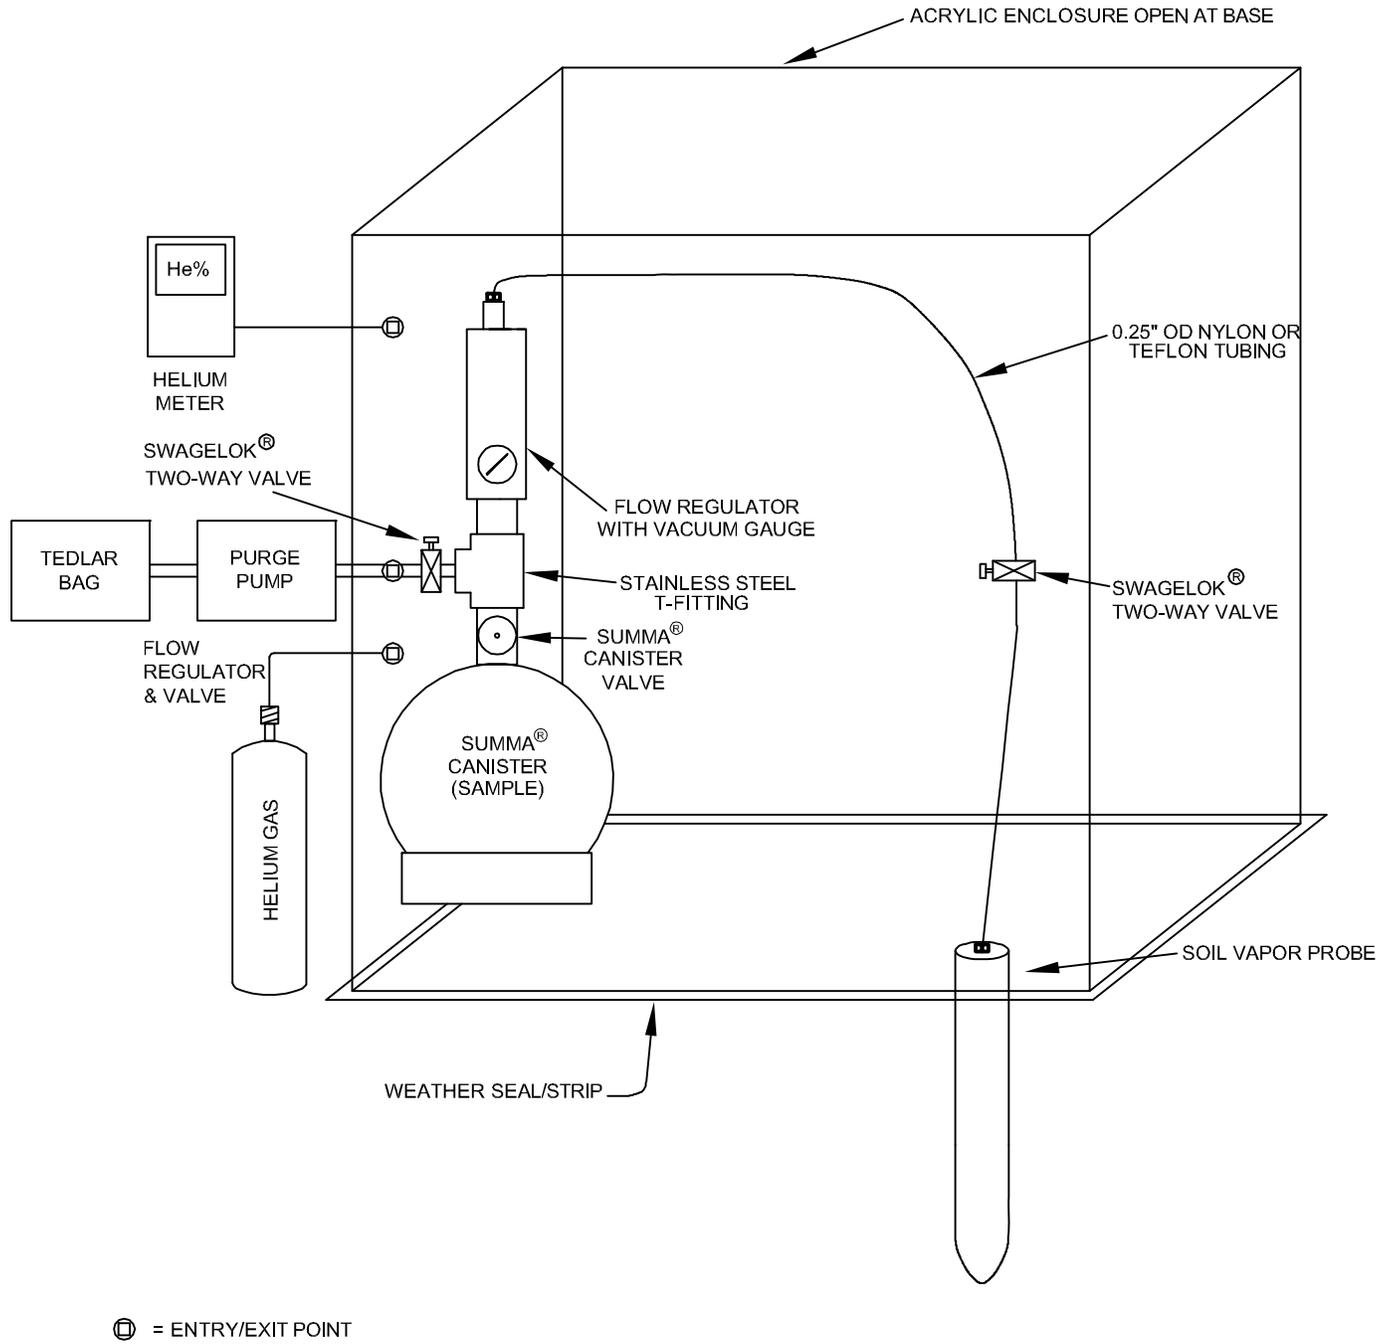
**SUB-SLAB VAPOR SAMPLING APPARATUS**

All gauges and flow control manifolds were supplied by Eurofins Air Toxics, Inc. of Folsom, California (Air Toxics). The gauges and manifolds were connected by chromatography-grade, stainless steel tubing and dedicated airtight, flexible, Teflon<sup>®</sup> tubing, which were supplied by the laboratory and have a low capacity for adsorbing VOCs. Samples were collected in 1-liter Summa<sup>®</sup> canisters provided by Air Toxics. All the canisters used for the sampling were 100%-certified as clean to support use of the soil vapor sample results in human health risk assessment. Each canister was field-verified to have a vacuum of at least 25 inches of mercury (inHg) prior to sampling.

Leakage of atmospheric air into the equipment during sampling can compromise sample integrity and dilute measured soil vapor hydrocarbon concentrations. Sampling equipment was thoroughly inspected to ensure tight fittings between all components. To minimize the potential for leakage, the soil vapor sampling rate was kept at less than (<) 200 milliliters per minute (mL/min) using a flow controller supplied by Air Toxics. Prior to sampling, the Summa<sup>®</sup> canister valve was opened to the still-closed Swagelok<sup>®</sup> valve for 10 minutes and the initial vacuum pressure recorded. Purging and sampling were not commenced until the sample train passed the leak test by maintaining constant vacuum for 10 minutes.

Laboratory-grade helium was used as the tracer gas to test for air leakage into the sampling system for the purpose of sample integrity verification, in general accordance with the CalEPA guidance document (2012). A clear plastic chamber was placed over the soil vapor probe location and sealed to the ground surface with a rubber mat. Helium from a cylinder was discharged into the chamber, and a helium detector was used to the percentage of helium inside the chamber. The values measured ranged from approximately 19.7% to 22.2% helium during sampling. Field measured helium concentrations were recorded on vapor sampling field sheets included as **Appendix C**. Laboratory analysis for helium was used to assess if leakage occurred during sampling. The laboratory report indicates that no helium was detected in the samples. Acceptable leakage is up to 10%; therefore, the sample results are considered valid (CalEPA 2012).

Sample collection from the sub-slab vapor probe was started immediately after purging. Sample train integrity testing was performed by enclosing the sampling train in a helium-enriched atmosphere concurrent with sampling, as described above. To begin sampling, the valve on the Summa<sup>®</sup> canister was opened and the time and initial pressure were documented. As the canister filled, the pressure gauge on the flow controller was observed to ensure that the vacuum in the canister was decreasing over time. Each canister was allowed to fill for approximately 8 minutes, until the canister vacuum gauge indicated the vacuum had decreased to 3.5 inHg.
