PHASE I ENVIRONMENTAL SITE ASSESSMENT 160 14th Street Oakland, California

ACC Project No. 01-6179-014.00

April 9, 2001

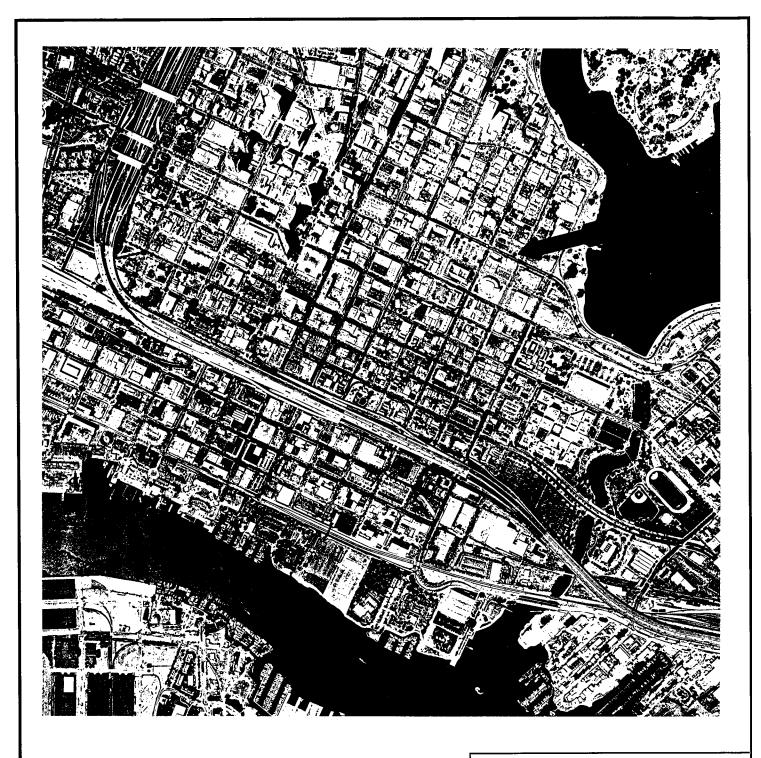
1	
		Islamic Culture Church Building and Parking Lot 1433 Madison Street	Madison Street		
Office Building 1410 Jackson Street One-Hour Dry Cleaning 190 14th Street		Public Parking Lot 160 14th Street		Apartment Building 1428 Madison Street	
				Retail & Residential 130-144 14th Street	
		14th Street			
		Little Stars Preschool 169 14th Street		Oakland Public Library 125 14th Street	
		Figure Project I A CO 7977 Oak	akland, Number: No.: 01-6 VIRONI DNSUL Capwell Dr land, Califo	Street California

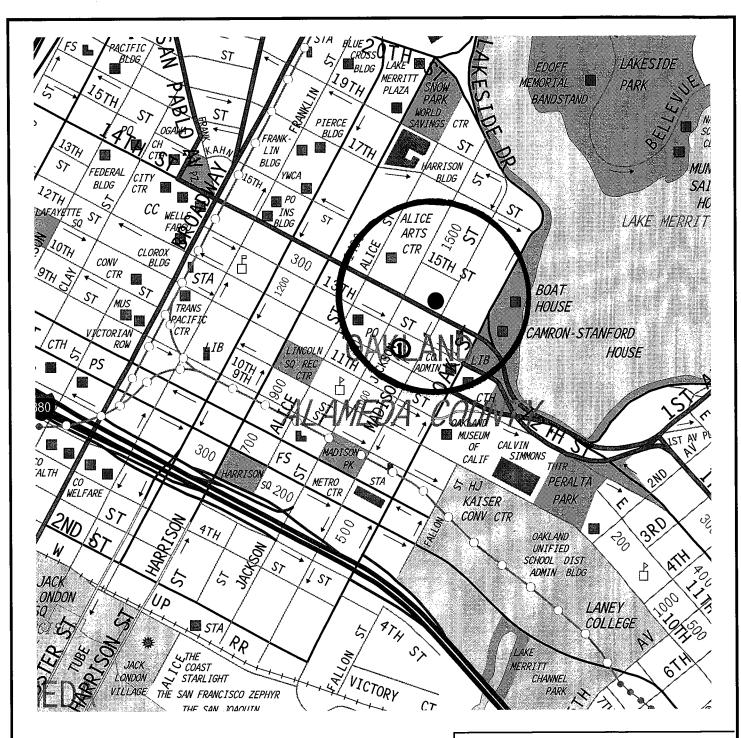
Title: 1/8 Mile Radius Map 160 14th Street Oakland, California

Radius Map: Figure 6, Mapped Site Subject Property

Radius Map: Figure 6, Mapped Site #1

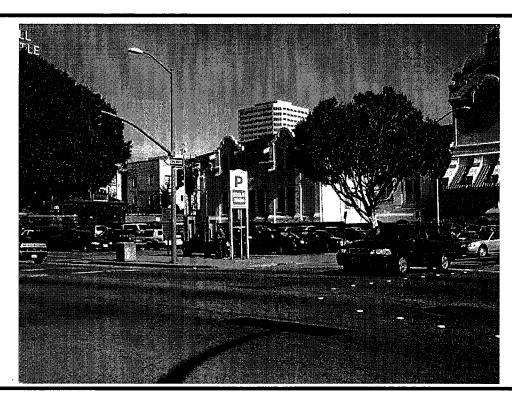
The subject property is an approximately 14,250-square-foot asphalt paved parking lot (Photograph 1). The property and surrounding areas are zoned Central Business by the City of Oakland Planning Department. The surrounding area is a mixture of service and commercial businesses and residential buildings.

Photograph 1: View of the subject property.

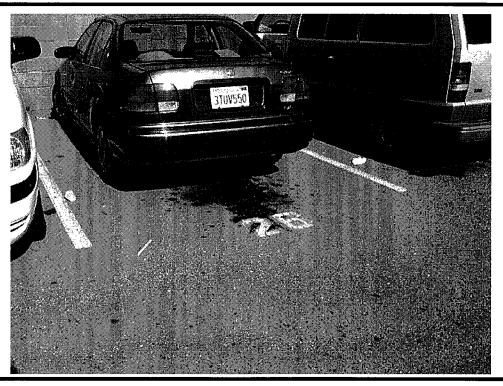
During the site reconnaissance, ACC observed surficial staining in the parking lot of the subject property. The staining appeared to be the result of leaking fluid from automobiles. The asphalt pavement in the vicinity of the staining appeared to be intact. It is ACC's opinion that the presence of the staining poses a low potential to impact the environment.

Photograph 2: View of surficial staining in the parking lot.
