**REVISED CLOSURE PLAN
FORMER HANSON AGGREGATES SITE
PLEASANTON, CALIFORNIA**

**Haley & Aldrich, Inc.
Walnut Creek, California**

**File No. 39187-000
23 April 2013**

Subject: Revised Closure Work Plan Dated 04.23.2013 – Hanson Radum Facility
SLIC Case RO0002941 and Geotracker Global ID SLT19719376
3000 Busch Road
Pleasanton, California 94566

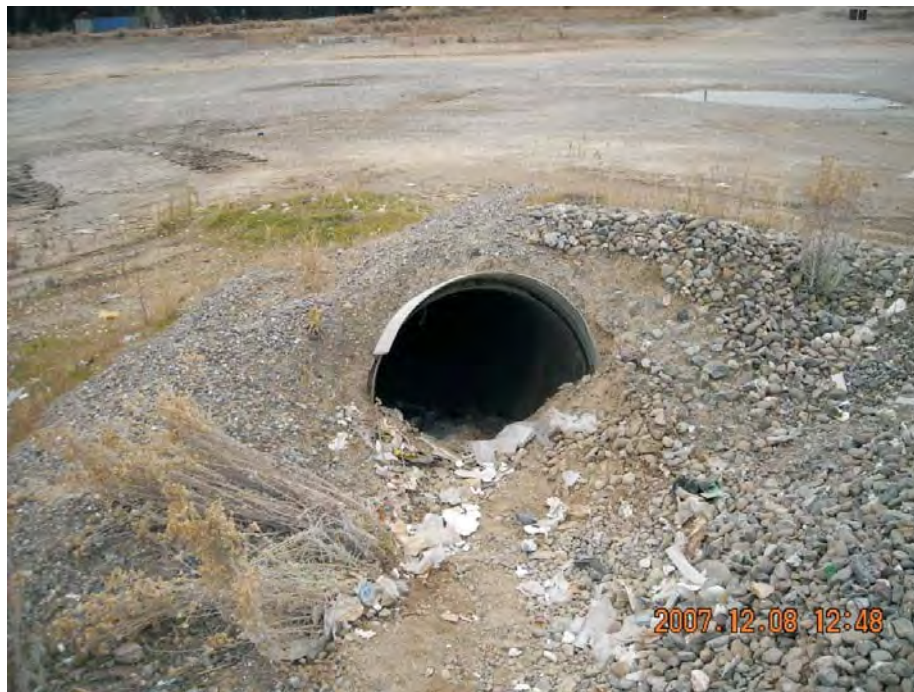
Eastern Entrance to Conveyor Tunnel

No signs of human transient occupancy were identified in either the primary or the escape culverts at the time of closure. The entrances to the main culvert and the escape culverts were subsequently sealed by placing a large amount of soil in front of the entrances.

As discussed in Section 3.1, the underground conveyor culvert was temporarily sealed in 2008 by placing a large amount of soil in front of the entrances. The culvert will be opened by removing the soil blocking its entrances and the backfill overlying the culvert. The corrugated metal structure and contents will be removed. Confirmation soil samples will be collected from beneath the main conveyor culvert during removal. Soil samples will be collected at a minimum every 40 linear feet from the depth where the highest degree of staining or odor was observed during excavation, or as directed during field inspection by ACEH or LPFD. Soil samples will also be collected beneath any joints, seams, or other breaks in the conveyor culvert. The attached escape tunnel will also be removed. It is anticipated that the items removed from the culvert can be recycled for scrap. The culvert will then be backfilled with clean fill stockpiled on-Site. The final disposition of the contents of the culvert will be presented in the report documenting the implementation of this closure plan.

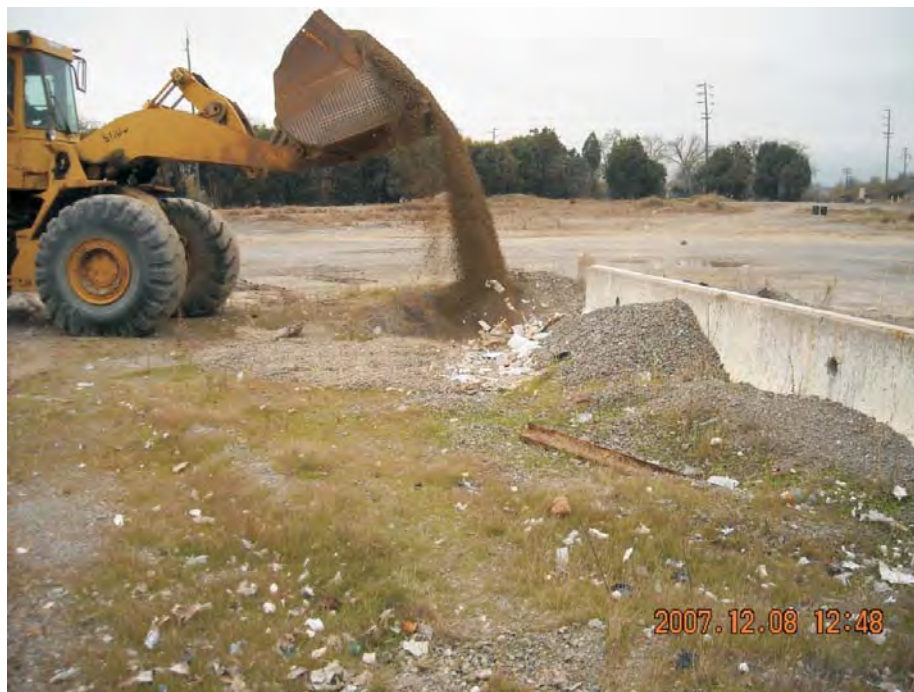
Eastern Conveyor Entrance Post Abandonment

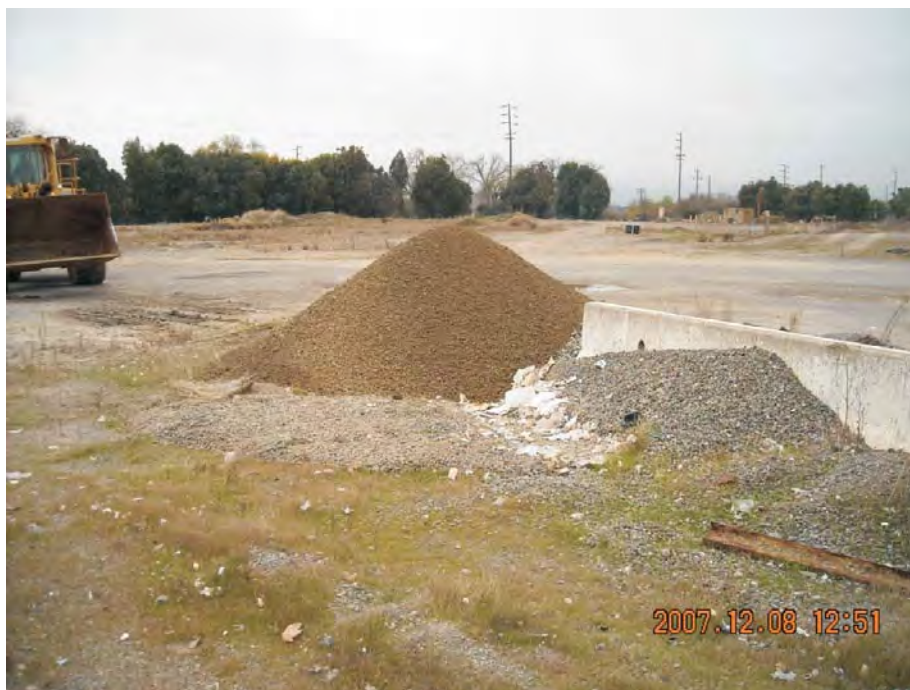
Eastern Conveyor Entrance Post Abandonment

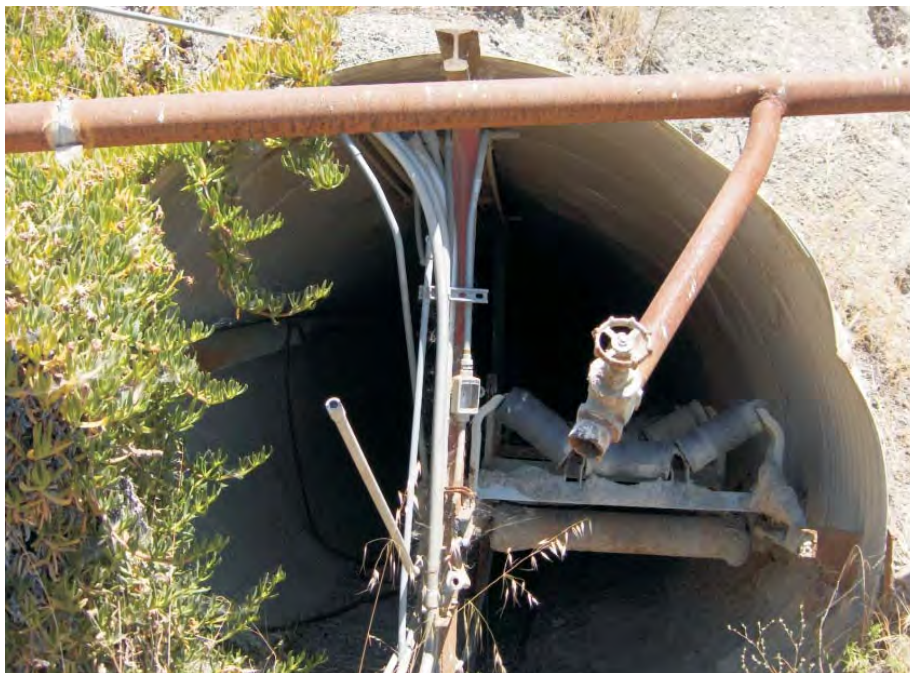
Western Conveyor Entrance Pre-Abandonment

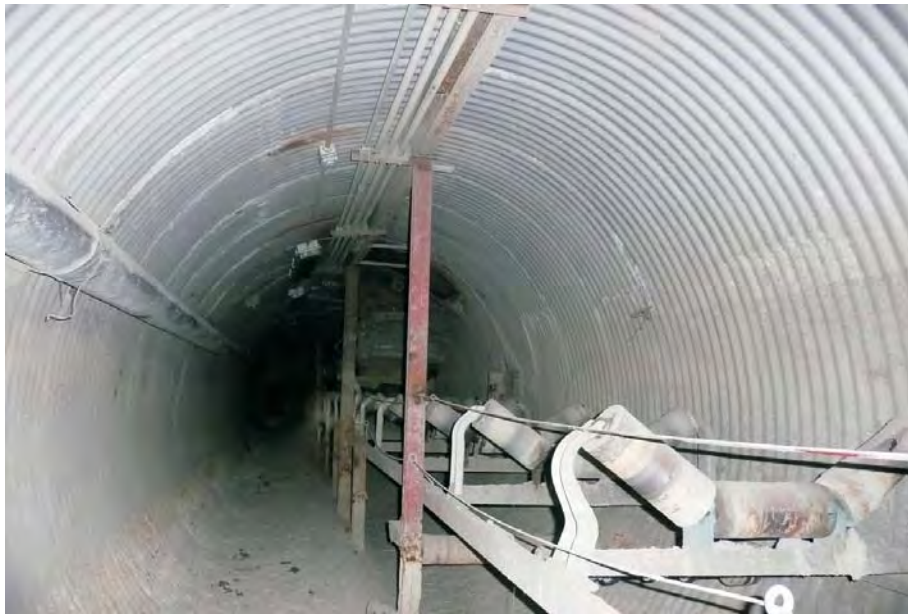
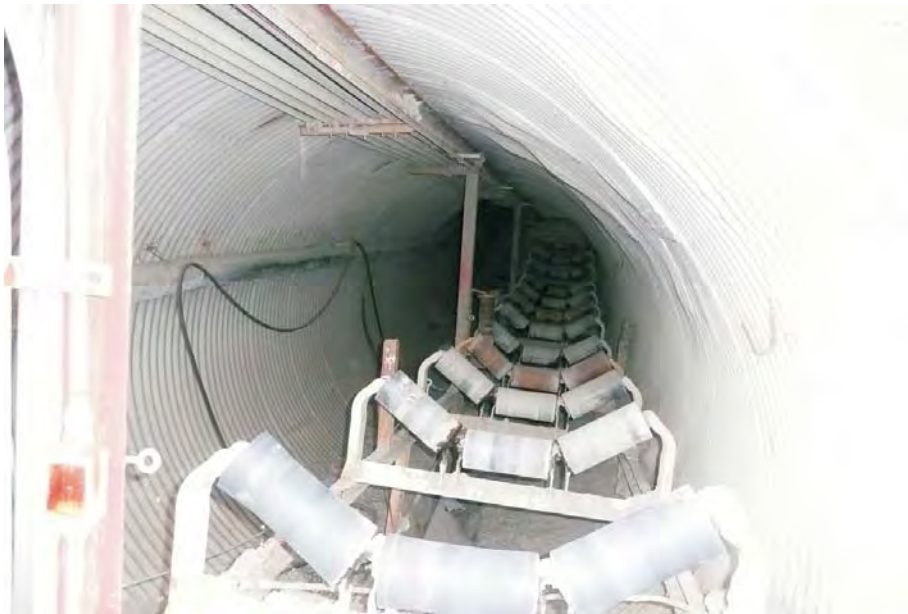
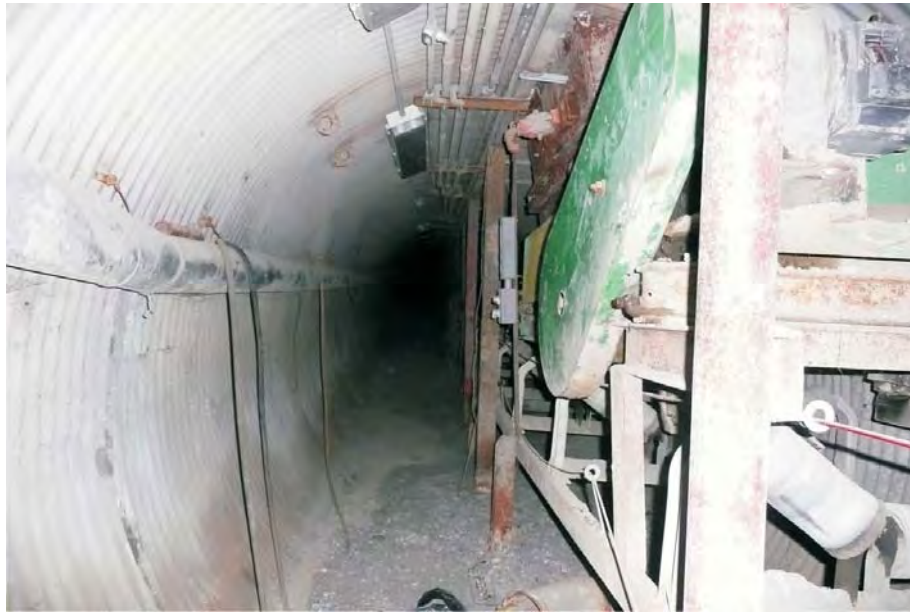
Hanson contracted NRC Environmental Services (NRC) of Alameda, California, to inspect and seal the culvert. NRC's report is provided in Appendix B. NRC personnel entered the culvert using appropriate health and safety equipment and walked its length to inspect its condition and contents. The culvert, constructed out of corrugated metal, was found to be approximately 8 feet in diameter and approximately 130 feet long and stretching approximately to the east from its main entrance. The end of the culvert consisted of a solid wall constructed of concrete and wood. The culvert contained a former conveyor system, a metal support structure, metal pipes, and rubber tubing fastened along the center of the ceiling, and what may have been a motor at the end of the culvert. The culvert was relatively debris-free, although a layer of fine soil lined the floor of the culvert and plastic debris was found at the exit of the culvert. A smaller diameter escape tunnel, also constructed of corrugated metal, was identified near the exit of the main culvert and leading approximately north. The escape culvert was also inspected and found to be approximately 4 feet in diameter and approximately 60 feet long.

Inside Conveyor Tunnel

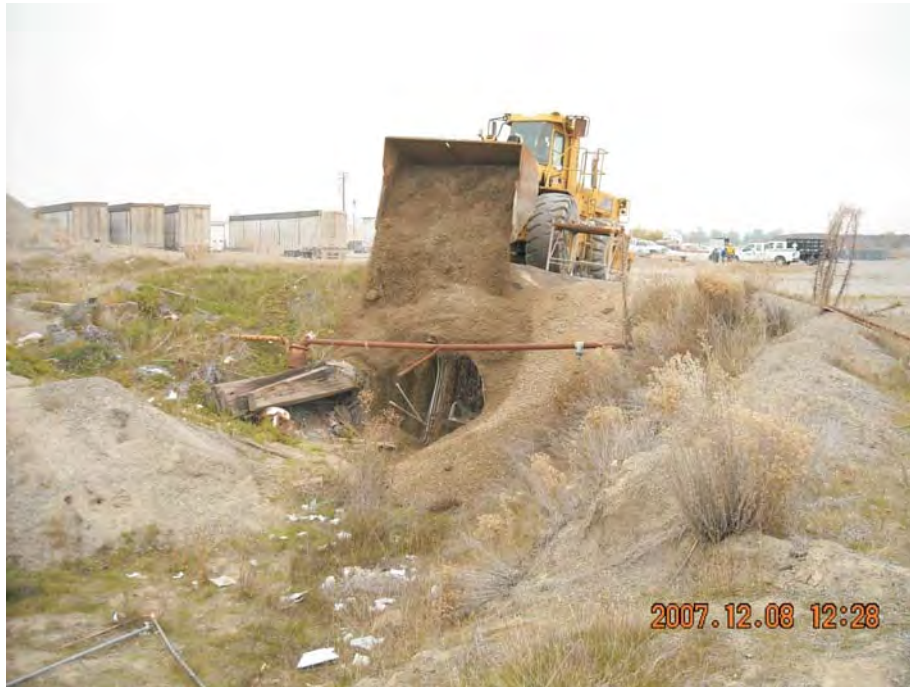
Western Conveyor Entrance During Abandonment

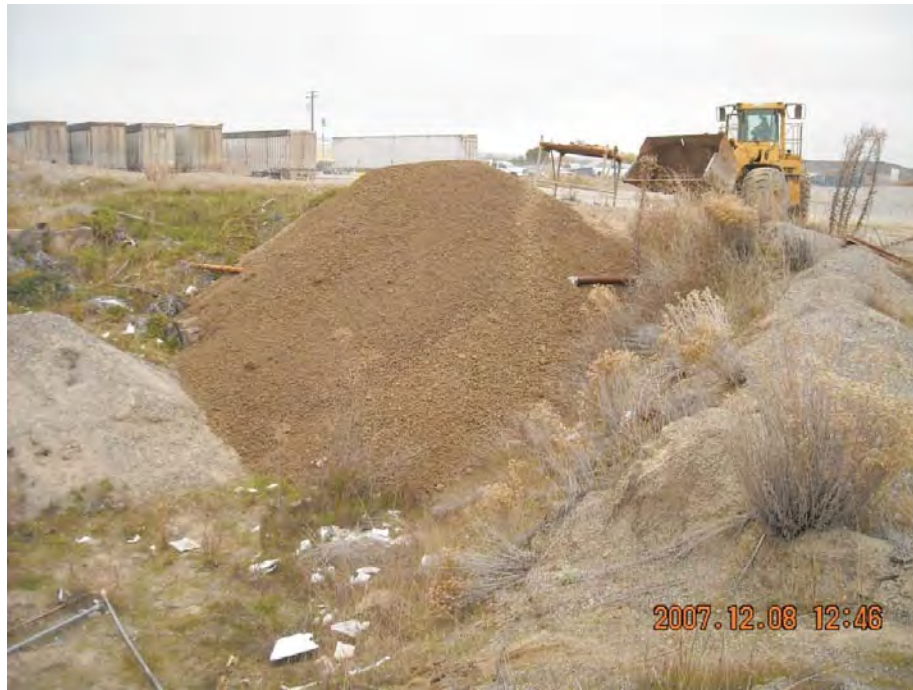
Western Conveyor Entrance Post Abandonment 1

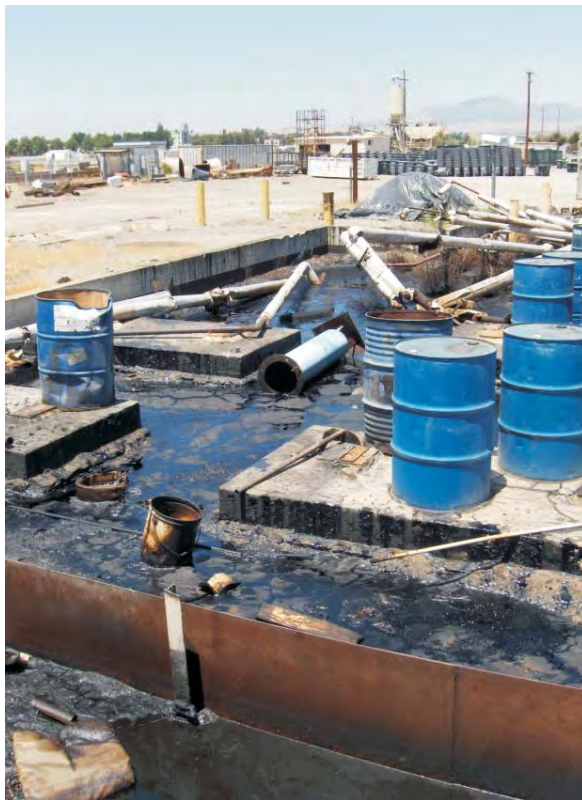
Containment Structure

After the oily water, drums, buckets, and piping are removed from the containment structure, the concrete walls and floor of the structure will be removed using earth-moving equipment. Based on the presence of the oily water within the containment structure, the concrete will likely require off-site disposal. It is anticipated that the stained concrete will be disposed of off-site as Class II waste.

Once the concrete structure is removed, the soil beneath the concrete containment structure will be visually observed for the presence of staining. Soil visually observed to be stained by petroleum hydrocarbons will be excavated laterally and/or vertically to a maximum depth of 8 feet bgs and stockpiled on-site following procedures in Section 5.7. Sidewall confirmation soil samples will be collected every 20 linear feet from the depth where the highest degree of staining or odor was observed during excavation, or as directed during field inspection by ACEH or LPFD. Bottom confirmation soil samples will be collected every 400 square feet at the base of the excavation, directly below the area where the highest degree of staining or odor was observed during excavation, or as directed during field inspection by ACEH or LPFD.

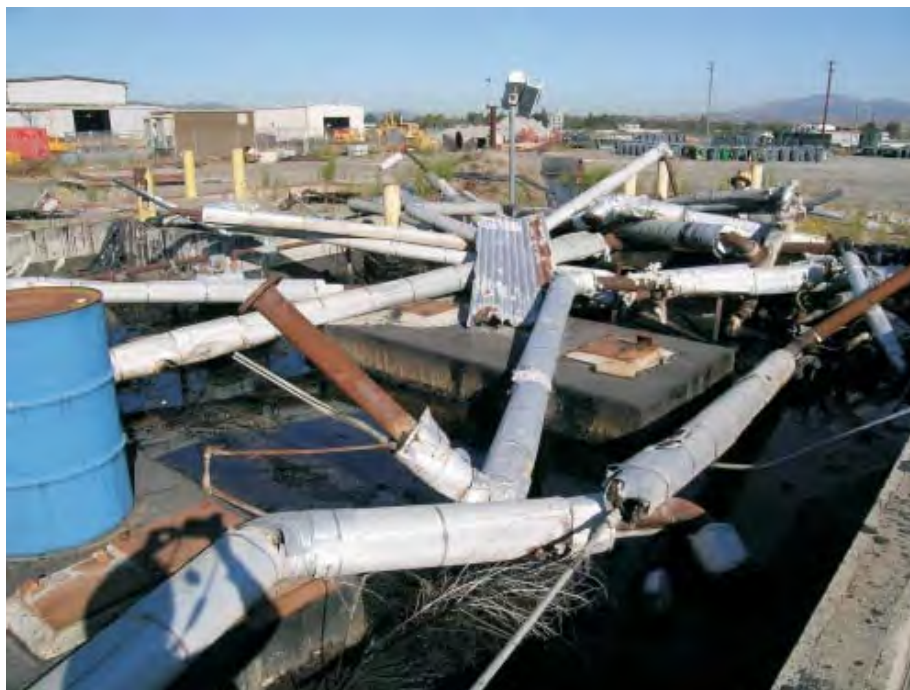
Piping in Containment Structure

The insulated piping present within the containment structure will be screened for the presence of ACM. A representative sample of the insulation material will be collected and submitted to a laboratory that has an EPA certification through the National Institute for Standards and Technology (NIST) National Voluntary Laboratory Accreditation Program (NVLAP) for analysis using polarized light microscopy (PLM). The samples will be analyzed for ACM using PLM with Dispersion Staining (PLM/DS) in accordance with the EPA “Interim Method for the Determination of Asbestos in Bulk Building Materials as found in 40 CFR, Part 763, subpart F, Appendix A” (EPA/600/R-93/116). Based on the results of this testing, the piping will be disposed of or recycled appropriately. If the analytical results of the insulation material indicate that ACM is present, an ACM abatement plan presenting the procedures to contain and dispose of the ACM will be prepared.

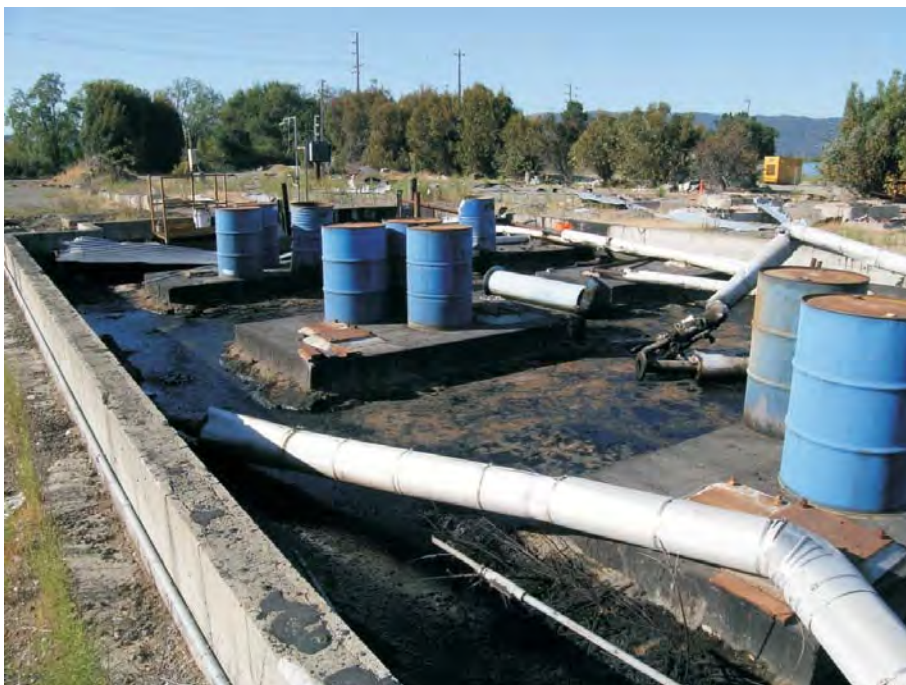
Drums in Containment Structure 1

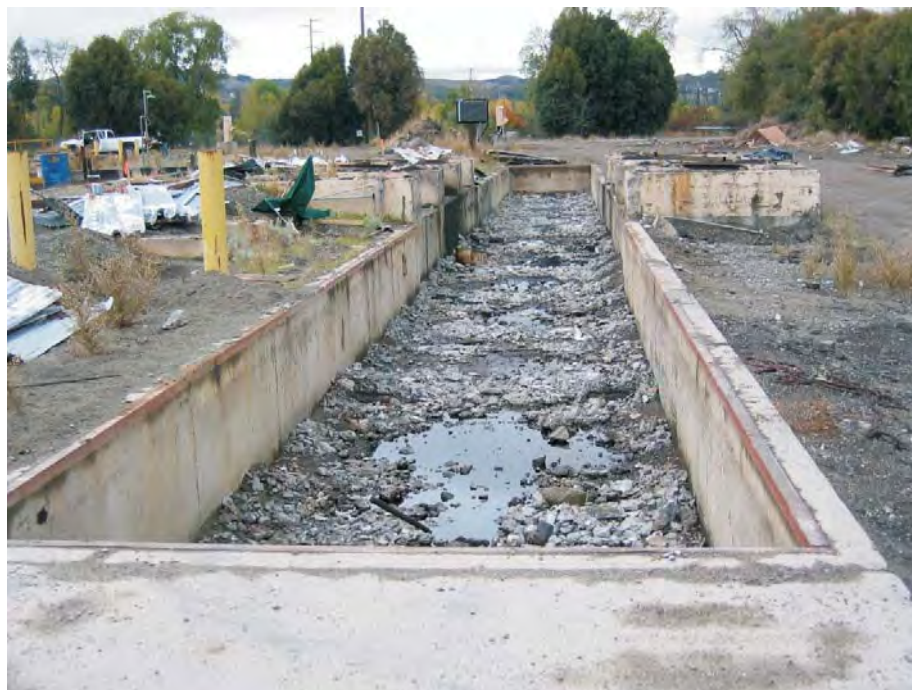
Former Truck Scale

Once the liquid (if present) is removed from the former truck scale, the concrete walls and floor of the former truck scale will be removed using earth-moving equipment. The unaffected-unstained concrete will be recycled. Stained concrete will be transported off-site for disposal as Class II waste. A total of five “weight plates,” comprised of concrete and metal, were located on the top of the former truck scale. These weight plates are now located on the western side of the former truck scale and are depicted on Figure 3. The metal will be separated from the concrete of the weight plates and all materials will be transported off-site for recycling.

After the concrete structure of the truck scale is removed, the soil beneath the former truck scale will be visually observed for the presence of staining. Soil visually observed to be stained by oil will be excavated laterally and/or vertically to a maximum depth of 8 feet bgs and stockpiled on-site using procedures provided in Section 5.7. Sidewall confirmation soil samples will be collected every 20 linear feet from the depth where the highest degree of staining or odor was observed during excavation, or as directed during field inspection by ACEH or LPFD. Bottom confirmation soil samples will be collected every 400 square feet at the base of the excavation, directly below the area where the highest degree of staining or odor was observed during excavation, or as directed during field inspection by ACEH or LPFD.

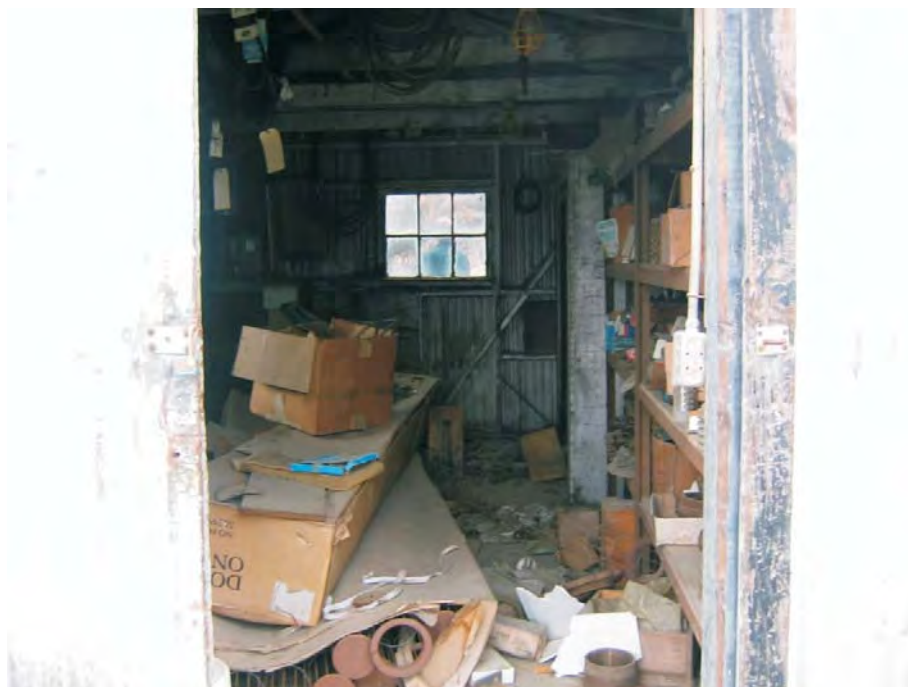
Contents of Storage Shed

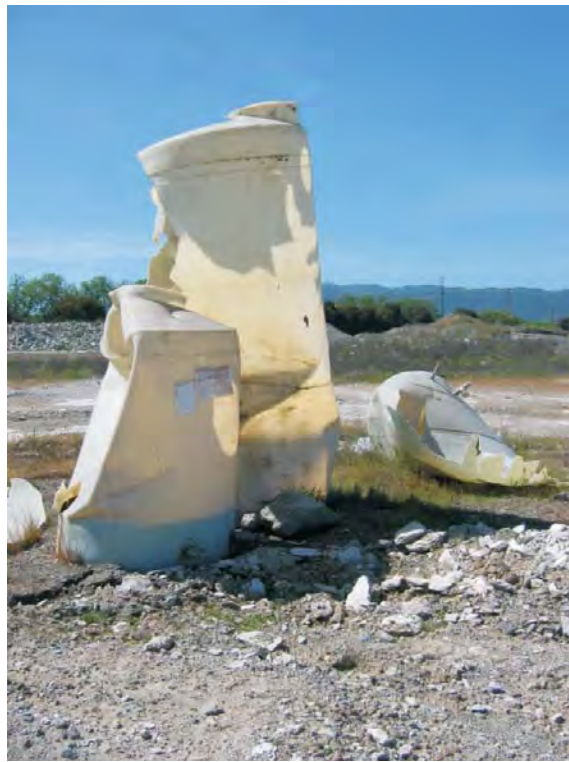
During the 2008 Site Walk, two plastic containers and one tote were identified east of AOC #1. The plastic containers were broken and contained rainwater. Based on the labeling of the tote and ARCADIS’s conversations with representatives of Hanson, these items appear to have been used to store accelerants that allow concrete to cure faster; they are typical of the concrete industry. To properly dispose of the liquid in the containers (if present) the selected Contractor will profile the contents of the containers. If appropriate and necessary, representative samples of the liquid will be collected for laboratory analyses using EPA Method 8082 for polychlorinated biphenyls (PCBs) and EPA Method 8260 for VOCs. Following testing, the liquid will be removed from the containers and disposed of properly. The empty

Plastic Containers

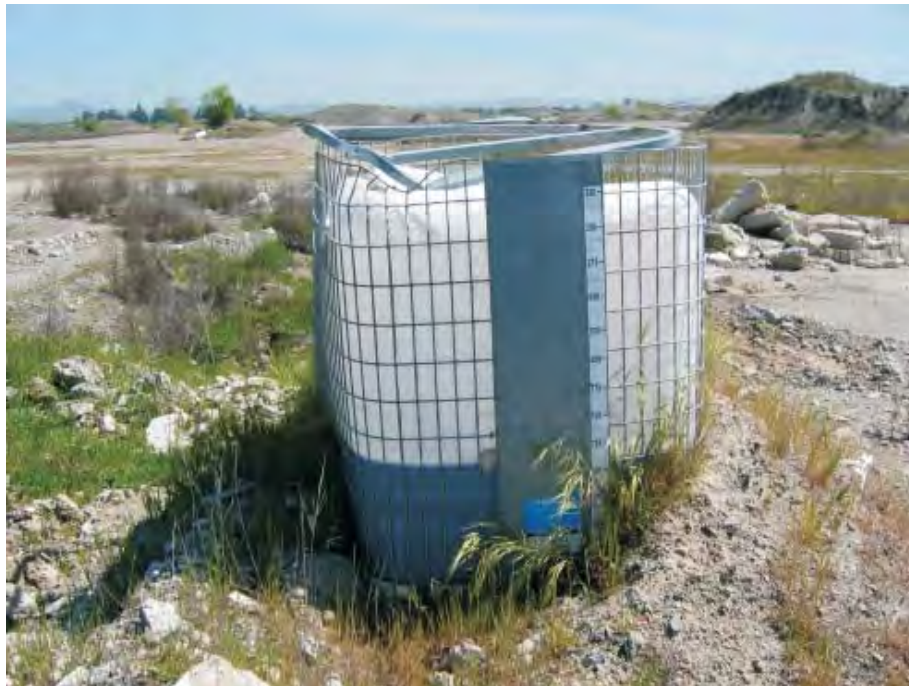
Plastic Tote
