February 21, 2008  
Project 11037.001

Subject: Former Shell Automotive Service Station  
2301 - 2307 Lincoln Avenue  
Alameda, California

#### **AUGUST 2007 SOIL AND GROUNDWATER SAMPLING**

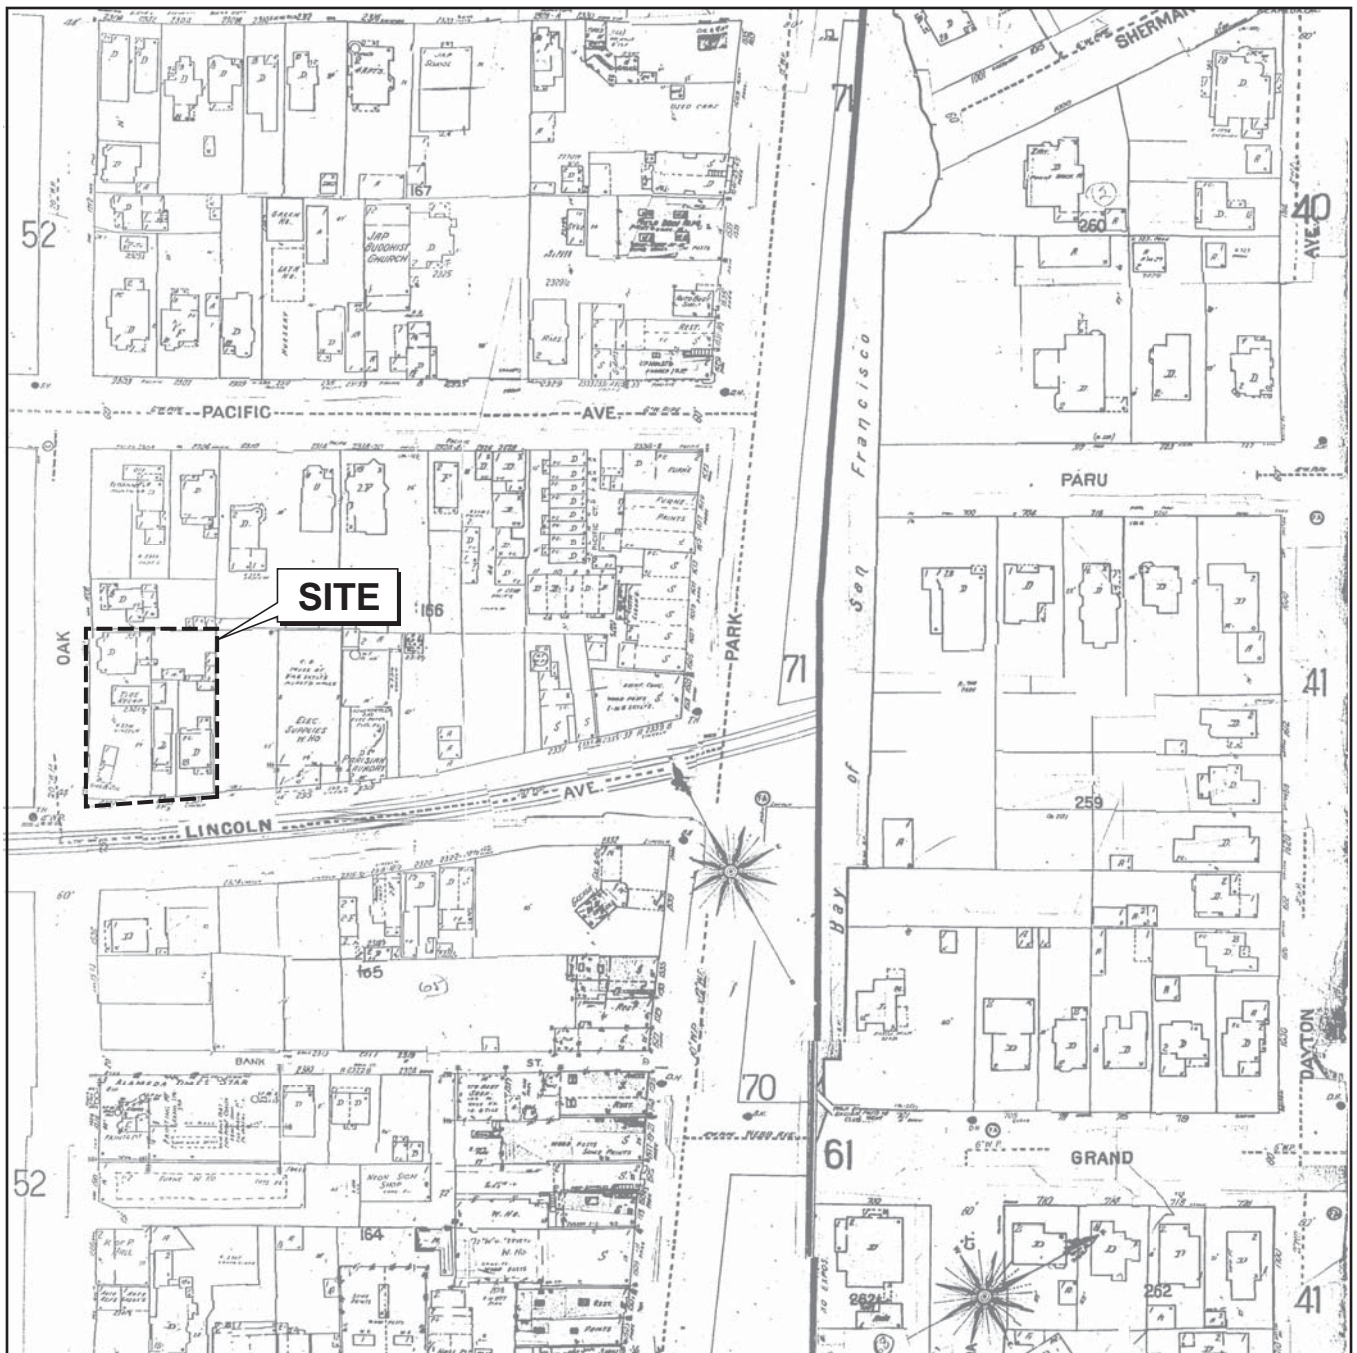
Figure **A-1**

Base map from The sanborn Library, LLC. 1950

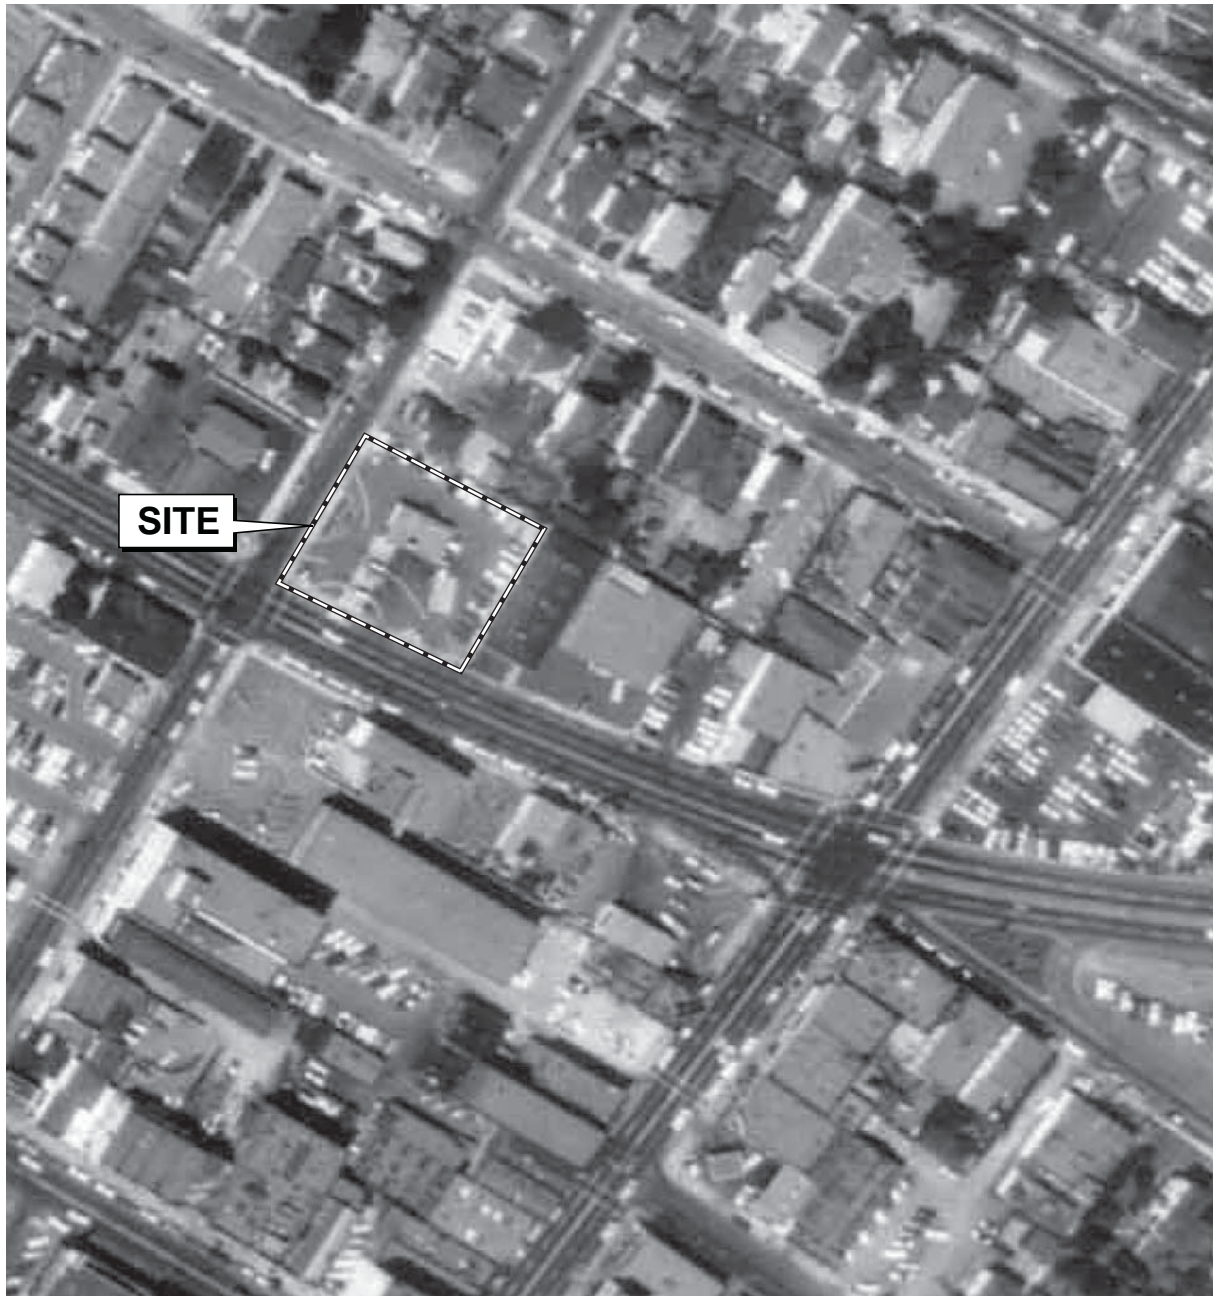
Figure **A-2**

1965 AERIAL VIEW CLOSE-UP  
2301-2307 Lincoln Ave.  
Alameda, California

Aerial photos and the Majors site plan show that some time between 1950 and 1965, the original fueling station in the southwestern corner of the Site was demolished and another fueling station was constructed, which occupied the entire Site. Toxichem Management Systems, Inc. (Toxichem) indicated that the western USTs were replaced in 1970; however, the structures shown on the 1982 Majors plan (depicting the second generation fueling station at the Site) are visible in a 1965 aerial photograph (Toxichem, 2000). The tanks in the eastern portion of the Site, and the associated pump islands in the center of the Site, are collectively referred to herein as the eastern tank area. The eastern USTs (one 8,000-gallon, two 2,000-gallon, and one 1,000-gallon) were removed in June 1982, when the Site was redeveloped into a retail center, as it exists currently.

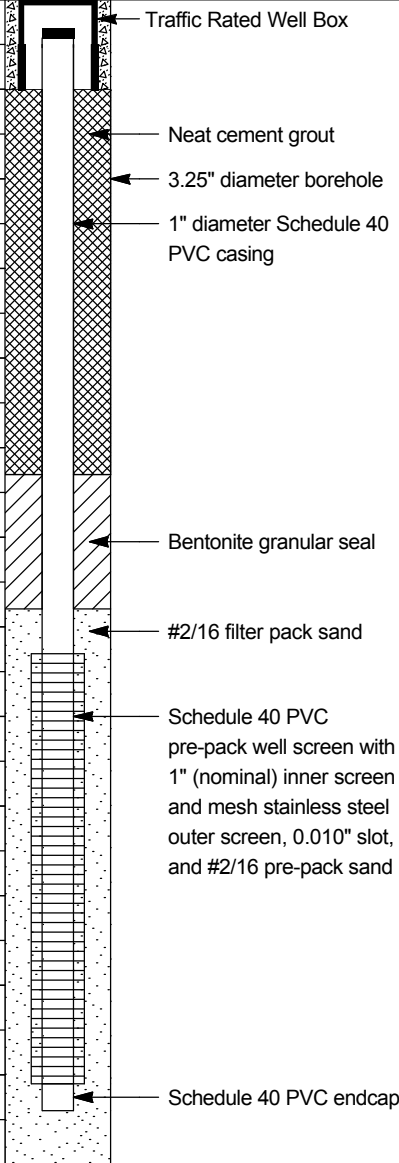
Surface Elevation: 28.96' MSL								
1					SANDY SILT (ML): very dark brown (10YR 2/2), moist, 60% fines, 40% fine sand, nonplastic, very soft

2					POORLY GRADED SAND with GRAVEL (SP): dark brown (10YR 3/3), moist, 60% fine sand, 25% fine gravel, 5% fines								
3					POORLY GRADED SAND (SP): dark brown (10YR 3/3), moist, 95% fine sand, 5% fines								
4													
5					CLAYEY SAND (SC): dark yellowish brown (10YR 3/4), moist, 65% fine sand, 35% low plasticity fines								
6				0.7	POORLY GRADED SAND with SILT (SP-SM): dark yellowish brown (10YR 4/4), moist, 90% fine sand, 10% nonplastic fines								
7				1.1	CLAYEY SAND (SC) very dark gray (10GY 2.5/ )								
8				23.2									
9				1804									
10				1800									
11				1872	wet								
12				82									
13				30.7	olive brown (2.5Y 4/3)								
14				11.7	dark yellowish brown (10YR 4/4)								
15				1.3 2.1									
										OAKWELLV_PPACKTOC (REV. 9/2007)
