**SUBJECT: CONDUIT STUDY AND WORK PLAN ADDENDUM**

County File # RO 2991

Acts Full Gospel Church & Industrial Properties

8410 Amelia Street

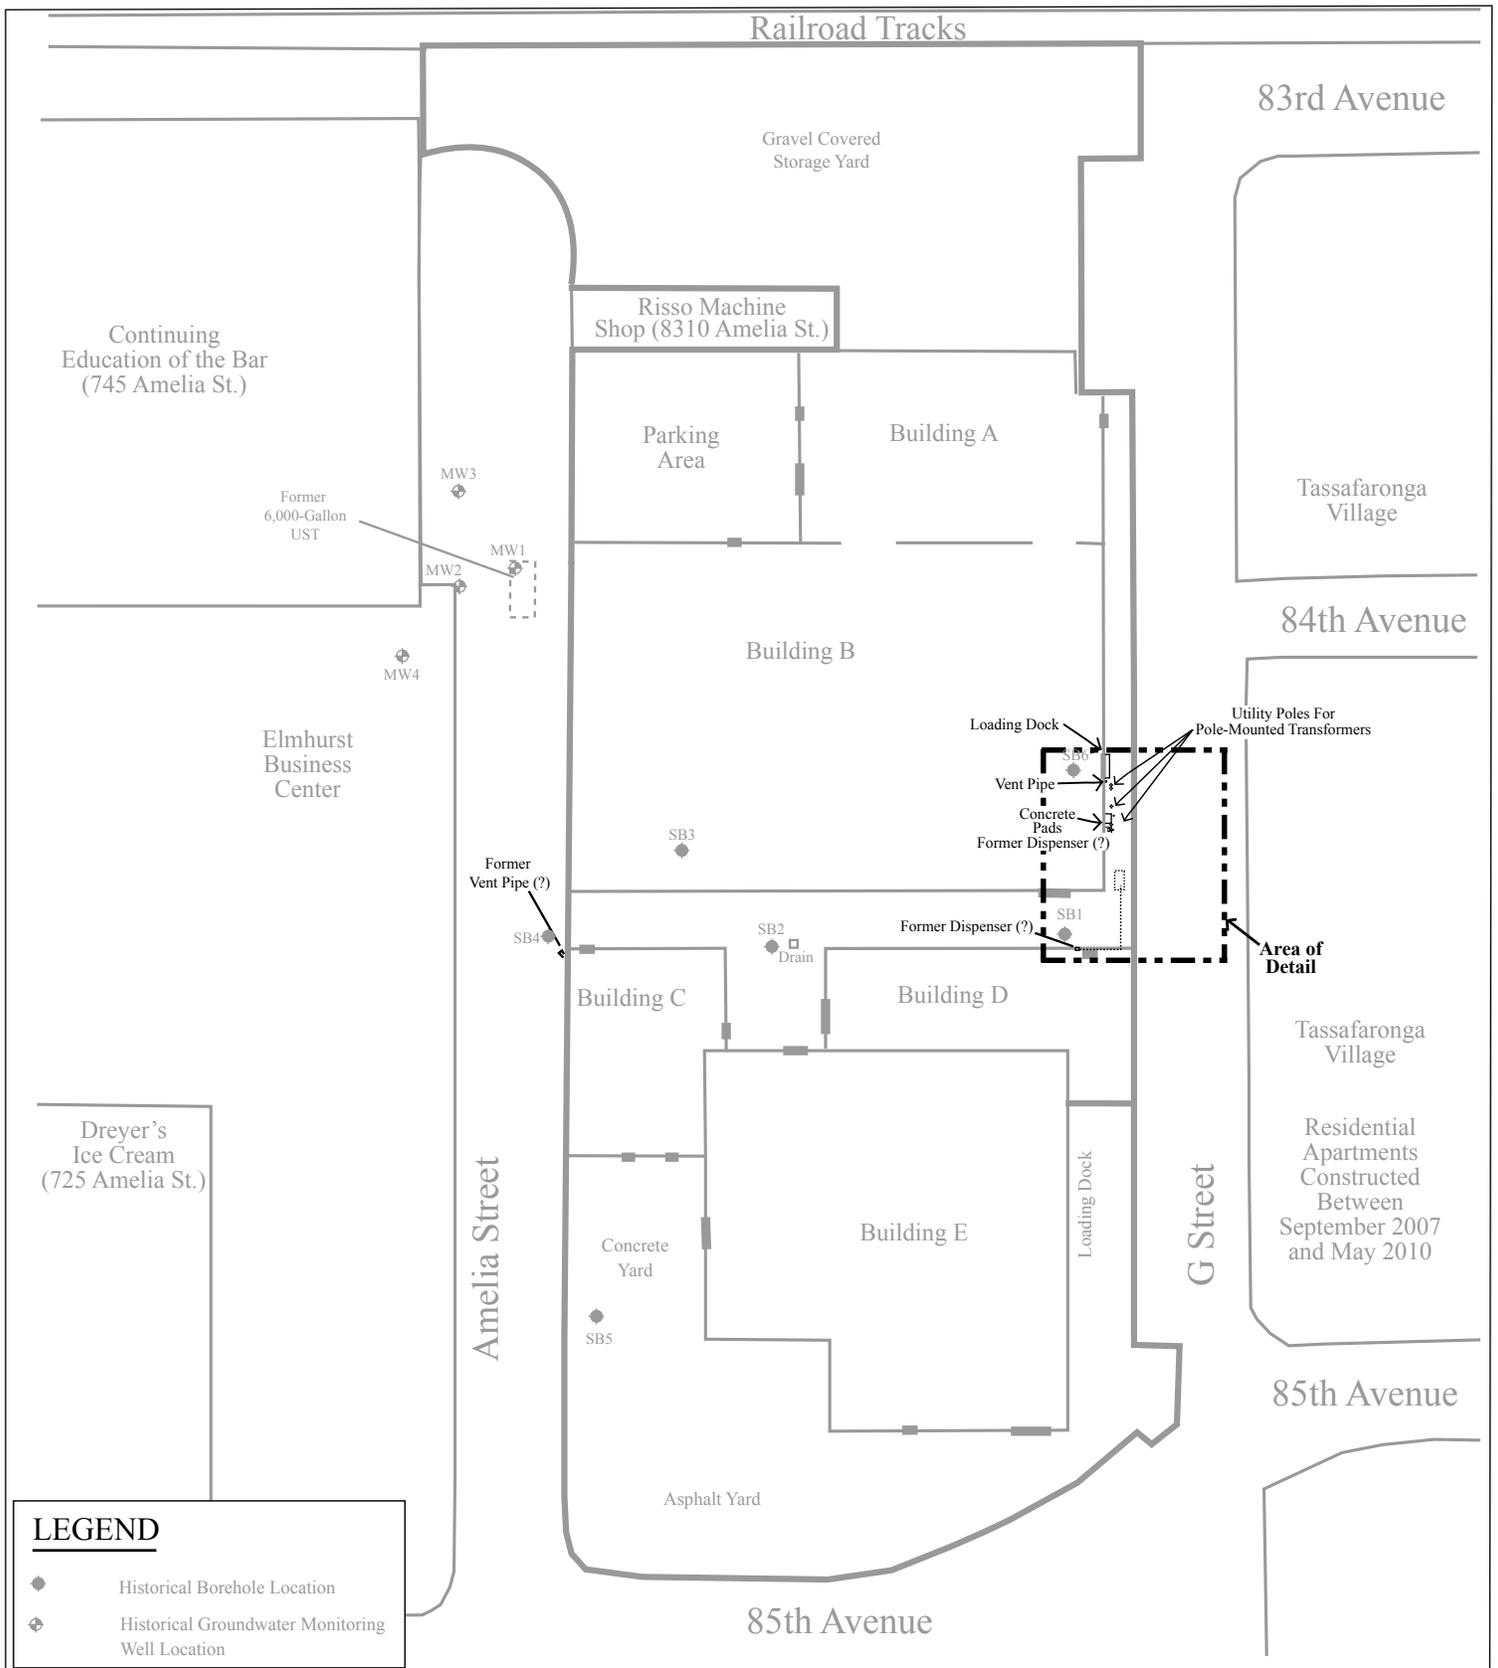
**Figure 3**  
**Site Vicinity Map Showing Suspected UST Features Identified By Basics**  
**8410 Amelia Street**  
**Oakland, California**

The area of detail for suspected UST features located on the east side of the building is shown in Figure 3. The details are shown in Figure 4. Investigations discussed below determined that a former sodium hydroxide tank associated with the vent pipe (Item 1 above) and the suspected former fuel dispenser located at the east side of the subject site (Item 2 above) may have been located in the northern portion of the area shown in Figure 4. However, piping that may have been connected to an UST had been disconnected and partially plugged with concrete. Additionally, an exploratory excavation to a depth of 7.5 feet bgs in the center of an anomalous metal detector zone failed to locate a buried UST.

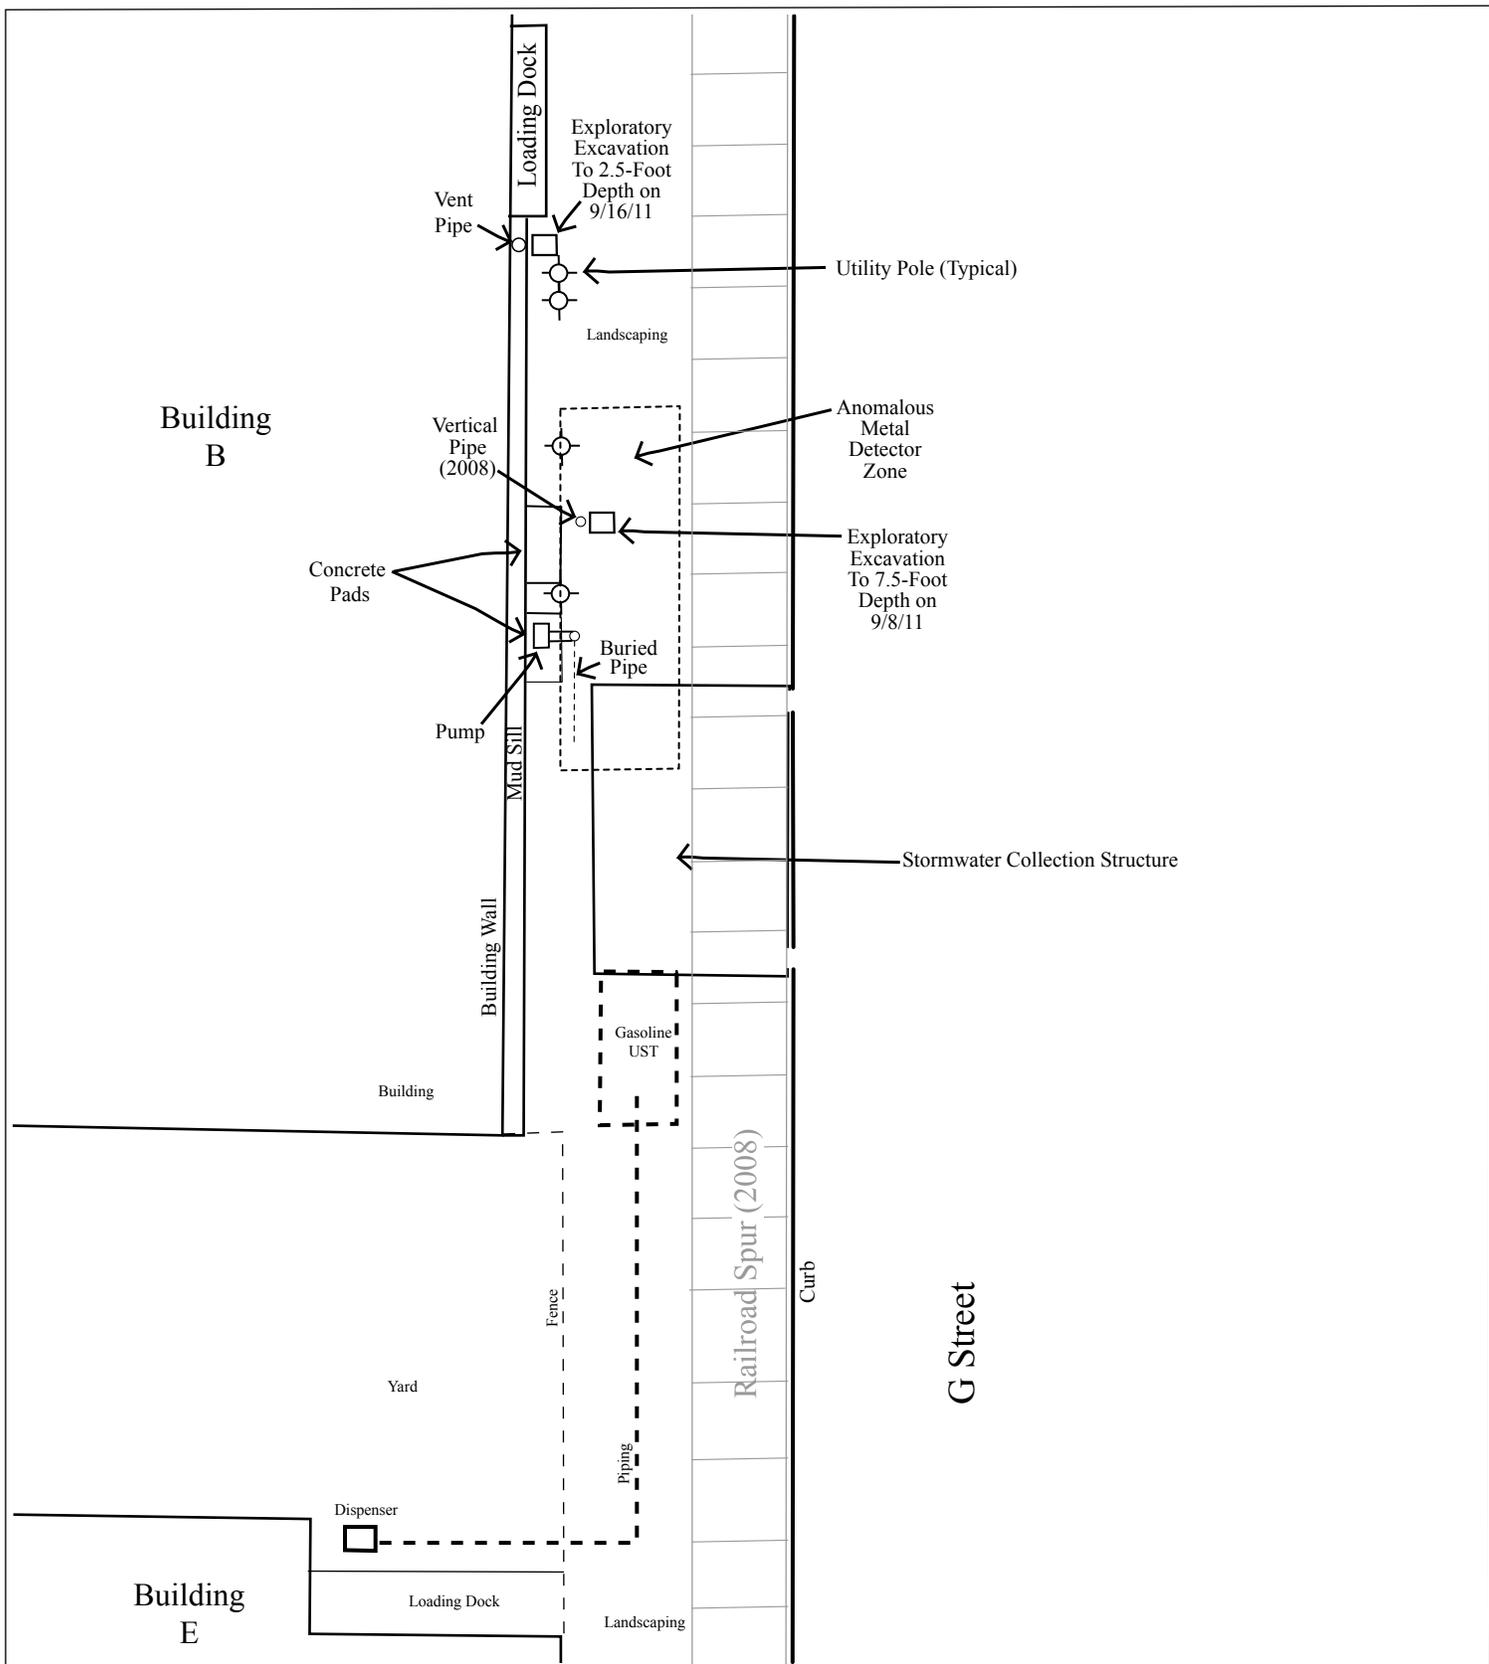
Figure 4  
 Site Vicinity Map Area of Detail  
 8410 Amelia Street  
 Oakland, California

In the southern portion of Figure 4 a steel gasoline UST filled with water measuring 4 feet in diameter was located at a depth of 5.5 feet bgs and was determined to be connected to piping that extended to the suspected former fuel dispenser located at the east side of the subject site (Item 4 above).

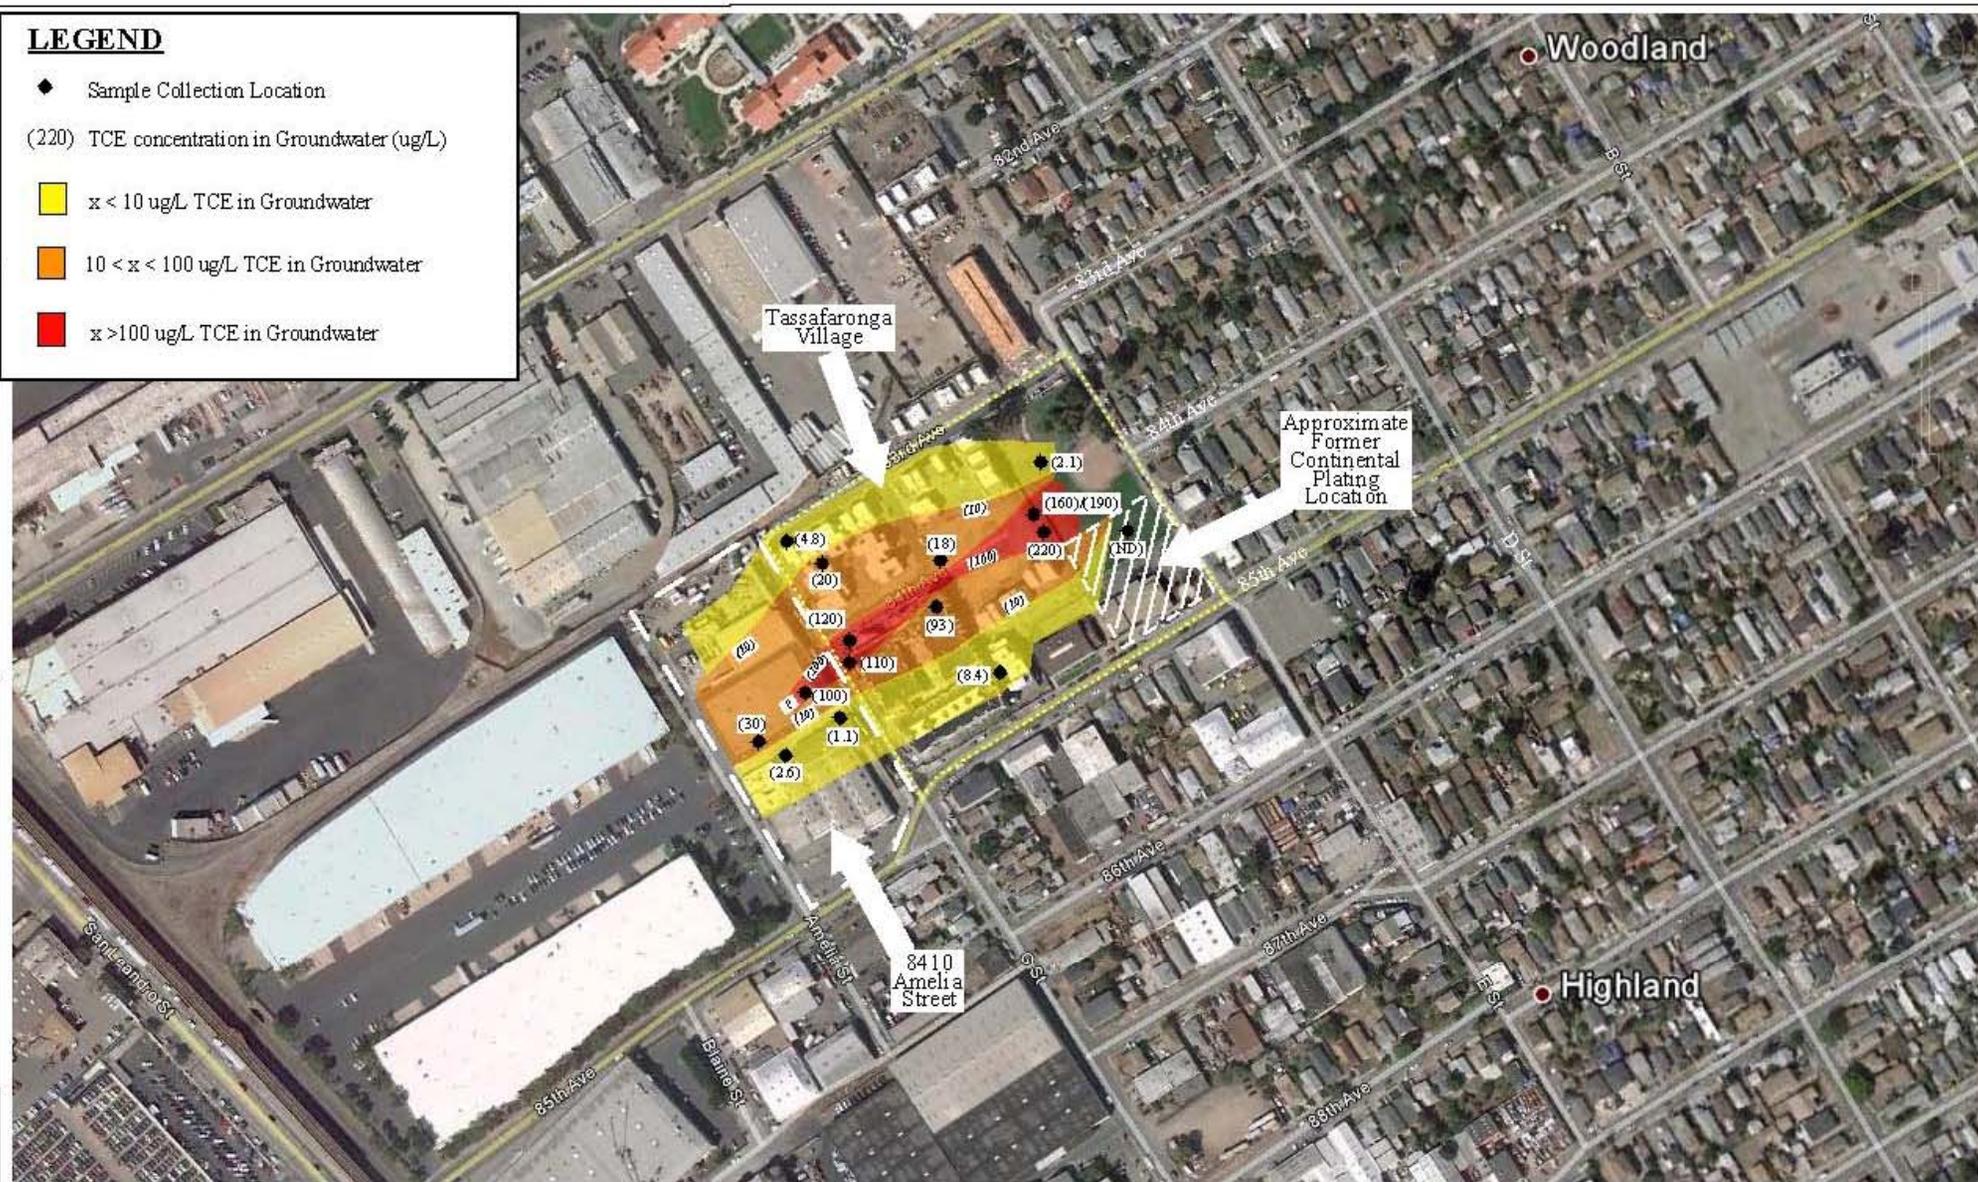
Figure 5  
Site Vicinity Aerial Photograph Showing TCE in Groundwater  
8410 Amelia Street  
Oakland, California

- ◆ Sample Collection Location
- (220) TCE concentration in Groundwater (ug/L)
- $x < 10$  ug/L TCE in Groundwater
- $10 < x < 100$  ug/L TCE in Groundwater
- $x > 100$  ug/L TCE in Groundwater

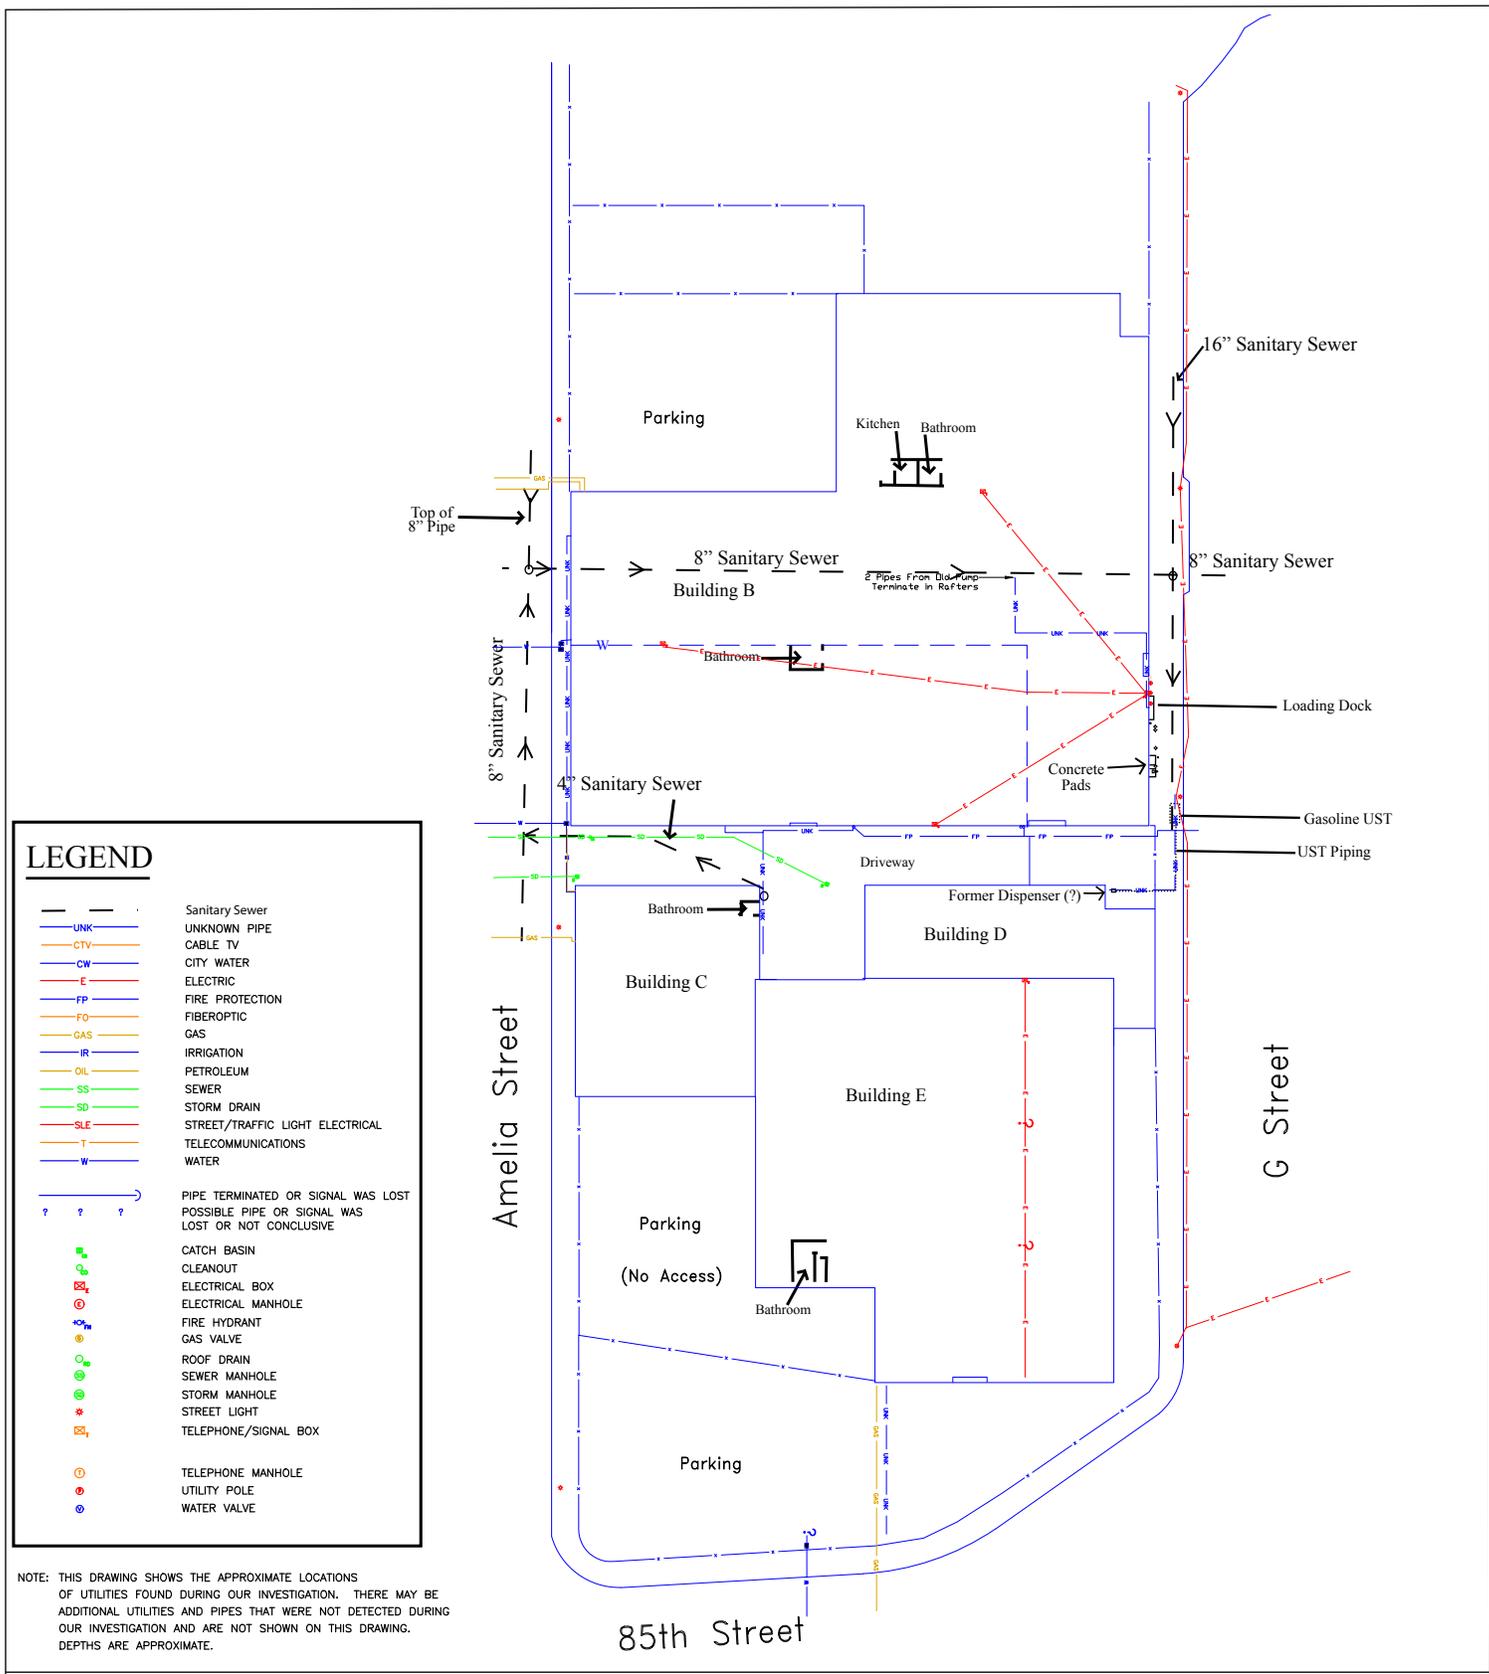
Figure 7  
 Underground Utility Map  
 8410 Amelia Street  
 Oakland, California

On September 28, 2011 JRA identified onsite underground utilities as shown on Figure 7. The sewer pipes could not be located by the instrumentation used during the conduit study.

On October 2, 2011 The Plumbing Ministry of Oakland, California identified sewer pipes at locations shown on Figure 7. The locations of sewer pipes between the bathrooms and the known sewer pipes could not be determined because sewer cleanouts were not present at any of the bathrooms, and the vent pipe diameters were too small for the camera that was used to perform the survey.

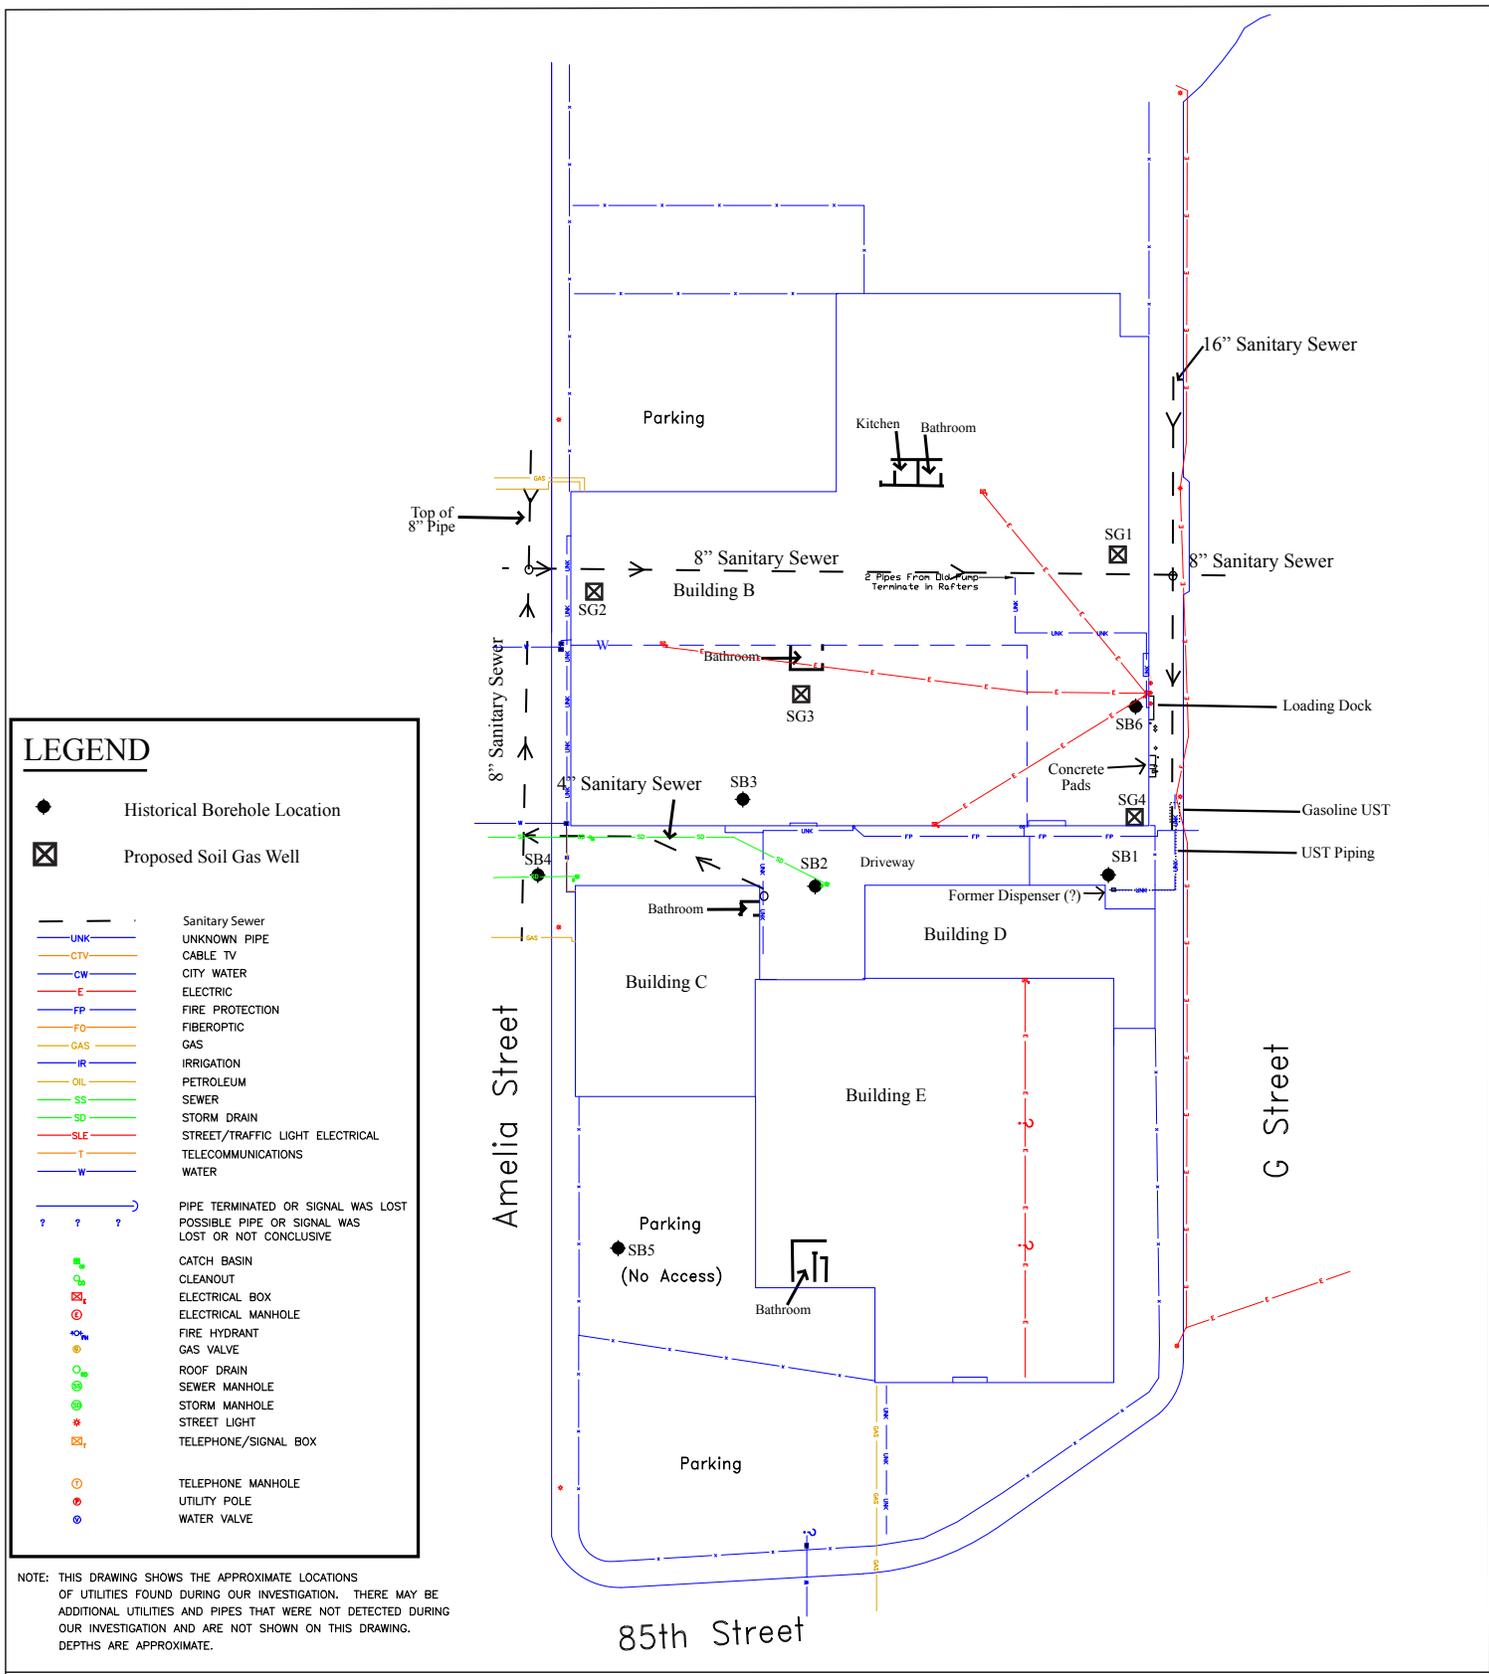
**Figure 8**  
**Underground Utility Map Showing Proposed Soil Gas Well Locations**  
**8410 Amelia Street**  
**Oakland, California**

Based on review of the TCE concentrations detected in groundwater at the subject site during the 2008 investigation, in conjunction with the information obtained during the conduit study, the locations of proposed permanent soil gas wells SG1 through SG4 are shown in Figures 6 and 8. The rationale for each of the locations is as follows.

- SG1 – To evaluate soil gas conditions adjacent to a sewer pipe trench on the upgradient side of the property in the vicinity of the TCE plume.
- SG2 – To evaluate soil gas conditions adjacent to a sewer pipe trench near the downgradient side of the property in the vicinity of the TCE plume.
- SG3 – To evaluate soil gas conditions in the central portion of the building and in a potential central portion of the TCE plume.
- SG4 – To evaluate soil gas conditions on the upgradient side of the property in the vicinity of the TCE plume, and also at a location that is immediately downgradient of the gasoline UST.

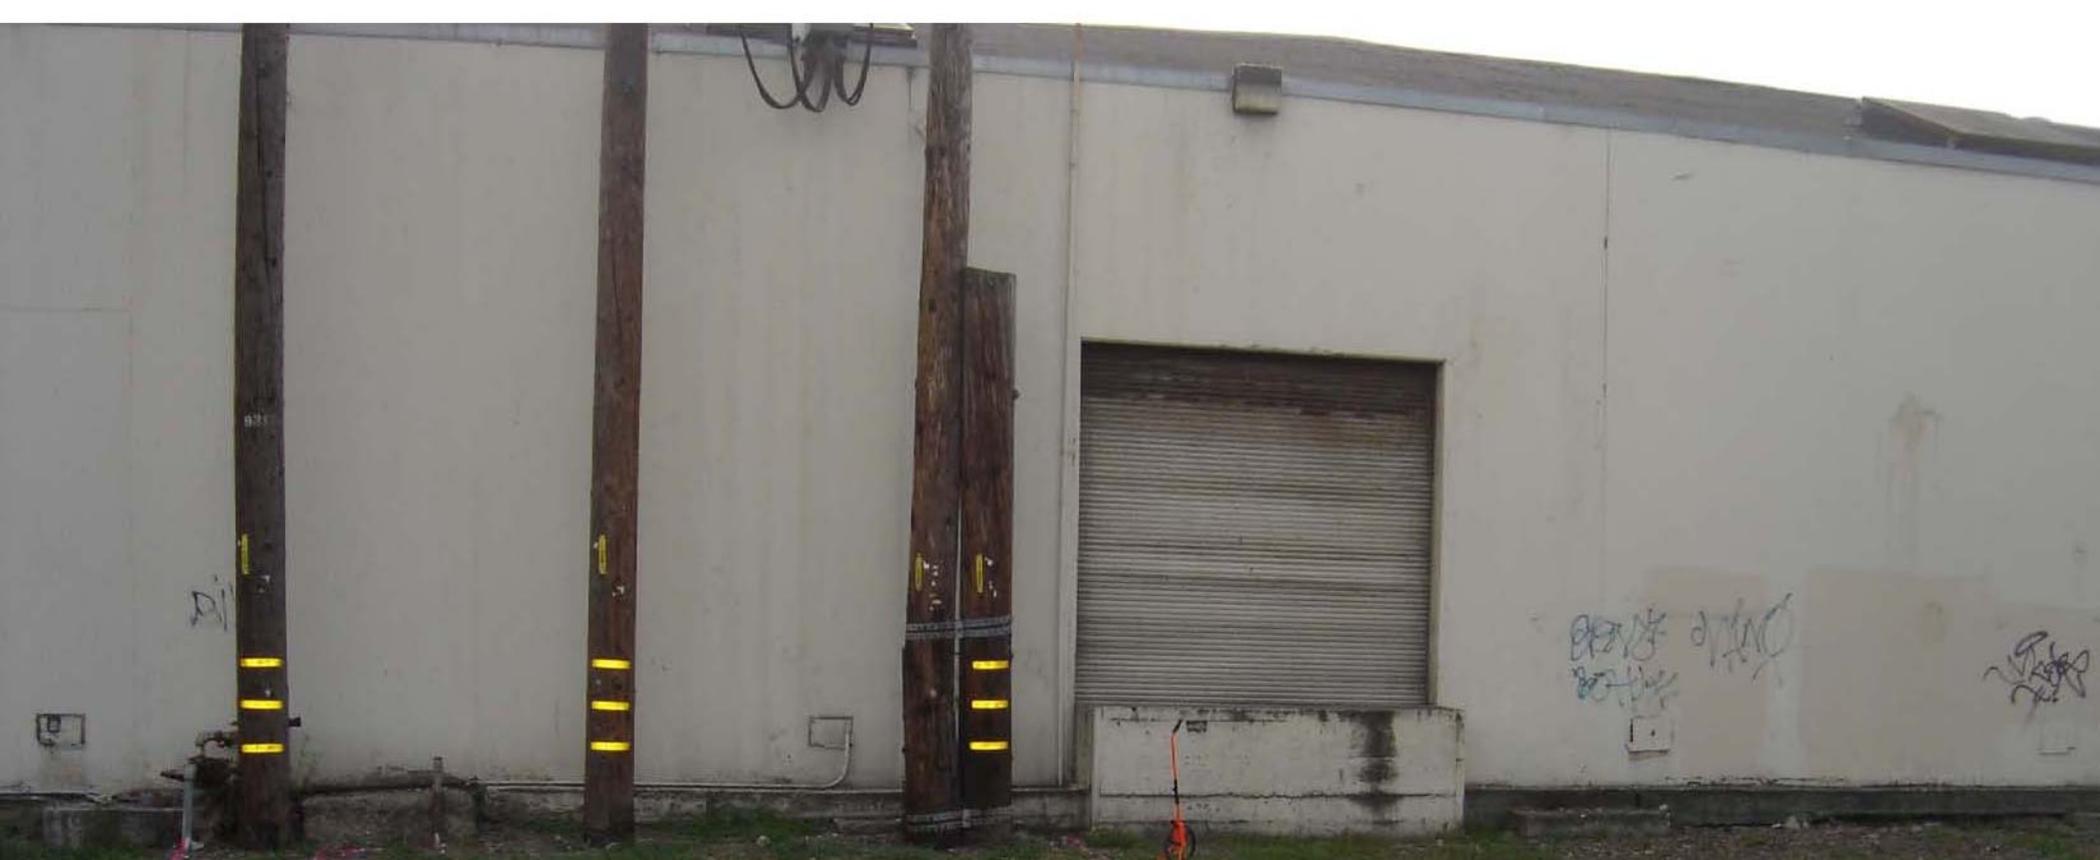
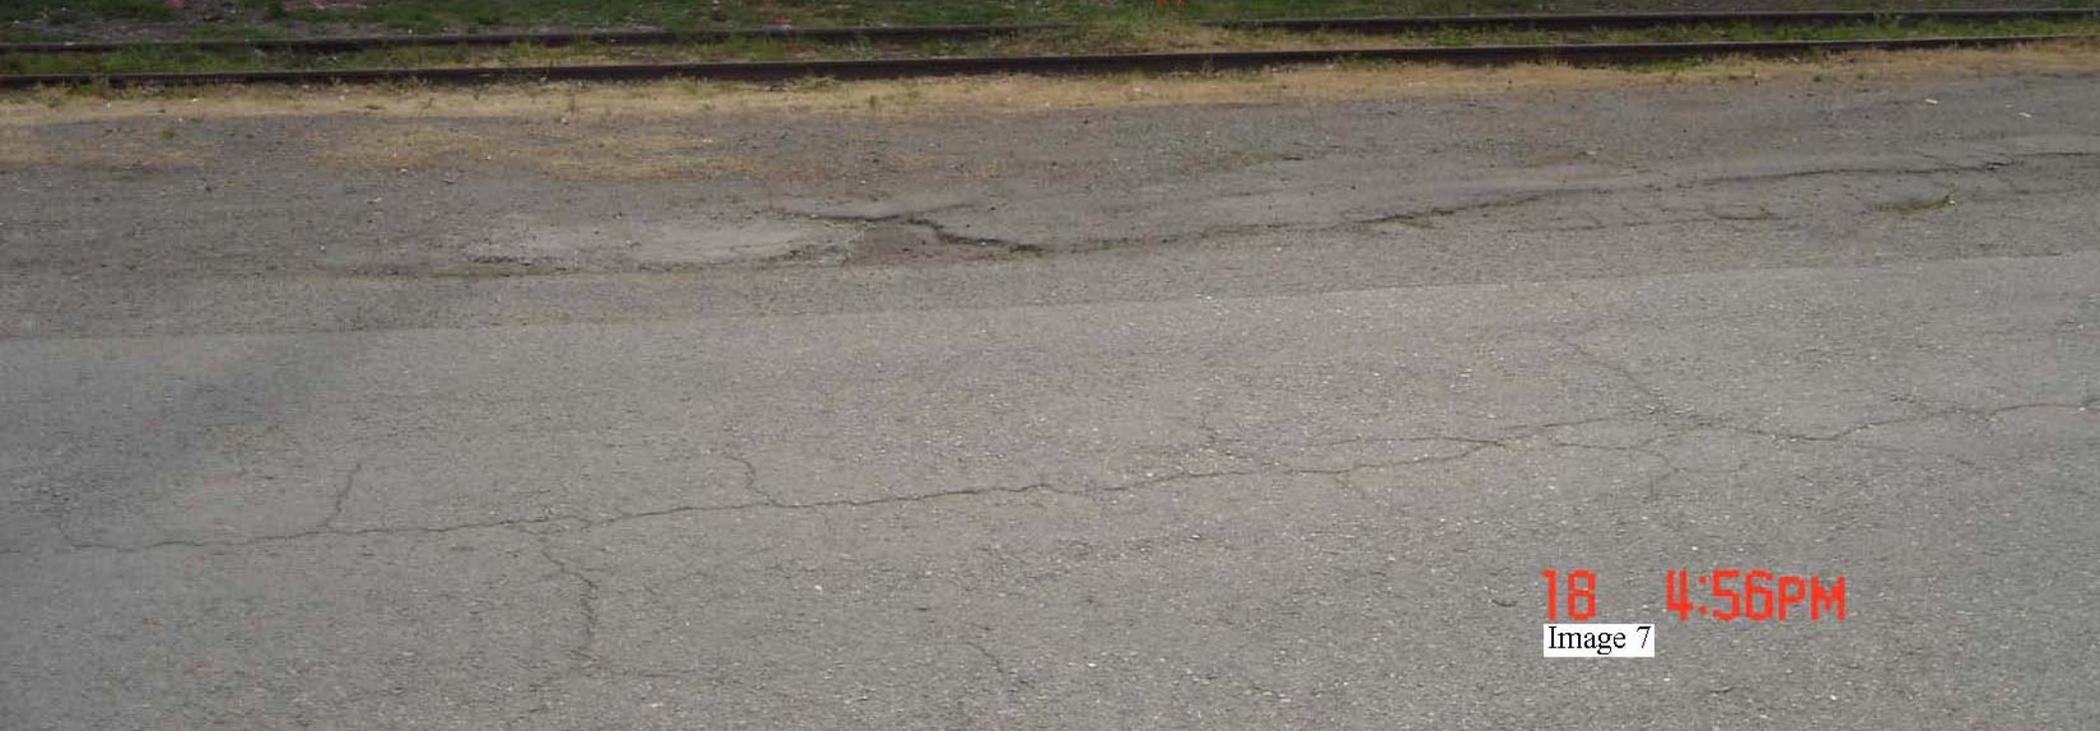
18 4:56PM  
Image 6

- Image 6 is a view southwestward showing the central portion of the area of detail (Figure 4). The southernmost two of the three utility poles for the pole-mounted transformers are visible.

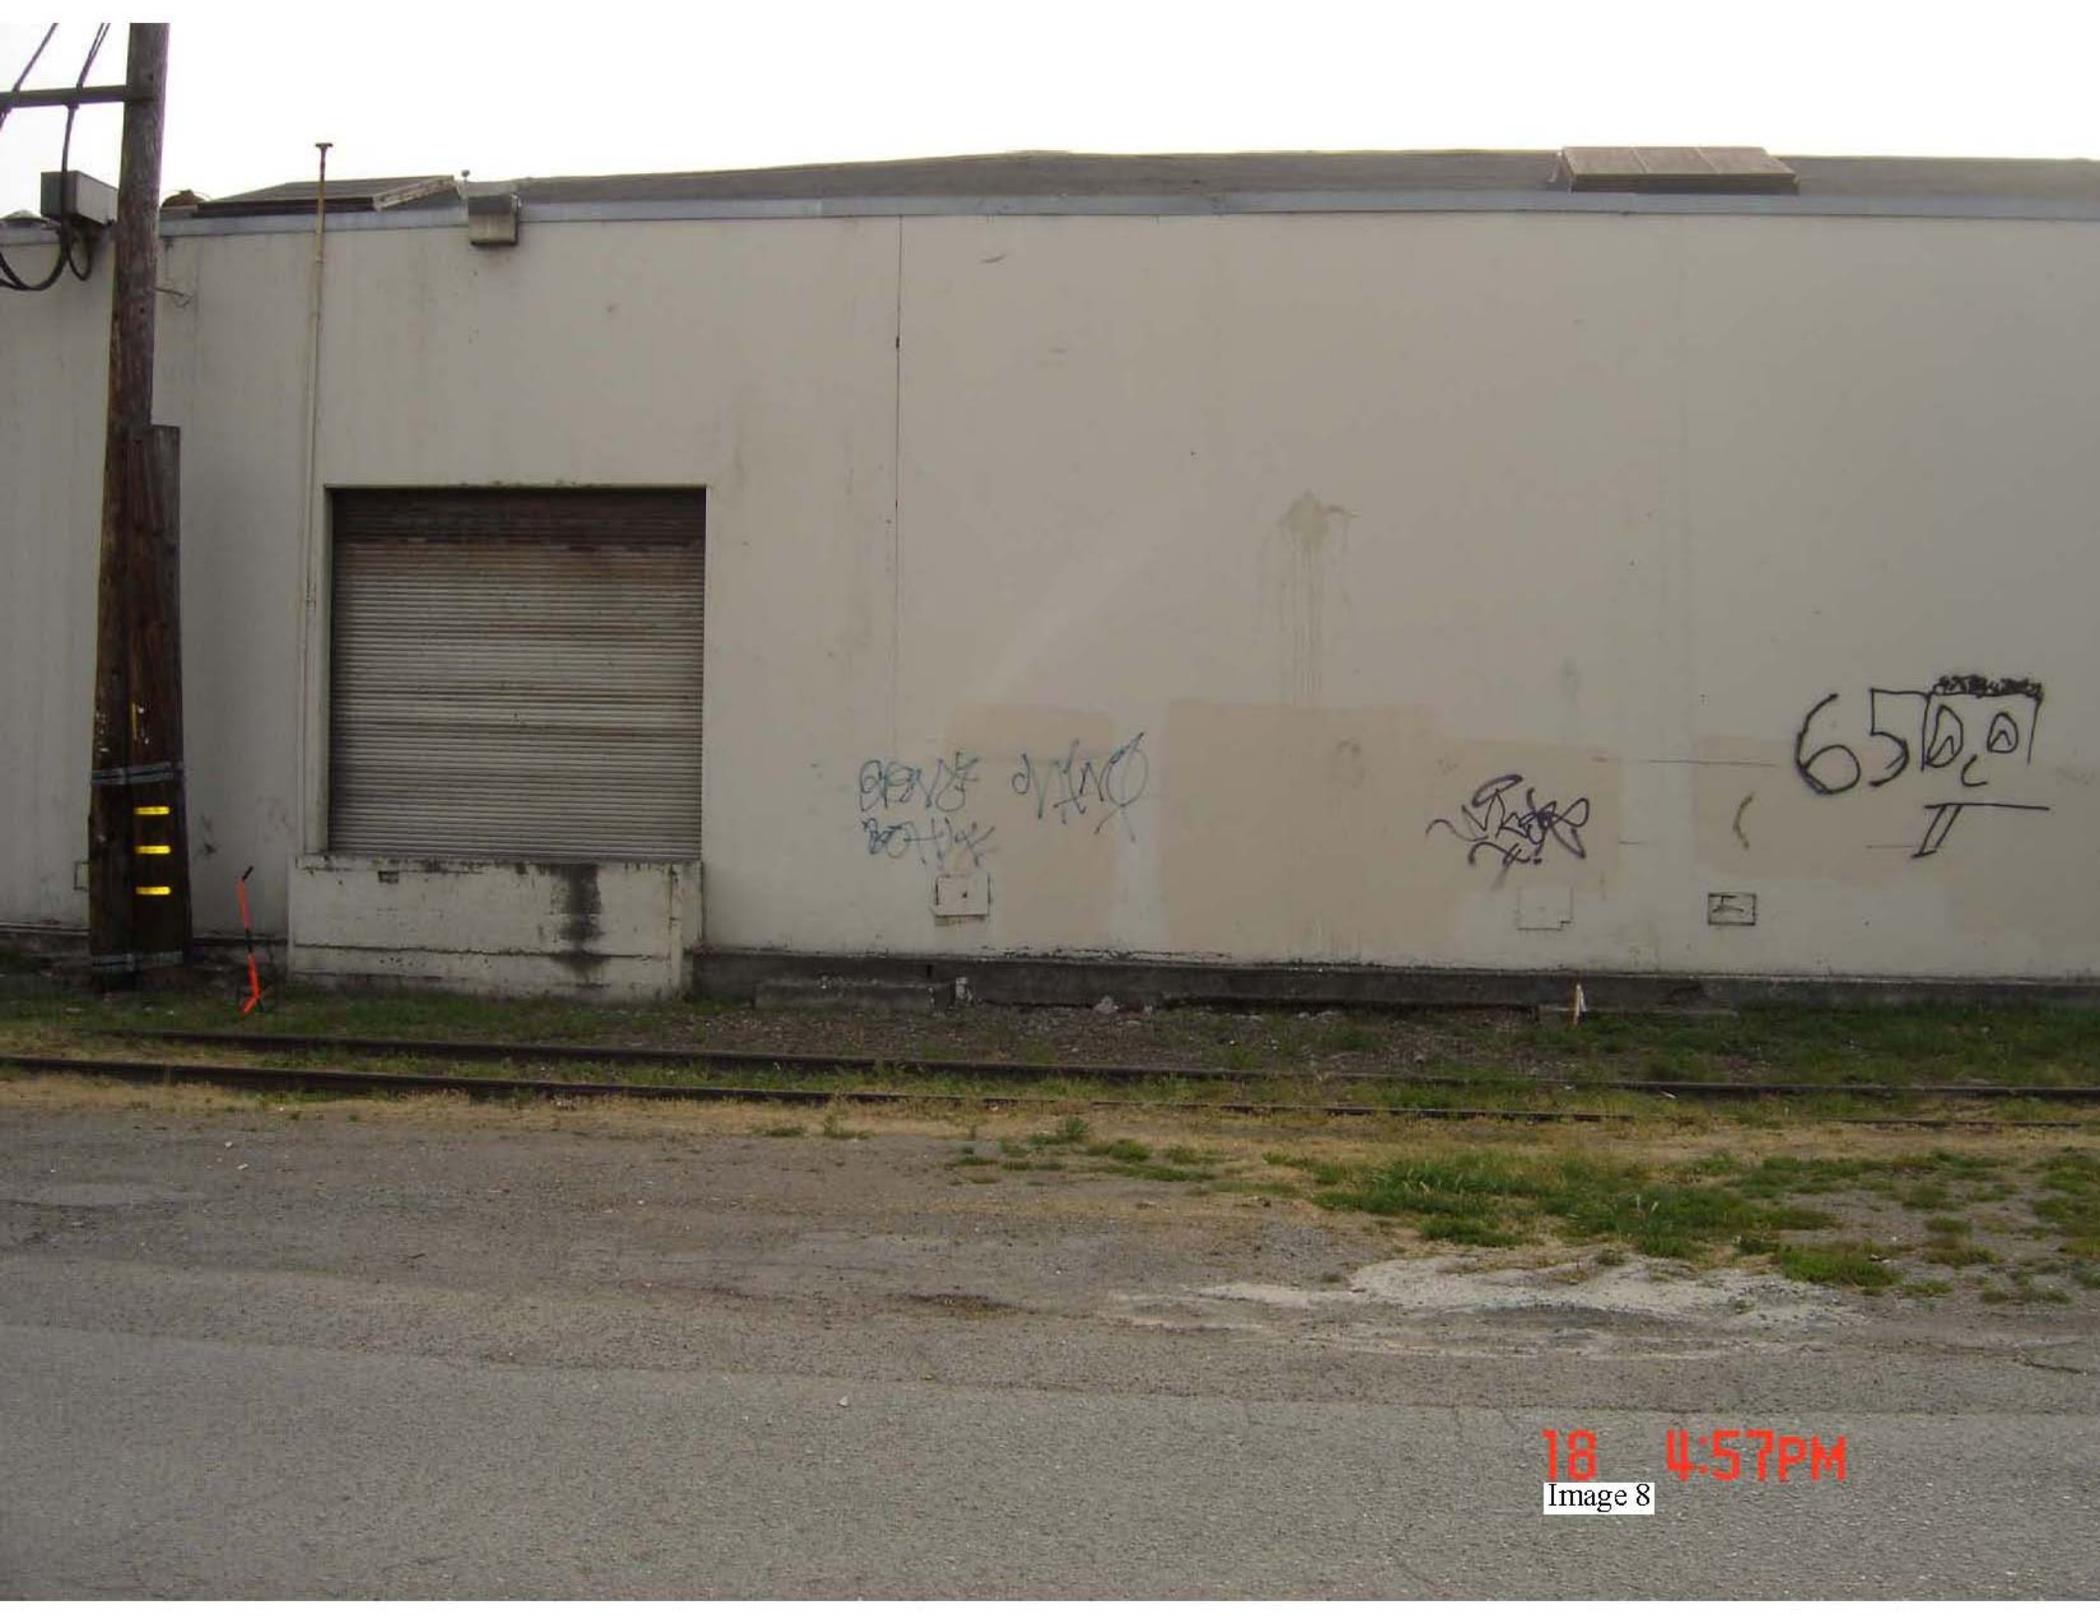
18 4:56PM  
Image 7

- Images 7 and 12 are a view westward showing the northern portion of the area of detail (Figure 4). All three of the utility poles for the pole-mounted transformers are visible. The vent pipe (Item 1 above) is located to the right of the northernmost utility pole (the utility pole on the right) and immediately to the left of the loading dock roll up door. A chemical transfer pump located adjacent to the wall is located immediately to the left of the southernmost utility pole (the utility pole on the left). The pump is mounted on a concrete pad. A vertical steel pipe that is connected to the pump is observed to penetrate the ground immediately to the left of the southernmost utility pole. A separate concrete pad is also visible to the right of the pump between the two utility poles, and a vertical steel pipe that is similar in diameter and height to the pipe that is connected to the pump is observed between the two utility poles adjacent to the concrete pad.
