**SUBJECT: CONDUIT STUDY AND WORK PLAN ADDENDUM**

County File # RO 2991

Acts Full Gospel Church & Industrial Properties

8410 Amelia Street

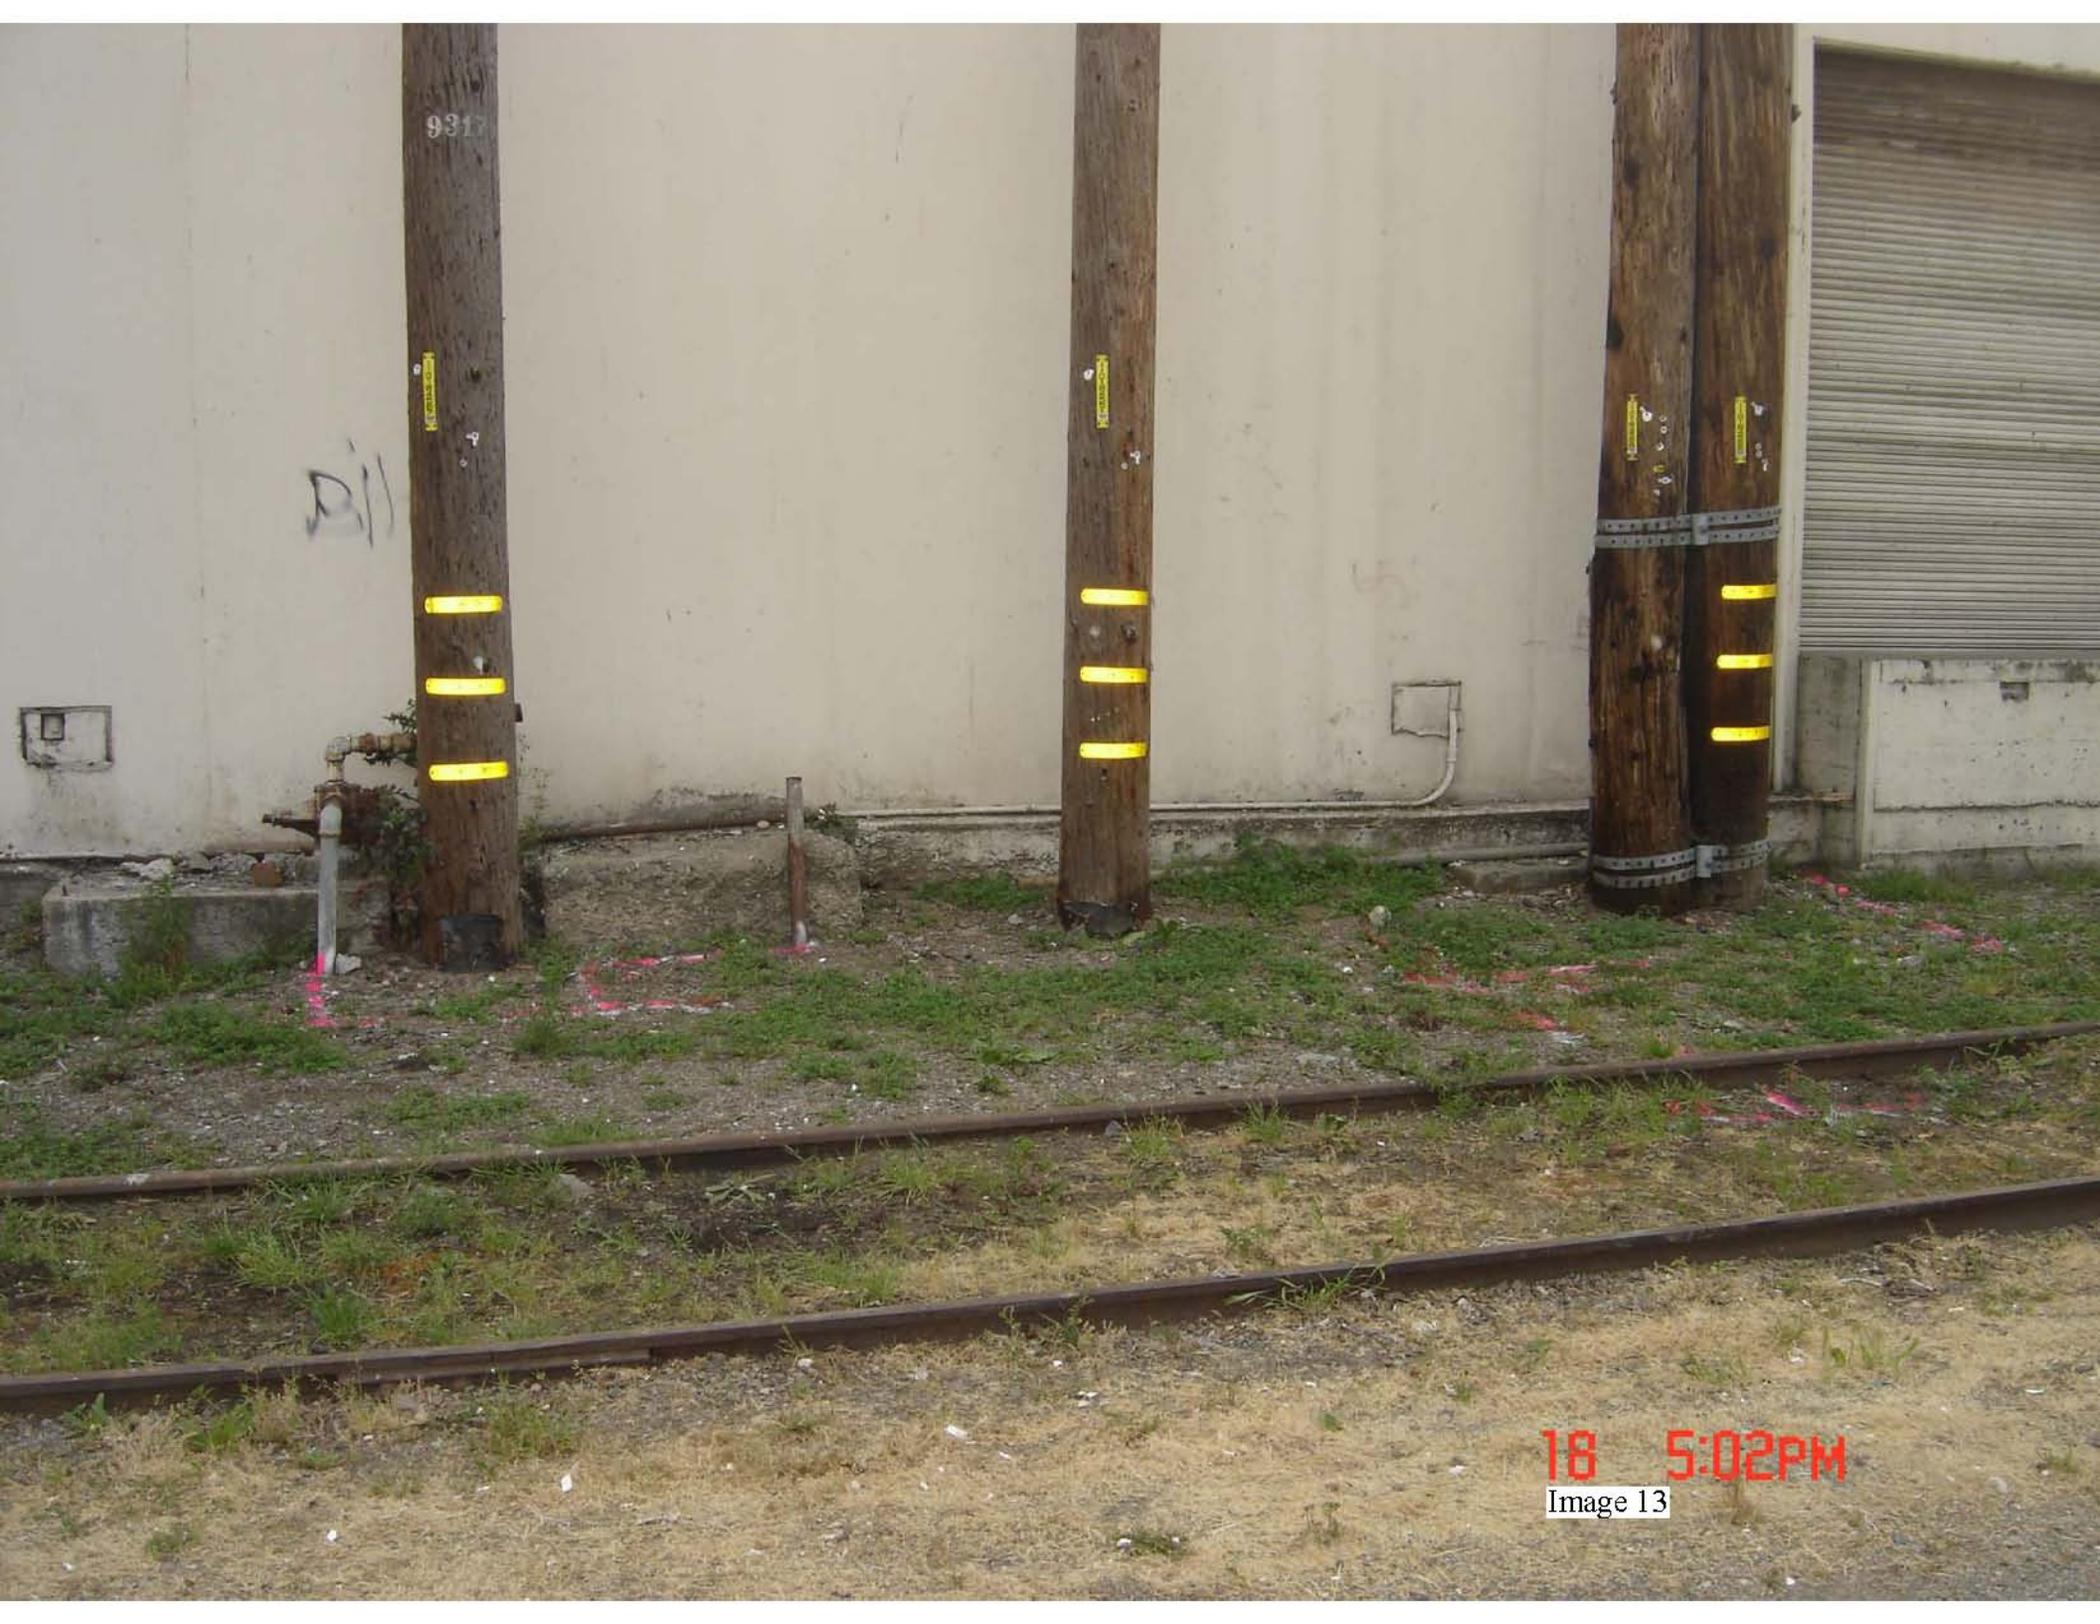
18 4:58PM  
Image 12

- Images 7 and 12 are a view westward showing the northern portion of the area of detail (Figure 4). All three of the utility poles for the pole-mounted transformers are visible. The vent pipe (Item 1 above) is located to the right of the northernmost utility pole (the utility pole on the right) and immediately to the left of the loading dock roll up door. A chemical transfer pump located adjacent to the wall is located immediately to the left of the southernmost utility pole (the utility pole on the left). The pump is mounted on a concrete pad. A vertical steel pipe that is connected to the pump is observed to penetrate the ground immediately to the left of the southernmost utility pole. A separate concrete pad is also visible to the right of the pump between the two utility poles, and a vertical steel pipe that is similar in diameter and height to the pipe that is connected to the pump is observed between the two utility poles adjacent to the concrete pad.
