**Subject: Tank Closure Report for 1000 North Vasco Road
in Livermore, California (Project 2010-035)**

**Project 2010-035
1000 North Vasco Road Livermore, California**

FIGURE 4
2011 Tank and Line Removal
1000 N. Vasco Road
Livermore, California

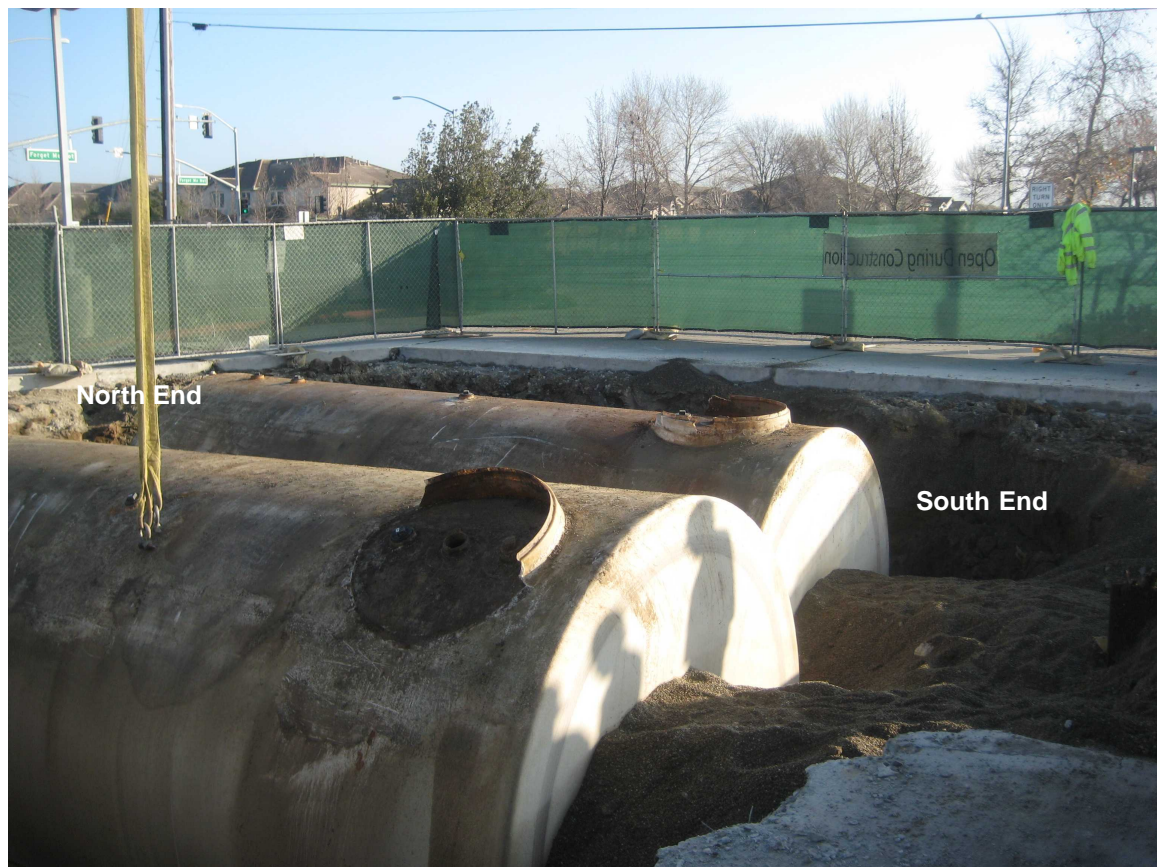
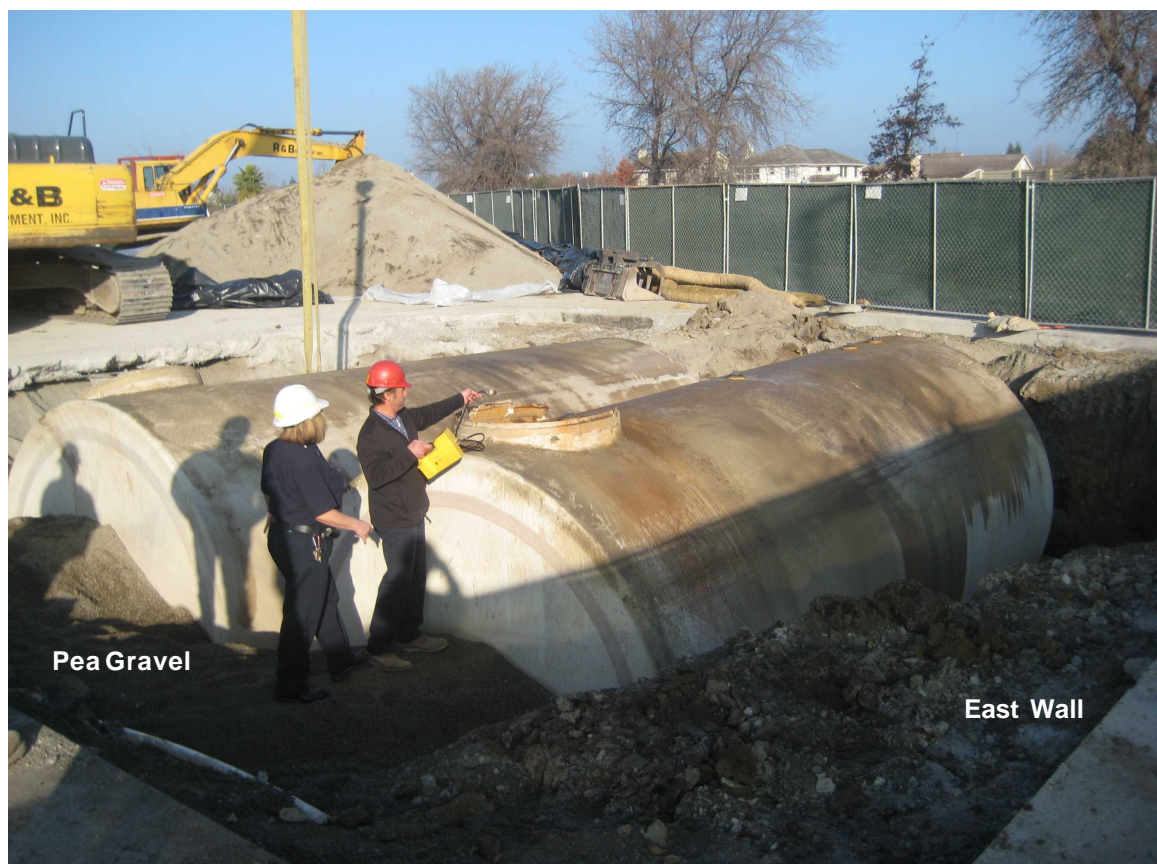
**Gasoline
Storage Tanks**

The gasoline storage tanks were noted to be in generally good condition without apparent product or vapor in the annular space. The fiberglass skins generally were intact with the exception that the fiberglass near the vapor monitoring probe inlet at the top end of one tank was missing. This break of the fiberglass skin may have occurred during excavation to uncover the tank top but was not observed by the report preparers.

Diesel Storage Tank—The tank was about 12,000-gallons and had a similar fiberglass skin over a steel inner tank, with interstitial vapor monitoring. This tank also was manufactured by TRUSCO according to Underground Storage Tank Application - Form B. The diesel storage tank was noted to be in good condition without apparent product or vapor in the annular space. The fiberglass skin was intact.

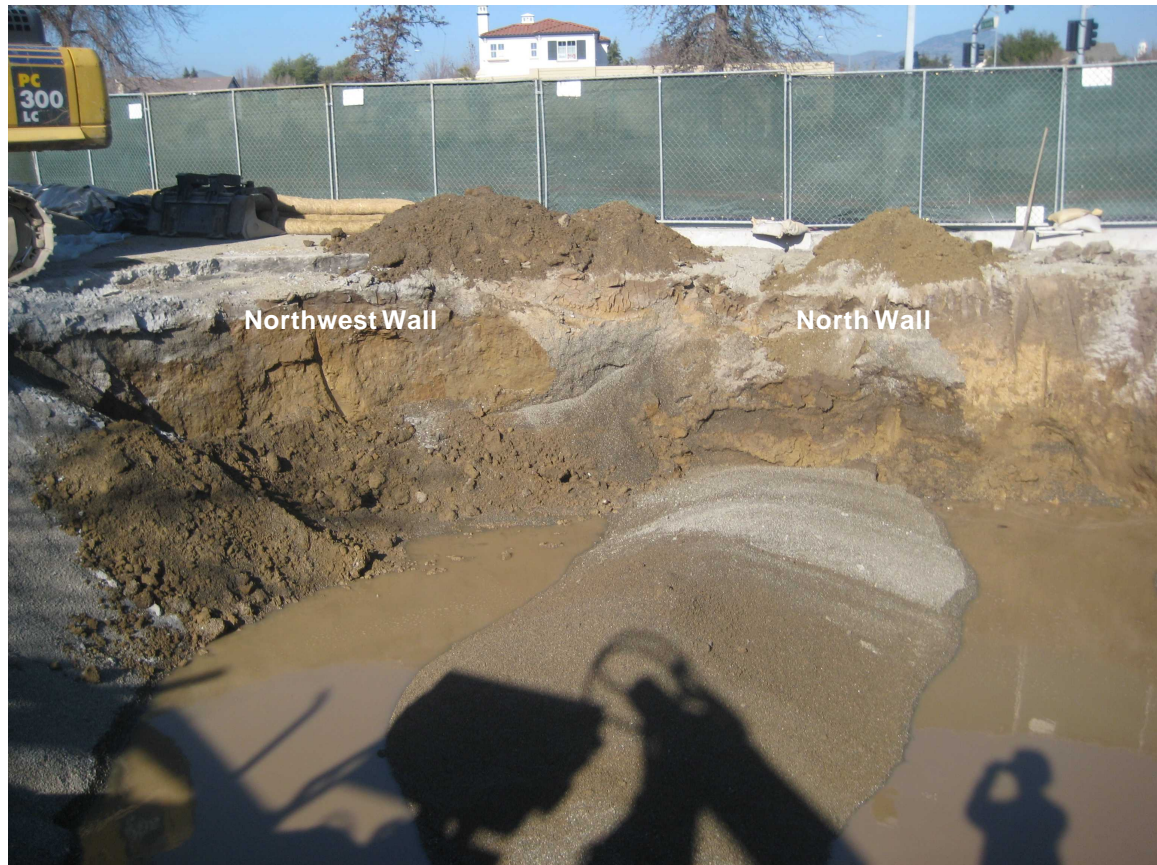
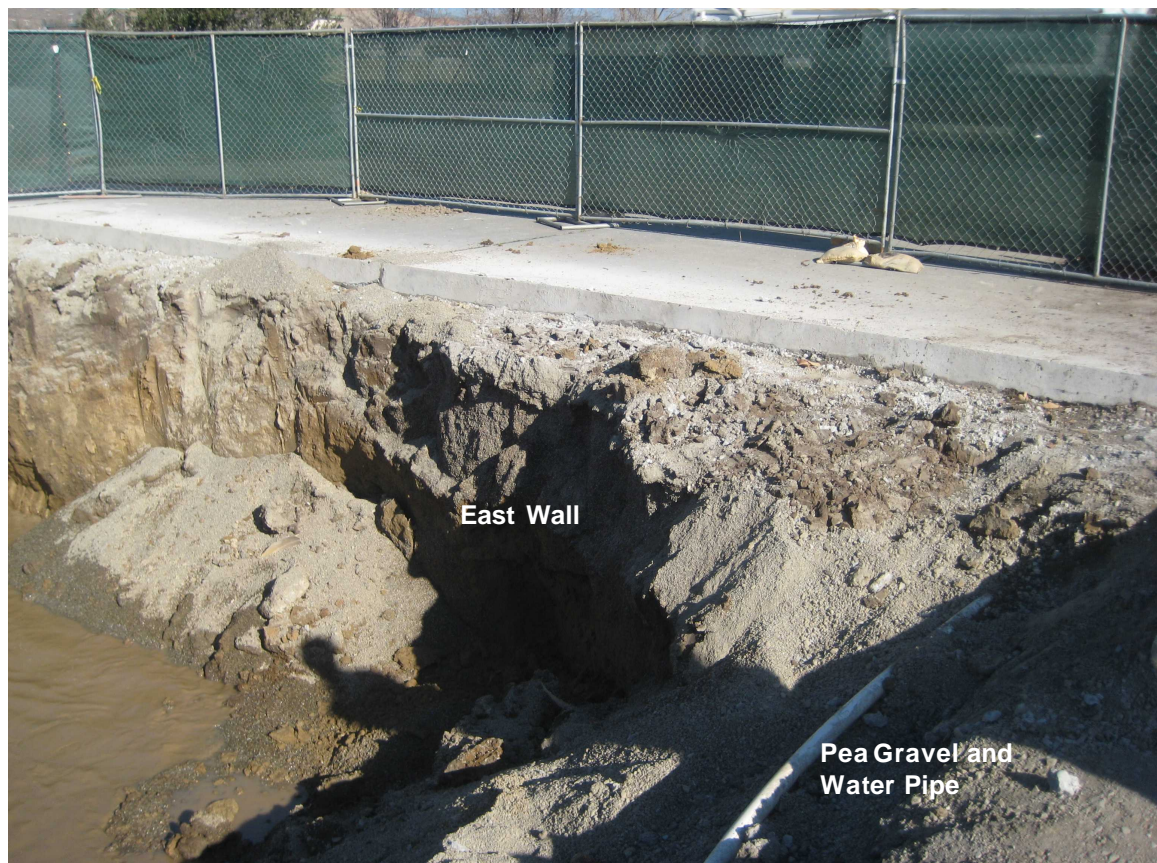
**Tank Pit TP1
Gasoline**

Gasoline Tanks and Tank Pit (TP1)—There were no obvious signs of tank or line failure. The two gasoline USTs were double-walled tanks with steel inner tanks and fiberglass outer skins. The interstitial space had vapor monitoring. Product piping was double-walled fiberglass. The steel inner tanks were not visible. One tank had lost a piece of the fiberglass along the upper north end of the tank below the bung which was the connection point for vapor monitoring. The fiberglass outer skins otherwise appeared intact.

Gross contamination (*e.g.*, a heavily stained sidewall or backhoe bucket full of odorous soil) was looked for but was not observed during sampling. Staining of the Tank Pit TP1 sidewalls was not apparent above the water line where native soil was visible. At the southeast, south and southwest portions of Tank Pit TP1, there was slumped fill (primarily, pea gravel) so that native soil was not visible generally above the water line along the south and southwest perimeter. Native soil was exposed near the southeast corner of the gasoline storage tank located nearest North Vasco Road using a backhoe. Soil staining was not observed in the Tank Pit TP1 east sidewall or in soil taken off the backhoe bucket.

Views of the Tank Pit TP1 sidewalls were blocked in multiple areas by pea gravel or sloughing native soil. Below the asphalt cover and base rock, to the 9 foot depth to the water surface, there was not an apparent stratification of the soil into layers or horizons. Observation of the stratigraphy was limited to observations of sidewalls above water surface for gross signs of contamination (*e.g.*, staining) and potential conduits.

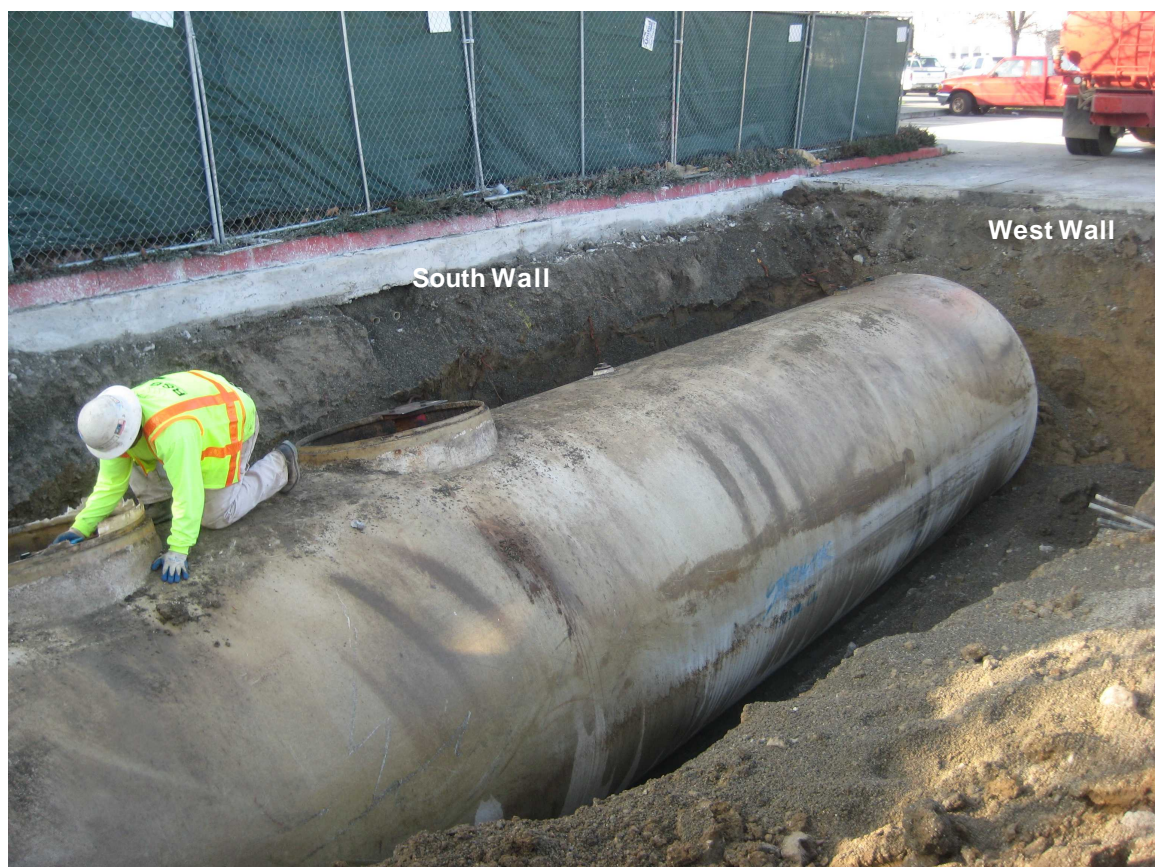
**Tank Pit TP2
and Diesel Storage Tank**

Diesel Tank Pit (TP2)—There were no obvious signs of tank or line failure. The single diesel UST was a double-walled tank with steel inner tank and fiberglass outer skin. The interstitial space had vapor monitoring. Product piping was double-walled fiberglass. The steel inner tank was not visible, and the fiberglass outer skin appeared intact.

Gross contamination (*e.g.*, a heavily stained sidewall or backhoe bucket full of odorous soil) was looked for but was not observed during sampling. Staining of the Tank Pit TP2 sidewalls was not apparent above the water line where native soil was visible. Soil staining was observed in soil taken off the backhoe bucket for the purpose of collecting Tank Pit TP2 sidewall soil samples along the tank pit's east side. Similar staining was not observed in soil taken off the backhoe bucket for the purpose of collecting Tank Pit TP2 sidewall soil samples along the tank pit's west side.

The view of the Tank Pit TP2 west sidewall generally was clear from surface to water surface. The appearance (*e.g.*, color, texture) of the soil where exposed appeared to be yellowish-brown (10 YR 5 / 3), fine-grained, and continuous with the appearance of the soil in the adjoining south sidewall. Conduits or aggregate fills were not observed in the Tank Pit TP2 west sidewall.

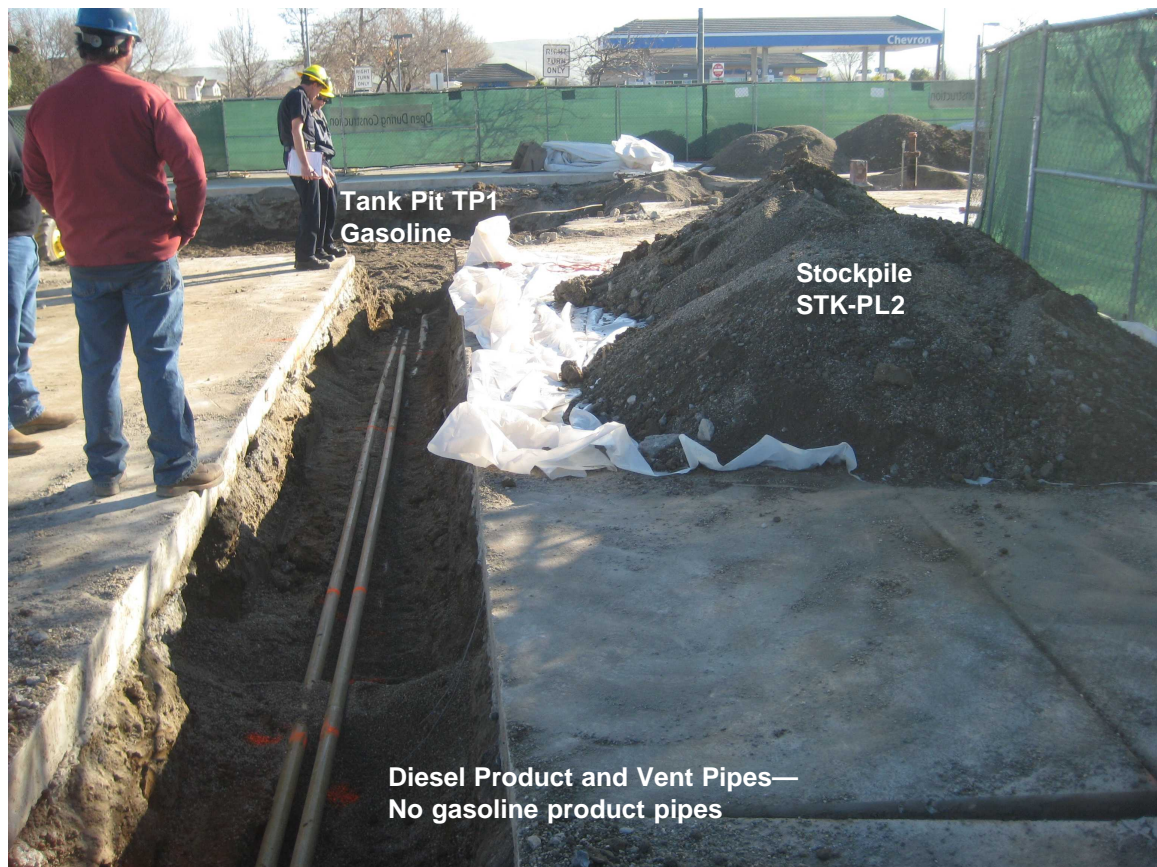
In Trench PL2, pea gravel backfill was excavated to native soil. Excavation removed the pea gravel and stockpiled it next to the trench as shown in the photograph. Visibility of native soil in Trench PL2 was better as most pea gravel in this short run of pipe was removed and stockpiled. At the time of sampling, after piping was removed from the trench, a hand shovel was used to skim off the soil “skin” over each sampling location. Staining was looked for but staining of the native soil was not observed during sampling.

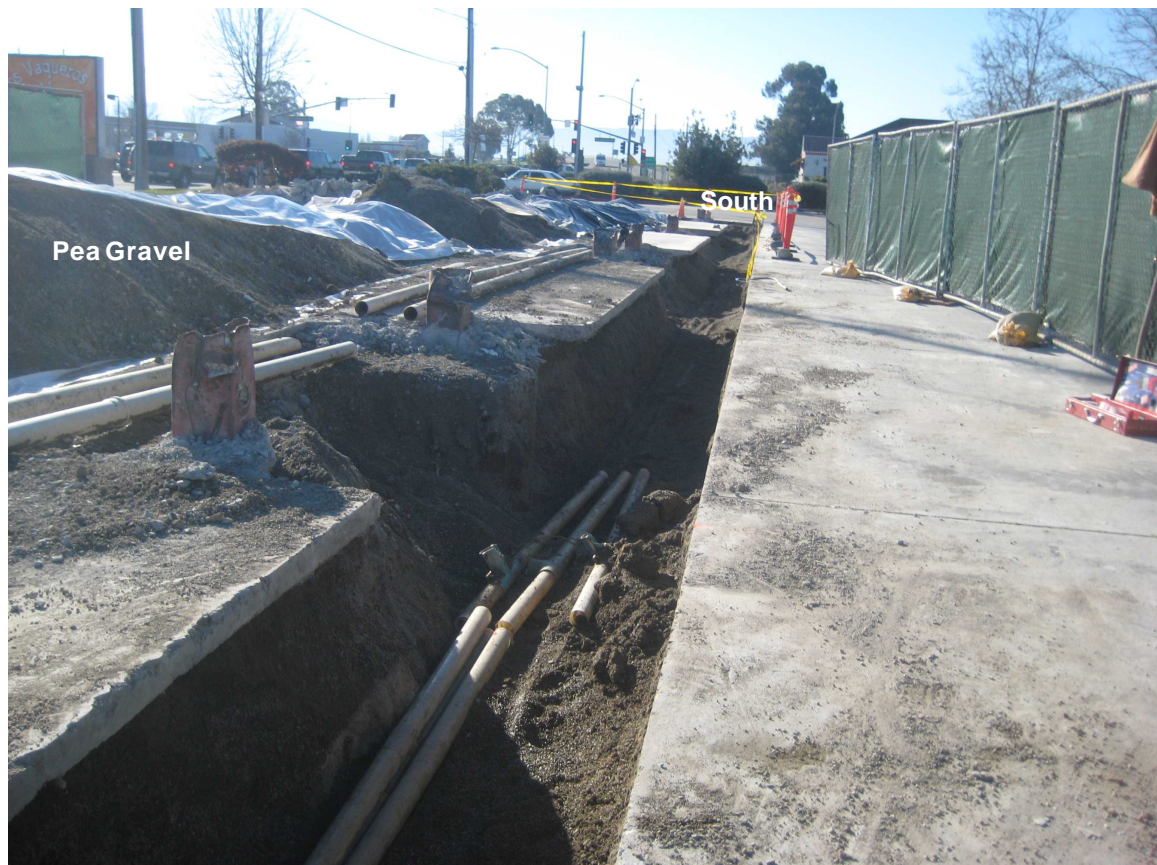
Trench PL1

At the time of sampling, after piping was removed from the trench, a backhoe was used to expose underlying native soil at each sampling location. Test pot holes were excavated an additional 1-1.5 feet with a back hoe to remove slumping pea gravel and expose the surface of native soil at each confirmation sample location. Minor soil staining without petroleum odor or Photo-Ionization Detector (PID) response was noted at location PL1-S1 but not at confirmation sample locations PL1-S2, -S3, -S4, or -S5.

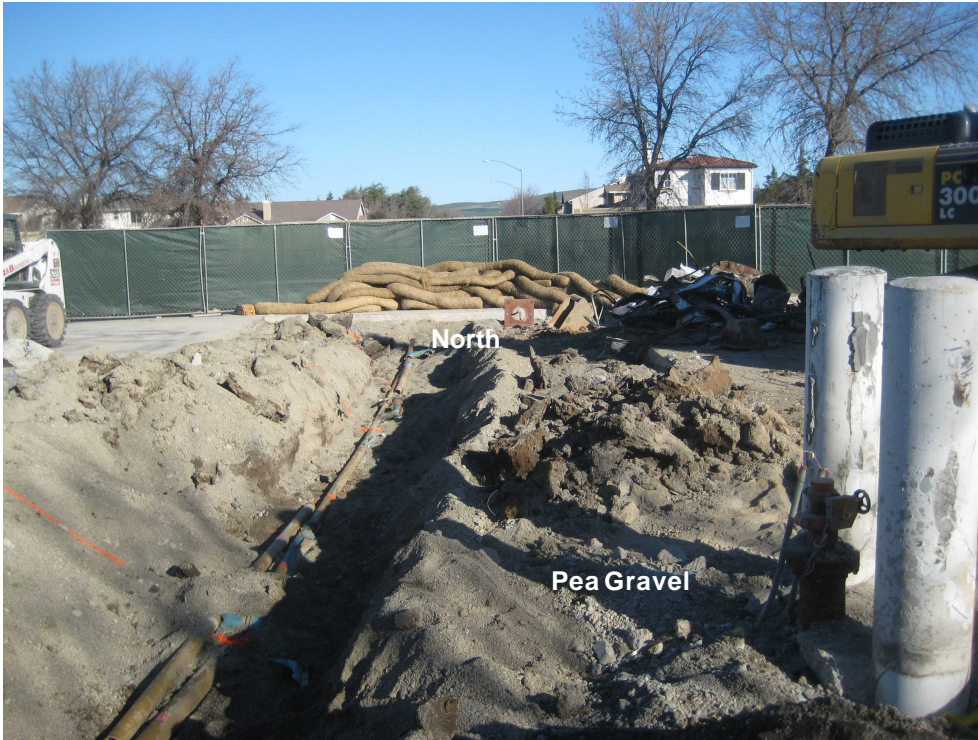
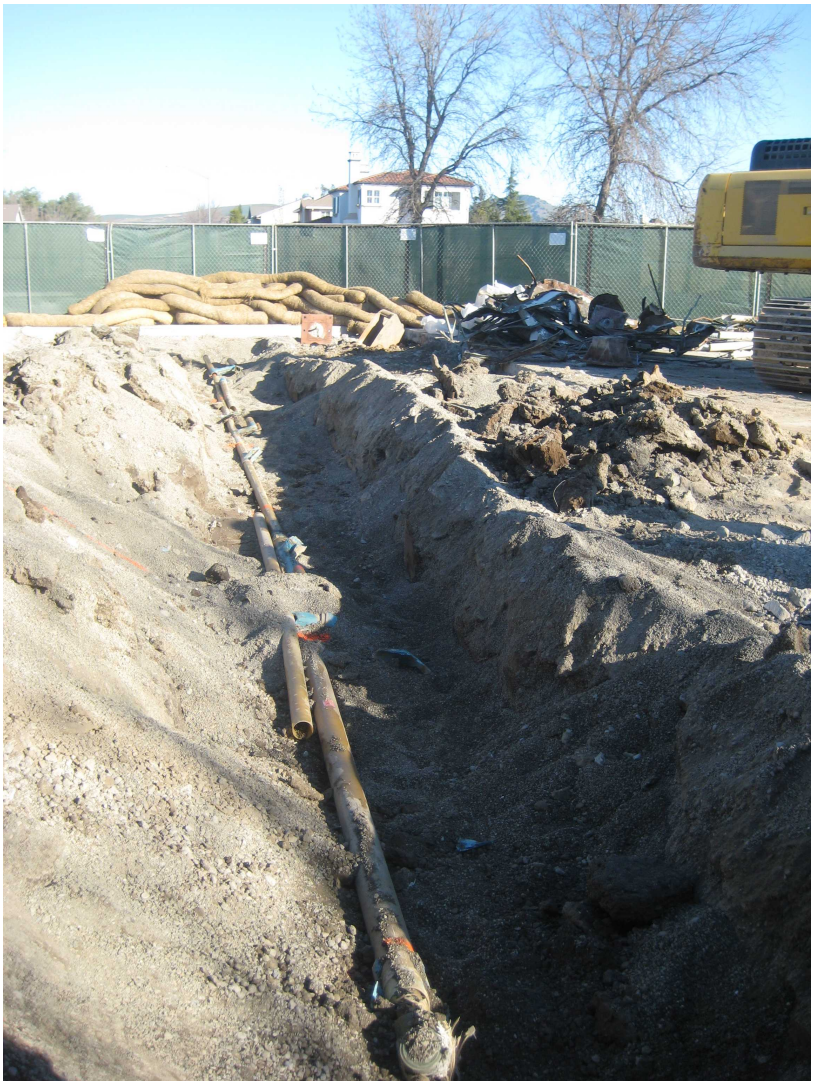
At the time of sampling, after piping was removed from the trench, a backhoe was used to expose underlying native soil at each sampling location. Test pot holes were excavated an additional 1-1.5 feet with a back hoe to remove pea gravel and expose the surface of native soil at each confirmation sample location. Minor soil staining without petroleum odor or PID response was noted at locations PL3-S10 and PL3-S12.

In January 2011, three instances of soil staining in the pipeline trenches were observed. One was at sample location PL1-S1 at the south end of Pipeline Trench PL1. The other two instances were at sample location PL3-S10 and PL3-S12. In Trench PL3, staining was not observed at adjacent sample locations PL3-S9 and PL3-S11. As stated in Section 4.2, observations of the pipeline trenches, except PL2, were limited by presence of unexcavated pea gravel fill. In Trench PL3, in which staining was identified in two potholes (PL3-S10 and PL3-S12), the laboratory reported diesel concentrations uniformly above 1,000 mg/Kg in consecutive adjacent locations PL3- S10, PL3-S11, and PL3-S12. Pipeline Trench PL3 was not over-excavated in January 2011.
