Subject: Revised Work Plan for Walgreens Fuel Spill Site Investigation
Interstate 680 at Koopman Road
Sunol, Alameda County, California
Site Cleanup Case No. RO 0003158

Revised Work Plan for Walgreens Diesel Spill Site Investigation

Truck Crash Site
Koopman Road and Interstate 680
Sunol, California

September 7, 2016
33115-015204.00

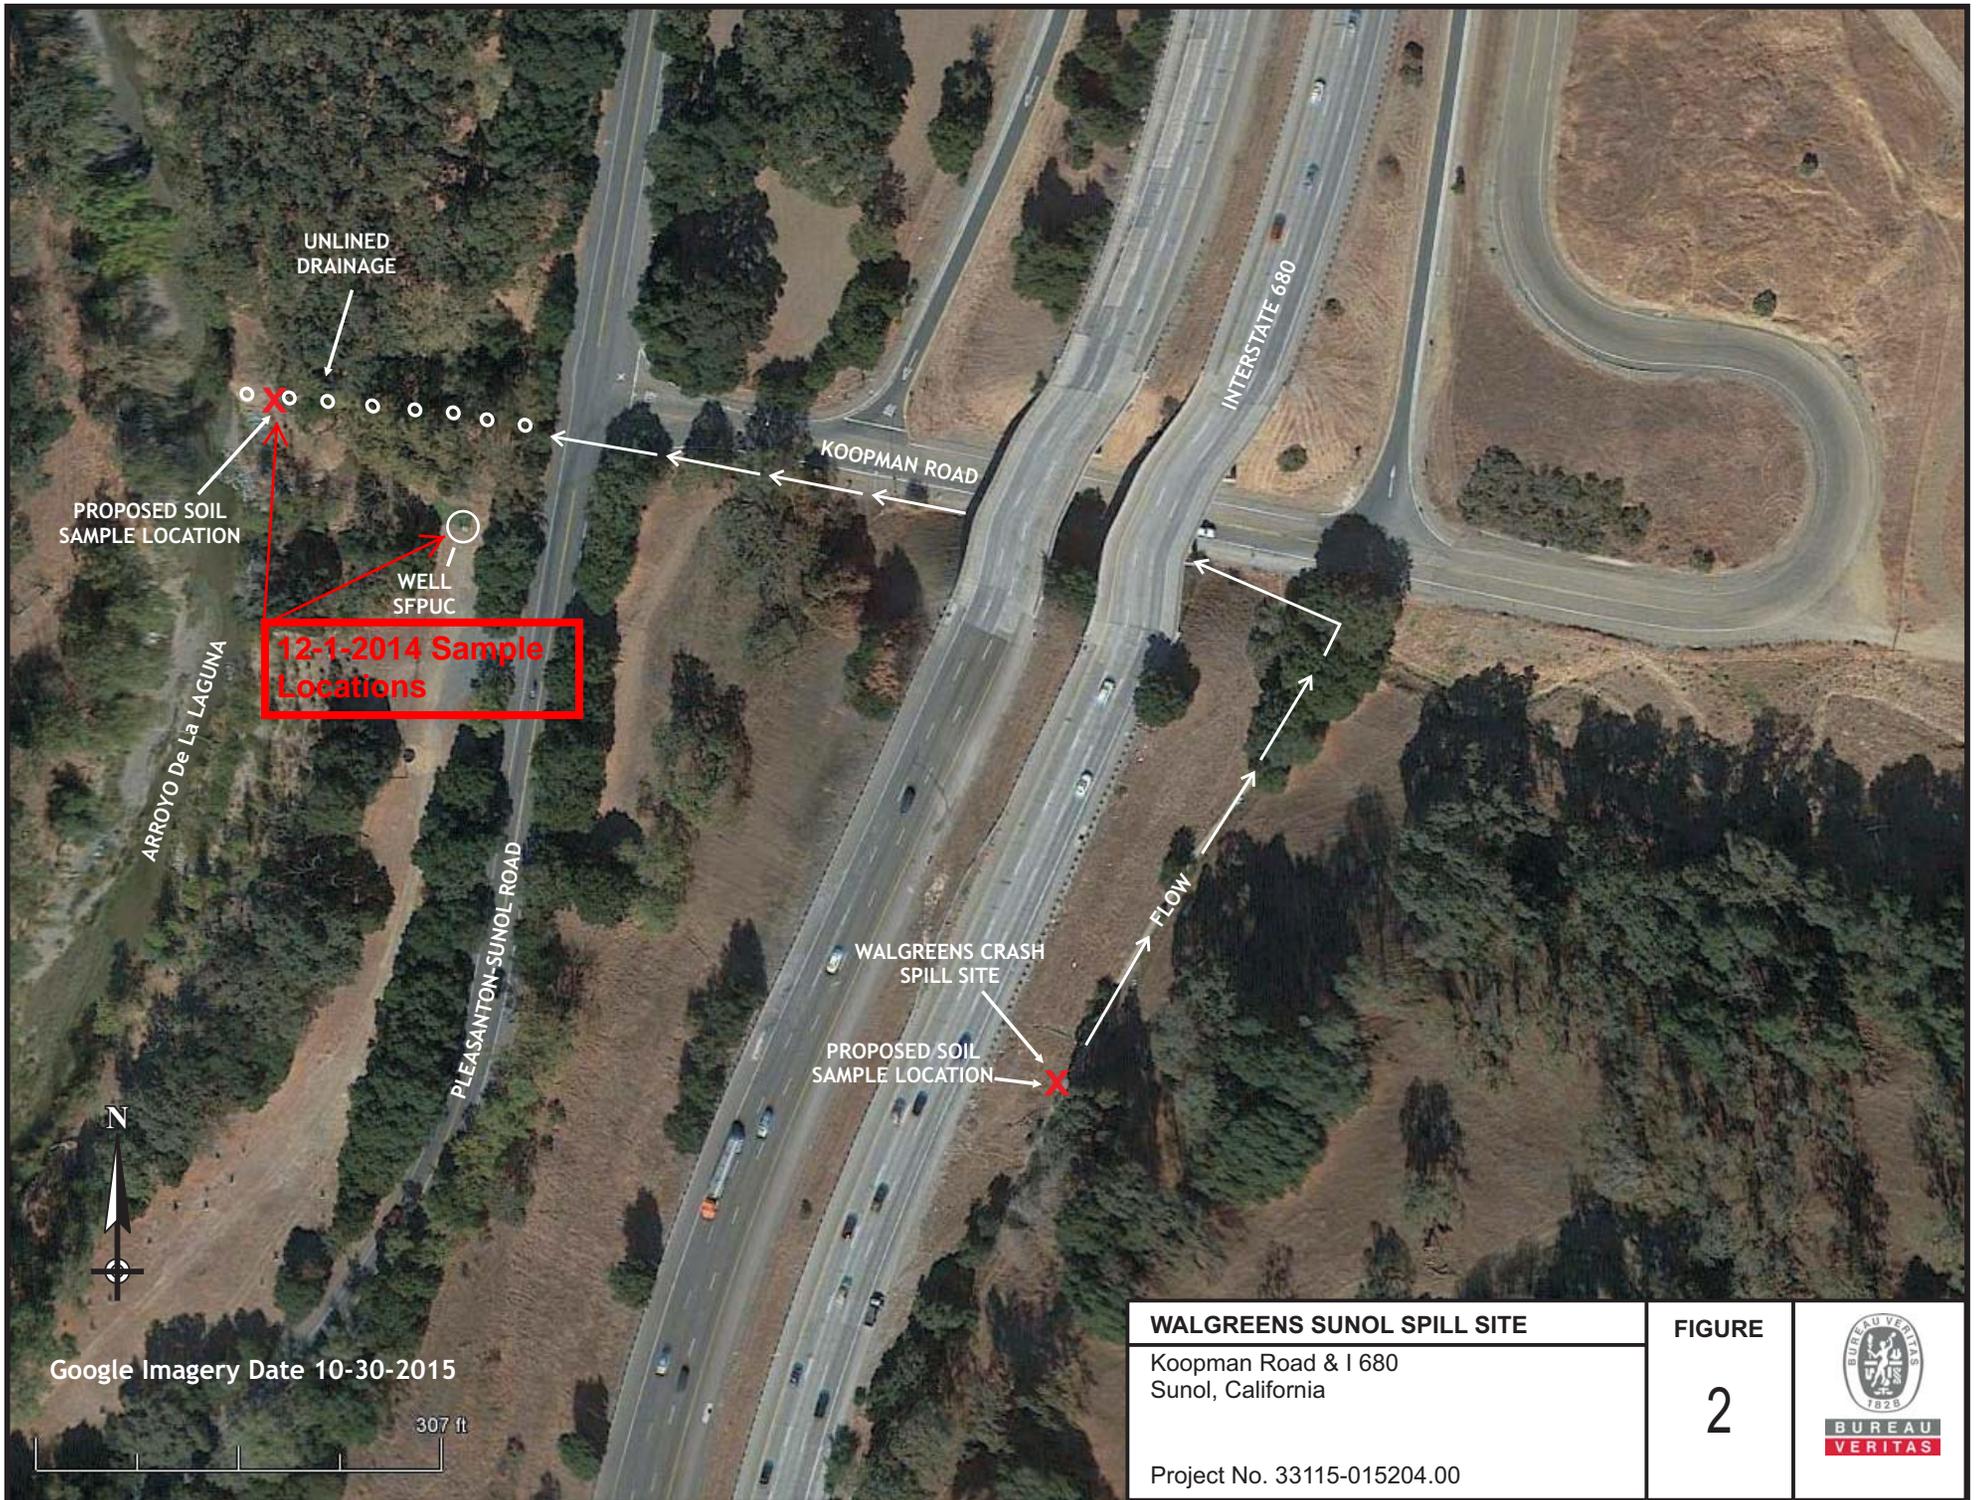
FIGURE
 2

WALGREENS SUNOL SPILL SITE
 Koopman Road & I 680
 Sunol, California
 Project No. 33115-015204.00

The CHES, 2014 report documents confirmation sampling of soil and groundwater in the area of the unlined drainage. On December 1, 2014, CHES collected duplicate soil samples from the base of the drainage that had recently been cleaned by soil removal (Soil Sample #1 and #2, two discrete samples) at the location at the west end of the unlined drainage near the bank of the Arroyo, and duplicate well water samples (Water Sample #1 and #2) from the nearby SFPUC well spigot. Figure 2 depicts the

sample locations on SFPUC property. The chain-of-custody (COC) documents that these samples were submitted to the Accutest Laboratory in San Jose within less than two hours of collection. The analytical program was by U.S. EPA SW846 and 8015B for total petroleum hydrocarbons as diesel ranged organics (DRO). This analytical procedure will report both polar and non-polar hydrocarbons within the diesel fuel range unless special sample preparation is requested using a silica-gel cleanup procedure that will remove polar compounds. Petroleum hydrocarbons as fuels are non-polar; therefore, if a sample includes significant biologic matter, the reported DRO concentration can be skewed high.

- BVNA will schedule a site visit for surficial soil sampling using hand sampling equipment. Soil sampling will be conducted at two locations (see Figure 2). The first location is the crash site where soil cleanup occurred. ACEH Inspection Notes include photographs of the crash site and the area of soil remediation. Therefore, providing the crash site can be located, BVNA will collect discrete soil samples using hand sampling equipment at the depth of 6 inches bgs and at 2 feet bgs at the crash site. BVNA will attempt to collect soil samples from the second location, which is the same location in the unlined drainage near the Arroyo where CHES collected Soil Samples #1 and #2 in 2014. BVNA will rely on being escorted by Mr Fujita and that Mr Fujita can locate the same sample location where soil samples were collected on December 1, 2014. If the prior sample location can not be determined, BVNA will select a sample location within the bottom of the indicated unlined drainage where discrete soil samples can be collected at the depth of 6 inches and 2 feet bgs.

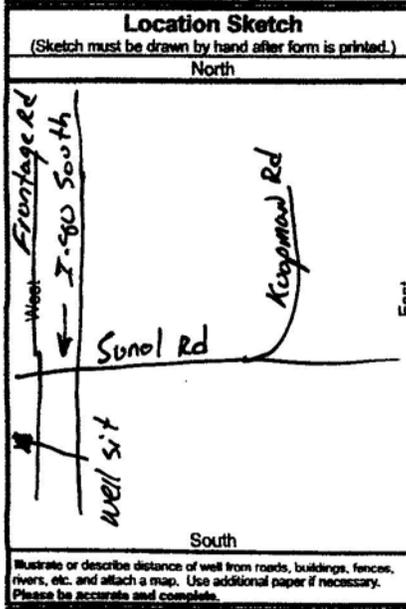
Water Level and Yield of Completed Well	
Depth to first water	<u>23'</u> (Feet below surface)
Depth to Static	
Water Level	<u>21.5</u> (Feet) Date Measured <u>6/16/14</u>
Estimated Yield *	<u>35</u> (GPM) Test Type <u>Pump</u>
Test Length	<u>4 hrs</u> (Hours) Total Drawdown <u>.5</u> (Feet)
*May not be representative of a well's long term yield.

Casings							
Depth from Surface	Borehole Diameter	Type	Material	Wall Thickness	Outside Diameter	Screen Type	Slot Size if Any
Feet to Feet	(Inches)			(Inches)	(Inches)		(Inches)
0	24	20"	Casing	PVC	Sch 80	9"	-
24	34	20	screen	Stainless	wirewrap	9"	wirewrap .010
38	39	20	CAP	Sch 80 Cap	Sch 80	9"	Cap

Annular Material			
Depth from Surface	Fill	Description	
Feet to Feet			
28	23.5	Seal	3/8 Bentonite
23.5	0	Seal	Neat Cement
26.0	39	Gravel Pack	Med. Aquarium

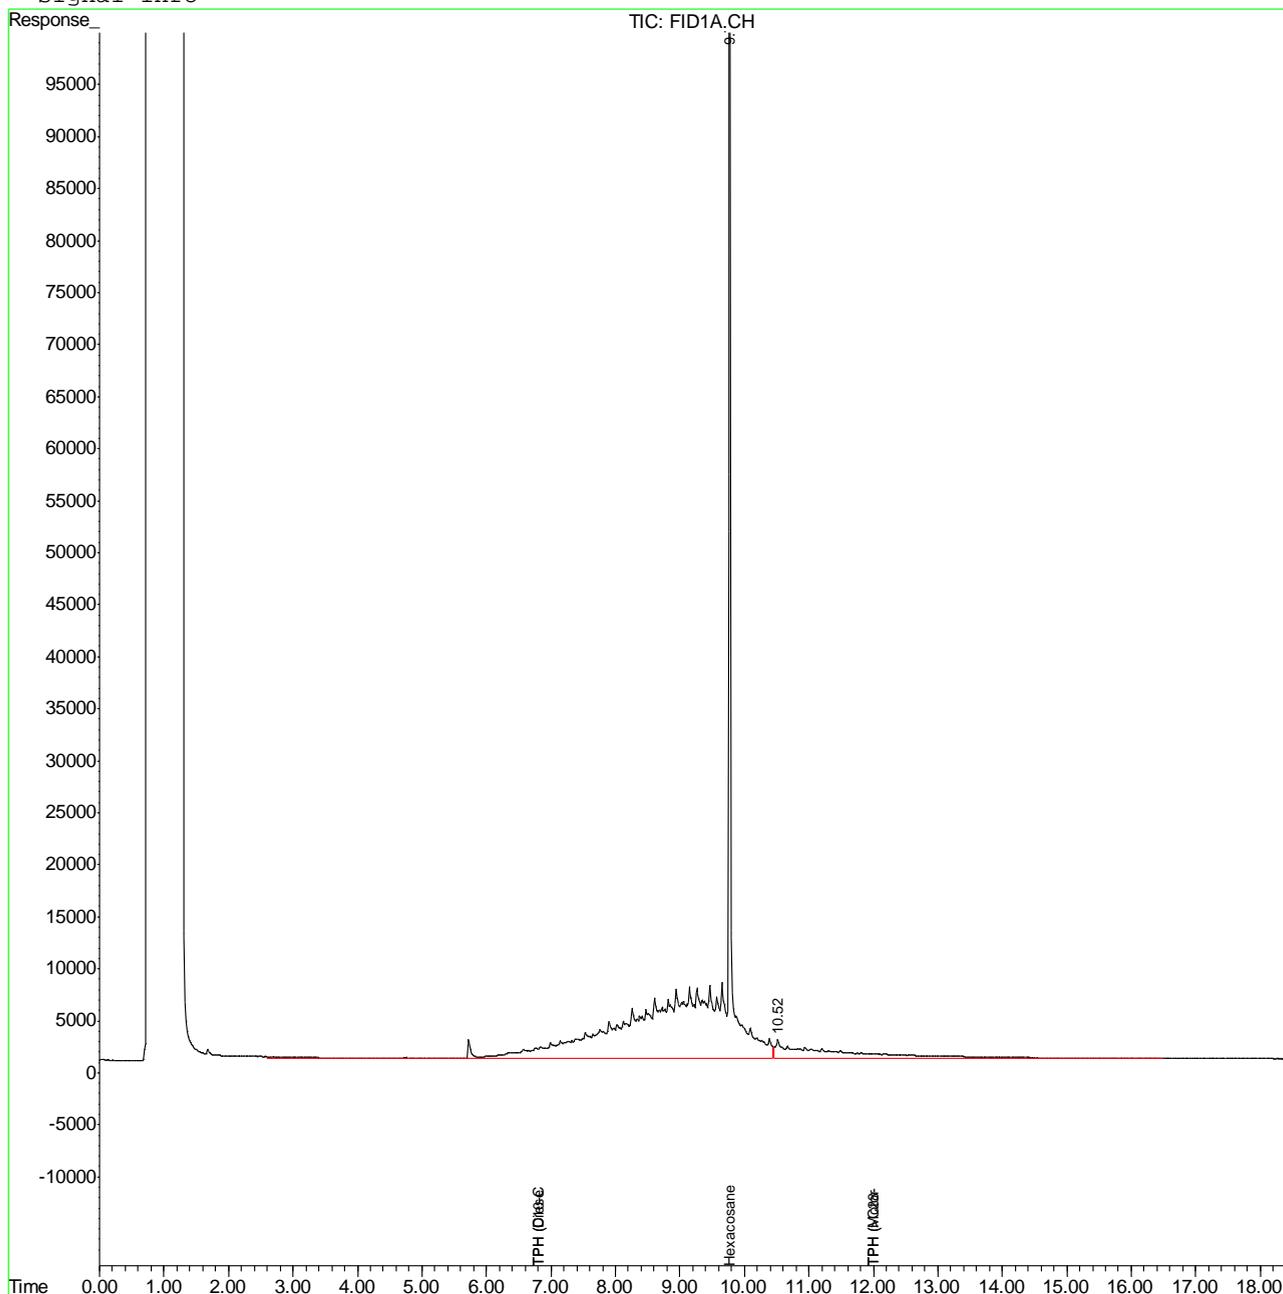
Quant Method : C:\MSDCHEM\2\METHODS\GHH1360.M (Chemstation Integrator)
Title : TPH-Extractable by SW-846 Method 8015B
Last Update : Thu Nov 13 11:38:16 2014
Response via : Multiple Level Calibration
DataAcq Meth : ACQ_TPH5.M

Quantitation Report (QT Reviewed)

Data File : C:\HPCHEM\2\DATA\GHH1413\HH319274.D Vial: 4
 Acq On : 01-Dec-2014, 15:10:54 Operator: ALLENG
 Sample : C37385-2 Inst : HP5890
 Misc : OP11297,GHH1413,30.03,,,10,3,S Multiplr: 1.00
 IntFile : AUTOINT1.E
 Quant Time: Dec 01 16:46:38 2014 Quant Results File: GHH1360.RES

BVNA obtained and reviewed the laboratory chromatograms for each of the 2014 sample results along with a standard diesel and motor oil chromatogram provided by the laboratory, which is presented in the Quantitation Report, Page 2; last page of Appendix B. Review of the standard chromatogram indicates that the diesel chromatogram and the motor oil ranged organics (ORO) curves both have typical bell shaped curves. However, the two soil sample chromatograms have a somewhat skewed petroleum hydrocarbon curve for the DRO concentrations and also a second and more pronounced skewed curve for ORO concentrations (see Appendix B: C37385 page 22 and C37385R page 22). Chromatograms for the two water samples (Appendix B: C37385 page 20 and C37385R page 20) show a suppressed curve significantly skewed toward the longer chained carbon compounds within the DRO limits, characteristic of aged and weathered DRO with little to no ORO concentrations. Therefore, the skewed signature of DRO compounds in the soil and water samples indicate that that the petroleum hydrocarbons reported in the samples are likely from other sources, likely aged and not due to the Walgreens release of fresh diesel fuel to the unlined drainage.

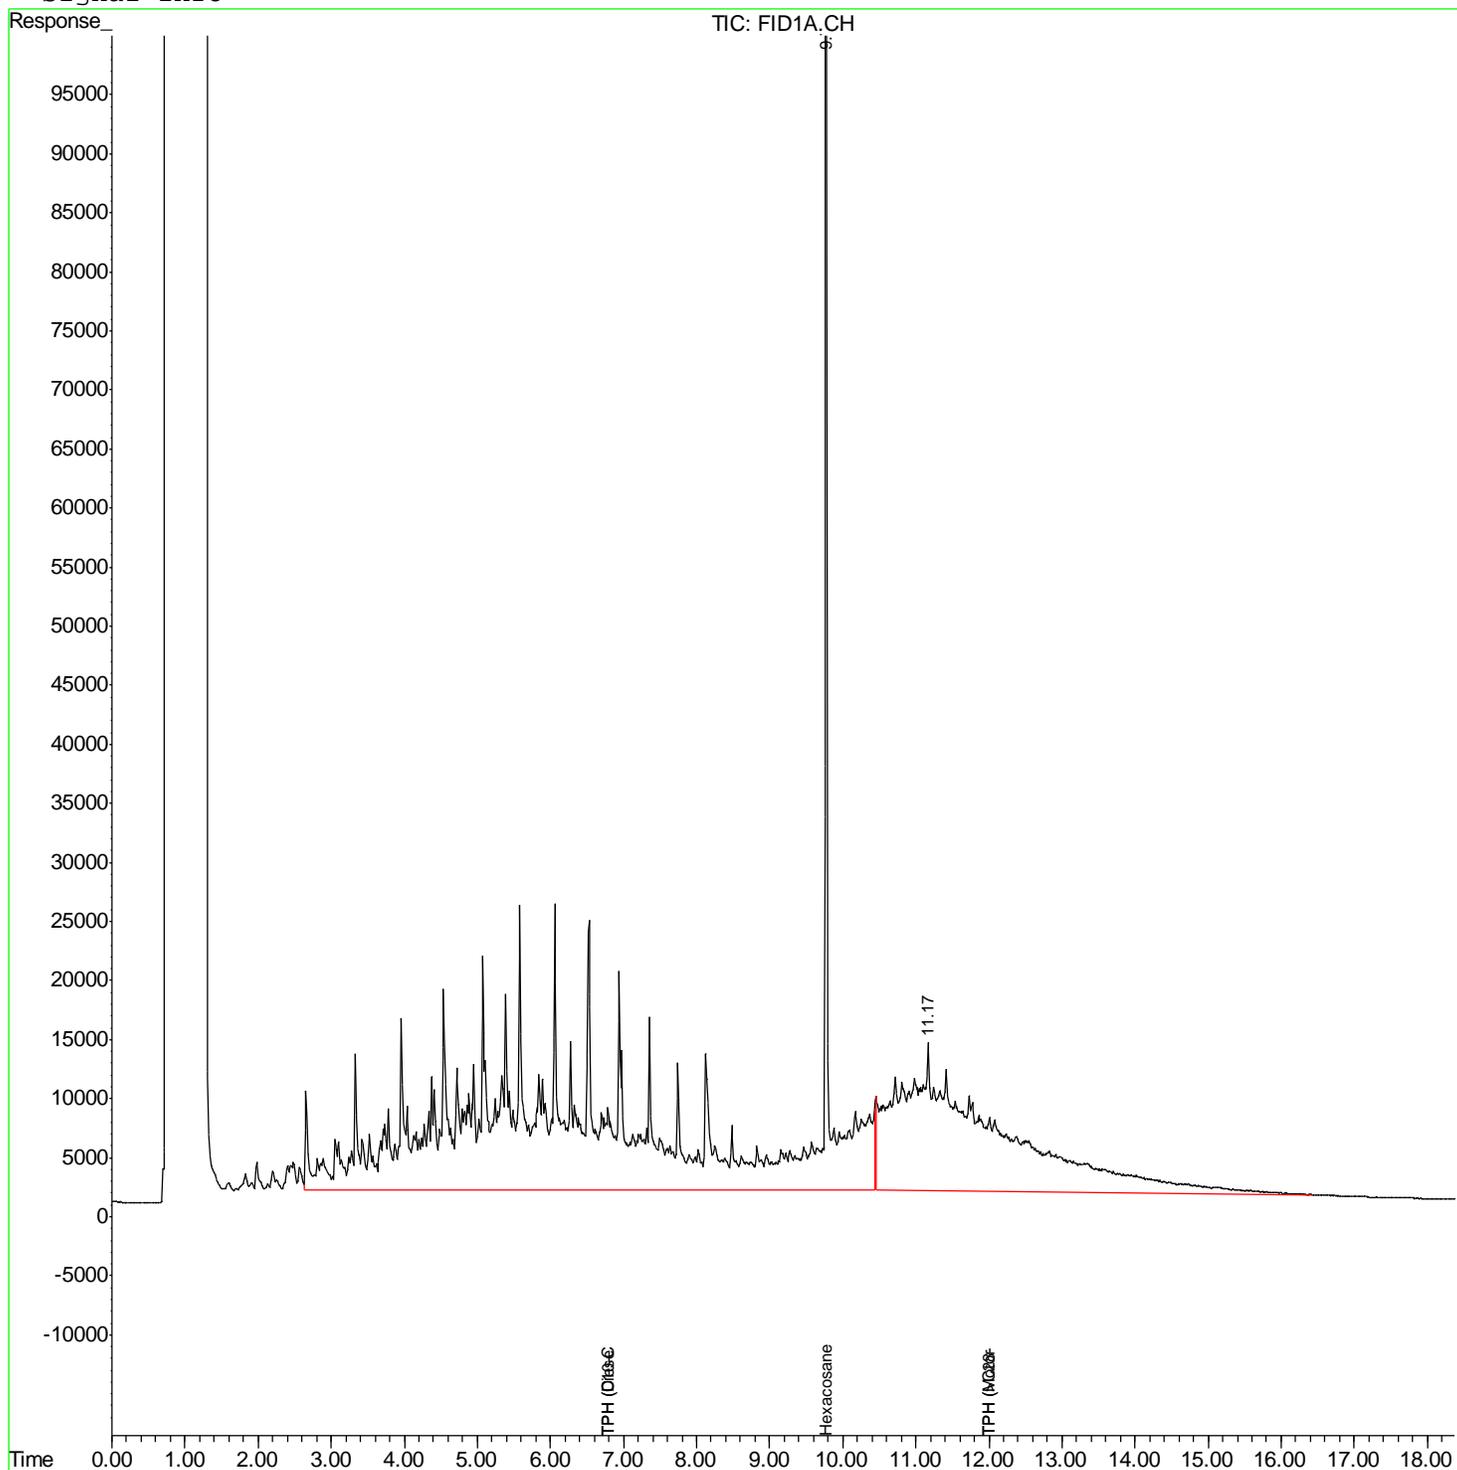
Quant Method : C:\MSDCHEM\2\METHODS\GHH1360.M (Chemstation Integrator)
 Title : TPH-Extractable by SW-846 Method 8015B
 Last Update : Thu Nov 13 11:38:16 2014
 Response via : Multiple Level Calibration
 DataAcq Meth : ACQ_TPH5.M
