Re: Soil, Soil Vapor, and Ground Water Quality Evaluation and Request for Case Closure; East Bay Bridge Center, 3839 Emery Street, Emeryville, CA 94608. Fuel Leak Case No. RO0003210; Geotracker Global ID T10000008569

Type of Services	Soil, Soil Vapor, and Ground Water Quality Evaluation and Request for Case Closure
Location	East Bay Bridge Center 3839 Emery Street Emeryville, California
Client	Federal Realty Investment Trust
Client Address	356 Santana Row, Suite 1005 San Jose, California 95128
Project Number	371-5-4
Date	October 20, 2016

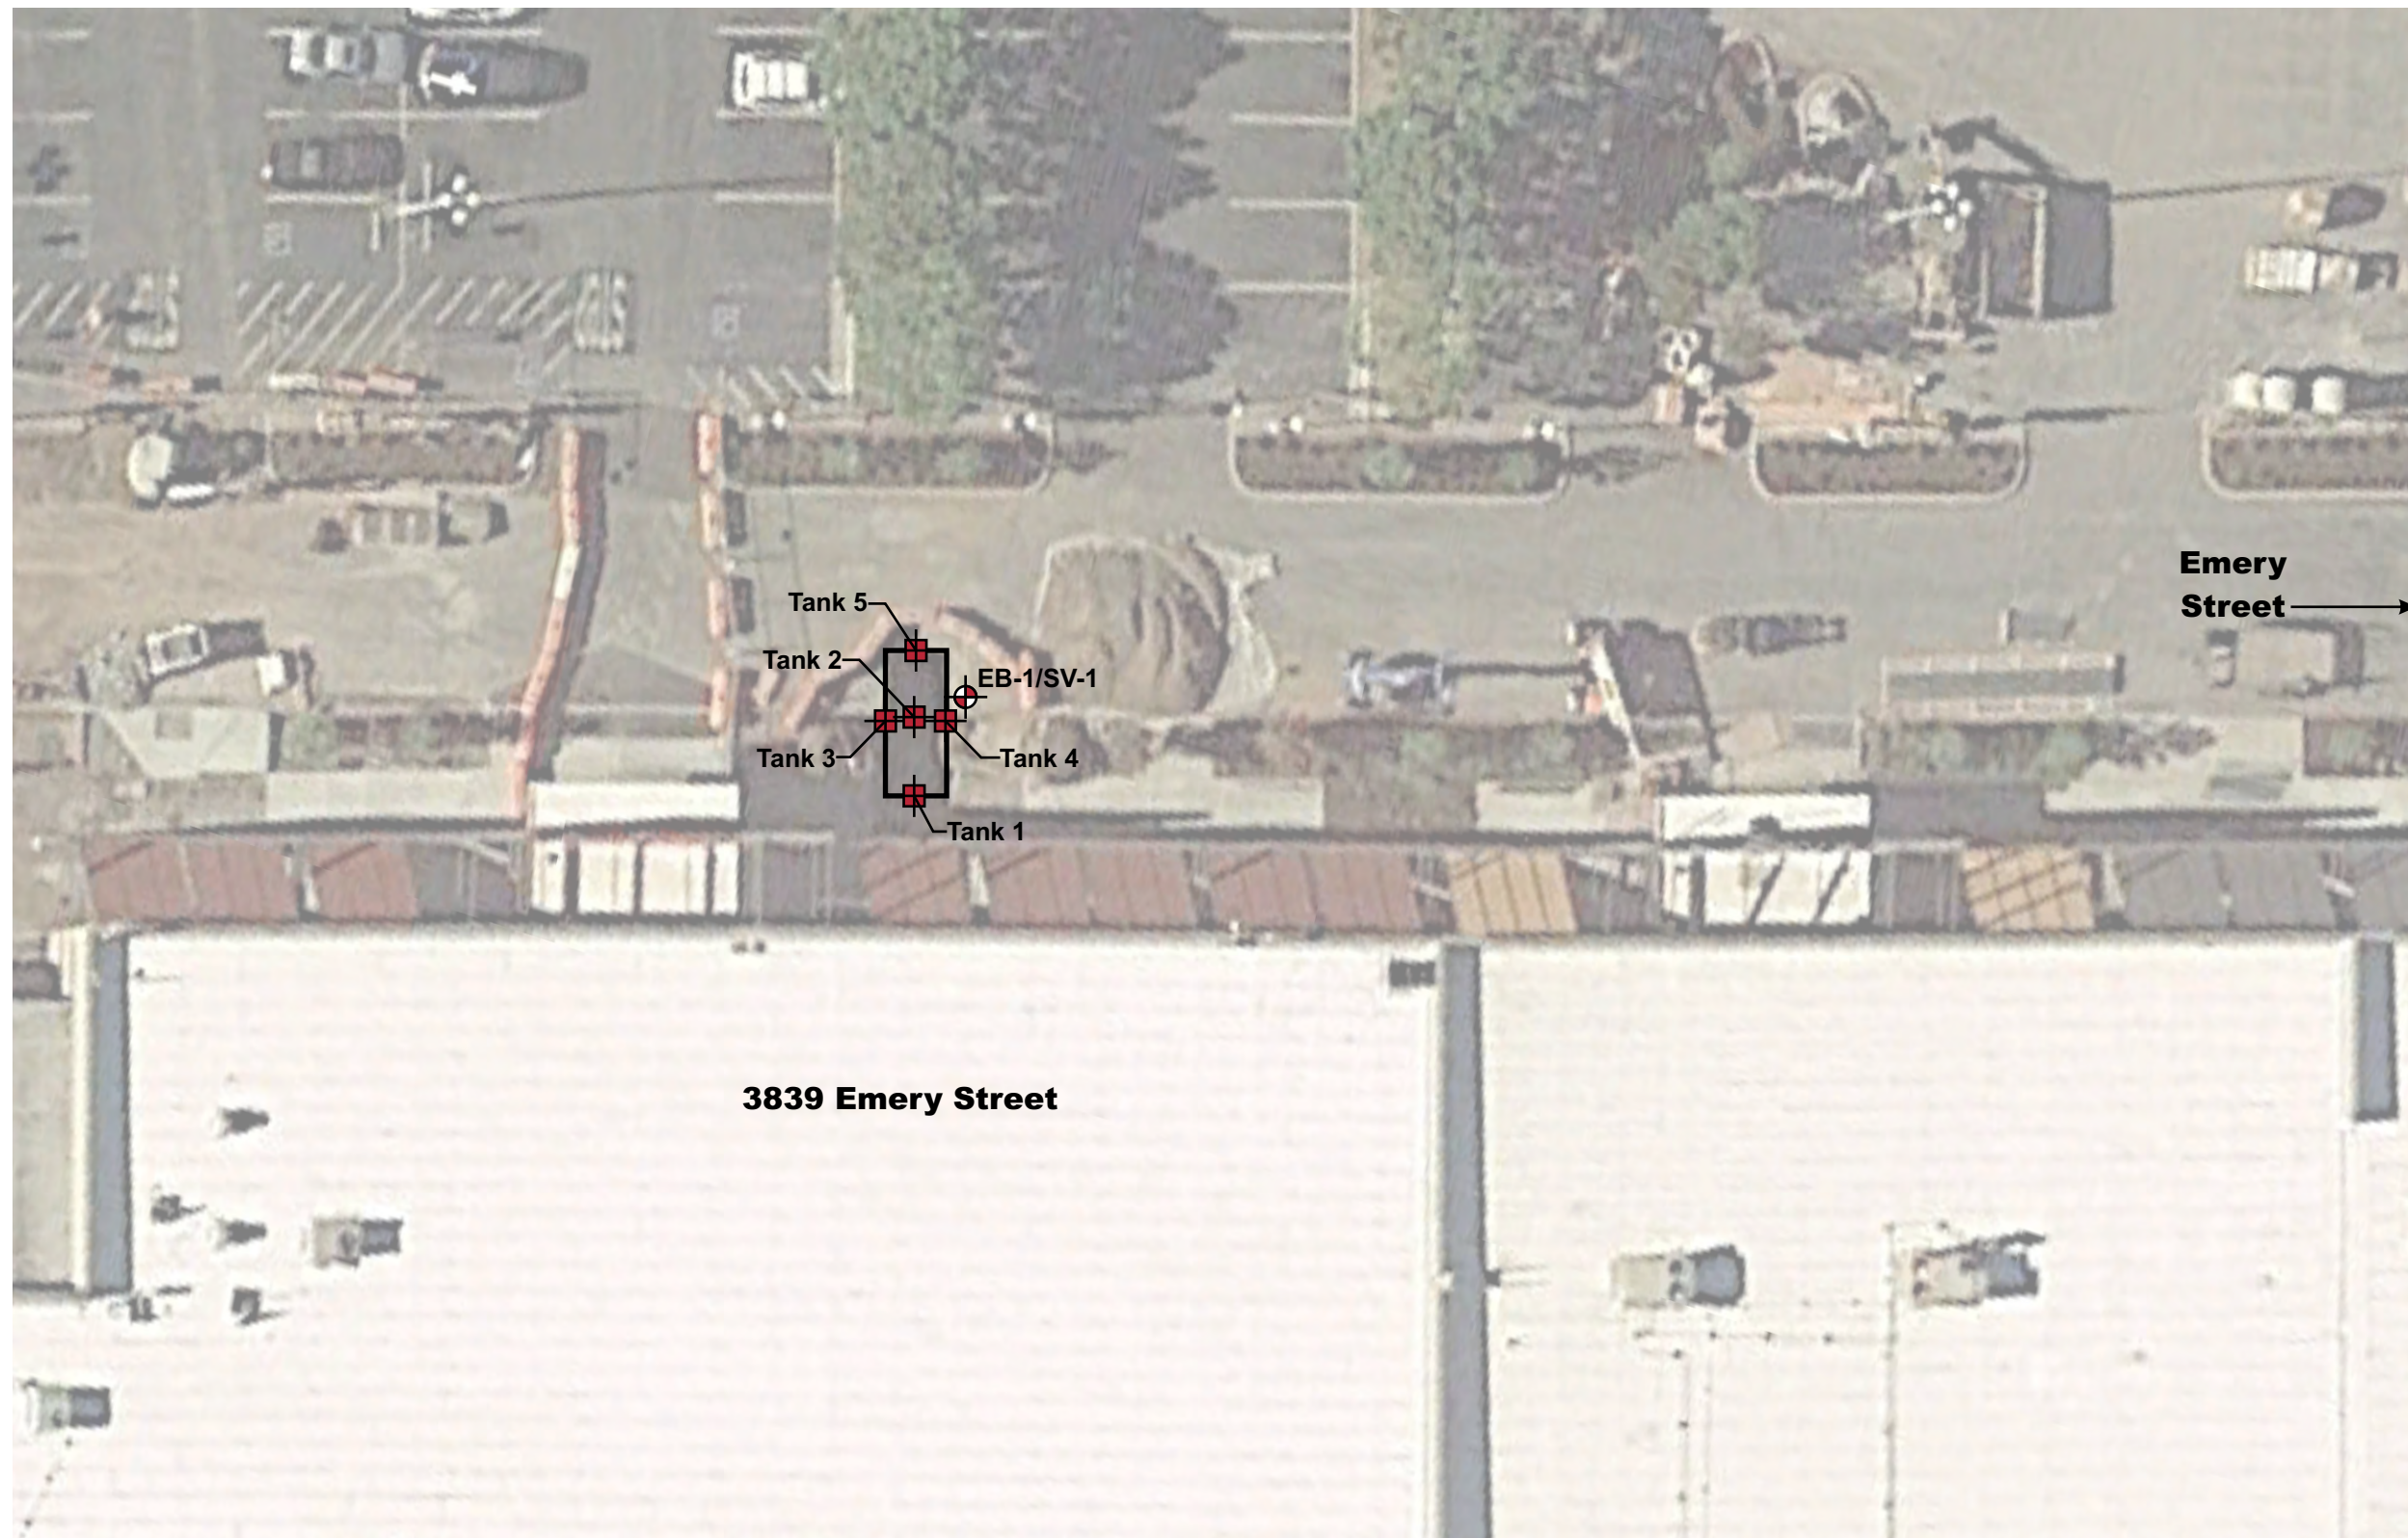
Project Number	371-5-4
Figure Number	Figure 3
Date	October 2016
Drawn By	RRN

Approximate location of UST excavation

UST and Verification Sample Location
 East Bay Bridge Project
 3839 Emery Street
 Emeryville, CA

The location of the boring is shown on Figure 3.

On September 27, 2016, Cornerstone installed one temporary soil vapor probe (SV-1) adjacent to the soil and ground water boring location (Figure 3). The temporary soil vapor probe was installed following in general accordance with the July 2015 document entitled “Advisory – Active Soil Gas Investigations”, prepared by the Department of Toxic Substances and Control and the California Regional Water Quality Control Board, Los Angeles Region.

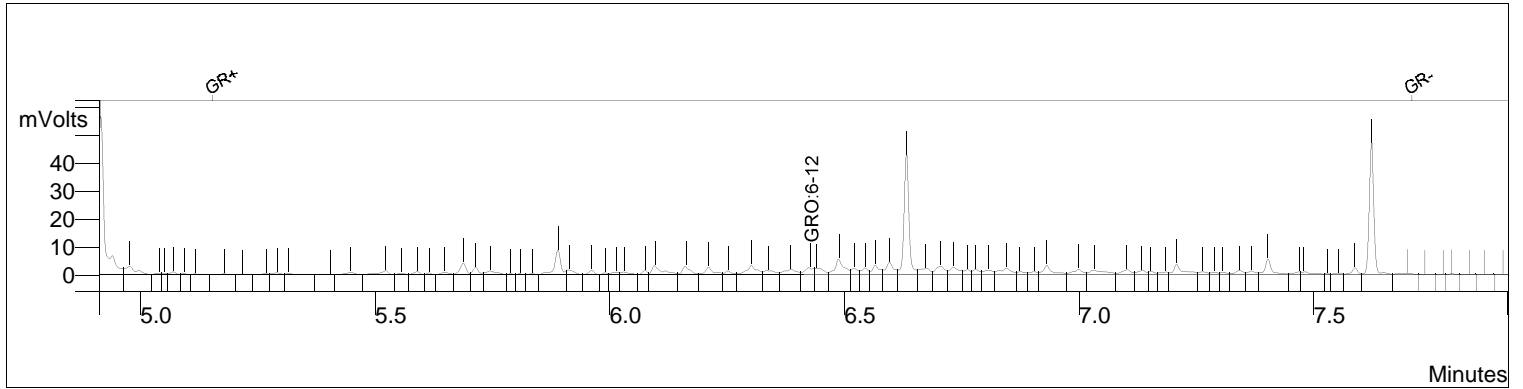
GRO by TO-3

Sample ID: 281560-001,239691
 Data File: c:\varianws\data\093016\274_004.run
 Sample List: c:\varianws\093016.smp
 Method: c:\varianws\to3_091616.mth
 Acquisition Date: 09/30/2016 16:27:32
 Calculation Date: 09/30/2016 16:39:35
 Instrument ID: MSAIR03 Operator: sjd
 Injection Notes: 1x Divisor: 1.000
 Multiplier: 1.000

#	RT (min)	Peak Name	Area	Result (ppbv)
1	6.431	GRO:6-12	267545	3438.311
Totals			267545	3438.311

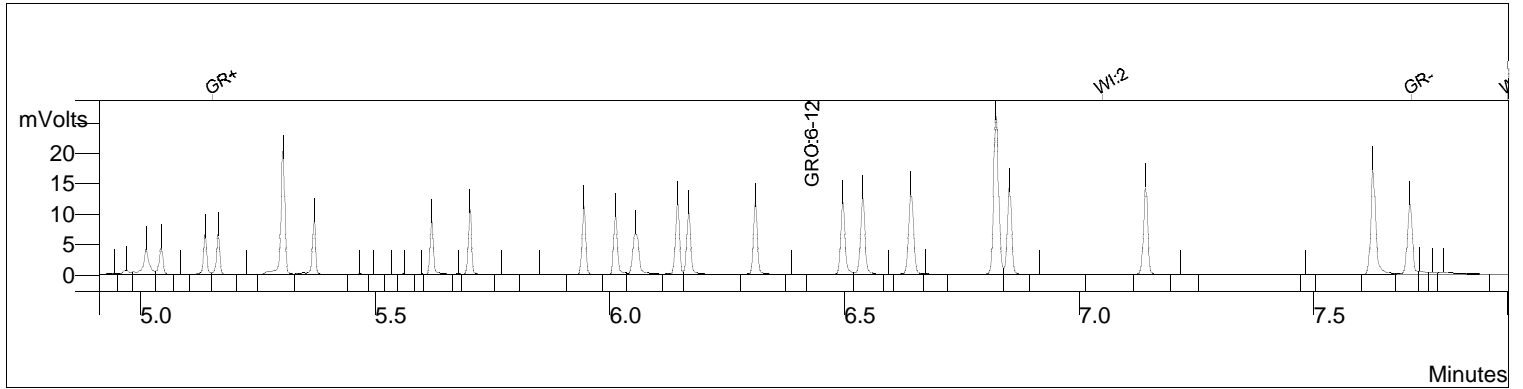
GRO by TO-3

Sample ID: ccv/bs,qc853843
 Data File: c:\varianws\data\093016\274_001.run
 Sample List: c:\varianws\093016.smp
 Method: c:\varianws\to3_091616.mth
 Acquisition Date: 09/30/2016 15:43:22
 Calculation Date: 09/30/2016 15:55:24
 Instrument ID: MSAIR03 Operator: sjd
 Injection Notes: 239691,s30906,1x
 Multiplier: 1.000 Divisor: 1.000

#	RT (min)	Peak Name	Area	Result (ppbv)
1	6.431	GRO:6-12	162495	2088.277
Totals			162495	2088.277
