ACTIVITY RECORD

SITE NAME & ADDRESS: 401 Jackson Street, Oakland

TOPIC: Subsurface Investigation (soil, groundwater, sub-slab)

Name: Former Amaro Poultry Co., Inc.

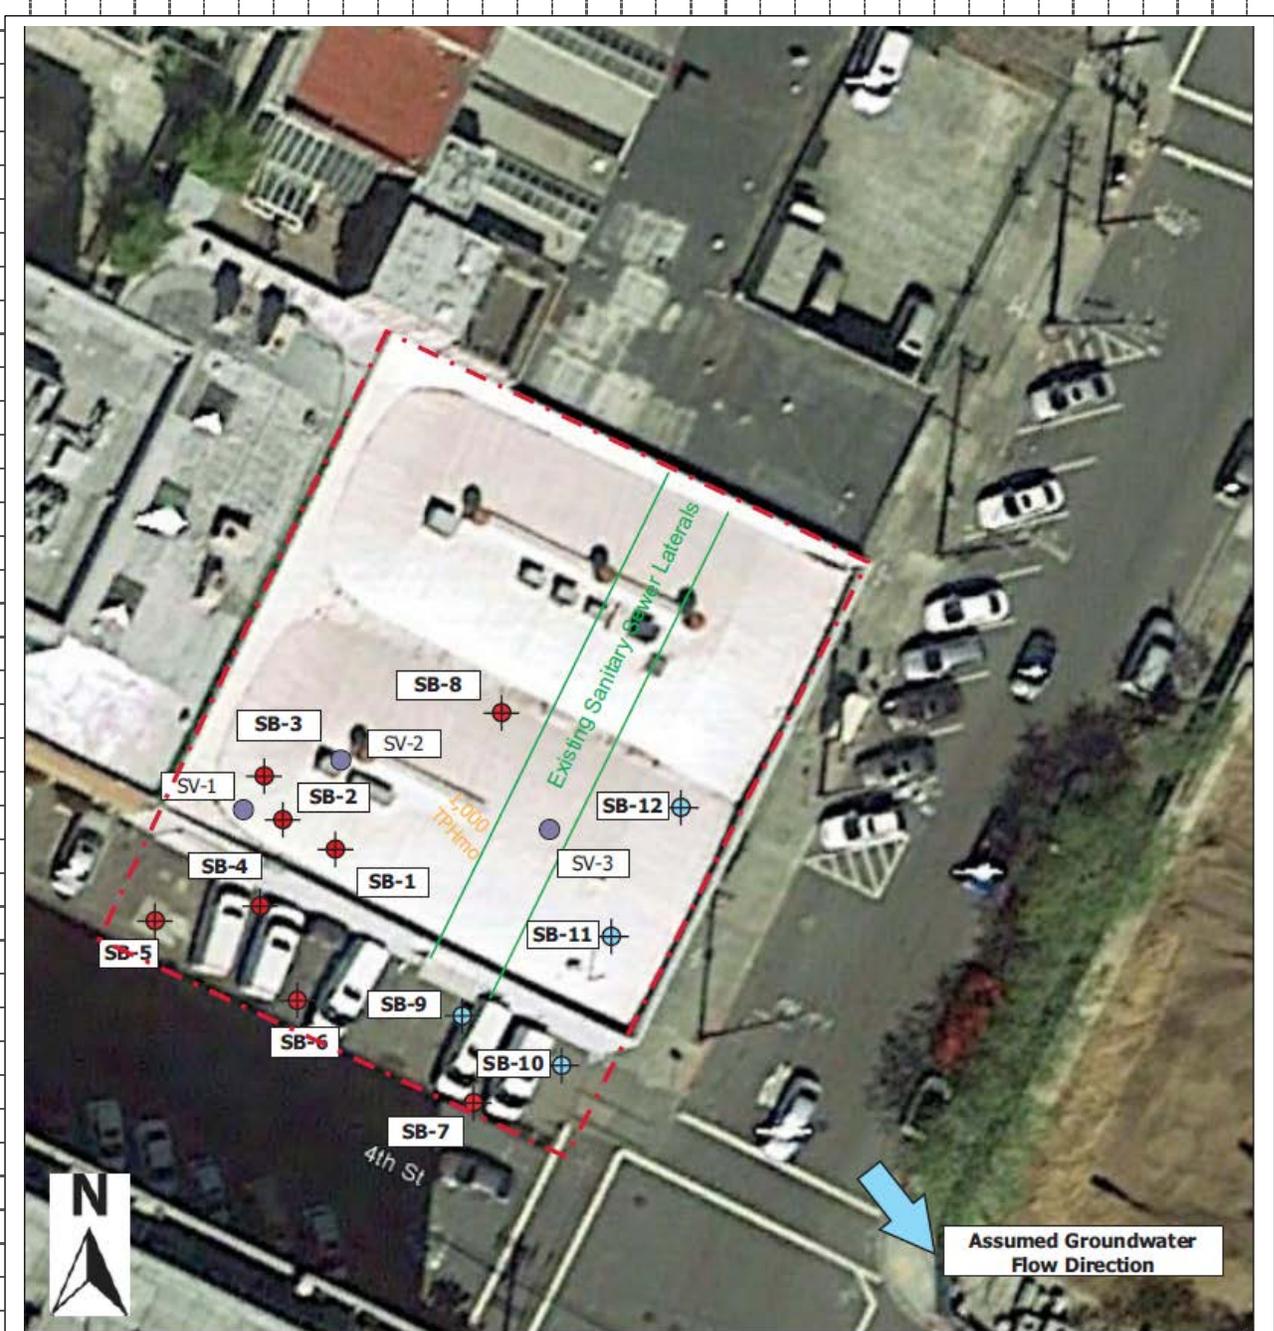
FIGURE 2
Project No. 372927

Two borings, SB-11 and SB-12 were completed. SB-11 was located inside the building as shown on the figure and was installed to a depth of 15 feet bgs. Sand was encountered in the first 10 feet of the boring. Soil samples were collected every two feet and changes in lithology or signs of contamination. First encountered groundwater was at 10 feet bgs with static water at 7.85 feet bgs.

SB-12, installed to a depth of 15 feet bgs was located further inside the building in the chicken processing area. Static groundwater was at 8.35 feet bgs.

Proposed Additional Investigation

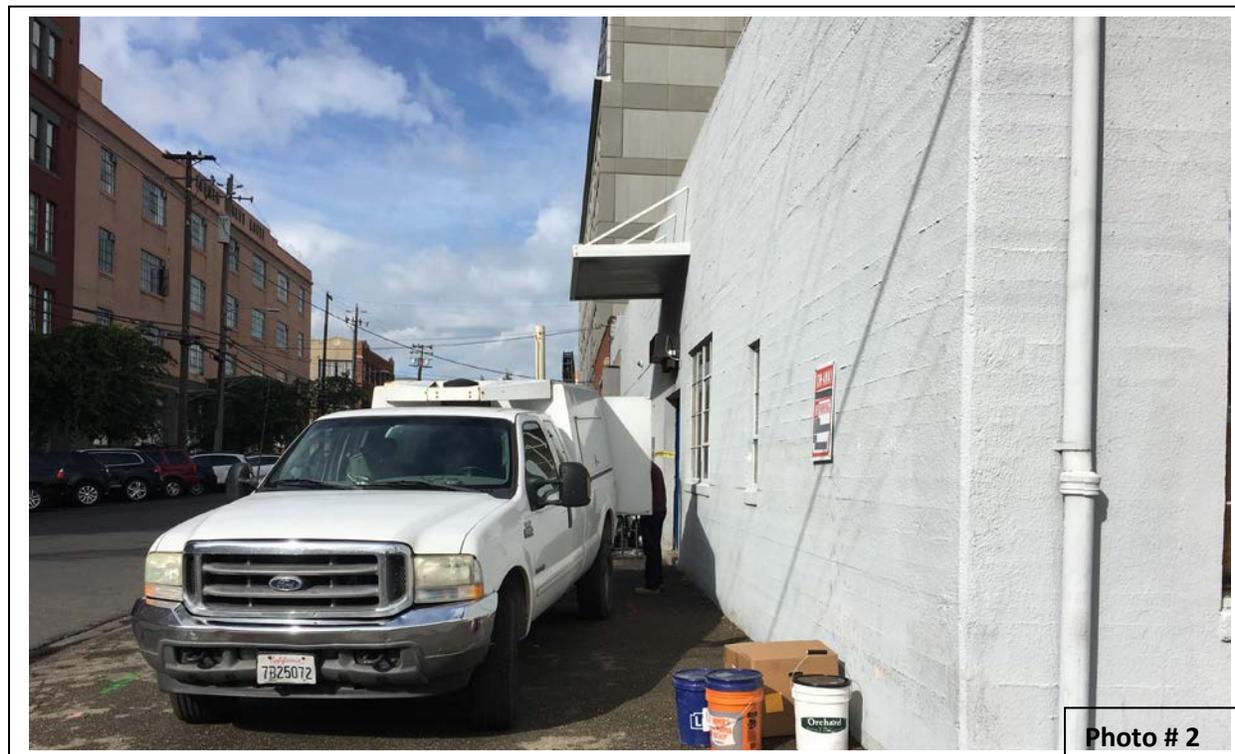
Photo # 2

Photo Taken by: Paresh Khatri	Insp. Rtp #:	Date: 11/9/2017
Description: West side of facility where UST was located

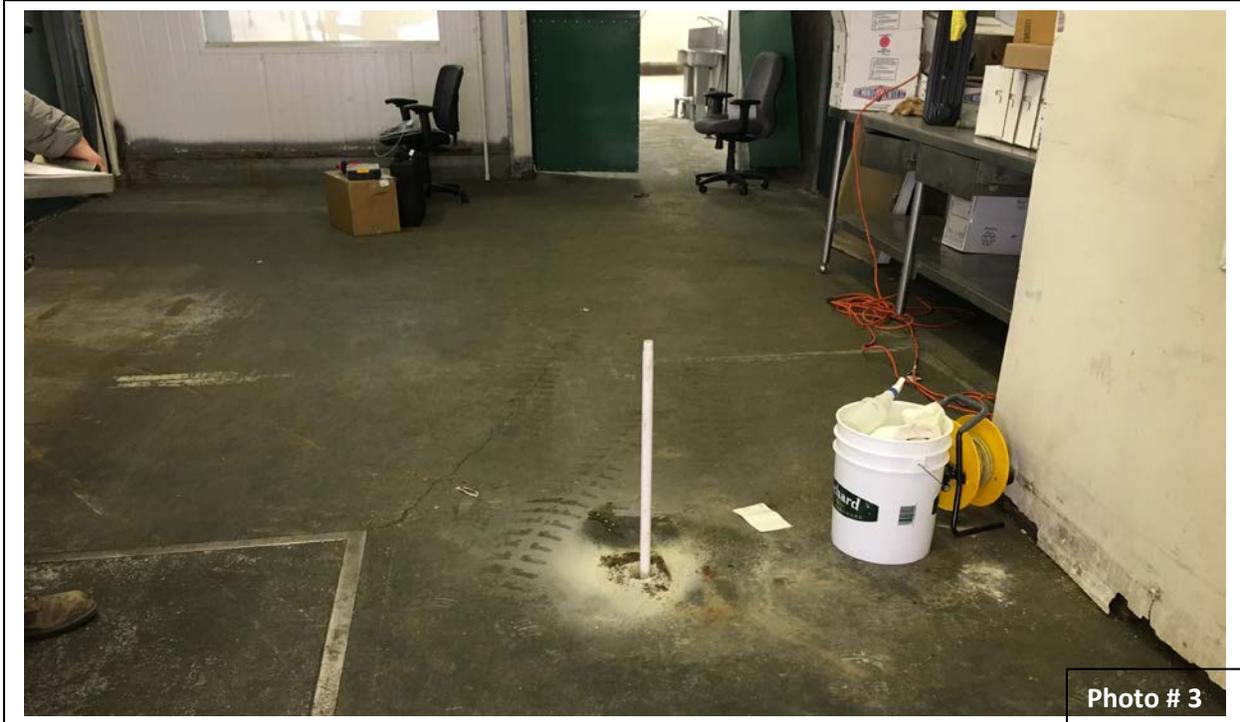
Photo # 3

Photo Taken by: Paresh Khatri	Insp. Rtp #:	Date: 11/9/2017
Description: Location of SB-11

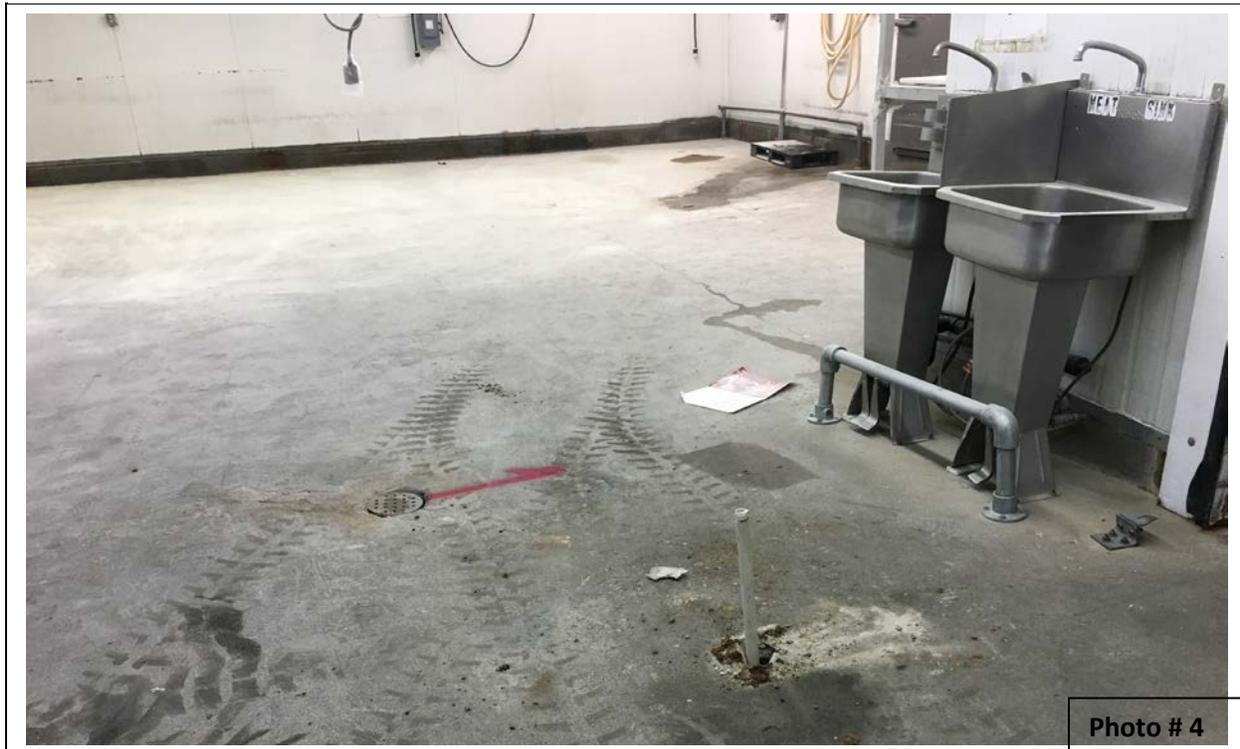
Photo # 4

Photo Taken by: Paresh Khatri	Insp. Rtp #:	Date: 11/9/2017
Description: Location of SB-12

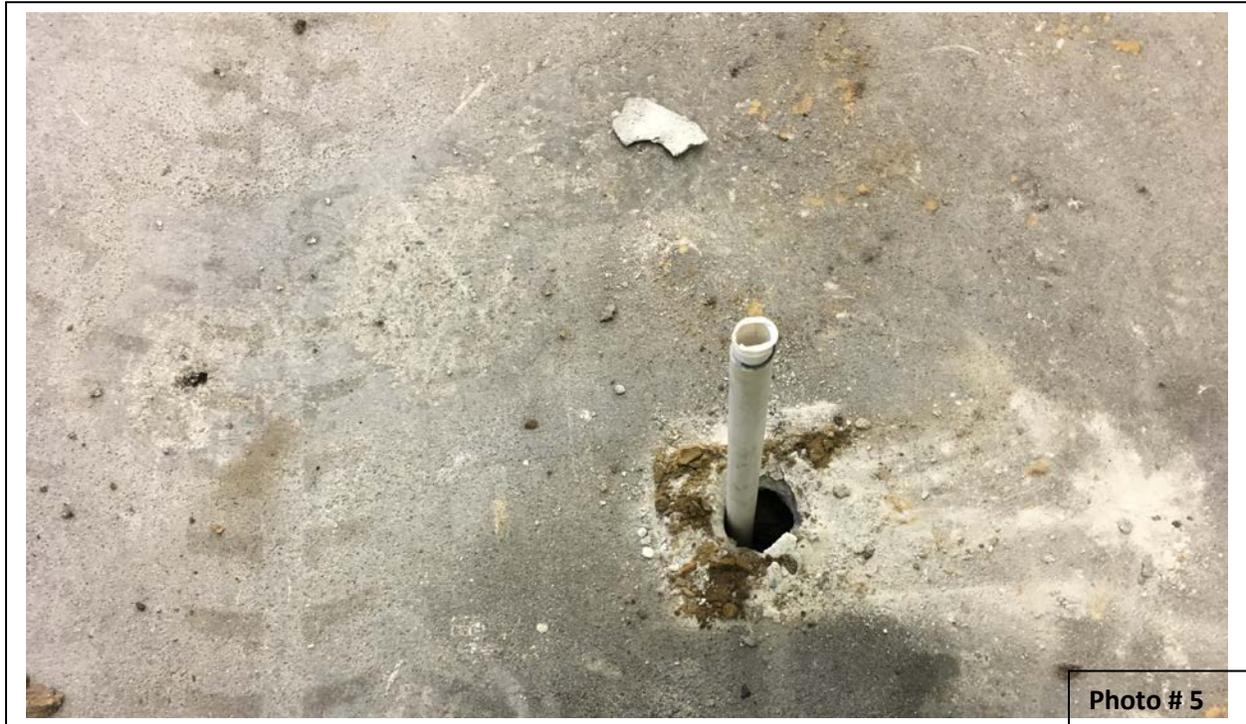
Photo Taken by: Paresh Khatri	Insp. Rtp #:	Date: 11/9/2017
Description: SB-12 location

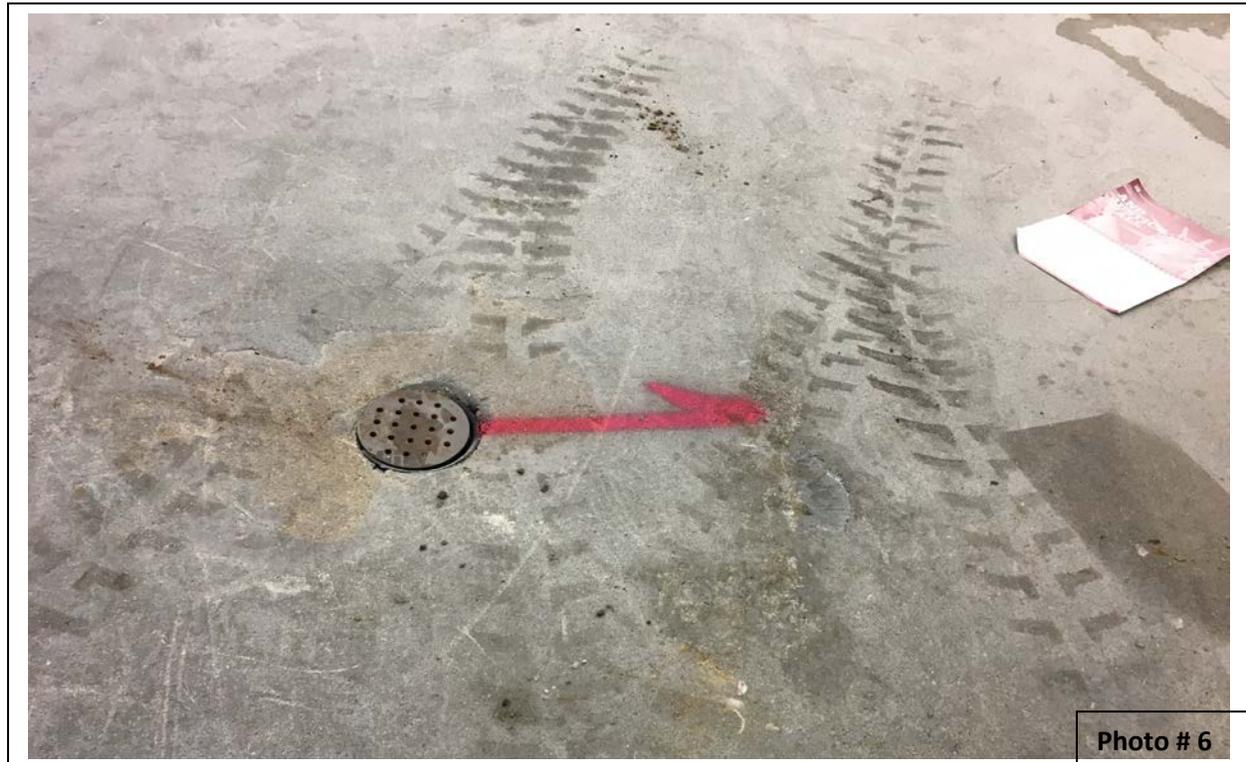
Photo Taken by: Paresh Khatri	Insp. Rtp #:	Date: 11/9/2017
Description: Floor drain which is suspected to connect to sewer line.

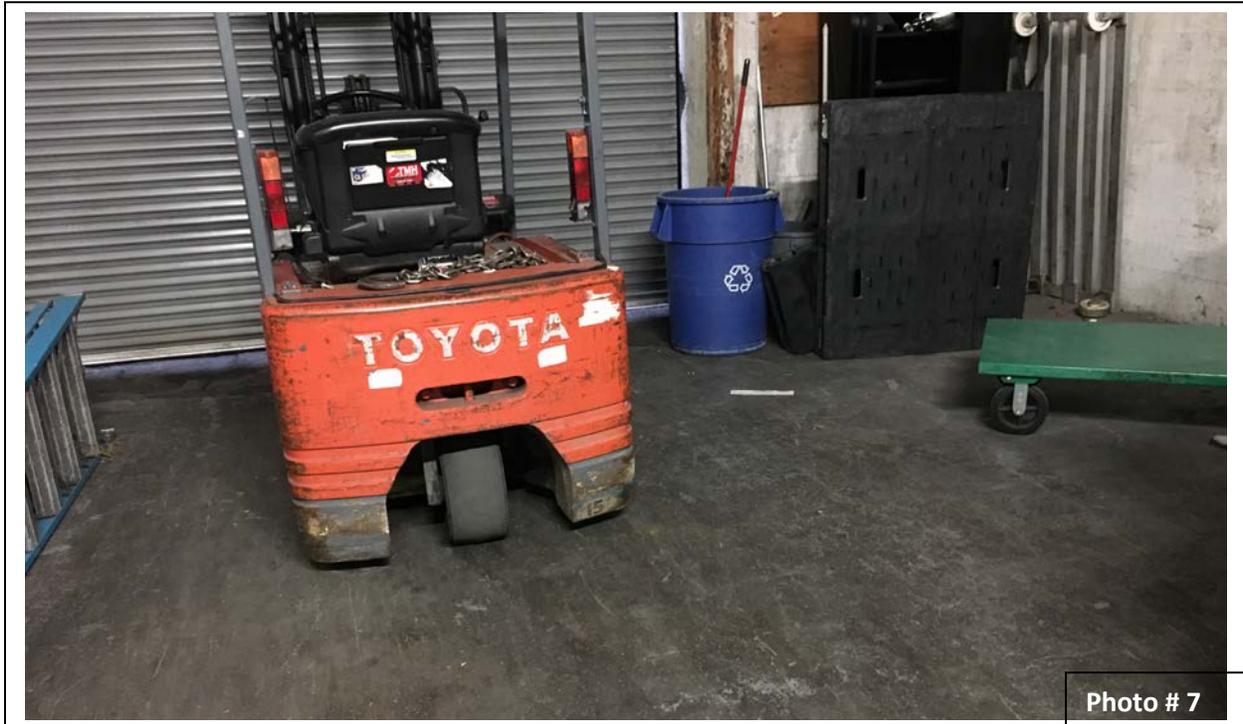
Photo # 7

Photo Taken by: Paresh Khatri	Insp. Rtp #:	Date: 11/9/2017
Description: Loading roll-up door where UST is suspected to be closed-in-place.

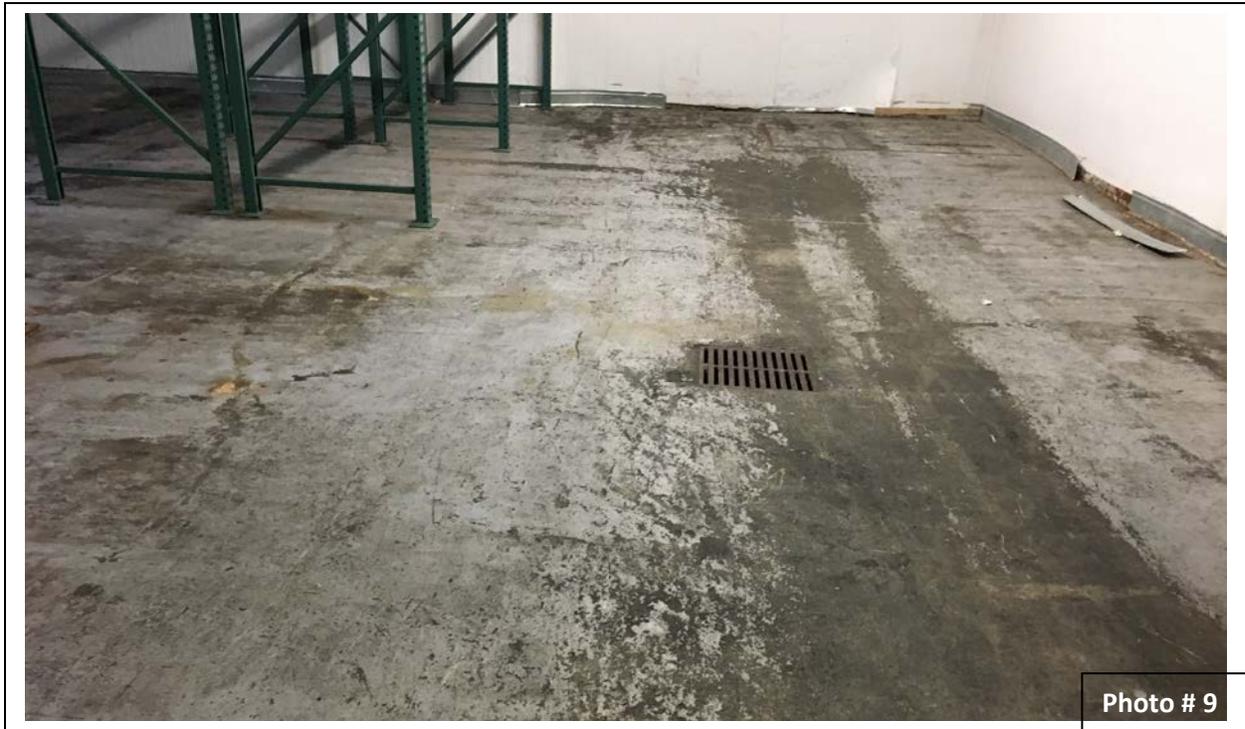
Photo # 9

Photo Taken by: Paresh Khatri	Insp. Rtp #:	Date: 11/9/2017
Description: Floor drains located inside the building.

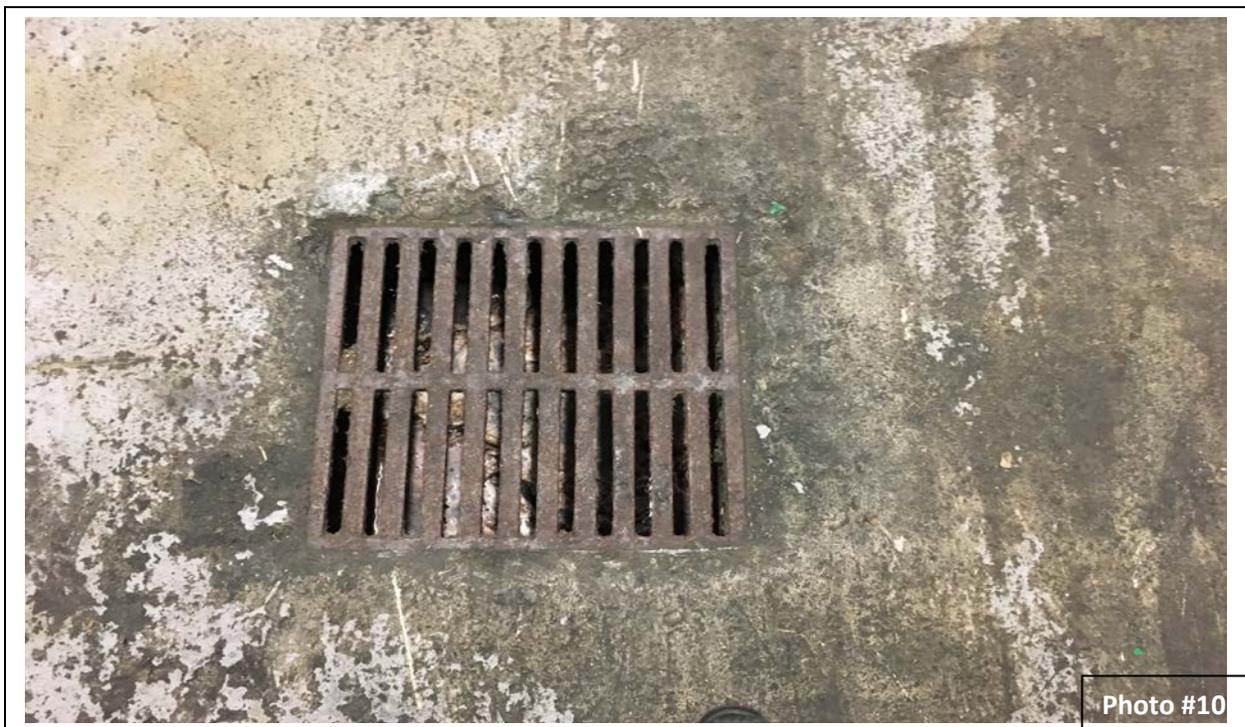
Photo #10

Photo Taken by: Paresh Khatri	Insp. Rtp #:	Date: 11/9/2017
Description: Close of up floor drain; filled with organic debris

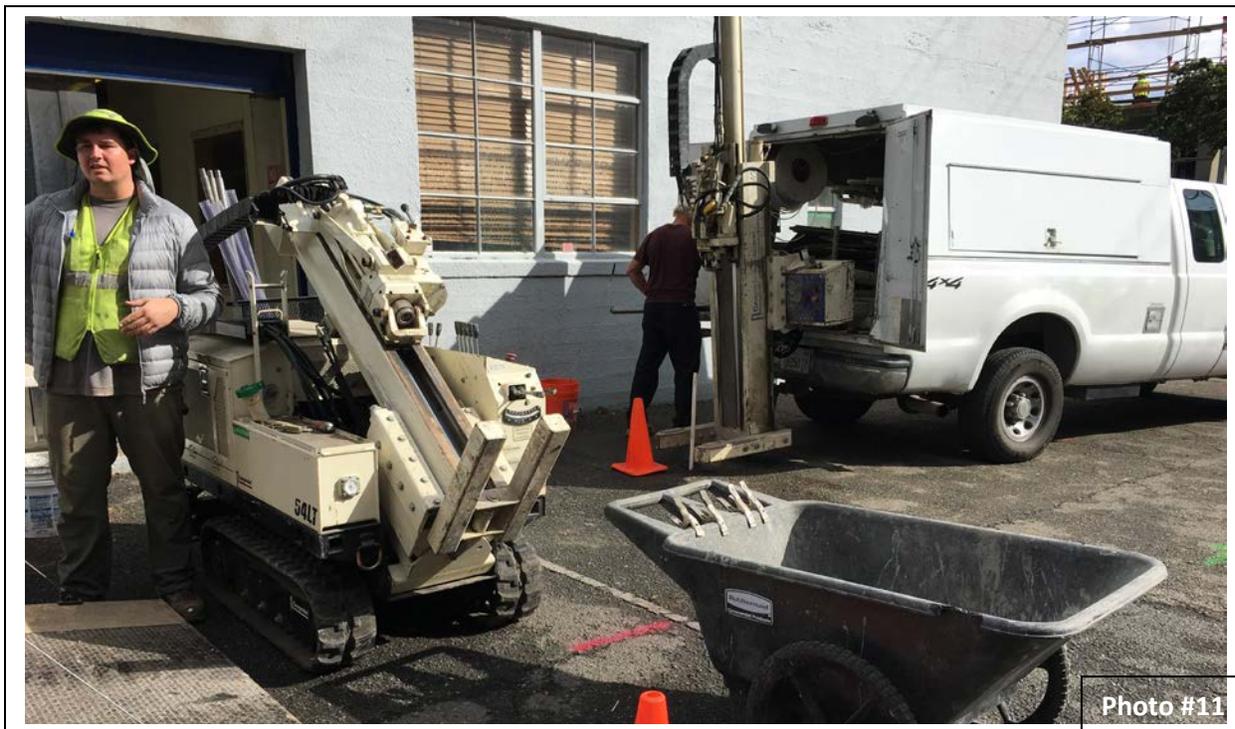
Photo #11

Photo Taken by: Paresh Khatri	Insp. Rtp #:	Date: 11/9/2017
Description: Boring location, where elevated TPH-mo was previously detected

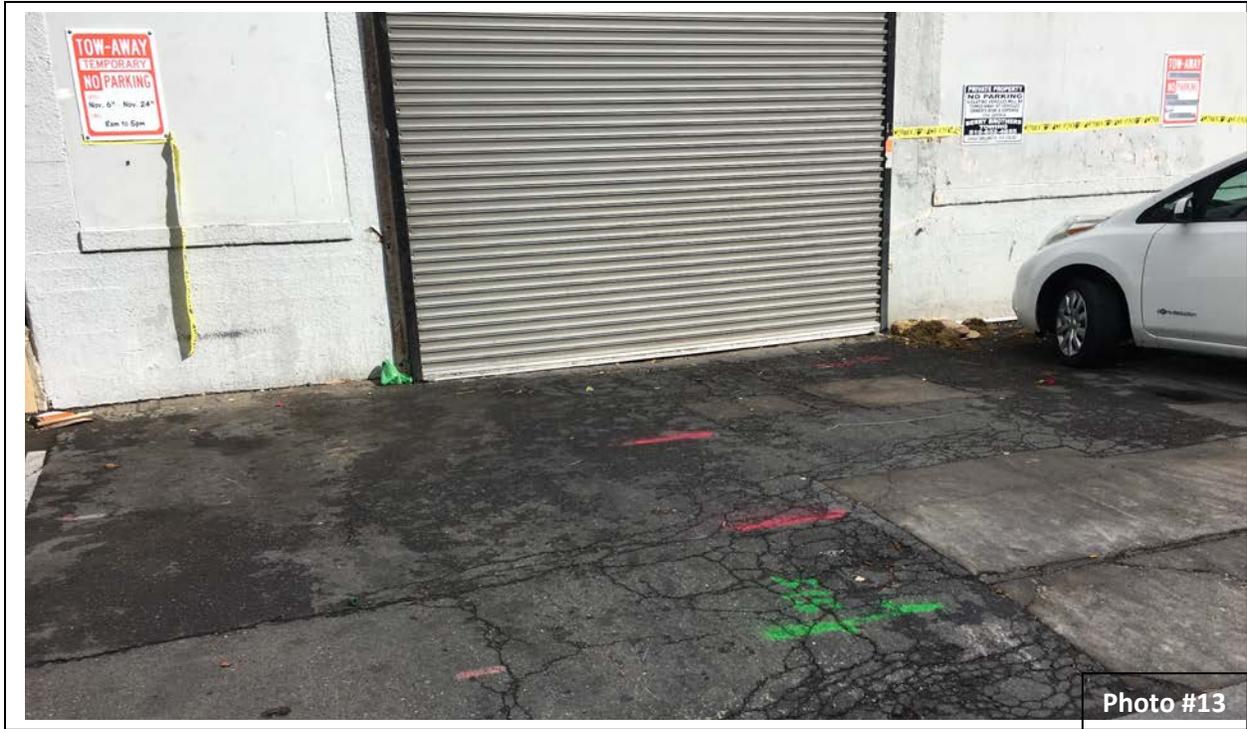
Photo Taken by: Paresh Khatri	Insp. Rtp #:	Date: 11/9/2017
Description: Outside of the building where UST is suspected to be closed-in-place
