## LIMITED PHASE II INVESTIGATION

**229 - 255 INTERNATIONAL BLVD.**

**Oakland, CA 94606**

**Subject: Limited Phase II Site Investigation**  
229-255 International Blvd.  
Oakland, California 94606  
P-1 ES Project #: P5-07-28-17

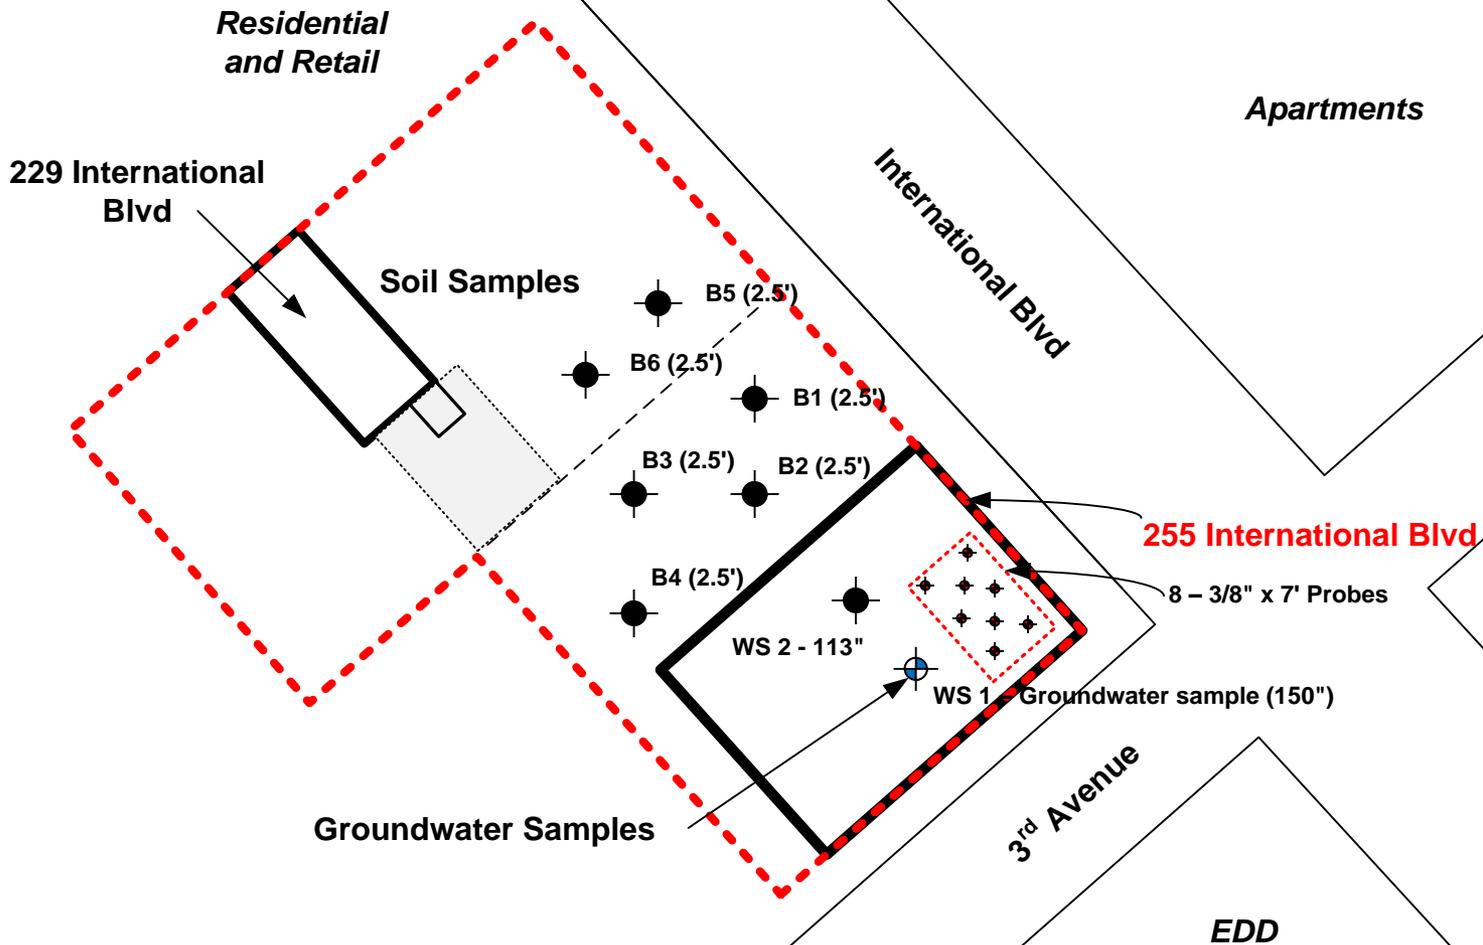
**Figure 2**  
**SITE PLAN**

Under Permit by the Alameda County Department of Public Works (**Appendix C**), Phase-1 ES advanced a total of 8 borings in locations shown on **Figure 2**. Two of the borings were advanced within the 255 International Blvd. building, where the previous gasoline service station existed. One of these borings (WS-1) was advanced to the depth of groundwater, and a sample of the water collected. Depth to groundwater was 150” (12’ 6”). A soil sample from WS-2 (also within the building) was collected at a depth of 113” (9’ 5”). Eight 3/8” steel probes were inserted into the subsurface soils in the areas within the building where previous fuel tanks may have been positioned to help determine if underground tanks still existed on site. The probes were inserted to a depth of 7 ft. below grade surface. None of the probes encountered refusal at any depth where they were inserted – indicating that there were no likely steel underground tanks in areas that were probed.

Using a 4-inch diameter concrete coring machine, Phase-1 ES cored through the concrete slab in the 2 designated areas within the 255 International Blvd. building as shown on **Figure 2**. Asphalt over the remaining 6 outside building borings was broken out to expose the soil beneath it.

Less than 3' Soil Borings

Groundwater Borings

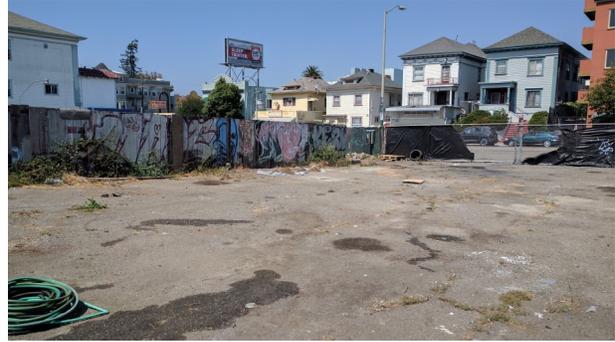
**Northern portion of the 255 International  
lot - Borings B1-B4**

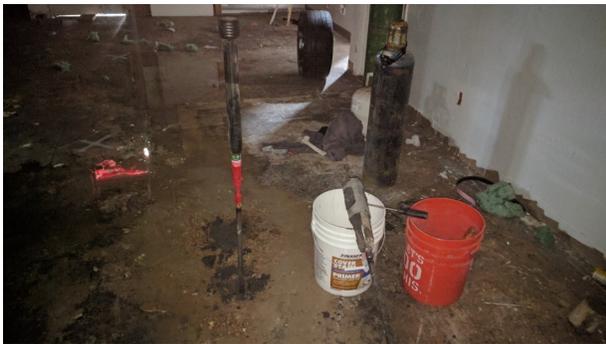
**Water Sample Boring:** Soil from the water sample boring (WS-1) was noted have a degraded petroleum odor and gray colored soil beginning at 18 inches BGS. At 36 inches, the soil was greenish-gray, and at 60 inches BGS the petroleum odor was strong, and soil was gray. This condition continued to the depth of water. To collect the water sample, a new, weighted, 36-inch by 1.6 in. diameter SinkFast bailer was lowered to the bottom of the boring, and a water sample collected. Two glass VOS sample containers and one amber glass 750 ml. bottle were immediately filled, sealed with caps, and immediately placed in the pre-chilled ice chest for transportation to a state-certified analytical testing laboratory.

**View of WS 1  
Interior of 255 International Blvd**

All soil samples were below laboratory detection limits (Non-Detect) for all constituents tested for. The water sample from WS-1 detected 6,800 parts per billion (PPB) of TPH-gasoline in groundwater.

The Maximum Contaminant Level (MCL) for Gasoline in groundwater in the Bay Area is 220 ppb. WS-1 detected 6800 ppb of TPH Gasoline in groundwater. The Odor Nuisance Level for gasoline in non-drinking water is 5000 ppb. The groundwater, however, does not contain the volatile (VOC) Chemicals of Concern (COCs) in gasoline, which are; Benzene, Toluene, Ethylbenzene, and Xylene (BTEX). These VOCs were non-detect (ND) in the groundwater sample, as well as in the soil sample collected from the WS-2 which was 3 ft. above the groundwater, and had significant soils discoloration and petroleum odors noted. The absence of VOCs in both soils and groundwater indicates that these constituents have biologically degraded over the 60+ years since their release into soils and (consequently) groundwater under the site.

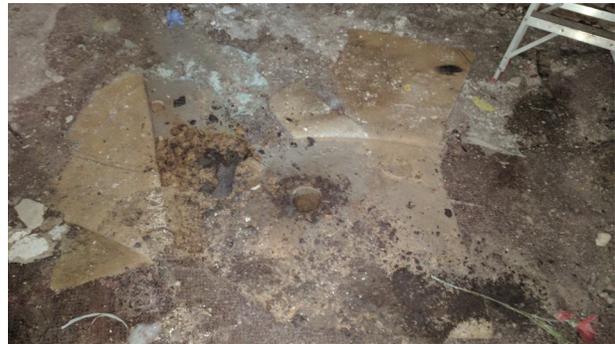
**WS 2  
Interior of 255 International Blvd**

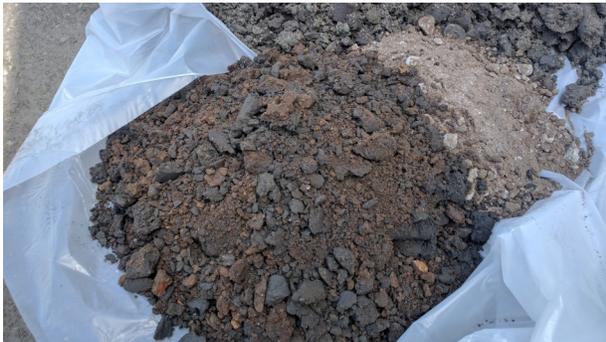
Soil cuttings from each of the borings were placed on plastic 6 mil. Visquine plastic sheeting on site, and wrapped and covered, pending the results of the laboratory analyses.

**View of boring tailings  
At the Northwest portion of the building**

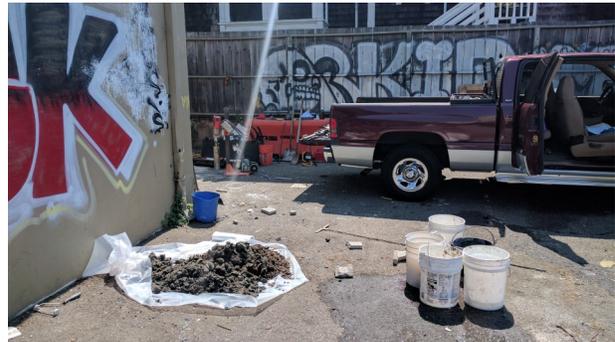
**Another view of the tailings**
