Subject: Indoor Air Survey Sampling Event 2 Letter of Findings Presenting the Impacts from LFC No

RO0000063on the Corder Properties -1475 and 1483 67th Street, Emeryville, California.

Subject: Indoor Air Survey Sampling Event 2 Letter of Findings—1475 and 1483 67th Street,

Emeryville, California.

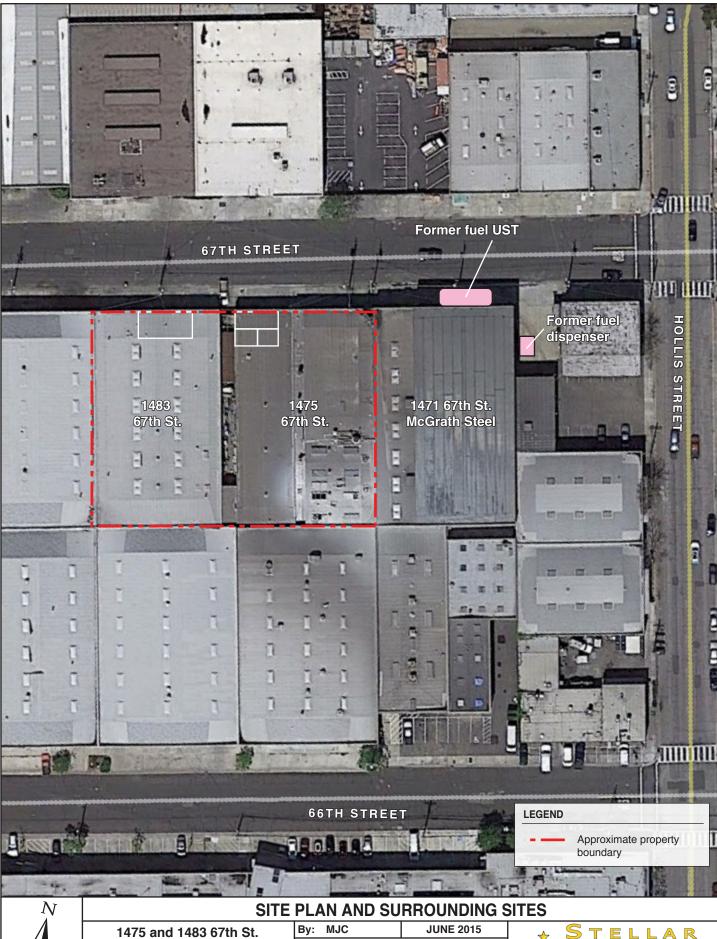
The 1475 67th Street building adjoins directly to the west of the McGrath warehouse and is a 15,000 square foot industrial building constructed in the 1940's. The building is occupied by Metalco, a metal anodizing business. 1483 67th Street adjoins directly to the west of the Metalco building and is a 13,000 square foot industrial structure occupied by Architectural Metal Works, which is a metal working shop for the building industry. Figure 1 presents the general site location. Figure 2 is a site map of the property and surrounding sites.

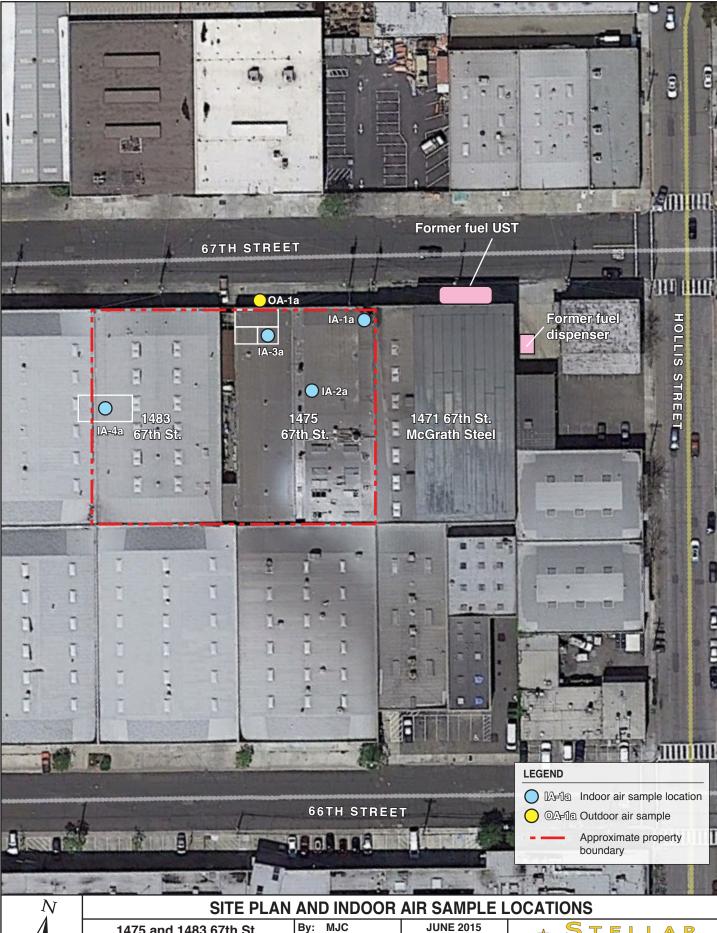
: MJC JUNE 2015 Figure 3

the previous 2014 sample IA-4 that showed the highest hydrocarbon concentrations. Sample IA-4 was in a small office while IA-4a is located further inside the open warehouse space architecture of the building and serves as a better indicator of the extent of the vapor intrusion. from the McGrath Steel facility hydrocarbon plume. Figure 3 depicts the sample locations.

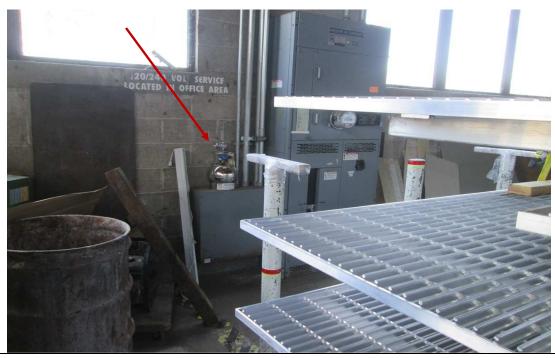
Photographer: H. Pietropaoli Photo No.: 01

Subject: Indoor air sampling location (IA-1a) in NE corner 1475 67th Street

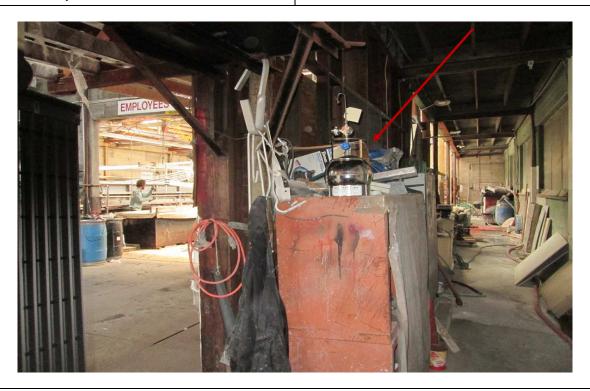
Photographer: H. Pietropaoli Photo No.: 02

Subject: Indoor ambient air sampling location (IA-2a) near 1475 67th Street building center

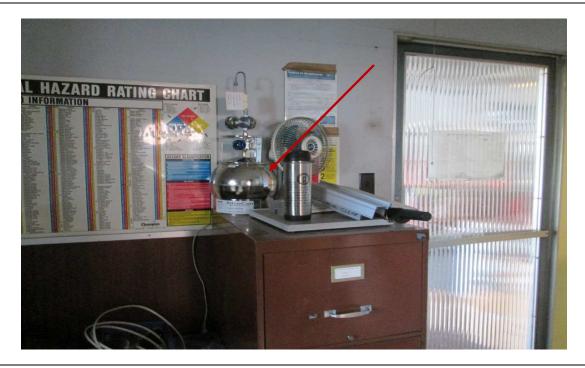
Photographer: H. Pietropaoli Photo No.: 03

Subject: Indoor air sampling location (IA-3a) in 1475 67th Street sales office near 67th Street.

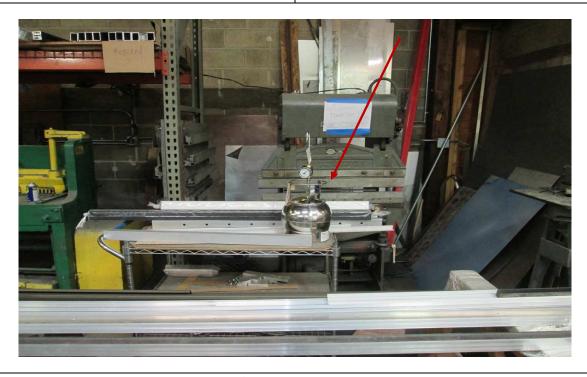
Photographer: H. Pietropaoli Photo No.: 04

The indoor air sample with the highest concentrations of the constituents analyzed for was sample IA-4a located by the west wall of the shop of 1483 67th Street. The November 2104 results showed the highest results in this same building but in the front office. Sample IA-3 located in the office area of 1475 67th Street contained the lowest range of concentrations.

Subject: Indoor air sampling location (IA-4a) in 1483 67th Street by the west wall.

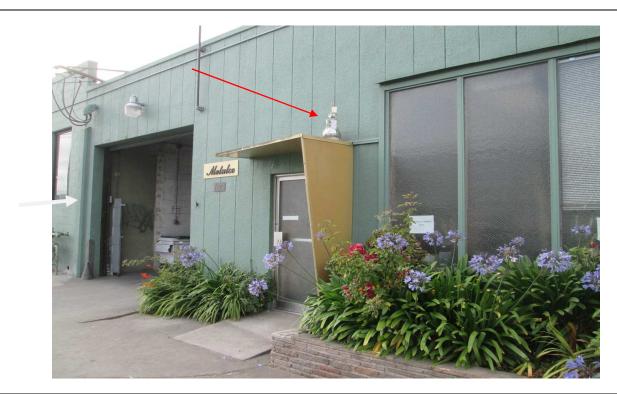
Photo No.: 05

The outdoor control sample OA-1 contained 0.7 $\mu g/m^3$ benzene. All four of the indoor air samples exceeded the 100 $\mu g/m^3$ commercial ESL for TPH as gasoline with concentrations ranging from 190 $\mu g/m^3$ to 320 $\mu g/m^3$. The outdoor sample contained 100 $\mu g/m^3$ TPHg. One sample (IA-4a) exceeded the naphthalene ESL of 0.36 $\mu g/m^3$ at a concentration of 0.52 $\mu g/m^3$, with the outdoor control sample containing 0.21 $\mu g/m^3$ naphthalene. Detections of toluene, ethylbenzene and xylenes did not exceed their respective ESLs in any of the samples.

Subject: Outdoor air sampling location (OA-1a) above front door at 1475 67th Street
