**NOTICE OF VIOLATION**

Subject: Notice to Violation; Fuel Leak Case No. RO0000063; (Global ID # T0600102099); McGrath Steel Company, 6655 Hollis Street, Emeryville, CA 94608

Subject: Indoor Air Survey Sampling Event 2 Letter of Findings—1475 and 1483 67<sup>th</sup> Street,  
Emeryville, California.

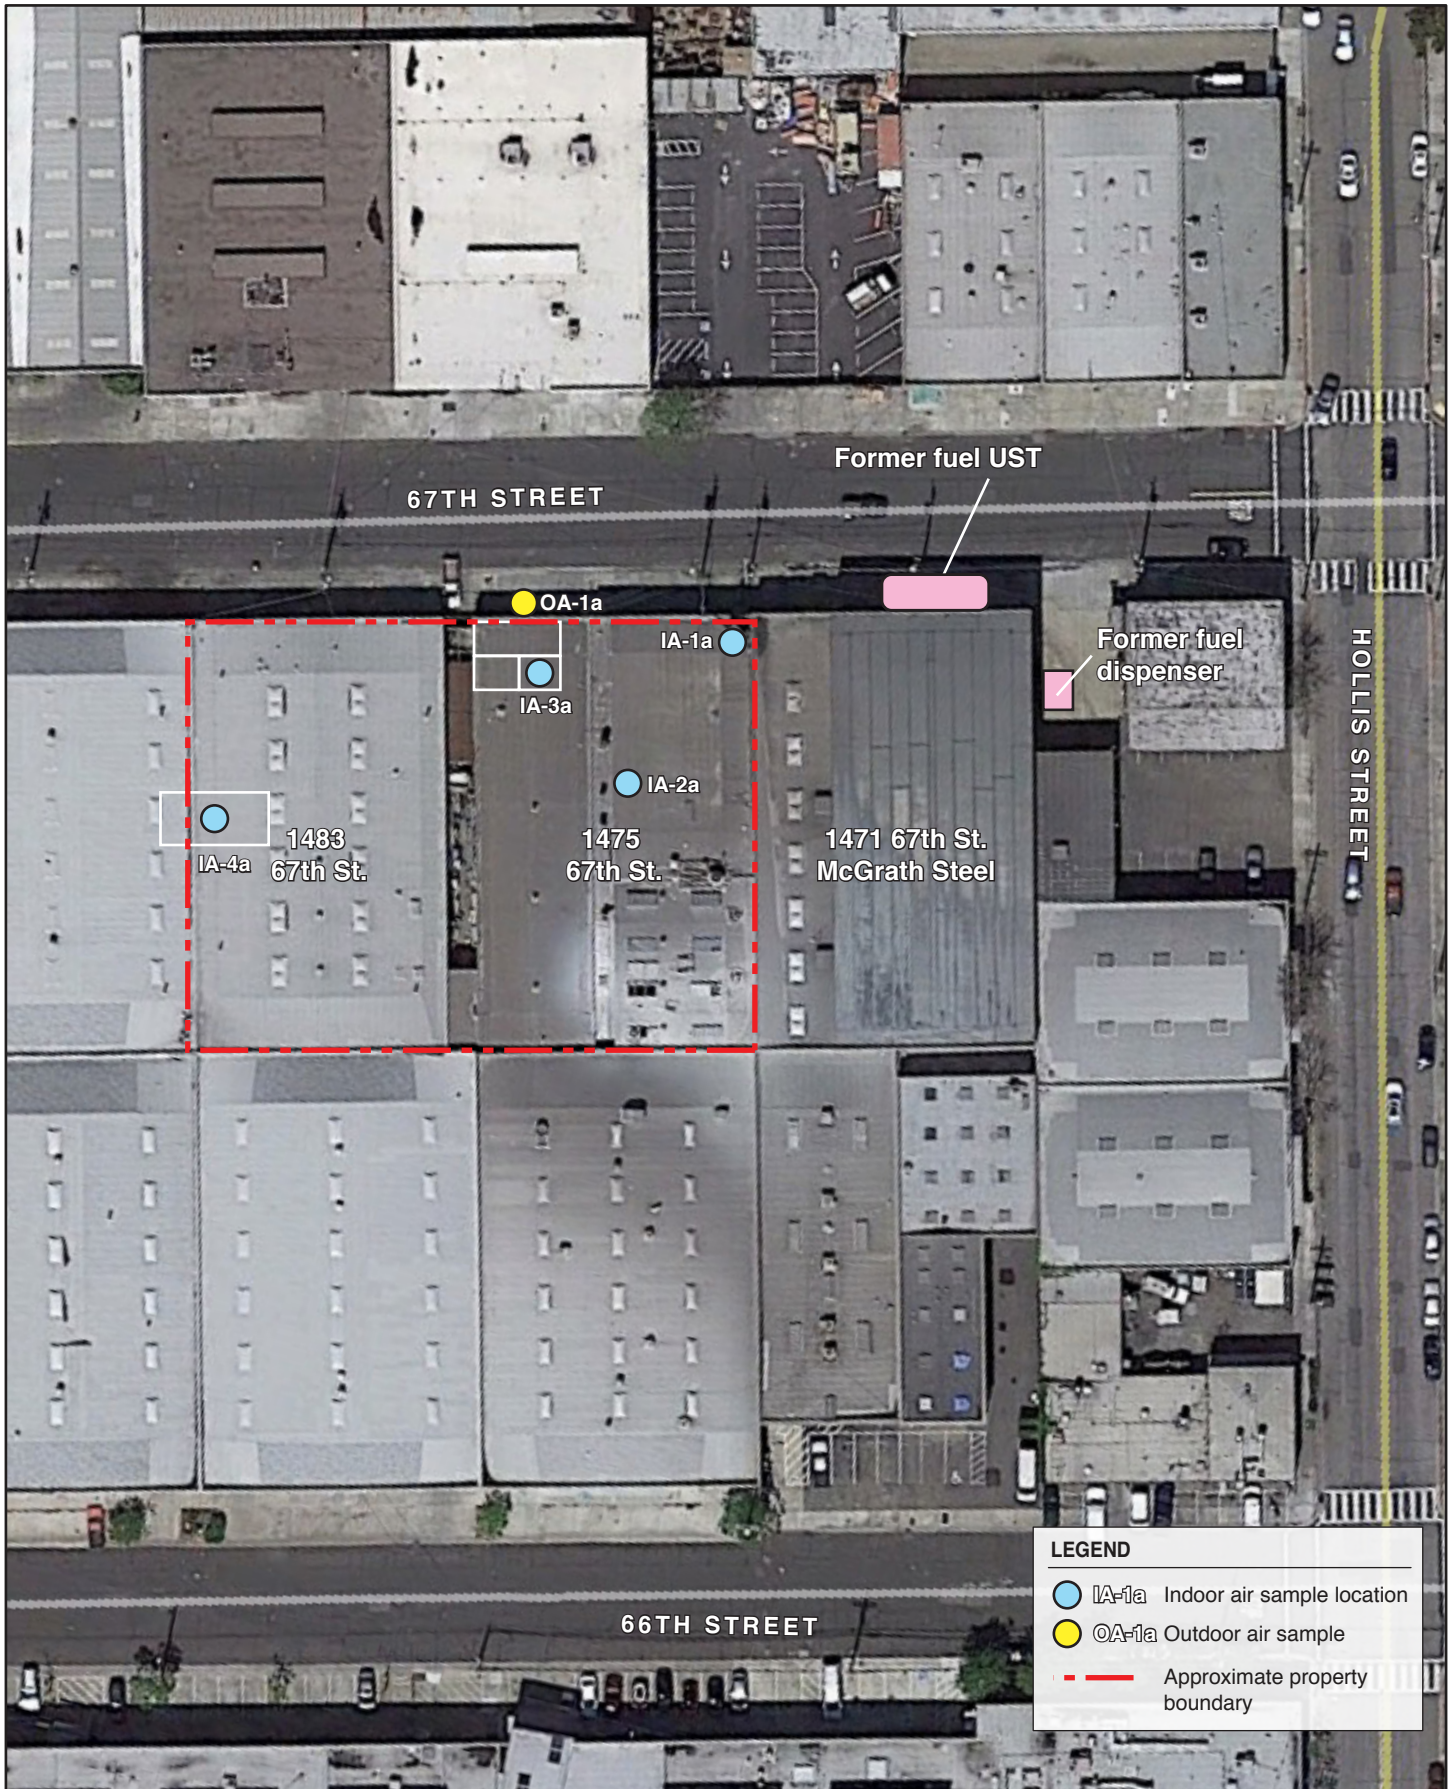
**Figure 3**

**SITE PLAN AND INDOOR AIR SAMPLE LOCATIONS**

1475 and 1483 67th St.  
Emeryville, CA

the previous 2014 sample IA-4 that showed the highest hydrocarbon concentrations. Sample IA-4 was in a small office while IA-4a is located further inside the open warehouse space architecture of the building and serves as a better indicator of the extent of the vapor intrusion from the McGrath Steel facility hydrocarbon plume. Figure 3 depicts the sample locations.

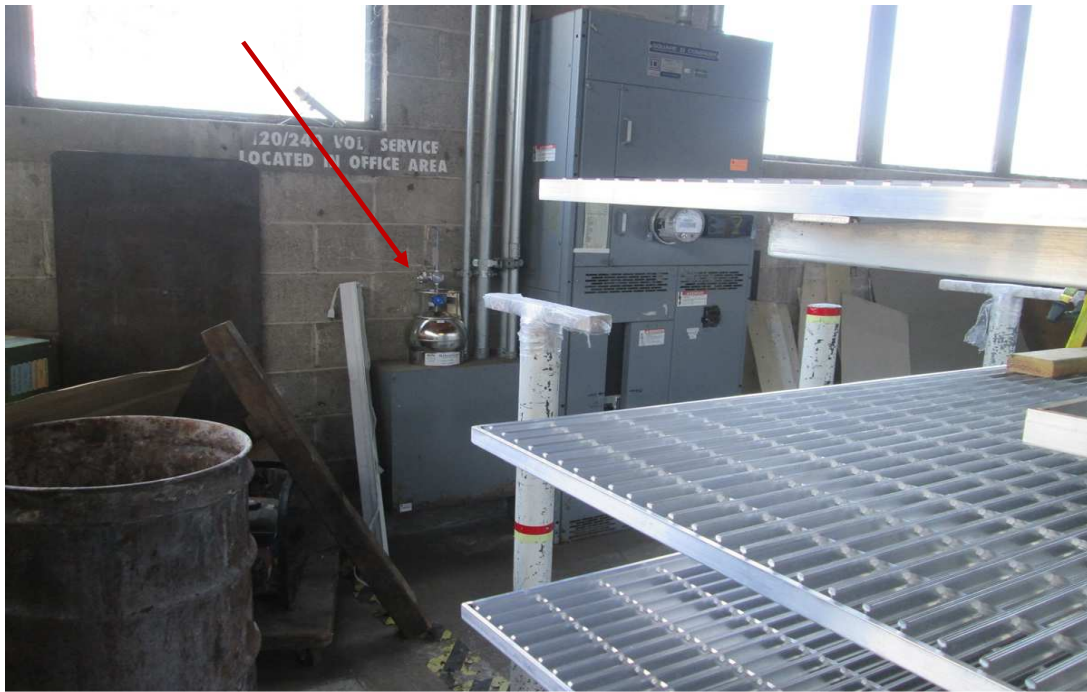
Photo No.: 01

Subject: Indoor air sampling location (IA-1a) in NE corner 1475 67<sup>th</sup> Street

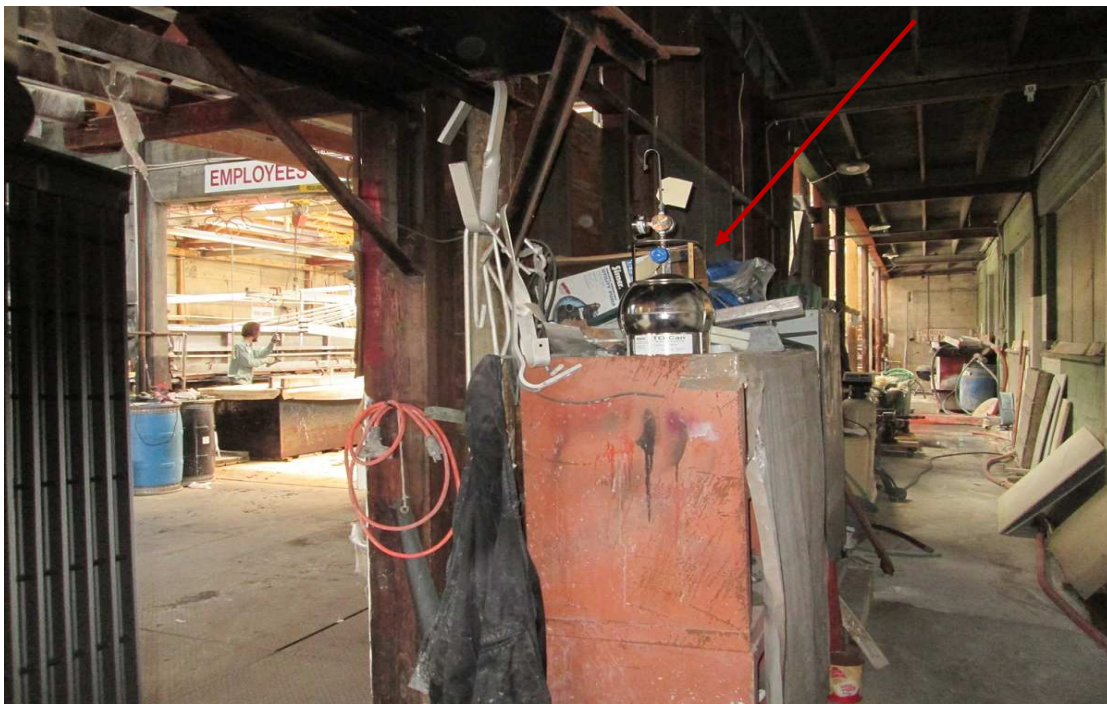
Photo No.: 02

Subject: Indoor ambient air sampling location (IA-2a) near 1475 67<sup>th</sup> Street building center

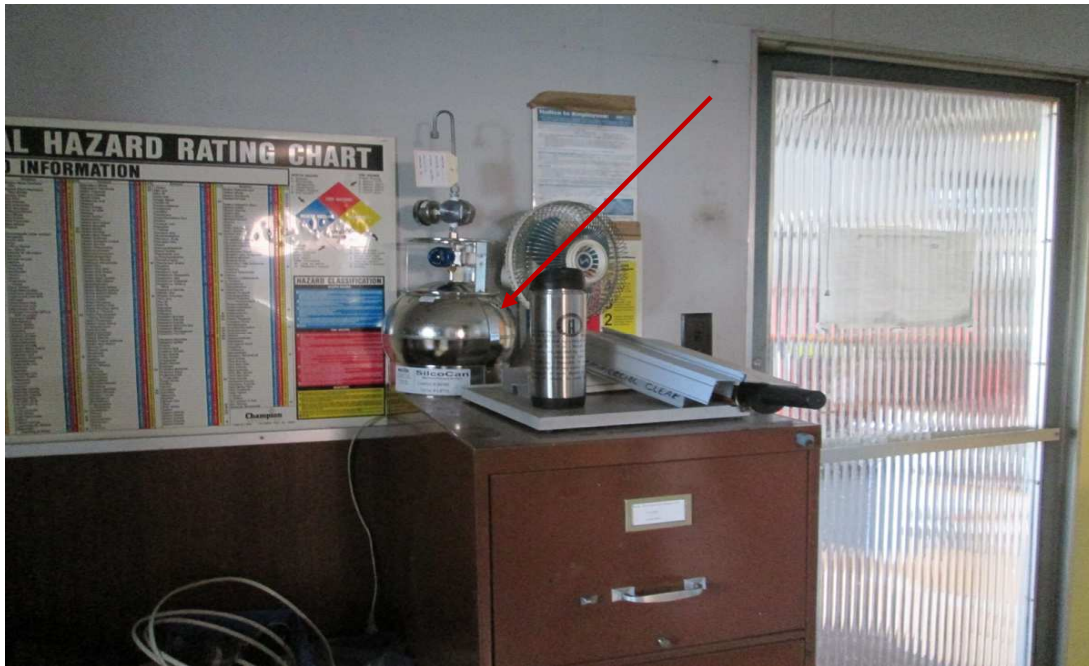
Photo No.: 03

Subject: Indoor air sampling location (IA-3a) in 1475 67<sup>th</sup> Street sales office near 67<sup>th</sup> Street.

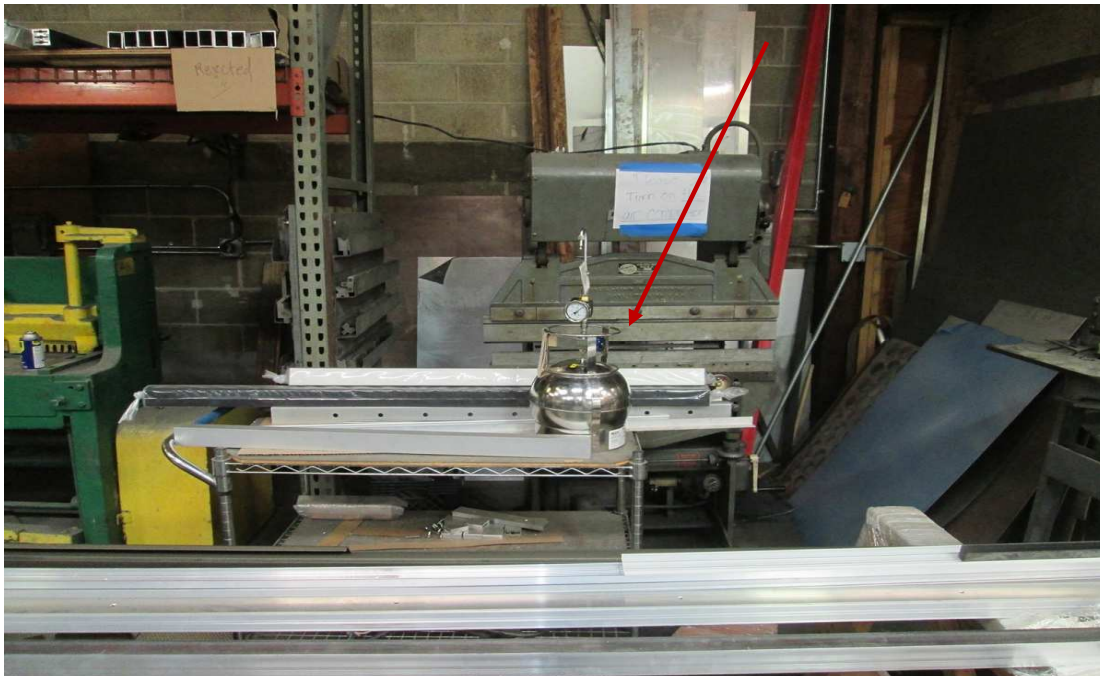
Photo No.: 04

Subject: Indoor air sampling location (IA-4a) in 1483 67<sup>th</sup> Street by the west wall.

The indoor air sample with the highest concentrations of the constituents analyzed for was sample IA-4a located by the west wall of the shop of 1483 67<sup>th</sup> Street. The November 2104 results showed the highest results in this same building but in the front office. Sample IA-3 located in the office area of 1475 67<sup>th</sup> Street contained the lowest range of concentrations.

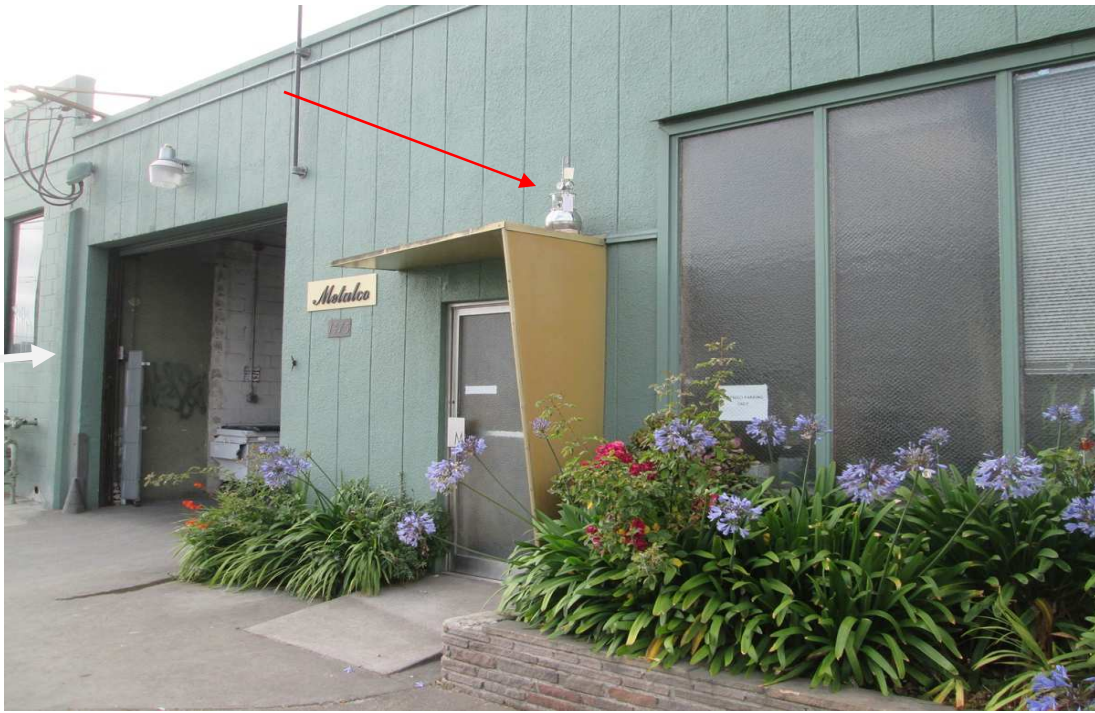
Subject: Outdoor air sampling location (OA-1a) above front door at 1475 67<sup>th</sup> Street

The outdoor control sample OA-1 contained 0.7  $\mu\text{g}/\text{m}^3$  benzene. All four of the indoor air samples exceeded the 100  $\mu\text{g}/\text{m}^3$  commercial ESL for TPH as gasoline with concentrations ranging from 190 $\mu\text{g}/\text{m}^3$  to 320  $\mu\text{g}/\text{m}^3$ . The outdoor sample contained 100  $\mu\text{g}/\text{m}^3$  TPHg. One sample (IA-4a) exceeded the naphthalene ESL of 0.36  $\mu\text{g}/\text{m}^3$  at a concentration of 0.52  $\mu\text{g}/\text{m}^3$ , with the outdoor control sample containing 0.21  $\mu\text{g}/\text{m}^3$  naphthalene. Detections of toluene, ethylbenzene and xylenes did not exceed their respective ESLs in any of the samples.
