**FEASIBILITY STUDY AND
CORRECTIVE ACTION PLAN**
OAKLAND BUS TERMINAL
2103 SAN PABLO AVENUE
OAKLAND, CALIFORNIA 94608

Green Star Environmental Report No. 15-1379

FirstGroup America, Inc.
600 Vine Street, Suite 1400
Cincinnati, OH 45202

October 9, 2015

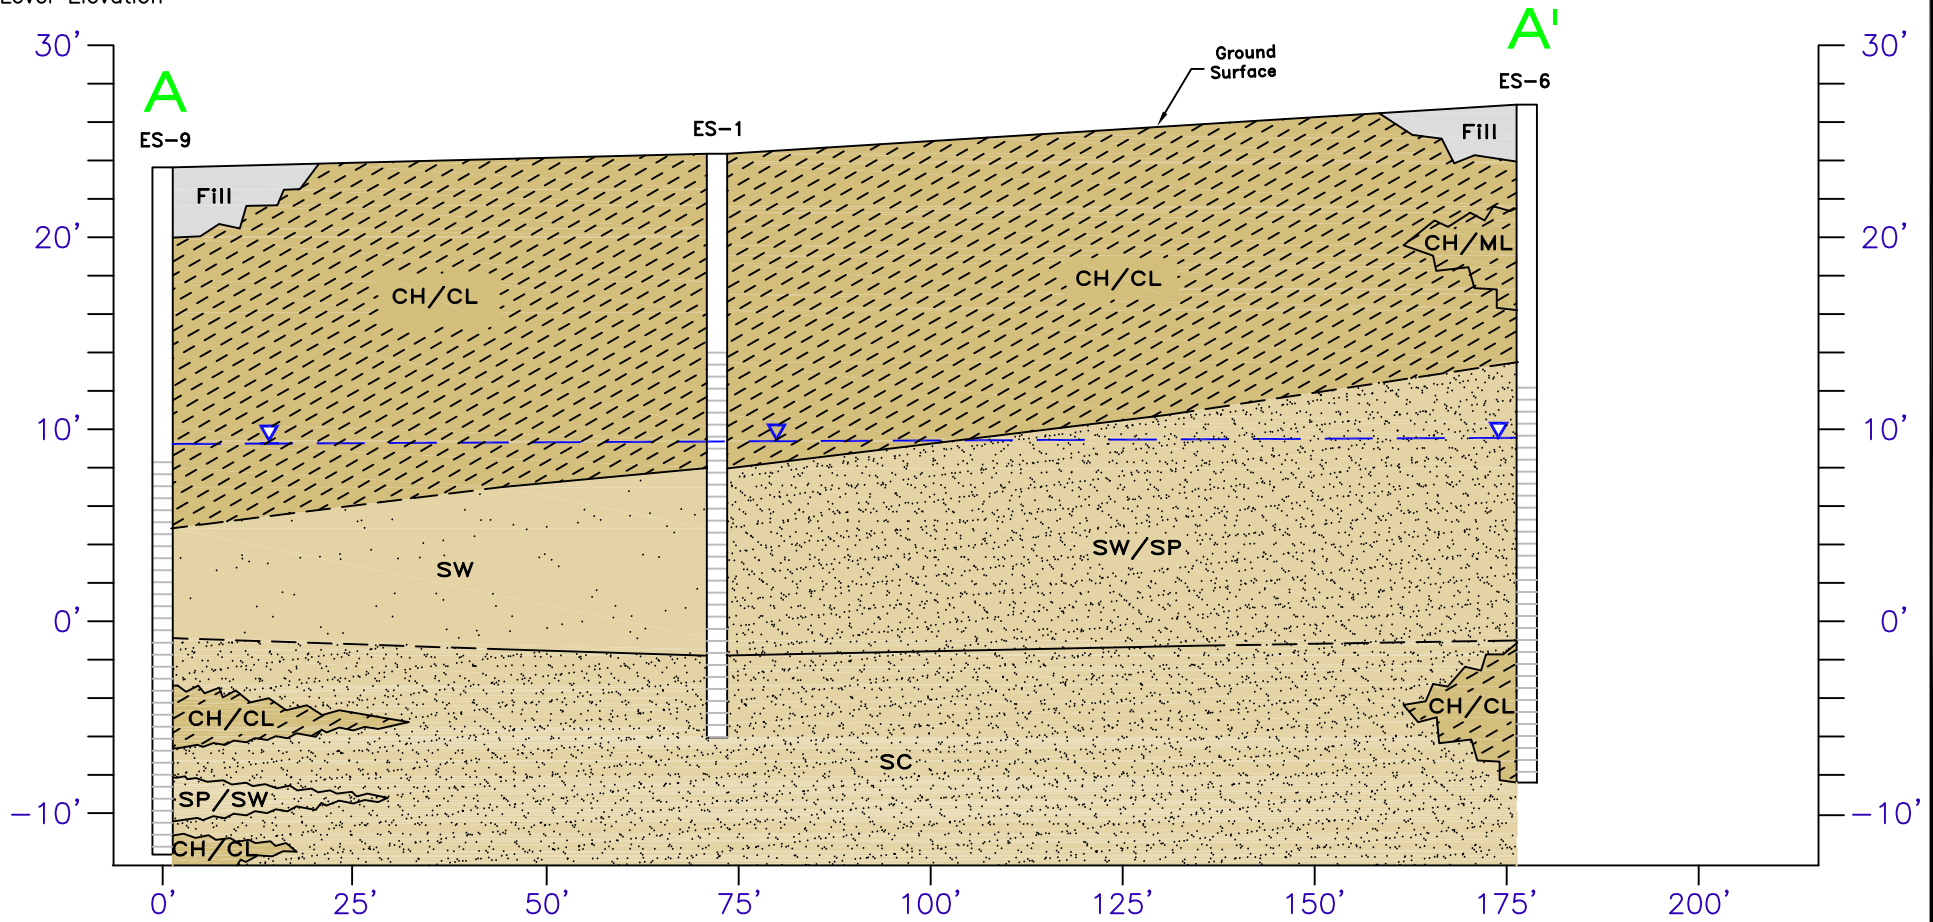
LEGEND	
CH	High Plasticity Clays
CL	Low Plasticity Clays
ML	Clayey Silt
SC	Clayey Sand
SP	Poorly-Graded Sands
SW	Well-Graded Sands
	Groundwater Table

Petroleum impacts in soils at the site are generally confined to the former tankpit and are observed at depths of approximately 10 feet bgs down to the groundwater table at approximately 16-17 feet bgs. Soils in the shallow subsurface across the Site, at depths ranging from the surface to approximately 17 feet bgs are primarily comprised of fill material within the former tankpit which

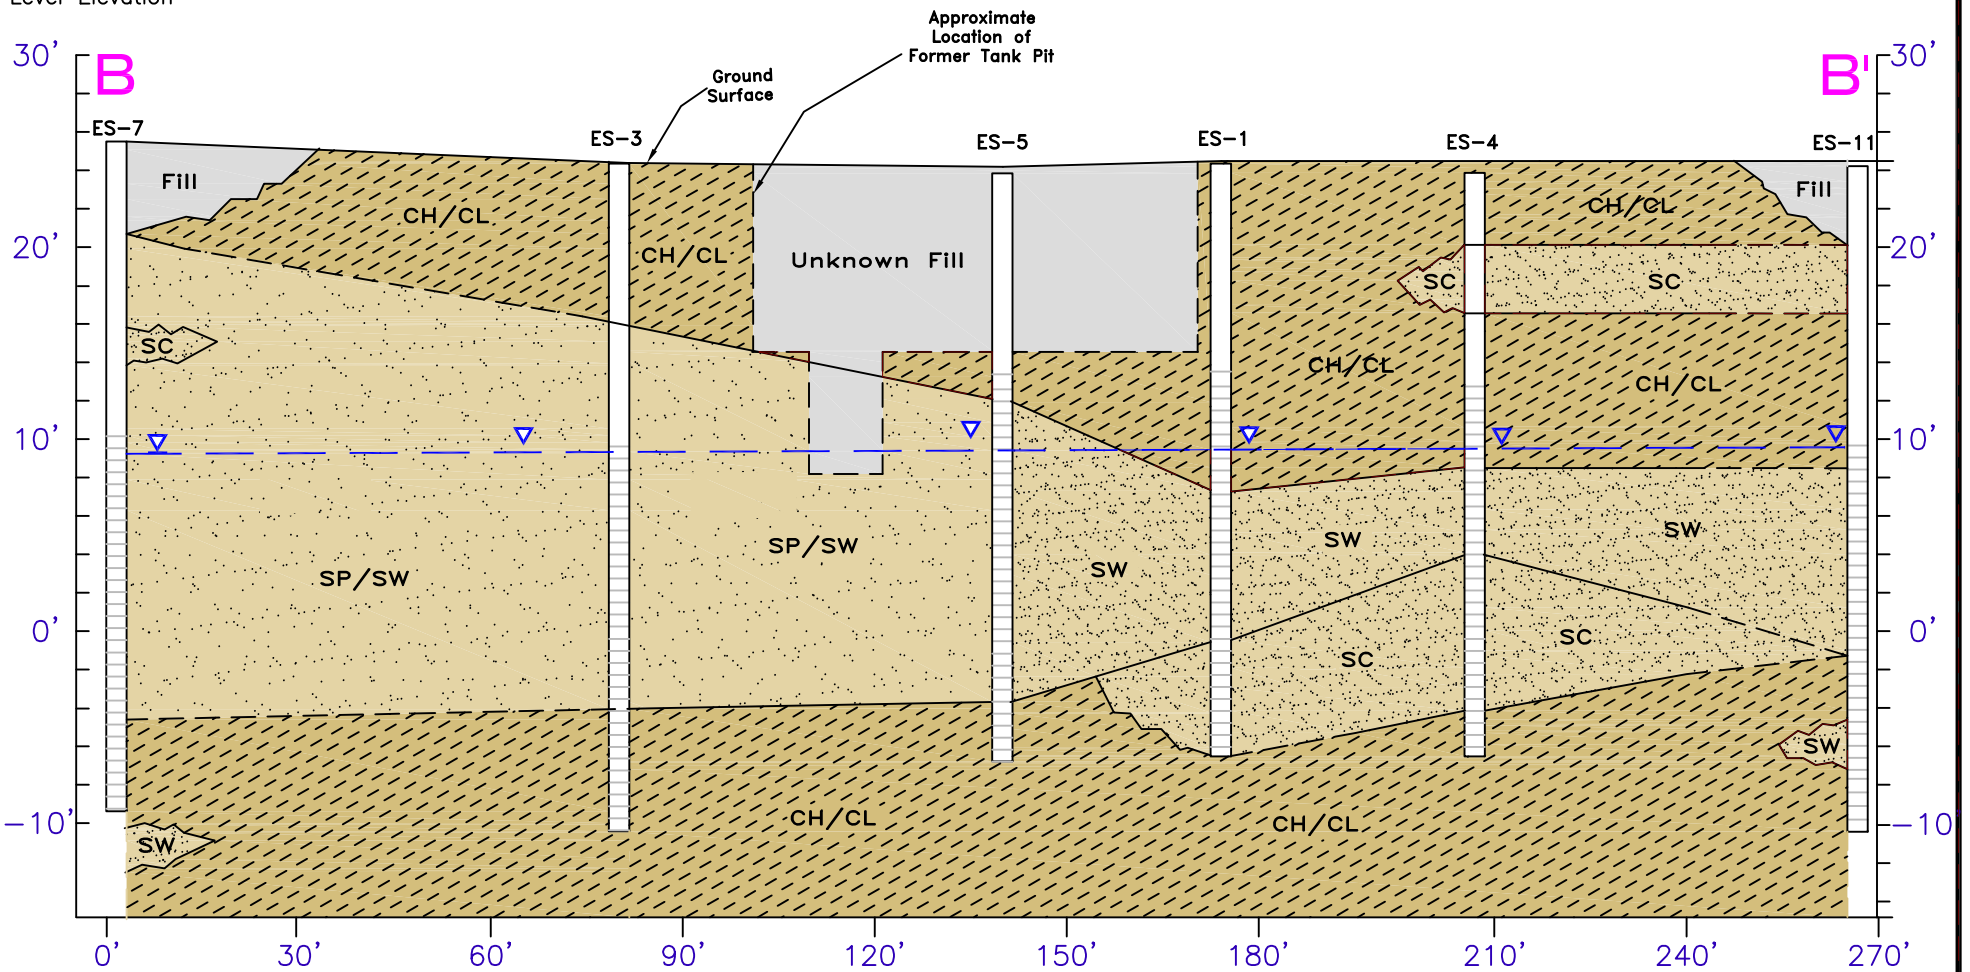
LEGEND	
CH	High Plasticity Clays
CL	Low Plasticity Clays
ML	Clayey Silt
SC	Clayey Sand
SP	Poorly-Graded Sands
SW	Well-Graded Sands
	Groundwater Table
