SUBJECT: Report of the source area primary pathway investigation at *Keep on Trucking*, 370 8th Avenue, Oakland, CA 94606

Report of the Source Area

Primary Pathway Investigation at Keep on Trucking 370 8th Avenue, Oakland, California

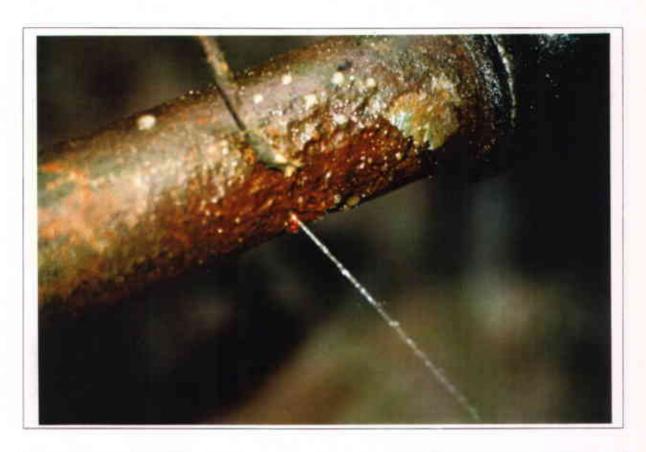
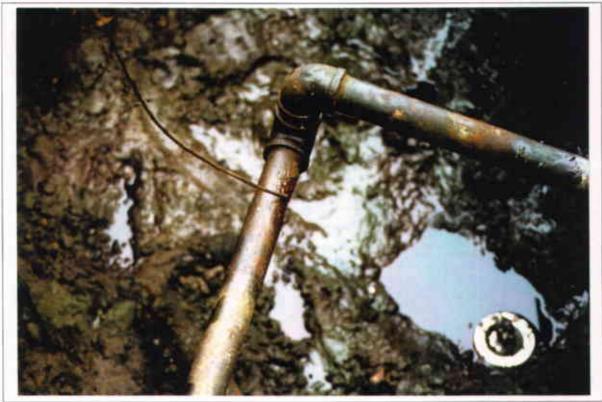
Figure 2: Photographs of Leak in Exposed Underground Dispenser Line

Two pipes were observed going into the ground at the source location. One was the 2-inch diameter fuel line for the dispenser which ran 1 to 2 feet underground for a distance of approximately 10 feet. A pinhole leak was observed midway between the fuel line's entry into the ground and the dispenser. No other leaks were observed.

Fuel line pressure tests conducted with water produced a steady stream emanating from a pinhole leak approximately four feet from the wall of the building which houses the aboveground storage tanks. The pinhole leak was verified as the only contamination source through volume/rate calculations performed by U&A personnel. A pressure gauge was attached to the garden hose, and a steady pressure of two to four pounds per square inch was maintained on the pipe. At this pressure, three gallons of fluid were collected in an hour from the leak. This would allow approximately 72 gallons to be released per day.

Approximately 100 gallons per day of diesel were collected from the storm drain during the search for the source of the release. This amount corresponds within a reasonable margin of error to the amount collected from the single pinhole leak found in the fuel line. This information, coupled with the presence of the red dye, identified the leak as the sole source of diesel release.

The source area primary pathway investigation verified the leak in the underground piping of the fuel dispensing system at KOT. The soils surrounding the underground piping were saturated with red dye and diesel. Volume/rate calculations verified that enough diesel could have escaped the fuel dispensing system from this one hole to match the volume of diesel accumulated during the clean-up activities. These calculations characterized the pinhole leak as the sole source of diesel release.

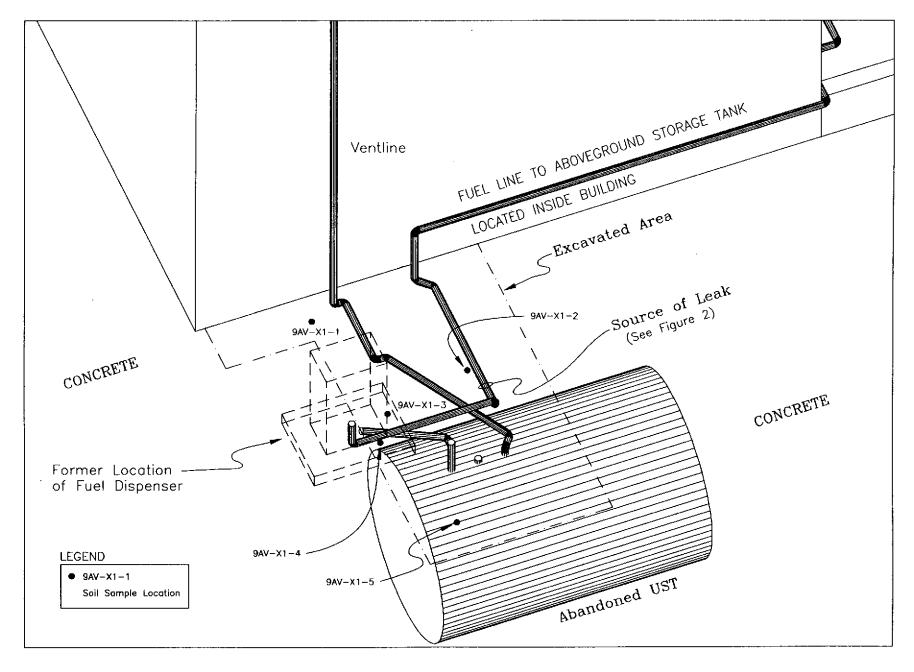
Figure 3: Extent of Excavation and Sample Locations

Five soil samples were collected from the excavation on February 12, 199\$ (Figure 3). In addition, two liquid samples were collected from the contents of the tank. One of the liquid sample containers broke during transportation to the laboratory. The other sample was analyzed and determined to be pure diesel. Table 1 summarizes the

On February 12, 1993, the underground fuel lines connected to the dispenser were excavated. The excavation was designed not to remove all contamination, but rather to keep the piping in place and characterize the source area. Vickers Concrete cutters cut the 9-inch thick reinforced concrete apron into removable 4-foot by 4-foot sections. Bay Area Tank and Marine personnel used a hand-held jackhammer to remove the first section of concrete and a backhoe for the subsequent sections. The soils were excavated with shovels as directed by on-site U&A personnel. The dispenser and surrounding chain-link fence were removed by Bay Area Tank and Marine personnel to gain access to the targeted area. Excavated soils were placed on visquine adjacent to the pit and covered at the end of the day. The pit was also covered at the end of the day with wooden boards, trench plates, and visquine anchored with sand bags.

Visibly contaminated soils were observed from directly beneath the concrete apron to the bottom of the excavation. Soil sample 9AV-X1-4 taken from the sand and clay directly beneath the dispenser contained the highest levels of diesel (130,000 mg/kg) and BTEX (85 mg/kg p,m-xylenes) found in the soil. The contents of the UST were analyzed as 1,000,000 mg/kg diesel (i.e., pure diesel). Complete sample results are contained in Table 1. Sample locations are shown in Figure 2 and described in Table 2. Groundwater samples were not collected during this phase of the investigation.

A layer of brown gravelly fill was observed beneath the concrete apron to approximately 2 to 2.5 feet deep. This layer was underlain by a greenish-gray clay continuing to the base of the excavation. Sand was observed surrounding the pipe fittings beneath the dispenser. As part of the search for the source of the diesel release, a red dye was placed in the underground piping. The exposed sand was stained red from this dye testing. Much of the excavated soil excluding the relatively impermeable clay was stained red from the dye test and had a heavy hydrocarbon smell.
