Re: Alaska Gas Service Station, 6211 San Pablo Avenue, Oakland, California (Fuel Leak Case No. RO0000127)

Re: Groundwater Monitoring and Sampling Results Report, Third Quarter 2016
Alaska Gas Service Station
6211 San Pablo Avenue, Oakland, California
Fuel Leak Case No. RO0000127

ALASKA GAS SERVICE STATION GROUNDWATER MONITORING AND SAMPLING RESULTS REPORT

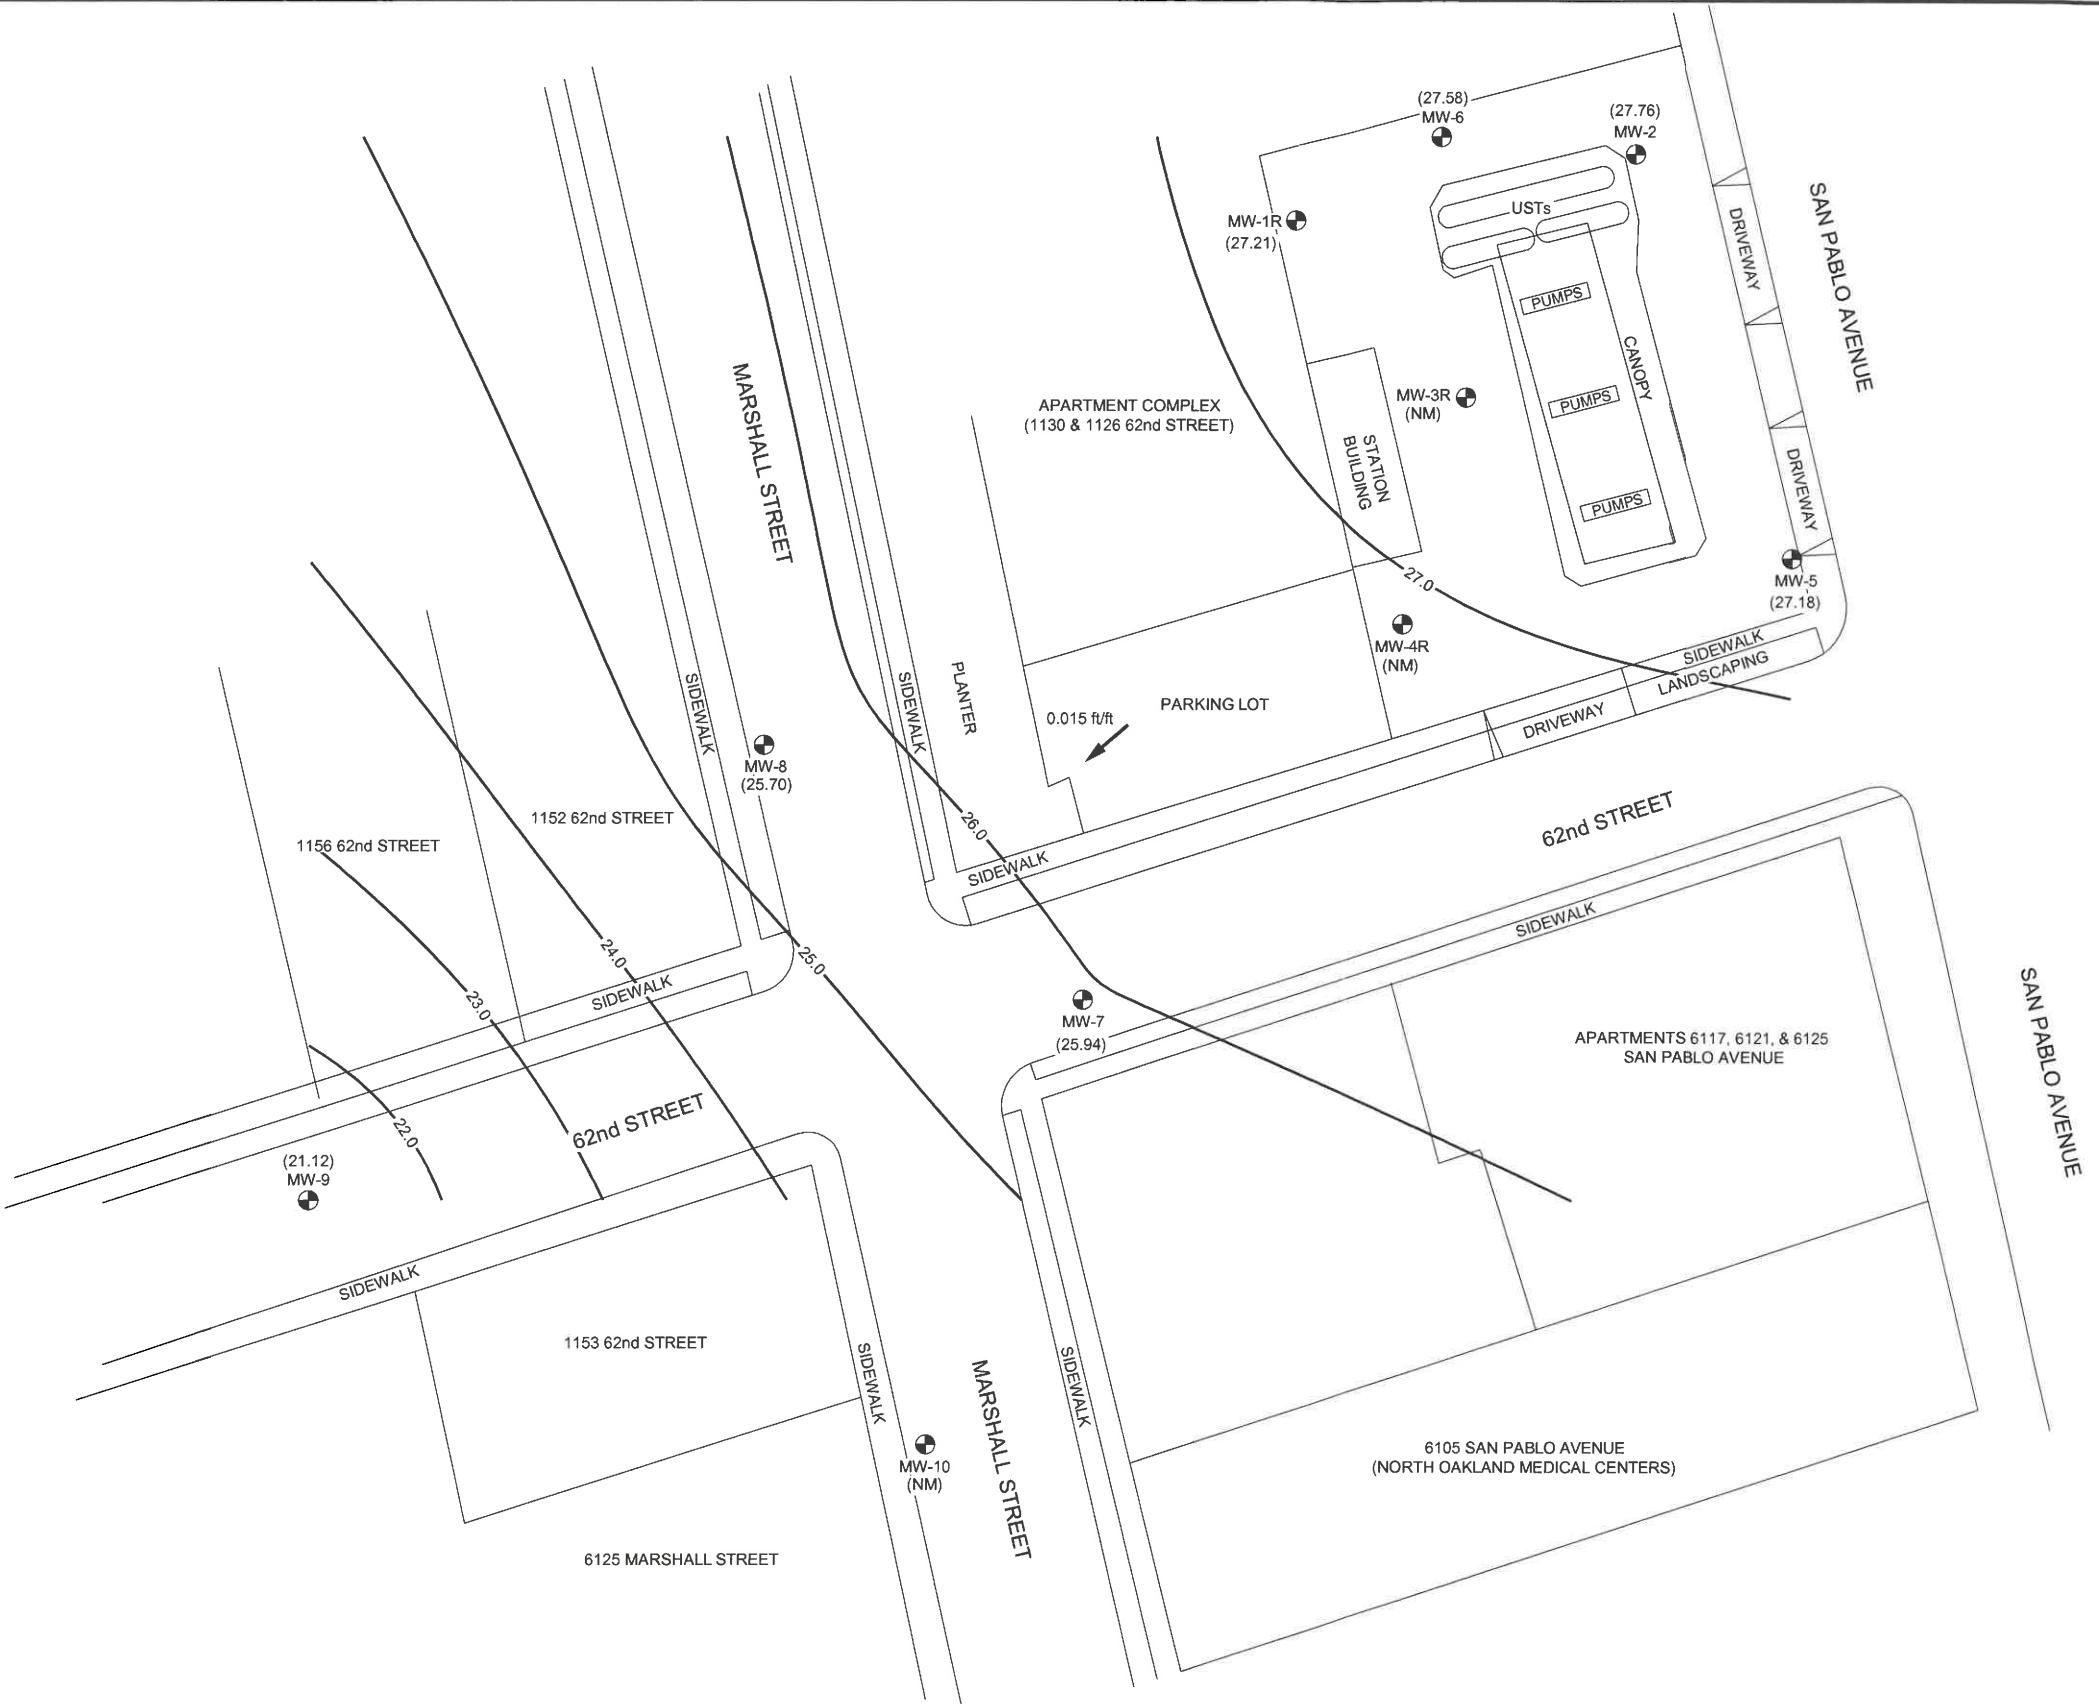
Groundwater levels beneath the property are relatively shallow, ranging from 5.22 to 9.46 feet below the top of the well casing on July 18, 2016. Using the available data, groundwater levels were corrected to elevation mean sea level and used to prepare a groundwater elevation contour map (Figure 3). On July 18, 2016, west-southwest groundwater flow, at an average gradient of approximately 0.015 ft/ft, was observed.

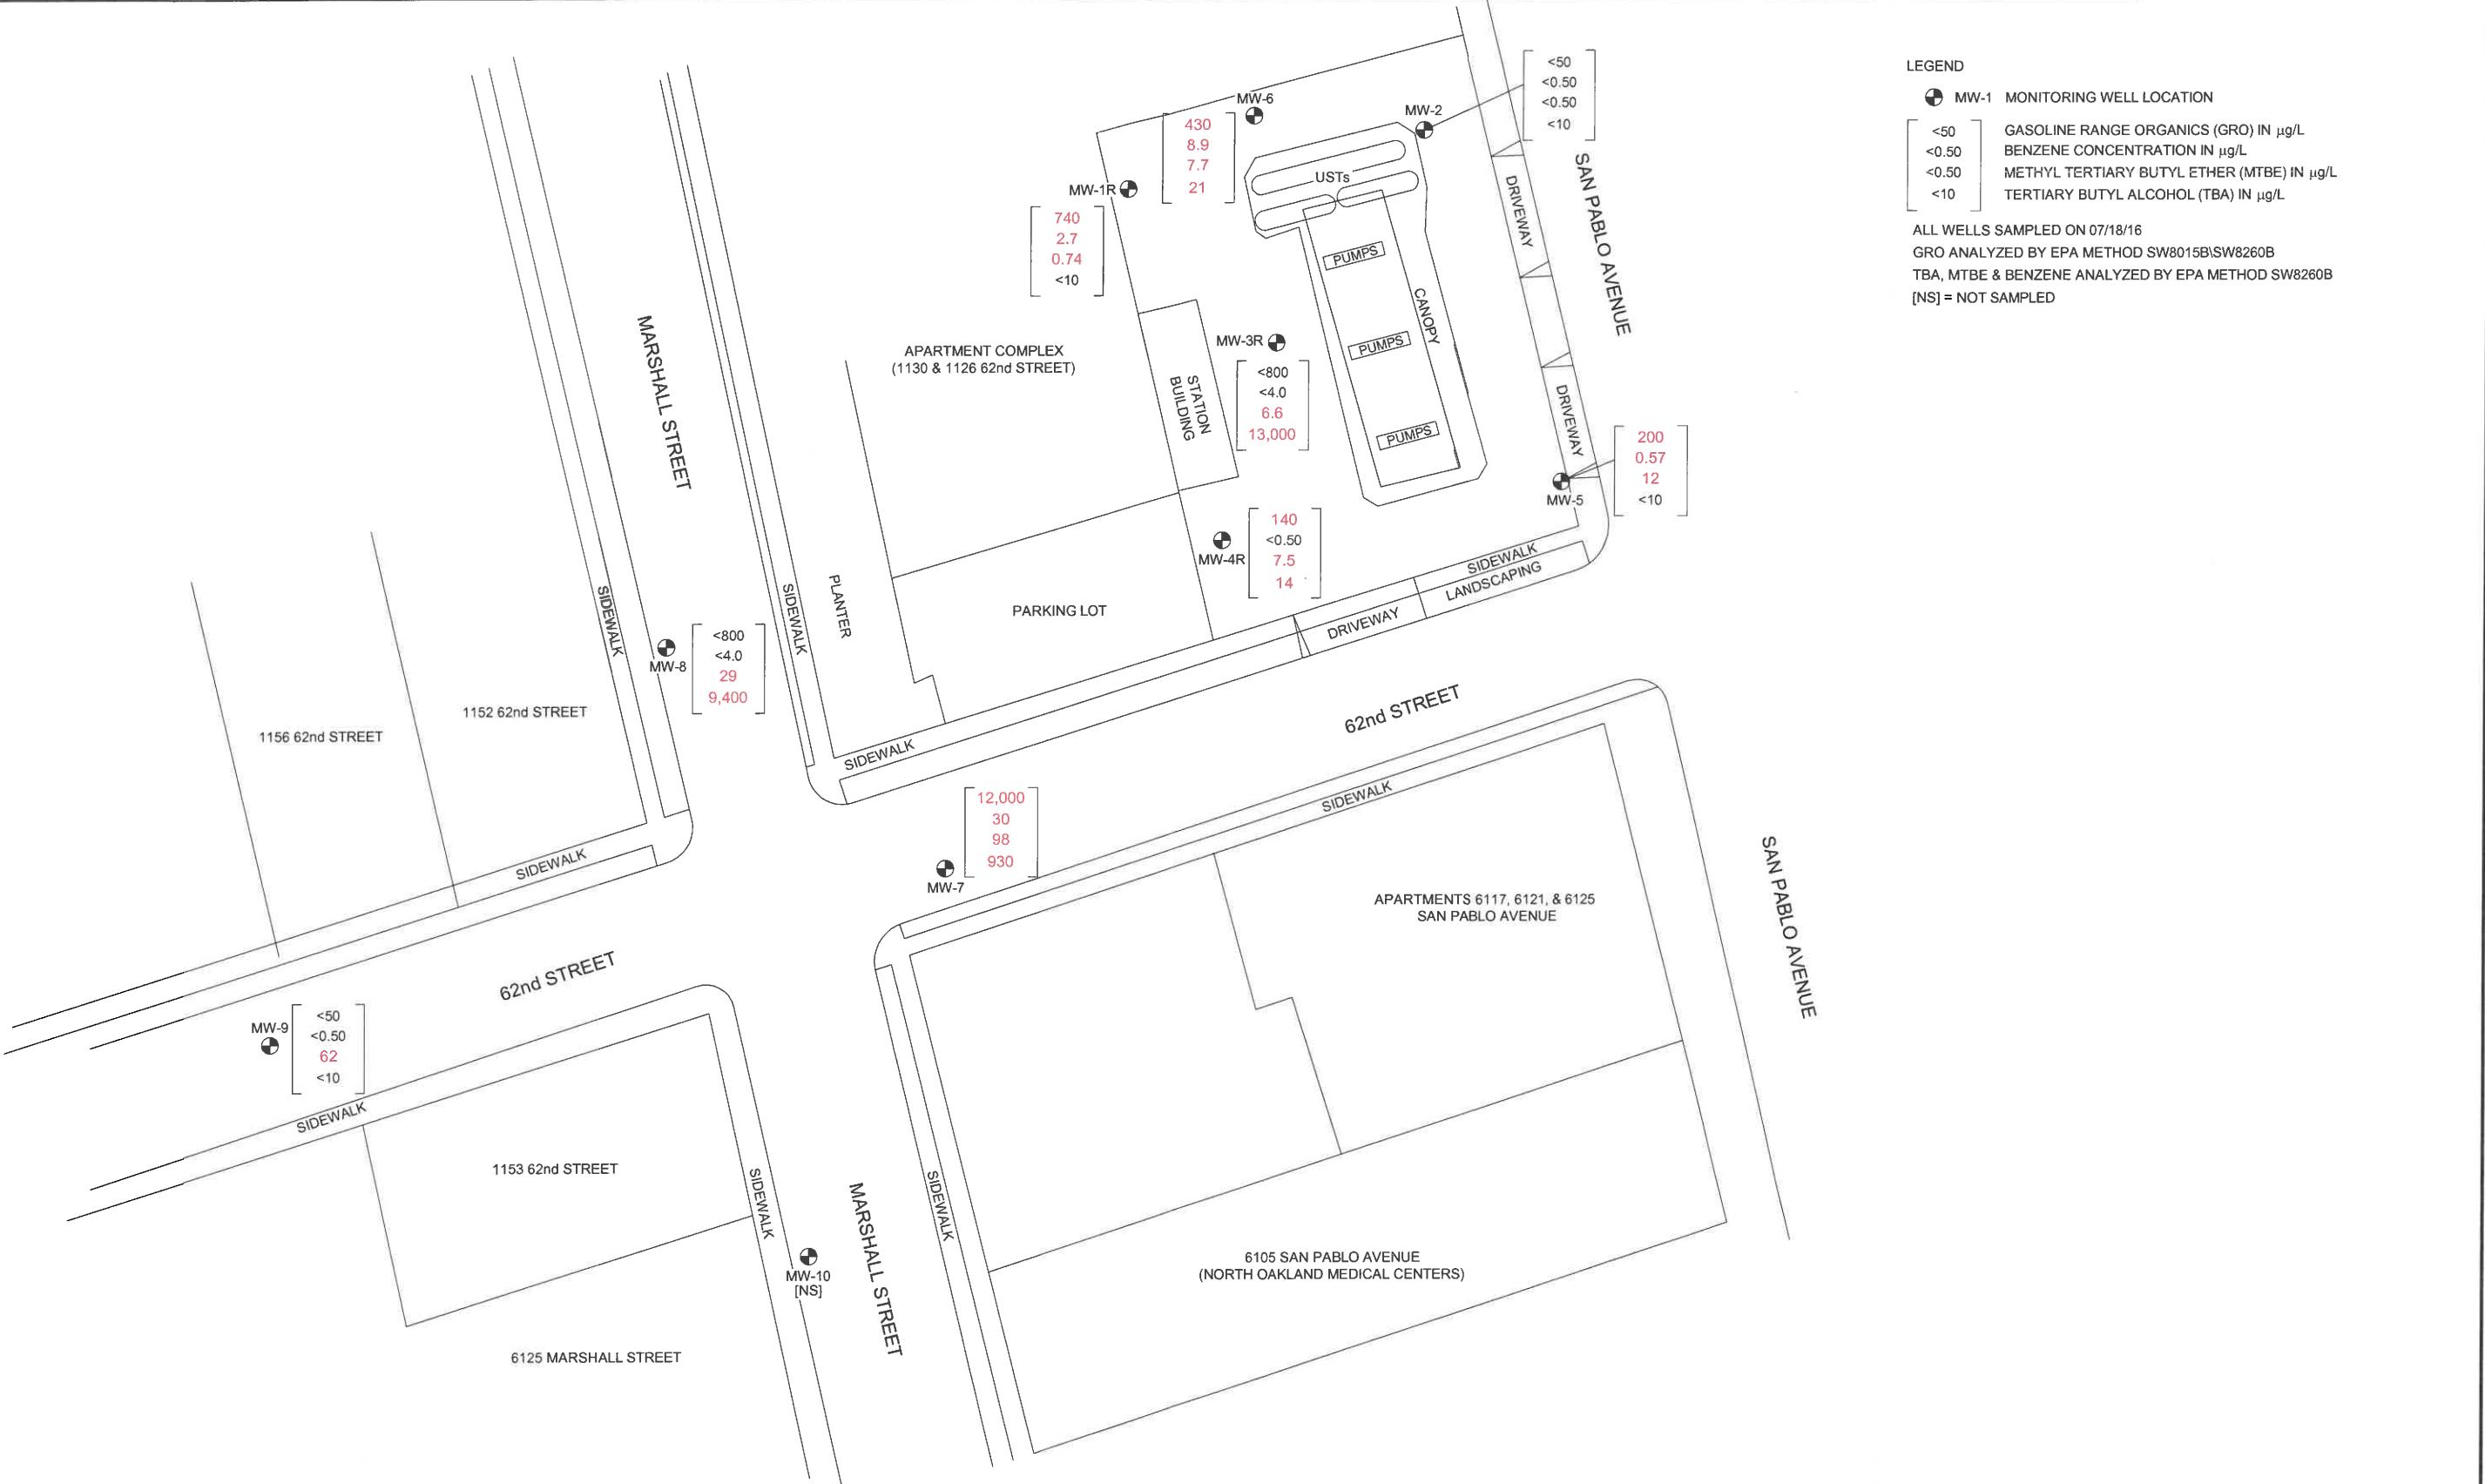
Figure 4 presents a summary of GRO, benzene, MTBE, and TBA concentrations in shallow groundwater using the July 2016 well sampling results. GRO was detected in four onsite wells samples, at concentrations ranging from 140 micrograms per liter [$\mu\text{g/L}$] to 740 $\mu\text{g/L}$, and at offsite well MW-7 (12,000 $\mu\text{g/L}$). Benzene was detected in three onsite well samples, at a maximum level of 8.9 $\mu\text{g/L}$, and also at offsite well MW-7 (30 $\mu\text{g/L}$). MTBE was detected in 8 of the 9 well samples; offsite MTBE concentrations ranged from 29 $\mu\text{g/L}$ to 98 $\mu\text{g/L}$ and onsite MTBE concentrations ranged from 0.74 $\mu\text{g/L}$ to 12 $\mu\text{g/L}$. TBA was detected in five of the nine well samples, at maximum concentrations of 13,000 $\mu\text{g/L}$ onsite (well MW-3R) and 9,400 $\mu\text{g/L}$ offsite (well MW-8).
