Re: Work Plan Addendum and Results of Additional Groundwater Monitoring
Former Chevron Service Station 90517
3900 Piedmont Avenue
Oakland, California
Case No. RO0000138

Conestoga-Rovers & Associates (CRA) has prepared this *Work Plan Addendum and Results of Additional Groundwater Monitoring* (work plan addendum) on behalf of Chevron Environmental Management Company (Chevron) for the site referenced above. CRA previously submitted the June 13, 2011 *Revised Work Plan for Additional Site Investigation* (revised work plan) in which the installation and sampling of two sub-slab vapor probes in the site building was proposed in lieu of previously requested onsite soil sampling to expedite moving the site toward potential case closure. However, in a letter dated March 28, 2012 (Attachment A), Alameda County Environmental Health (ACEH) again requested additional investigation of onsite soil quality in addition to the proposed sub-slab vapor sampling (Technical Comment 1a). A building plan was also requested to confirm that the proposed sub-slab probe locations were appropriate (Technical Comment 1b). As a storm drain inlet was noted on the site plan but no associated underground lines we

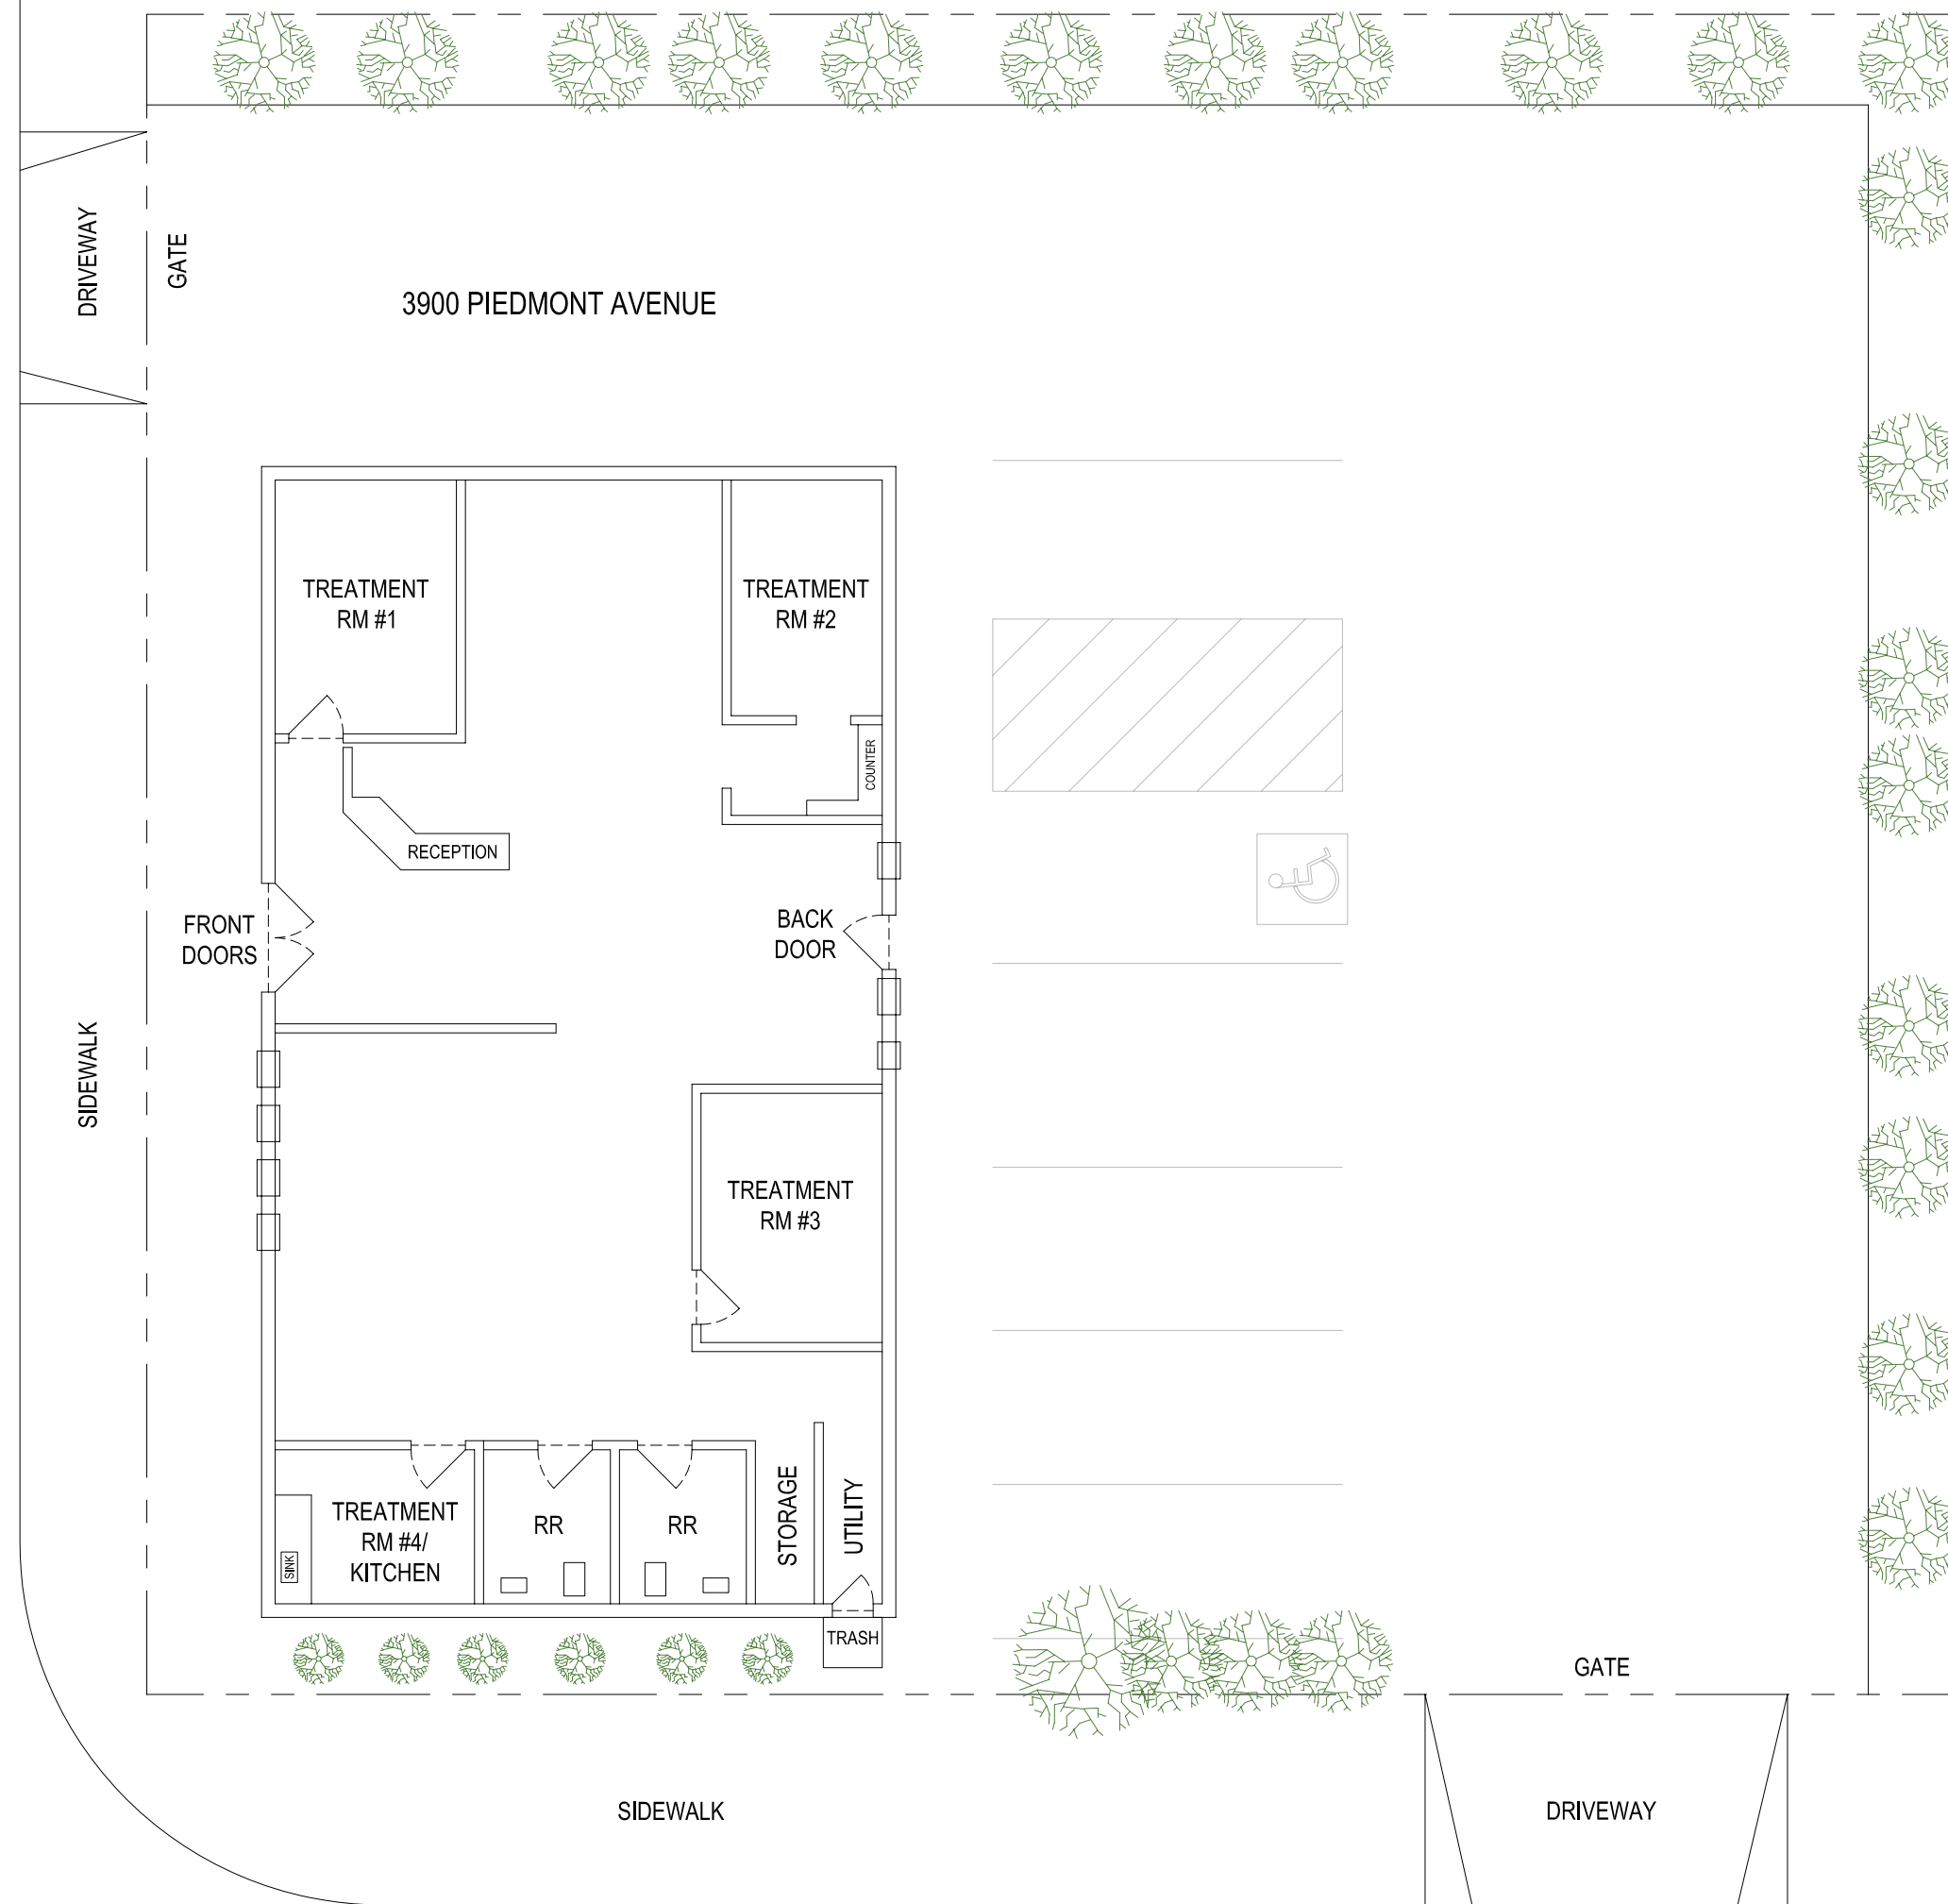
BUILDING PLAN

A copy of the building plan (obtained from the tenant) is included as Attachment E. The plan does not show utility laterals, but as described in the revised work plan, prior to probe installation ground-penetrating radar will be utilized to identify any utility lines beneath the slab. In addition, utilities entering the building will be identified and marked, and any internal locations where utilities penetrate the slab (e.g. furnace, water heater, circuit breaker box, and water or sewer lines) will be identified and avoided. It should be reiterated that the proposed locations shown on Figure 2 are approximate, and may change based on actual building interior conditions, the findings of the above-mentioned survey, or tenant concerns.
