May 1, 2006  
 File: 67972/PWENV

**SUBJECT: Limited Environmental Site Assessment of the Alders Site, located at 5812 Hollis Street in Emeryville, California.**

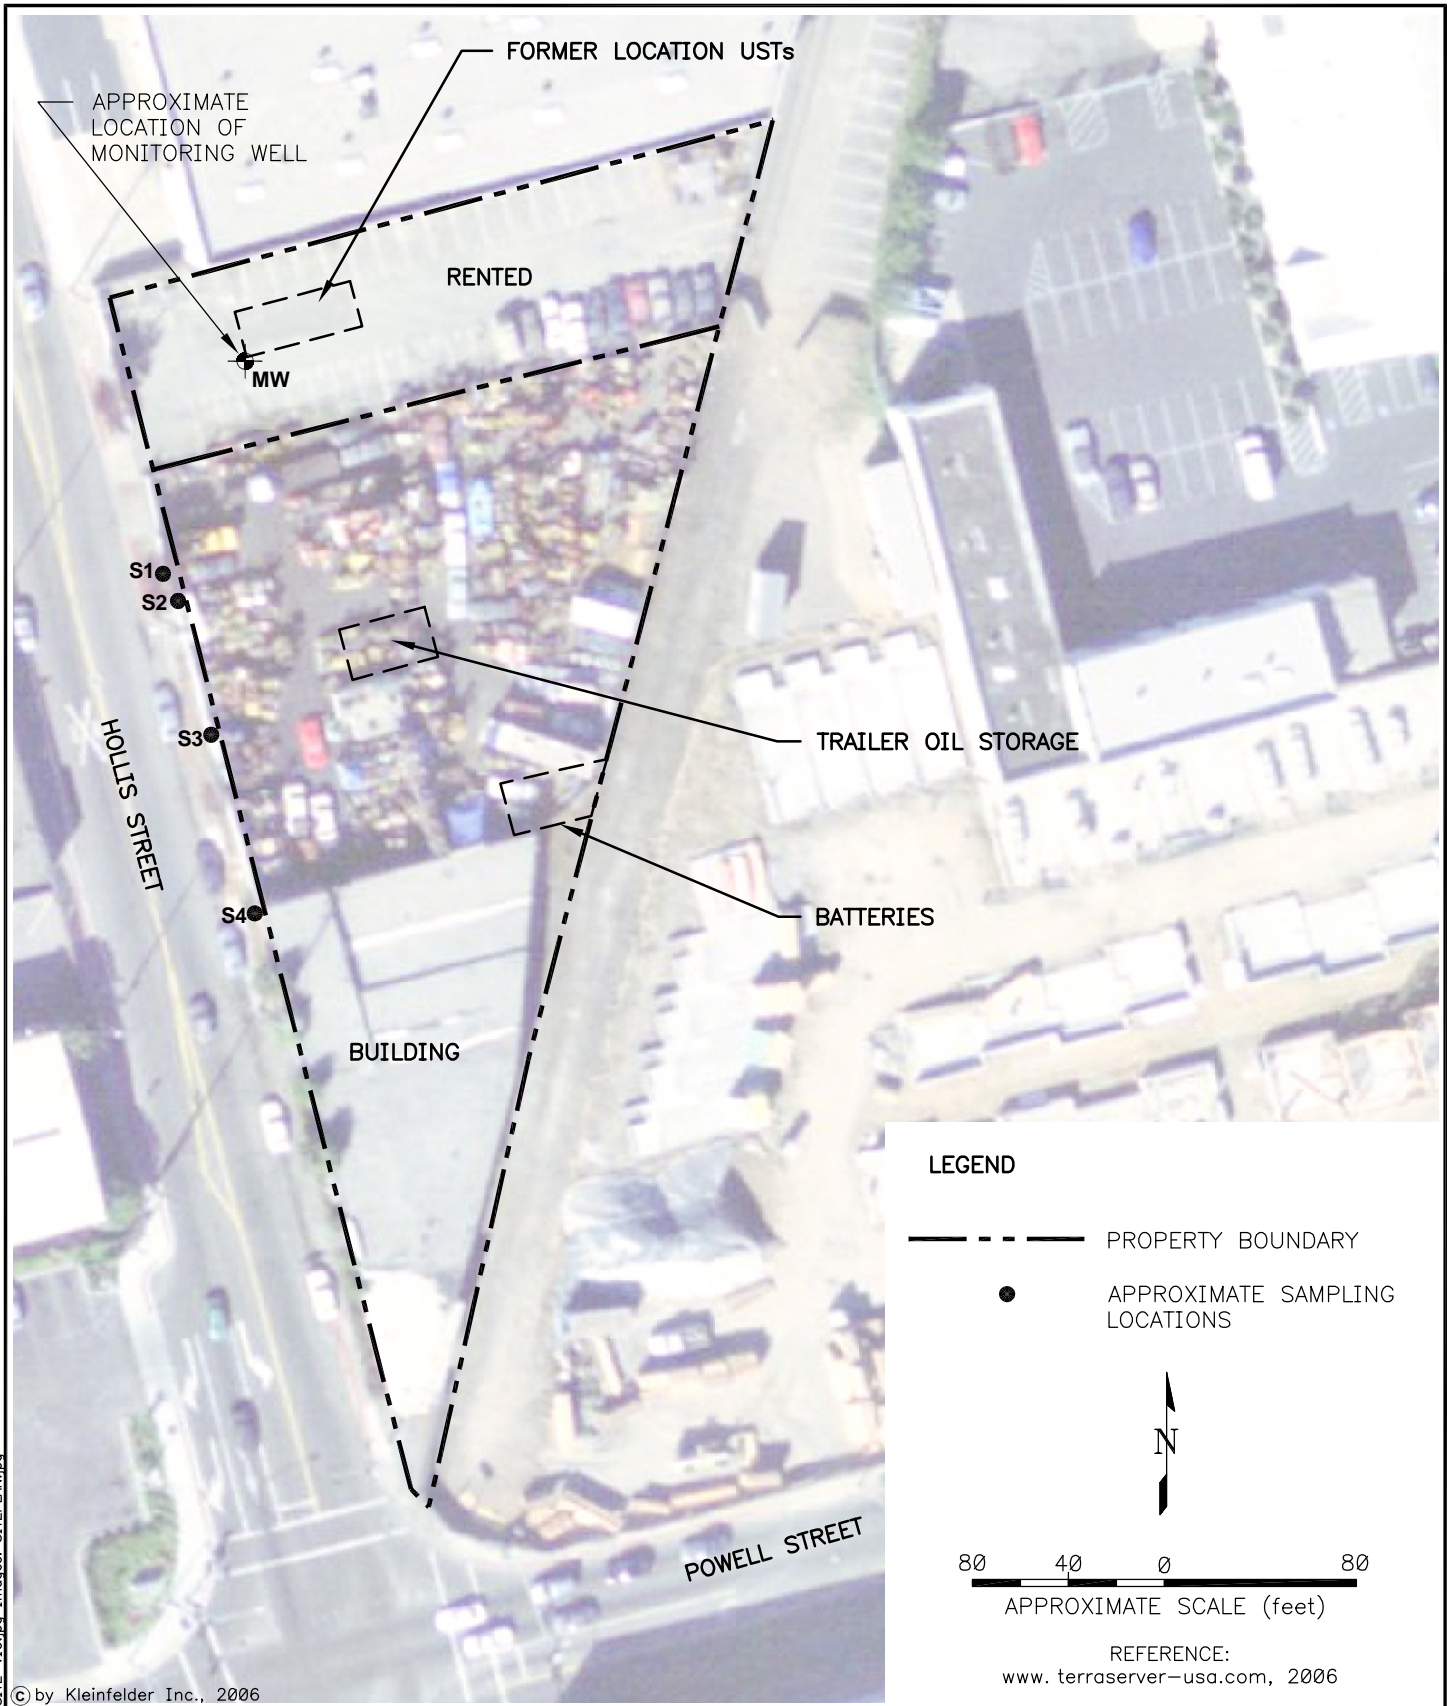
10,000 square feet, occupies the southern portion of the Site. The remaining 26,000 square feet are divided into a northern rectangular section of approximately 12,000 square feet, and a central section of approximately 14,000 square feet. A fence divides the northern and the central portions of the Site. The northern section of the property appeared to be vacant, except for two large storage bins. According to Mr. Alders, the northern portion of the Site is rented to the owners of the storage bins, but did not elaborate further. An aerial photograph of the Site, taken in 2006 (Plate 2) and reviewed by Kleinfelder, seemed to indicate that the northern portion of the Site has also been used as a paved parking lot. Mr. Alders mentioned that in the past, two 10,000-gallon underground storage tanks (USTs) for gasoline were located in the northern portion of the Site. According to Mr. Alders, the USTs were removed in the early 1990s. Based on the information available to us, the approximate location of the former USTs is shown on Plate 2.

On April 7, 2006, after completing the Site reconnaissance, Kleinfelder collected four discrete soil samples from vegetated areas along Hollis Street, in the public right of way in front of the site. Plate 2 shows the approximate sampling locations. The samples were collected in stainless steel sleeves, with the aid of a sampling hammer, from areas that appeared to be likely pathways for wastewater runoff from the Site. The ends of the sampling sleeves were covered with Teflon tape and covered with plastic caps. The samples were labeled and stored in a cooler with ice pending delivery to Curtis & Tompkins, a State certified chemical testing laboratory in Berkeley, California, under chain-of-custody protocols. The laboratory was requested to composite the four samples into one, chemically analyze the composite sample, and to archive the remaining portions of the samples for potential future analysis of the discrete samples.

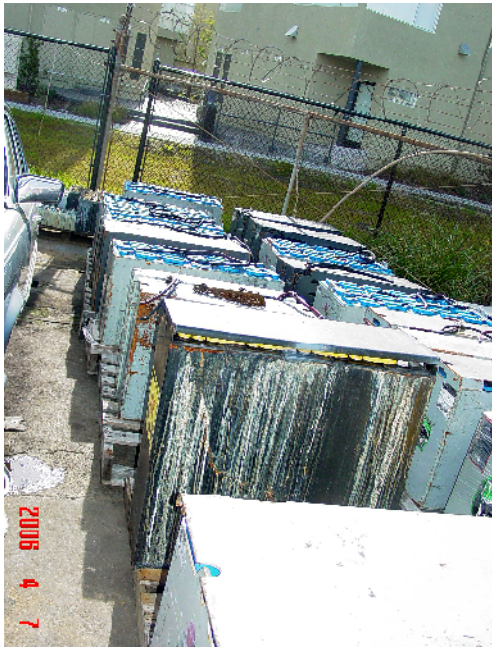
Numerous batteries were observed on crates in the southeastern section of the central portion of the Site. The bulk of the batteries were not covered, and showed signs of corrosion. This is illustrated in Plate 3, Photo 1. A pH reading of 5,

measured by the EBMUD representative using litmus paper, was obtained at a puddle of water adjacent to the stacked batteries.

**PHOTO 1.** Battery Acid: Batteries observed on crates in the southeastern section of the Site. Note that the batteries are uncovered and show signs of corrosion.

To further evaluate whether Site operations have resulted in impacts to soil or groundwater beneath the Site, Kleinfelder recommends that a soil and groundwater investigation be conducted at the property.

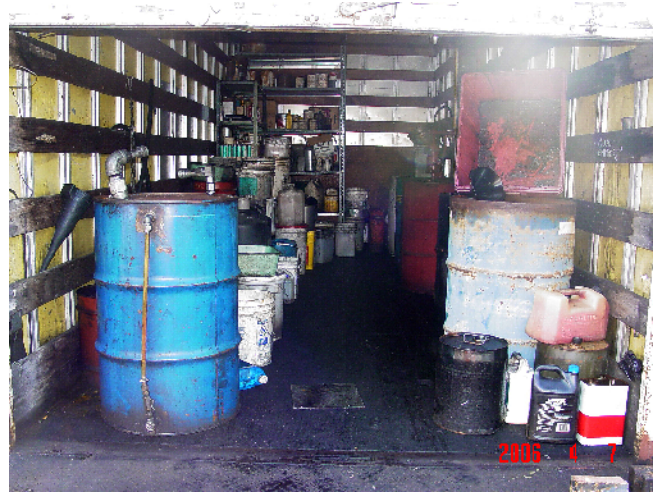
We also observed hazardous liquid materials, such as waste oil, in 55-gallon drums and smaller plastic containers. This is illustrated in Plate 3, Photo 2. These hazardous materials containers were stored within a trailer located near the center of the Site (the approximate location is shown on Plate 2). The floor of the trailer was stained with oil. Bins and drums lacked secondary containment structures, and the need to store liquid hazardous materials in structures with secondary containment was indicated by the ACHA representative.

**PHOTO 2.** Hazardous Waste Oil: Inside view of trailer used to store waste oil onsite.

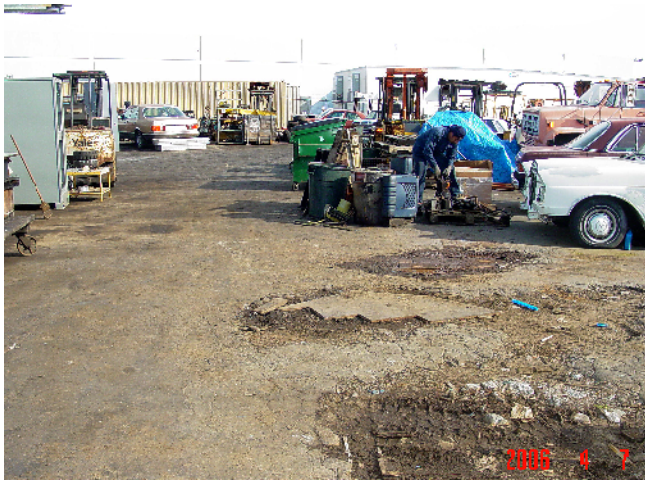
The pavement on the central portion of the Site appeared to be stained with hydrocarbon oils. Though most of the paved area was in relatively good condition, the pavement in some areas was damaged or entirely missing. Damaged pavement was most noticeable in the southeastern area of the central portion of the Site (Plate 3, Photo 3).

**PHOTO 3.** Broken Pavement: Some paved areas are deteriorated or missing.

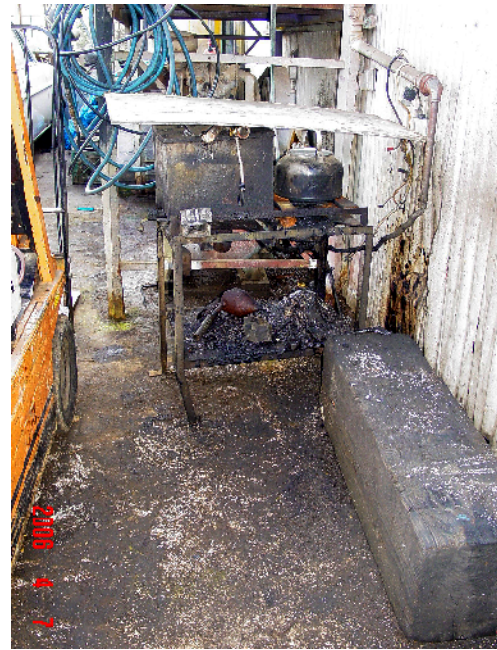
The building structure is used for storage of automobile parts and containers of hydrocarbon liquid wastes, and for operating machining equipment. The floor of the building structure is paved and appeared to be in relatively good condition. The floor was stained with what appeared to be hydrocarbon oil. Metal shavings were observed dispersed on the floor in the vicinity of the machining equipment. Some metal shavings were also observed immediately outside the building structure. This is illustrated in Plate 3, Photo 4.

**PHOTO 4.** Oily metal shavings: Metal shavings, some apparently mixed with waste oil, were observed scattered on the Site's floor.

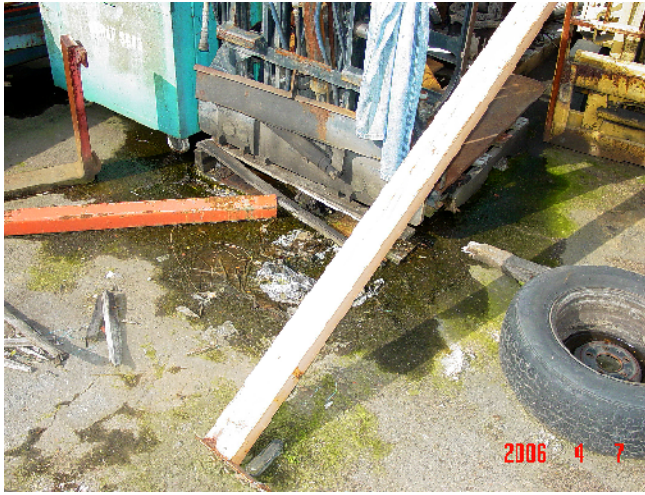
**PHOTO 5.** Housekeeping: View of parts and oil storage outside the building structure.

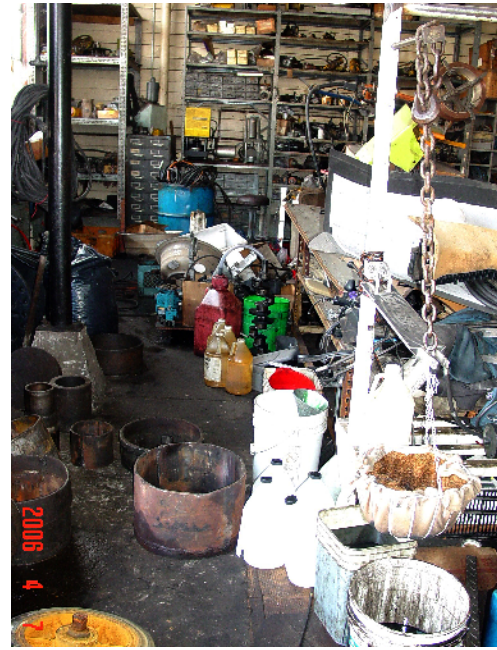
**PHOTO 6.** Housekeeping inside: View of parts and oil storage inside the building structure.

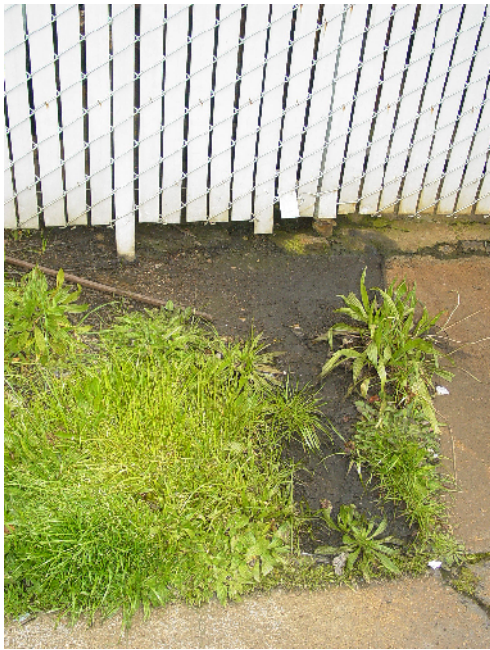
Kleinfelder also observed conditions in the public right of way along Hollis Street in front of the Site. The site is separated from the public right of way by a chain-link fence. The sidewalk is mostly paved, though a strip of grassy areas was observed along a few sections adjacent to the chain link-fence. Rust stains were observed in some areas of the sidewalk, and some of the grass areas showed signs of distress (lack of vegetation). This is illustrated on Plate 4, Photos 7 and 8.

**PHOTO 7.** Negatively-impacted vegetation, from apparent site runoff, observed in the public right-of-way along Hollis Street.

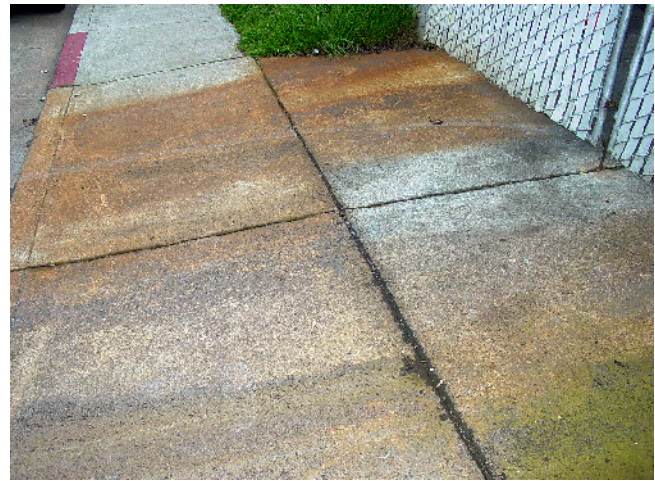
**PHOTO 8.** Sidewalk stained with rust on Hollis Street in front of the site.
