June 15, 1989

Subject: Preliminary Environmental Site Assessment  
4525 - 4561 Horton Street  
Emeryville, CA  
[ATT Project #9036]

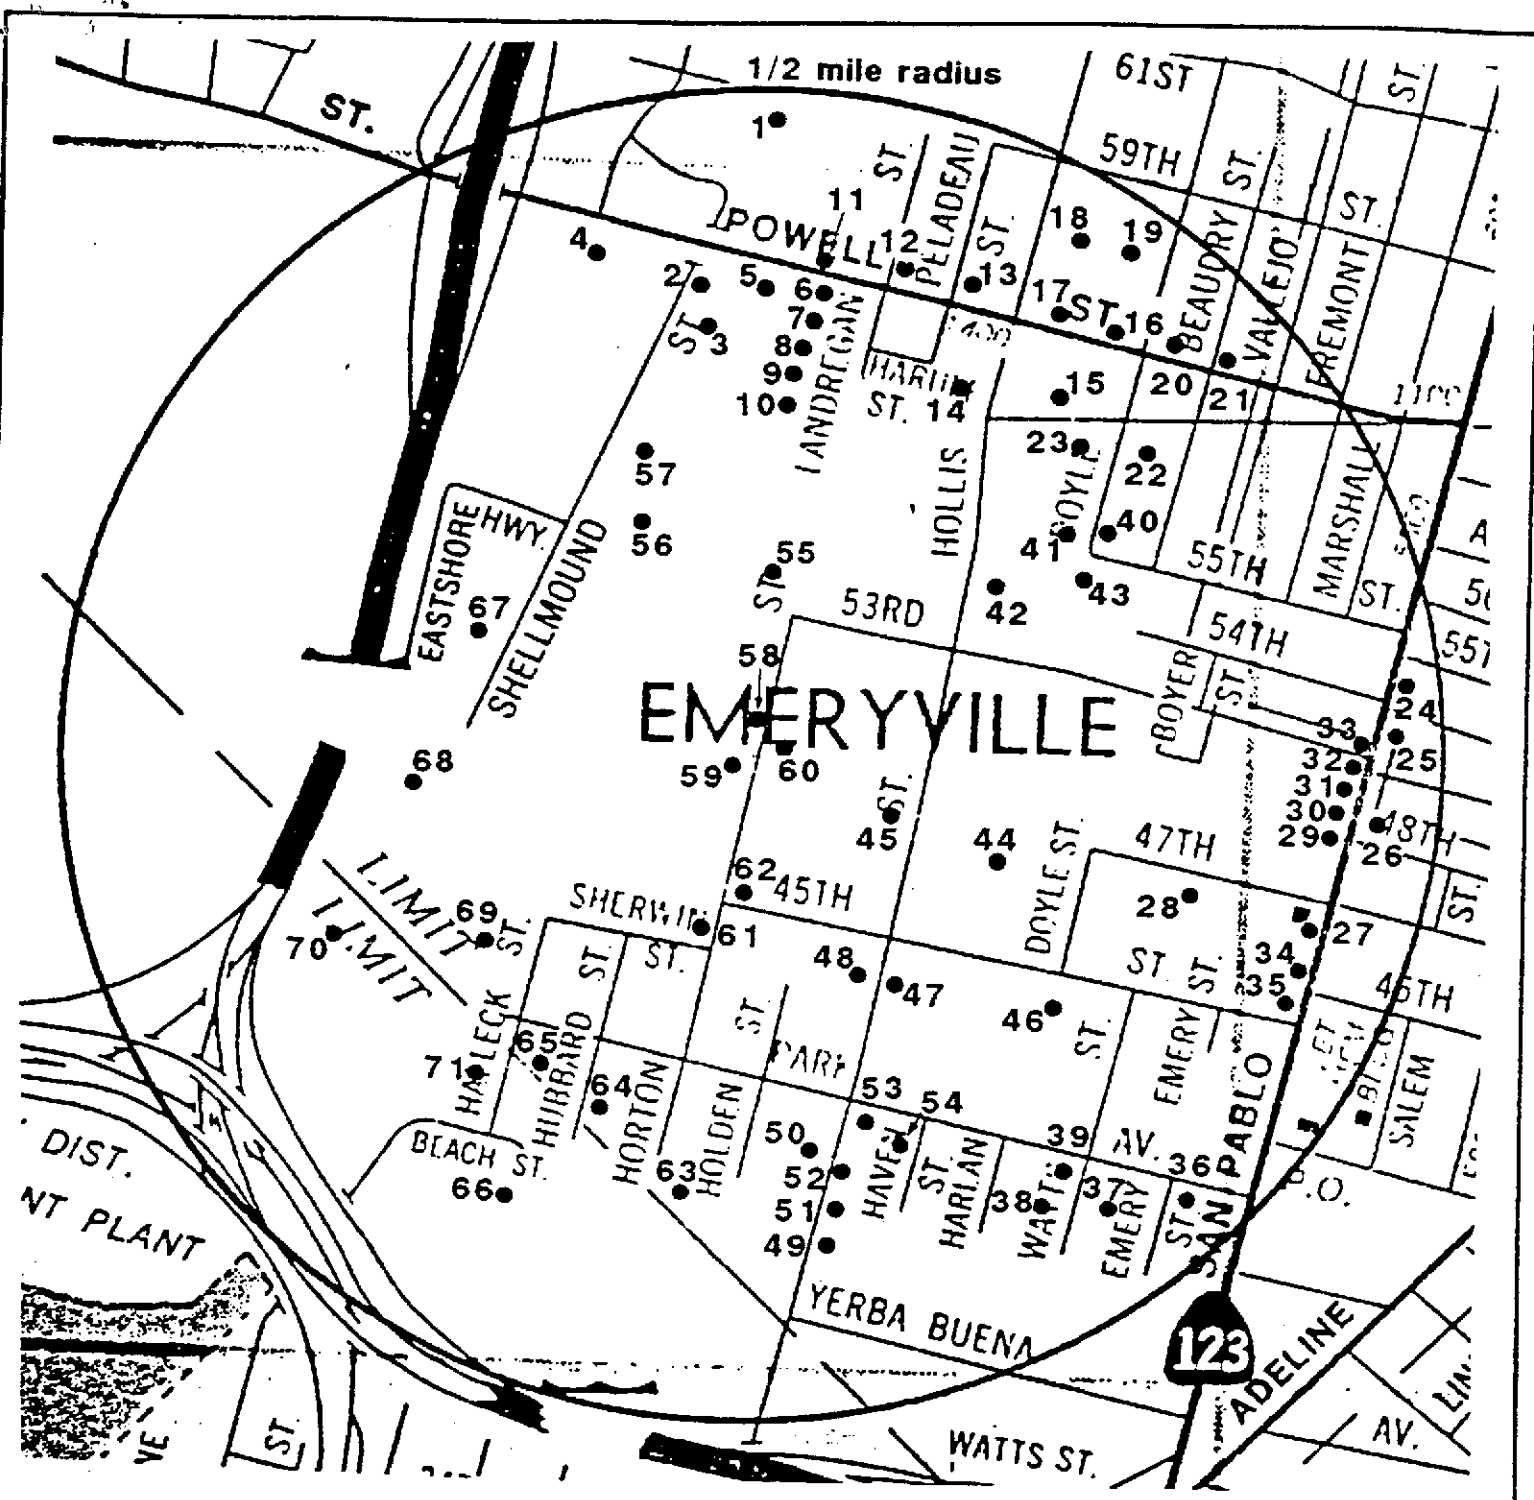
Historic Land Use 1911/1912  
Revised 1951

Directly across Horton Street between 45th and 53rd Streets was the Shell Development Company (Site 60, Plate 5, Attachment A). There appears to be many small laboratories, and a machine shop and welding facility close to 45th Street.

Pacific Gas & Electric Company (PG&E) operated a storage yard at 4525 Hollis Street (Site 45, Plate 5, Attachment A) due east of the site in 1951. The Gardener Electric Manufacturing Company and Transformer Factory was located at 4227 Hollis Street in the 1951 revised Sanborn Map (Site 48, Plate 5, Attachment A). The Shell Development Company Asbestos Products warehouse was

Sites which may have contributed to degradation of soil and/or groundwater quality in the area are shown on Plates 2, 3, 4, and 5 in Attachment A. Tables 1, 2, 3, and 4 in Attachment C list sites and the potential source of soil or groundwater contamination. The sites are numbered on the tables to match their locations on the plates.
