**SECOND SEMIANNUAL 2013
GROUNDWATER MONITORING,
PERMEABLE BARRIER INSTALLATION,
AND ANNUAL SUMMARY REPORT**

**REDWOOD REGIONAL PARK
SERVICE YARD
OAKLAND, CALIFORNIA**

**EAST BAY REGIONAL PARK DISTRICT
OAKLAND, CALIFORNIA**

Project No. 2013-02

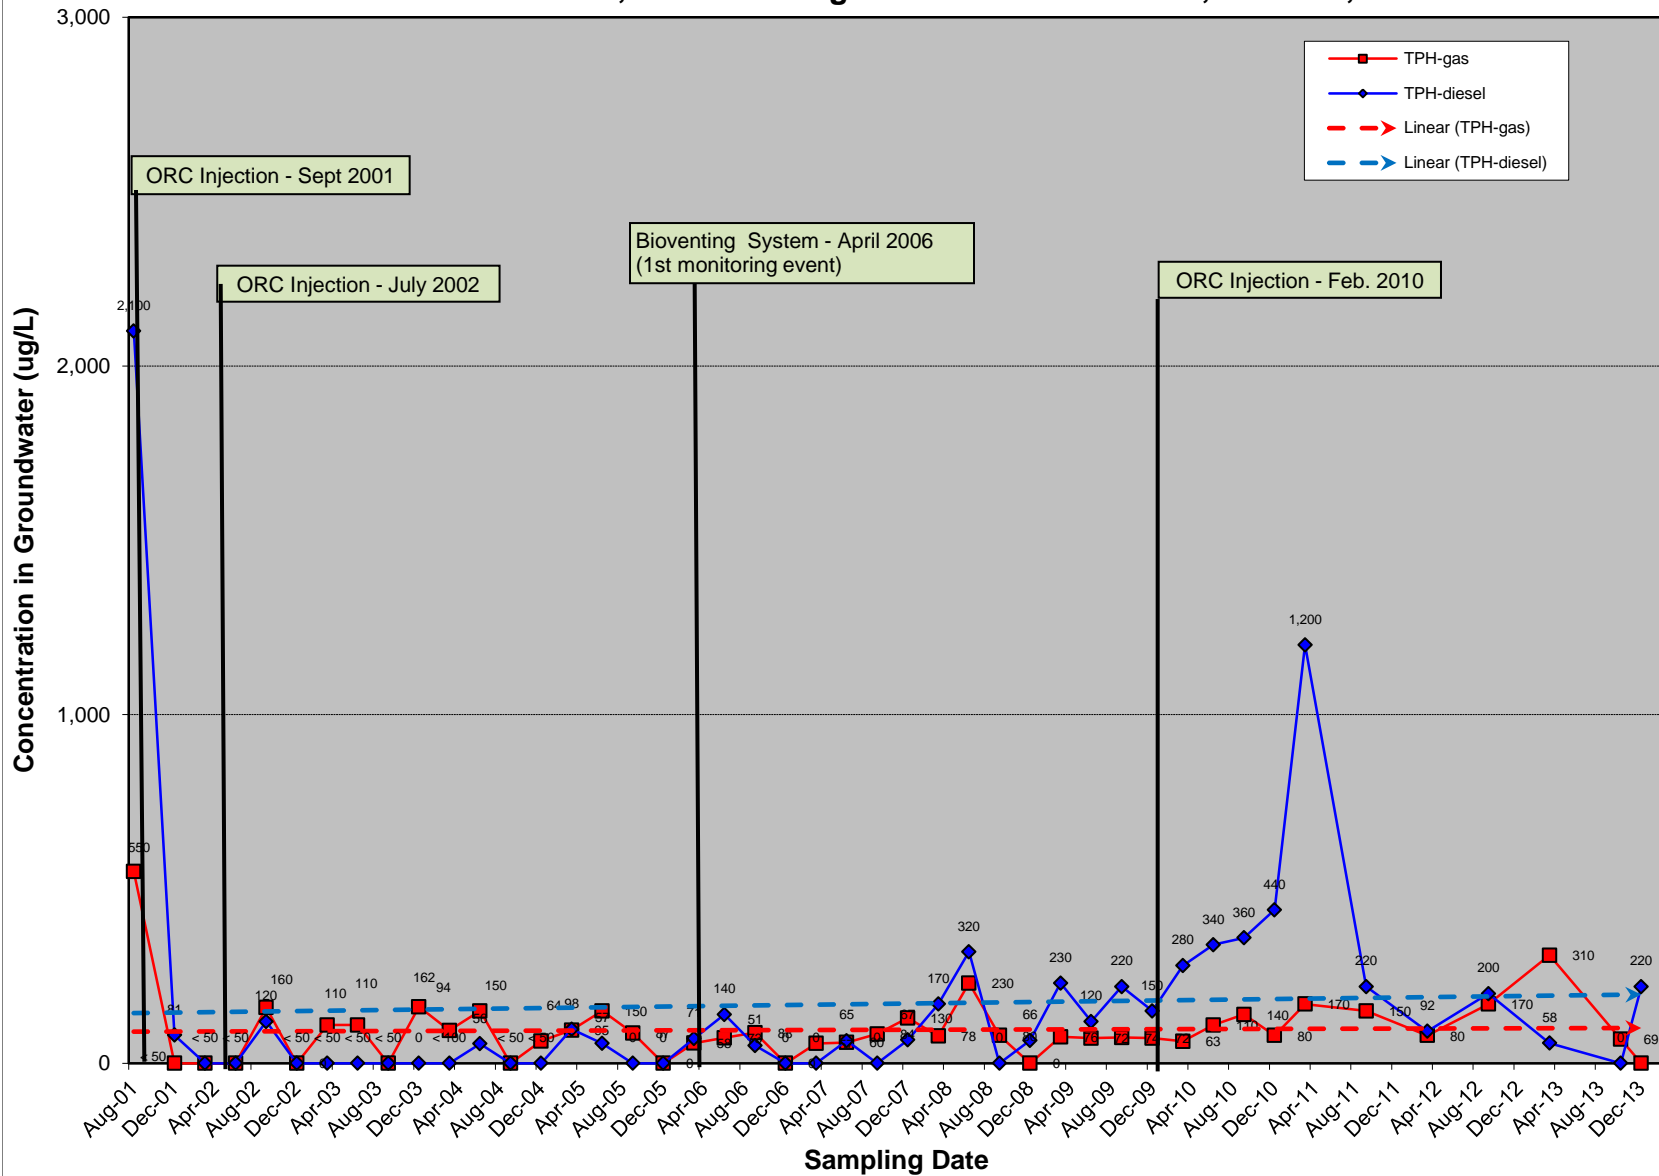
Figure 16: Gasoline and Diesel Hydrochemical Trends: 2001-2013

Well MW-10, Redwood Regional Park Service Yard, Oakland, California

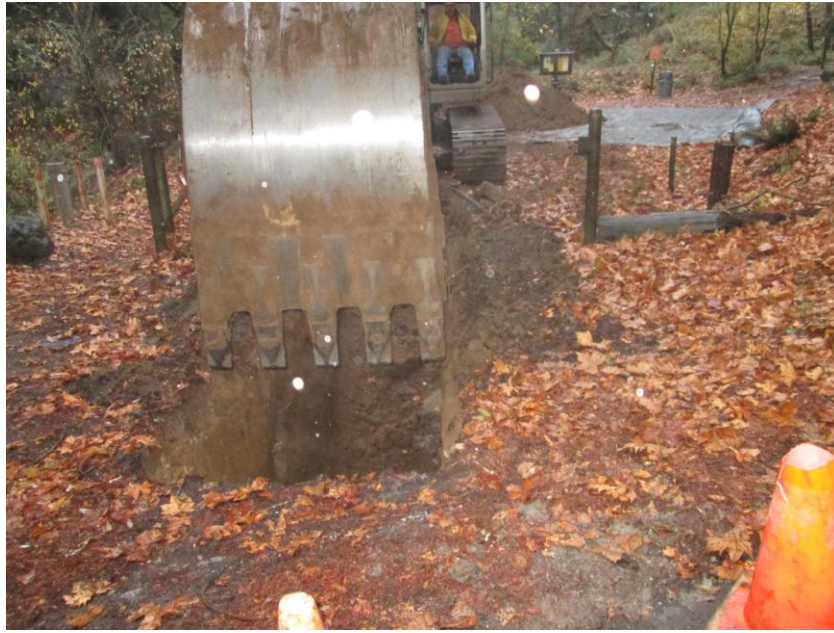
Photo No.: 01

Subject: Beginning PRB trench excavation

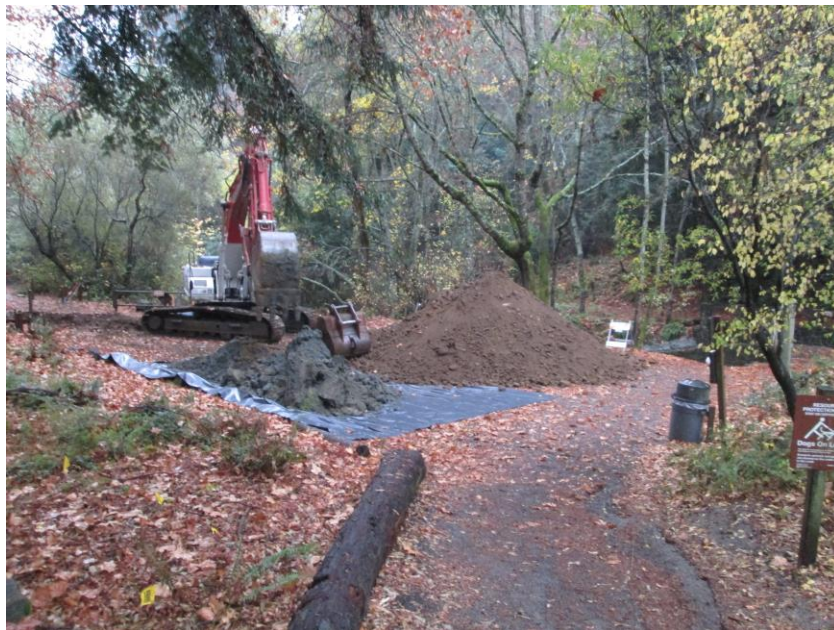
Photo No.: 02

Subject: Segregating contaminated soil on plastic from clean overburden soil

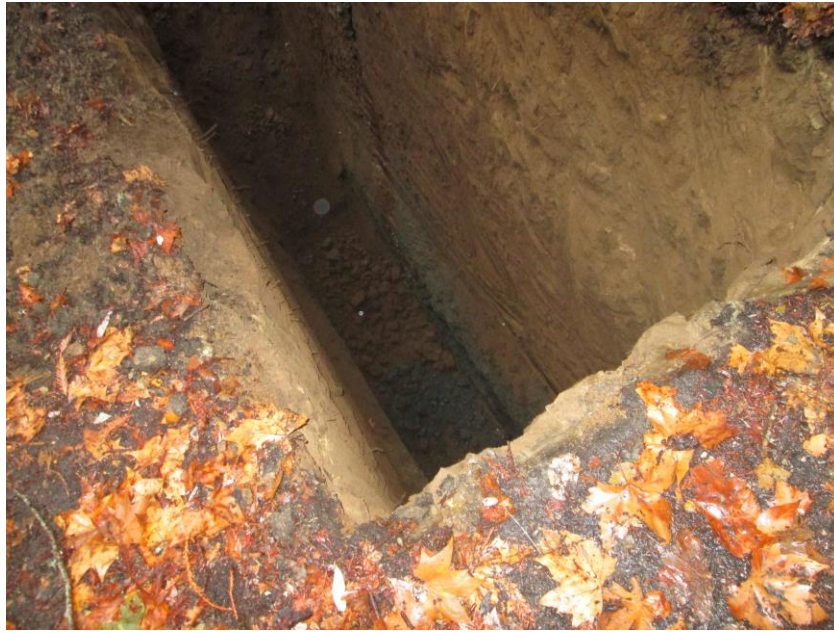
Photo No.: 03

During advancement of the trench, there was an obvious color change observed at approximately 11-12 feet bgs that demarked the boundary between the clean overburden light brown clayey silt soil and the underlying discolored blue-green contaminated soil interval had a strong petroleum

odor. The top of the discolored soil demarked the upper reach of the vadose “smear” zone. The observed discoloration resulted from hydrocarbons entrained in the groundwater plume that had sorbed onto the downgradient soil. Minimal groundwater was observed to infiltrate into the open trench and this was primarily observed at the 21-22 foot depth. The trench was backfilled immediately to prevent potential caving and thus the groundwater was not observed to equilibrate in the trench

Subject: Inside trench showing discolored blue contaminated soil from 10-22 feet bgs

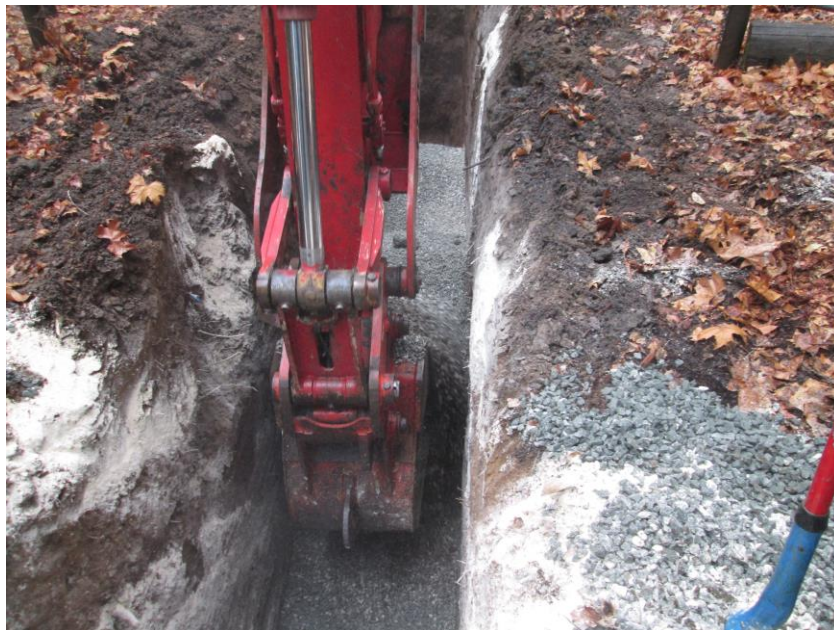
Photo No.: 04

Subject: Mixing EHC-O oxygen release product into drain rock

- Approximately 100 lbs of EHC-O was used every 1-foot lift between the trench base at 22 feet bgs to 10 feet bgs. The oxidant loading was based on a conservative average of 8,000 micrograms per liter (µg/L) TVHg and TEHd. The dosage was determined based on COD reported in monitoring wells, existing geochemical conditions and incorporating safety factors to account for unknown oxygen sinks.

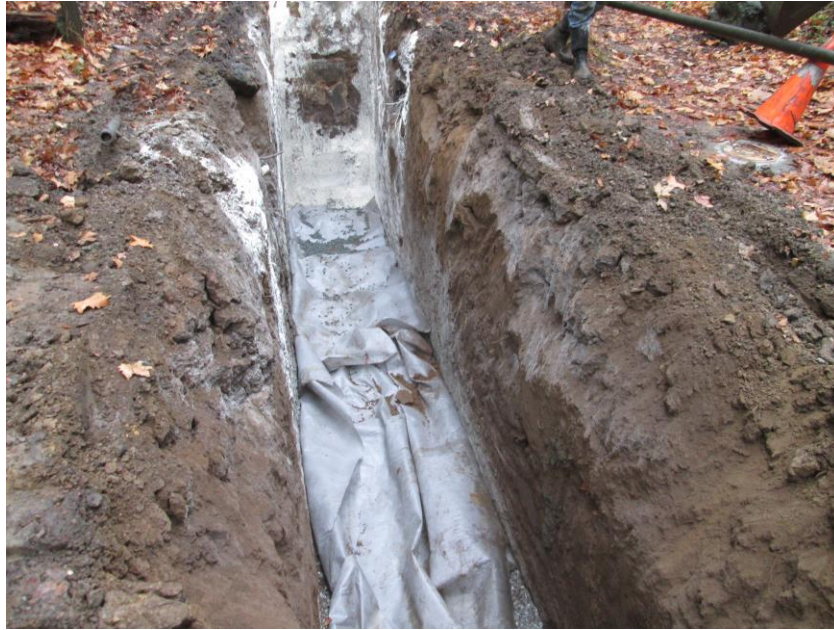
Photo No.: 05

Subject: Placing silt construction fabric over drain rock at 10 feet bgs

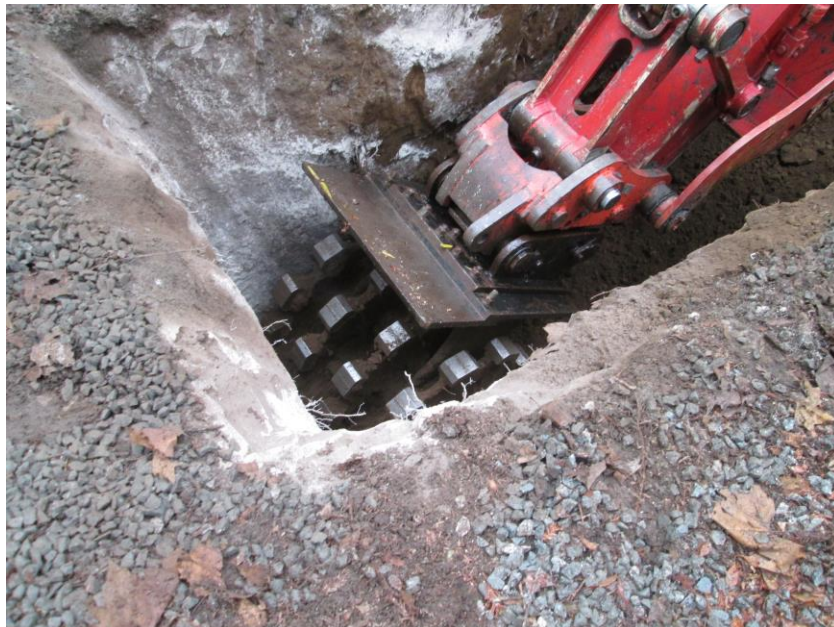
Photo No.: 06

Subject: Sheepfoot compactor mounted onto excavator being used to compact backfill

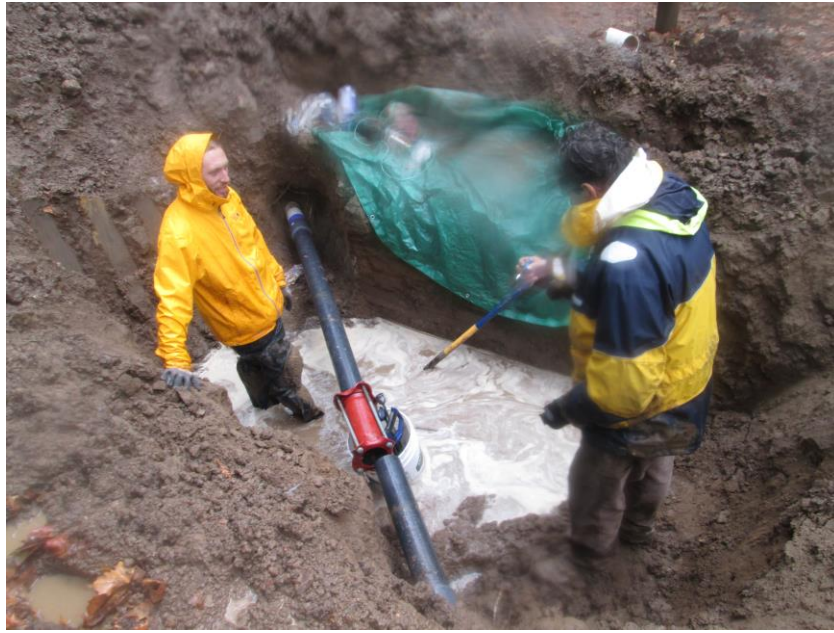
Photo No.: 07

Subject: EBRPD plumbers repairing 4-inch water main across trench area

Trench work was coordinated with the EBRPD superintendent and plumbers who conducted a planned shut-off, draining and subsequent repair of a 4-inch diameter high pressure water main that crossed the trench area excavation. Prior to the trench excavation and stockpiling of hydrocarbon contaminated soils, the Bay Area Air Quality Management District (BAAQMD) was notified as per Regulation 8, Rule 40.

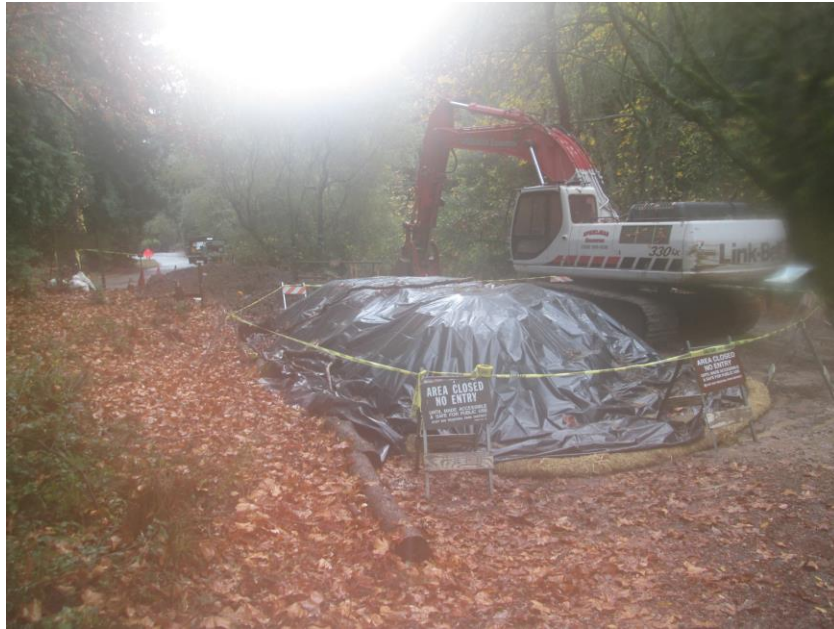
Photo No.: 09

Subject: Contaminated soil pile covered with plastic sheeting and barricaded prior to offsite disposal

On December 4, 2013, 84.38 tons of contaminated soil was loaded and transported offsite by Greg’s Trucking and disposed of at the Vasco Road Landfill in Livermore, California. Double 9 CY transfer trucks were used to transport the petroleum-contaminated soil with the appropriate non-hazardous waste manifest to the receiving landfill facility. Care was taken to avoid overloading the haul trucks to avoid spillage onto roadways.

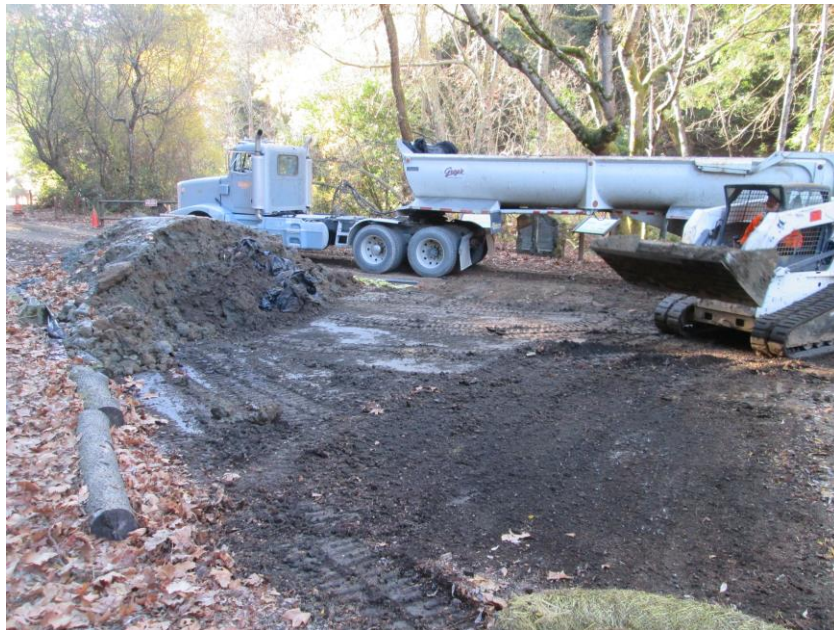
Subject: Contaminated soil being loaded into end dump for transport to off stie landfill
