SUBJECT: 9-MONTH REMEDIATION EFFECTIVENESS REPORT
RO0262
Albany Hill Mini Mart
800 San Pablo Avenue
Albany, California

REPORT OF
OZONE SPARGING SYSTEM
9-MONTH OPERATION REPORT
at
Albany Hill Mini Mart
800 San Pablo Avenue
Albany, California

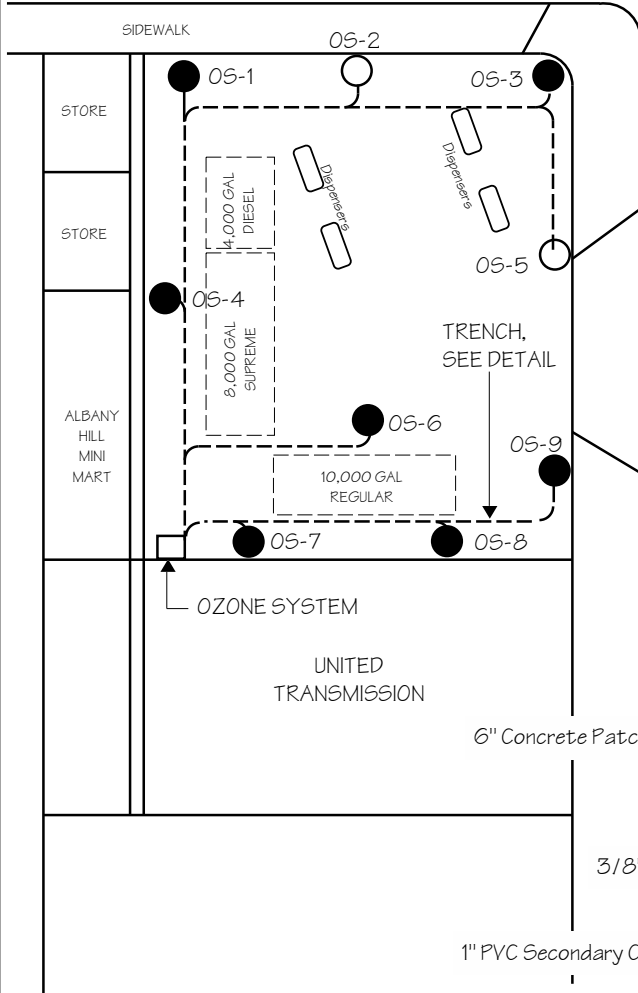
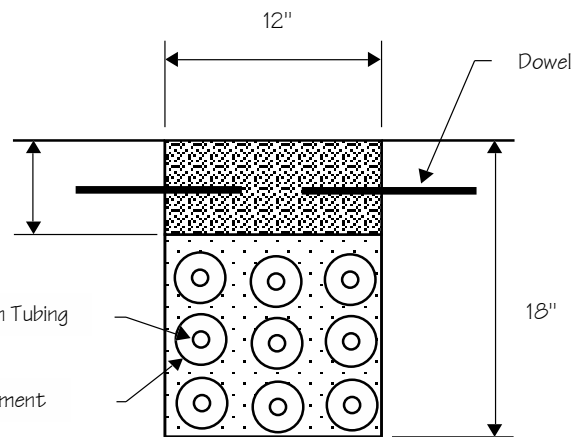
OZONE-SPARGE WELL AND TRENCH LAYOUT MAP

The remediation system incorporates the use of nine (9) ozone-sparge wells. Previous wells OS-1 and OS-3 were used for ozone sparging. OS-2 was not be used because it did not fit within the preferred grid pattern; OS-2 was properly destroyed. The locations of the nine ozone-sparging wells are shown on Figure 3. The wells are located to destroy hydrocarbons surrounding and downgradient of the USTs. All nine ports on the ozone generation unit are utilized.

The air/ozone mixture is pumped through double contained ozone-resistant Teflon tubing from the H2O-OSU20-26 unit to the sparging wells. This tubing consists of a 1/2-inch diameter inner transport tubing within a 1-inch schedule 40 PVC secondary-containment tube. This tubing is flexible and is buried through narrow trenches cut through the concrete surface.

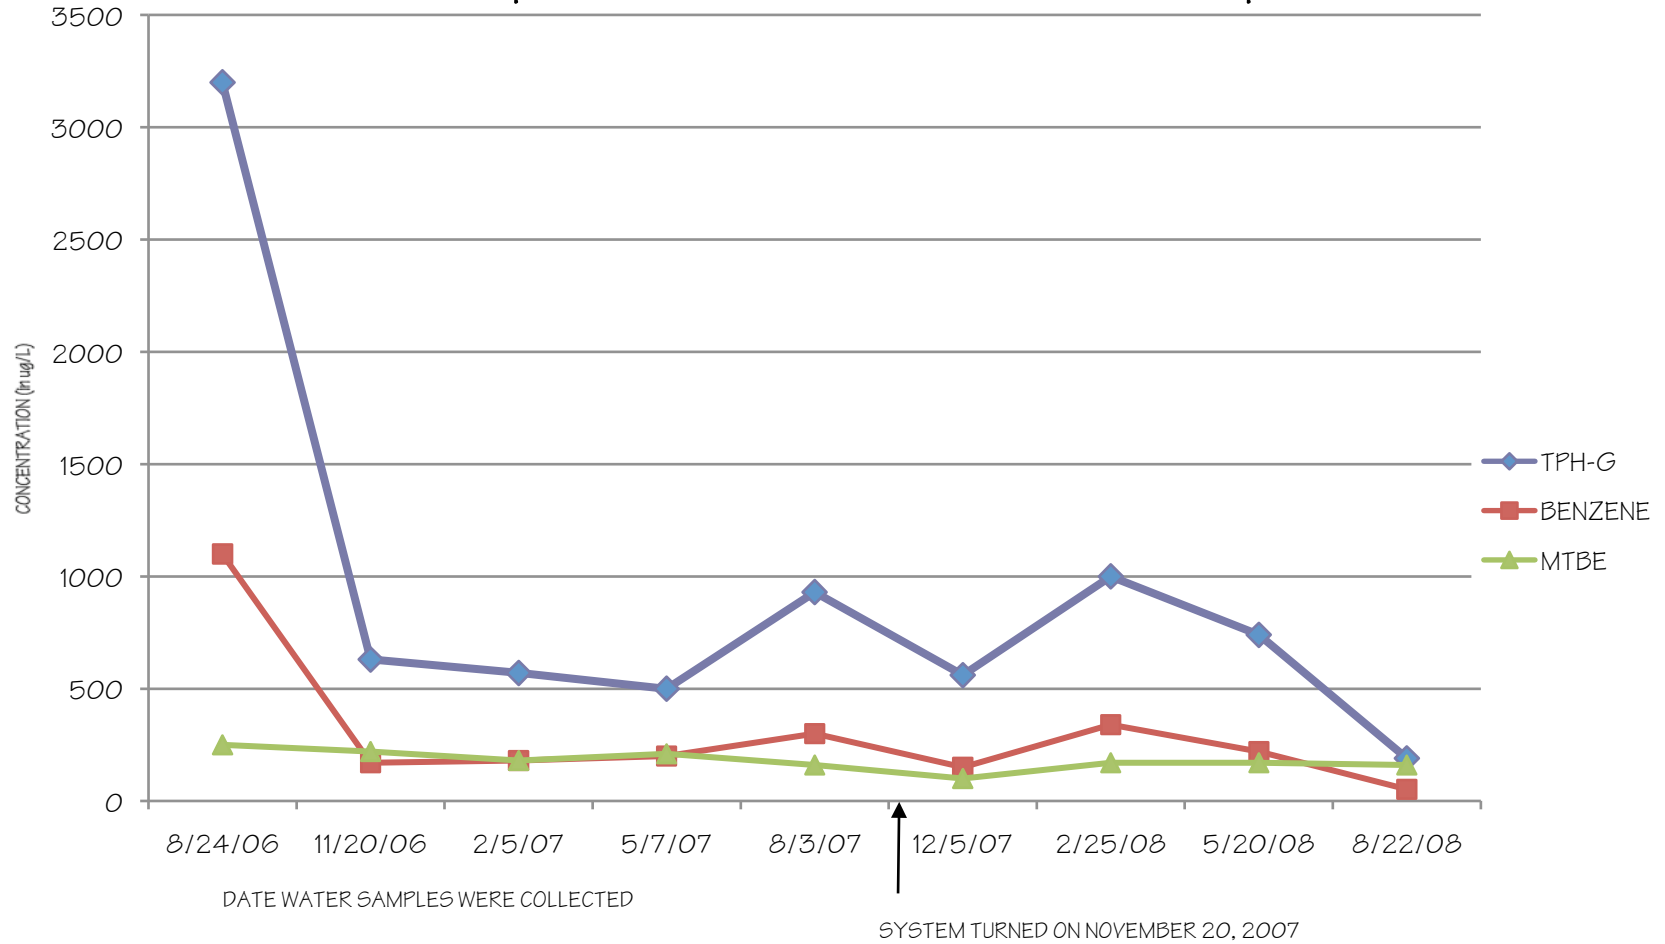
MTBE Concentrations in Monitoring Well MW-1 Since Ozone-Sparging Remediation System Start-Up

- A decreasing trend in concentrations of TPH-G and benzene, and a stable MTBE concentration is apparent in monitoring well MW-1.
- A decreasing trend in concentrations of TPH-G, benzene, and MTBE is apparent in monitoring well MW-2.

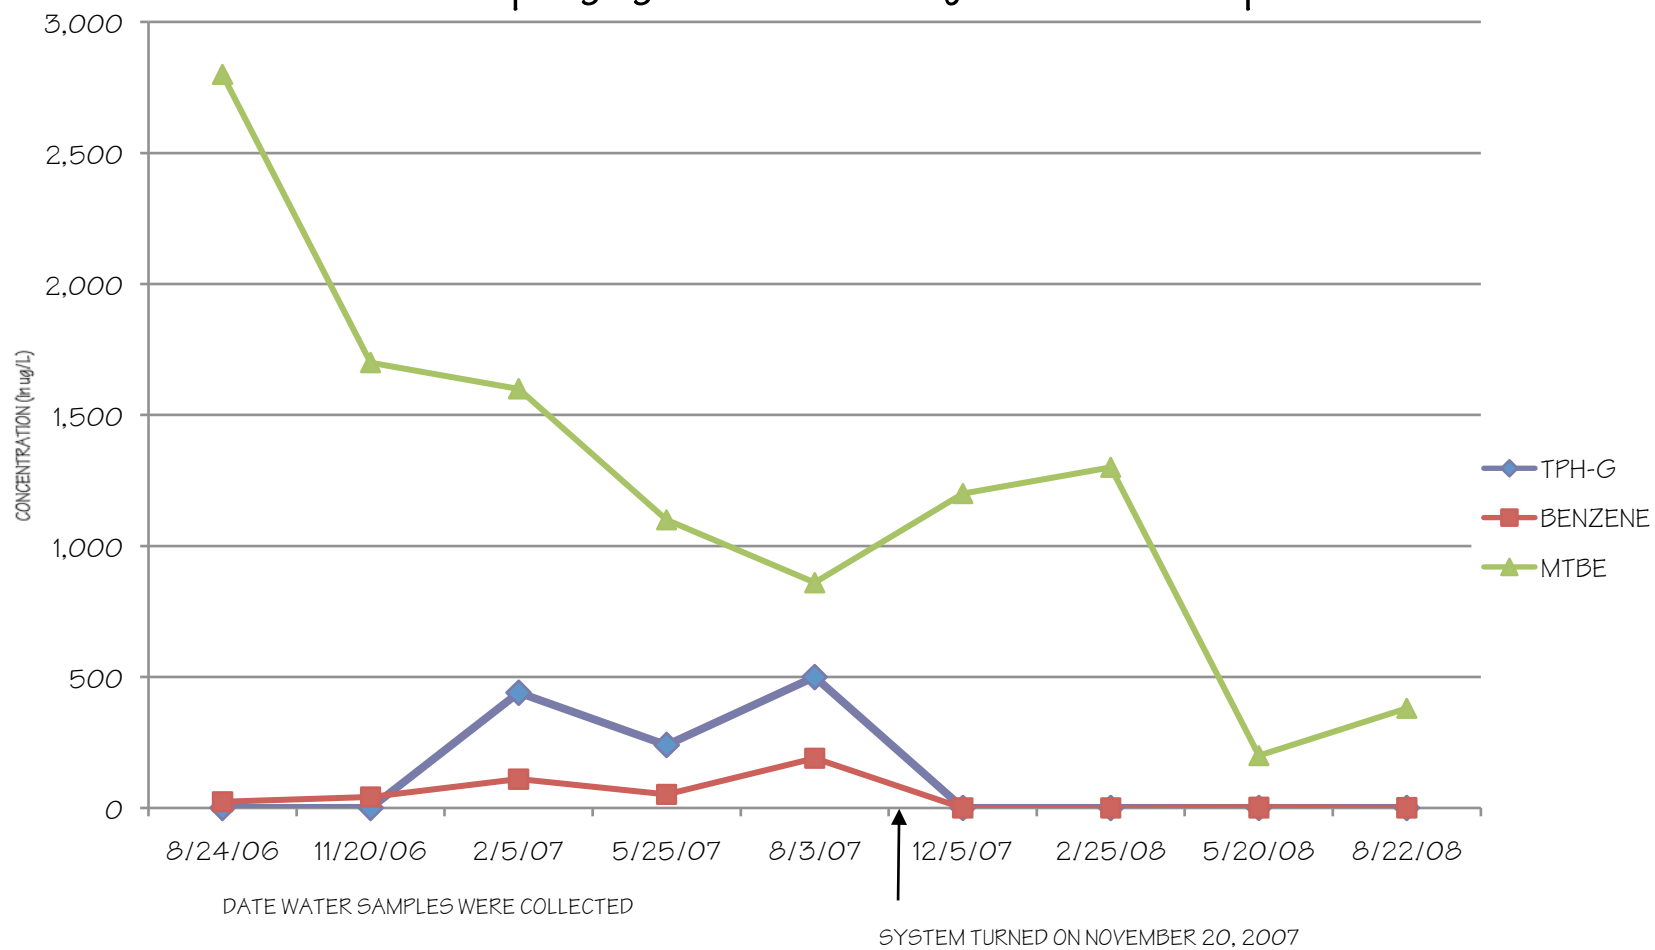
MTBE Concentrations in Monitoring Well MW-3 Since Ozone-Sparging Remediation System Start-Up

- A decreasing trend in concentrations of TPH-G, benzene, and MTBE is apparent in monitoring well MW-3.
- A decreasing trend in concentrations of TPH-G, benzene, and MTBE is apparent in monitoring well MW-4.

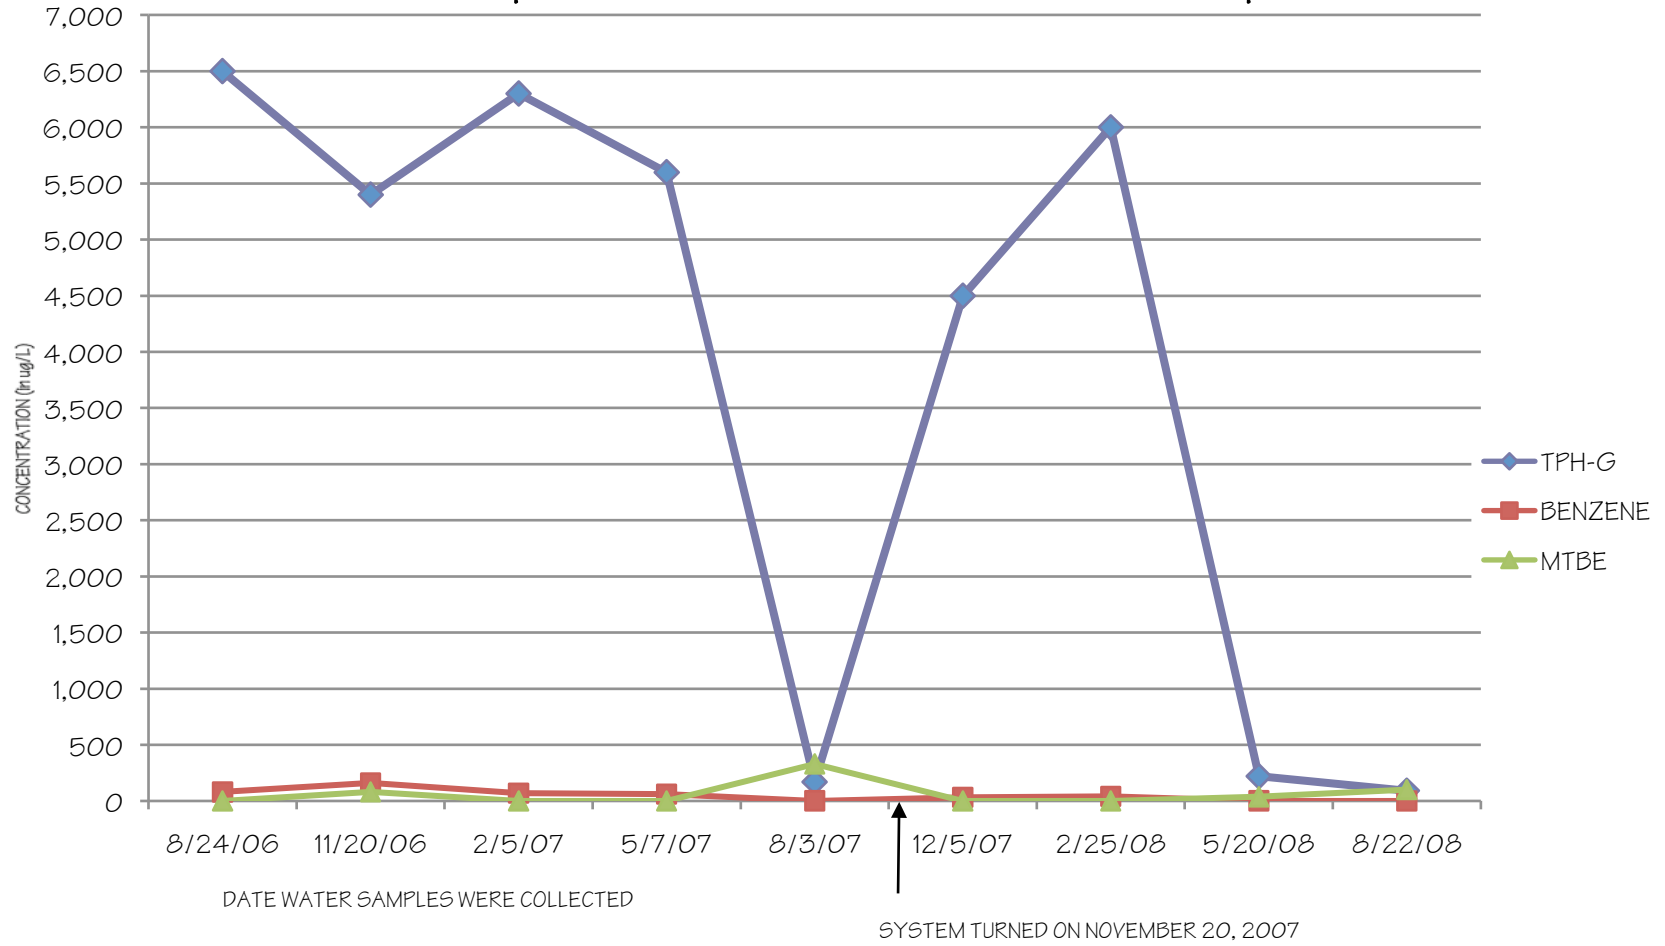
MTBE Concentrations in Monitoring Well MW-5R Since Ozone-Sparging Remediation System Start-Up

- Following an initial increase in TPH-G, a decreasing trend in concentrations of TPH-G and benzene is apparent in monitoring well MW-5R. The MTBE concentration has risen, but is not at an all time high.

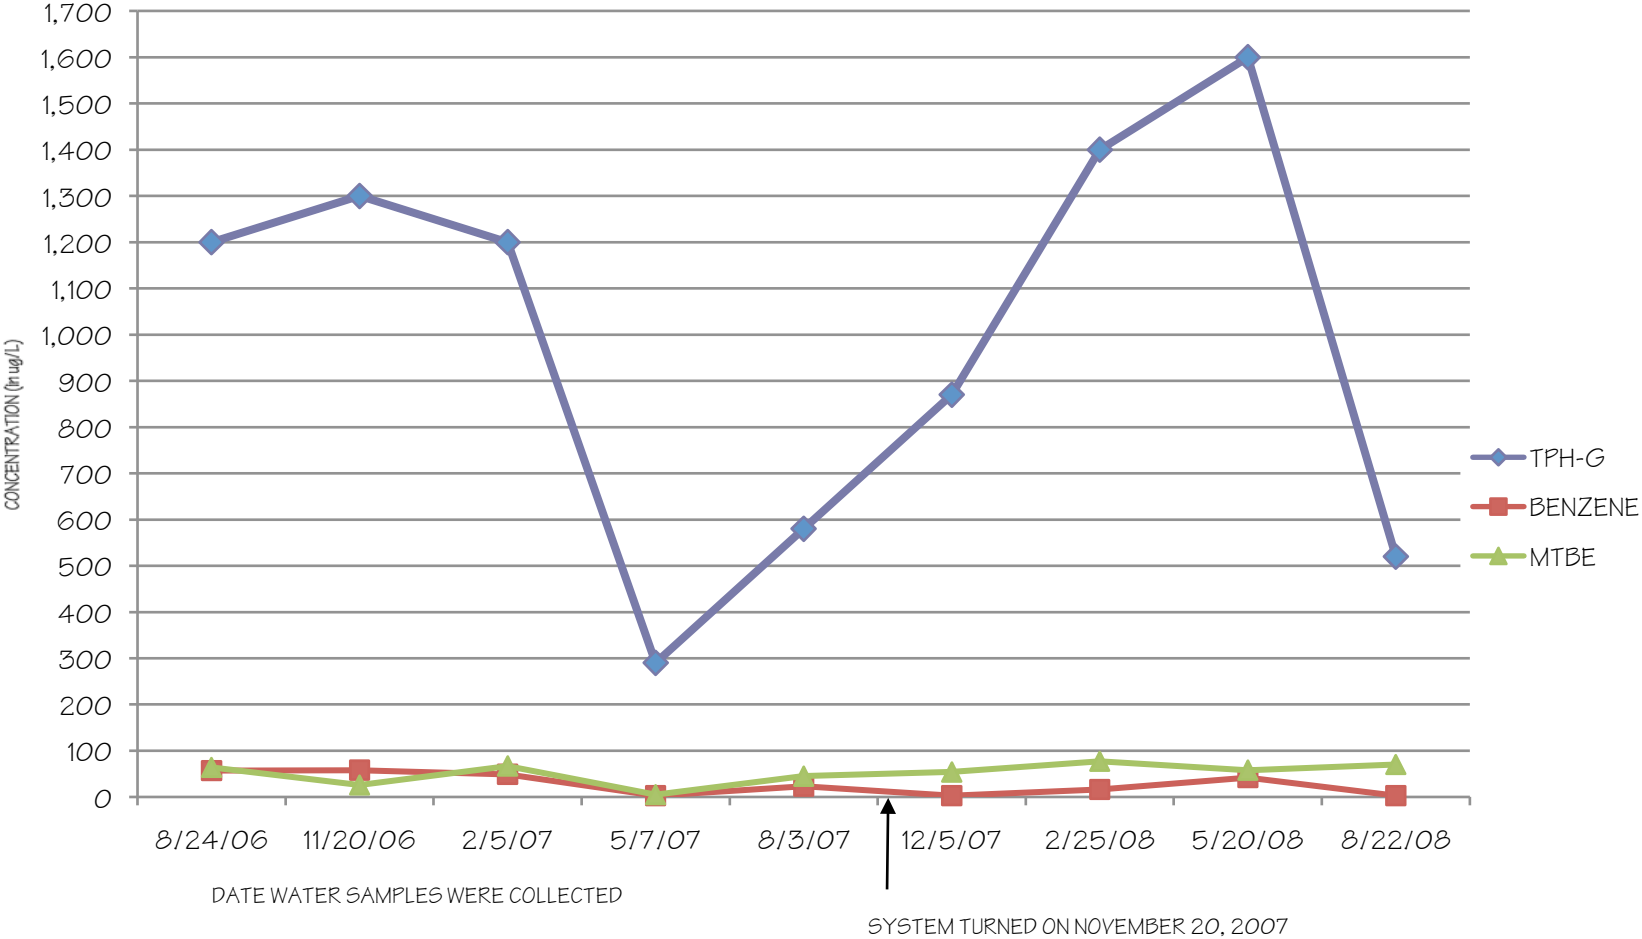
MTBE Concentrations in Monitoring Well MW-6 Since Ozone-Sparging Remediation System Start-Up

- Following an initial increase in TPH-G, a decreasing trend in concentrations of TPH-G is apparent in monitoring well MW-6. The benzene and MTBE concentrations have shown a fluctuation, but are still below historical highs.

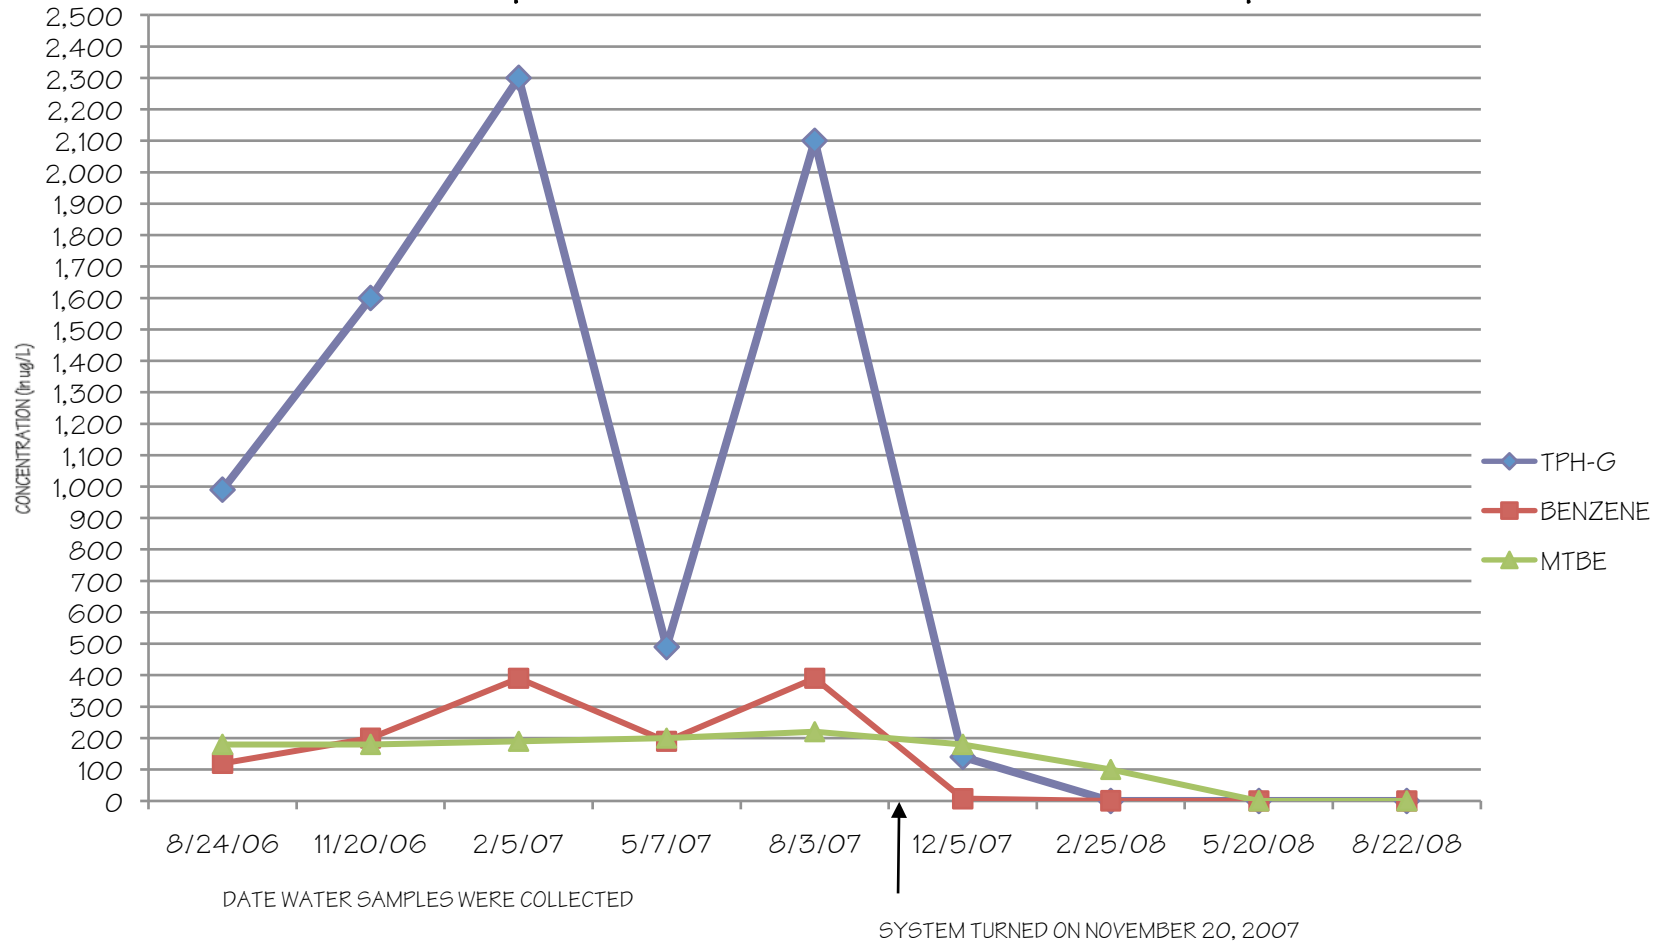
MTBE Concentrations in Monitoring Well MW-7 Since Ozone-Sparging Remediation System Start-Up

- A decreasing trend in concentrations of TPH-G, benzene, and MTBE is apparent in monitoring well MW-7.
- A decreasing trend in concentrations of TPH-G, benzene, and MTBE is apparent in monitoring well MW-8.

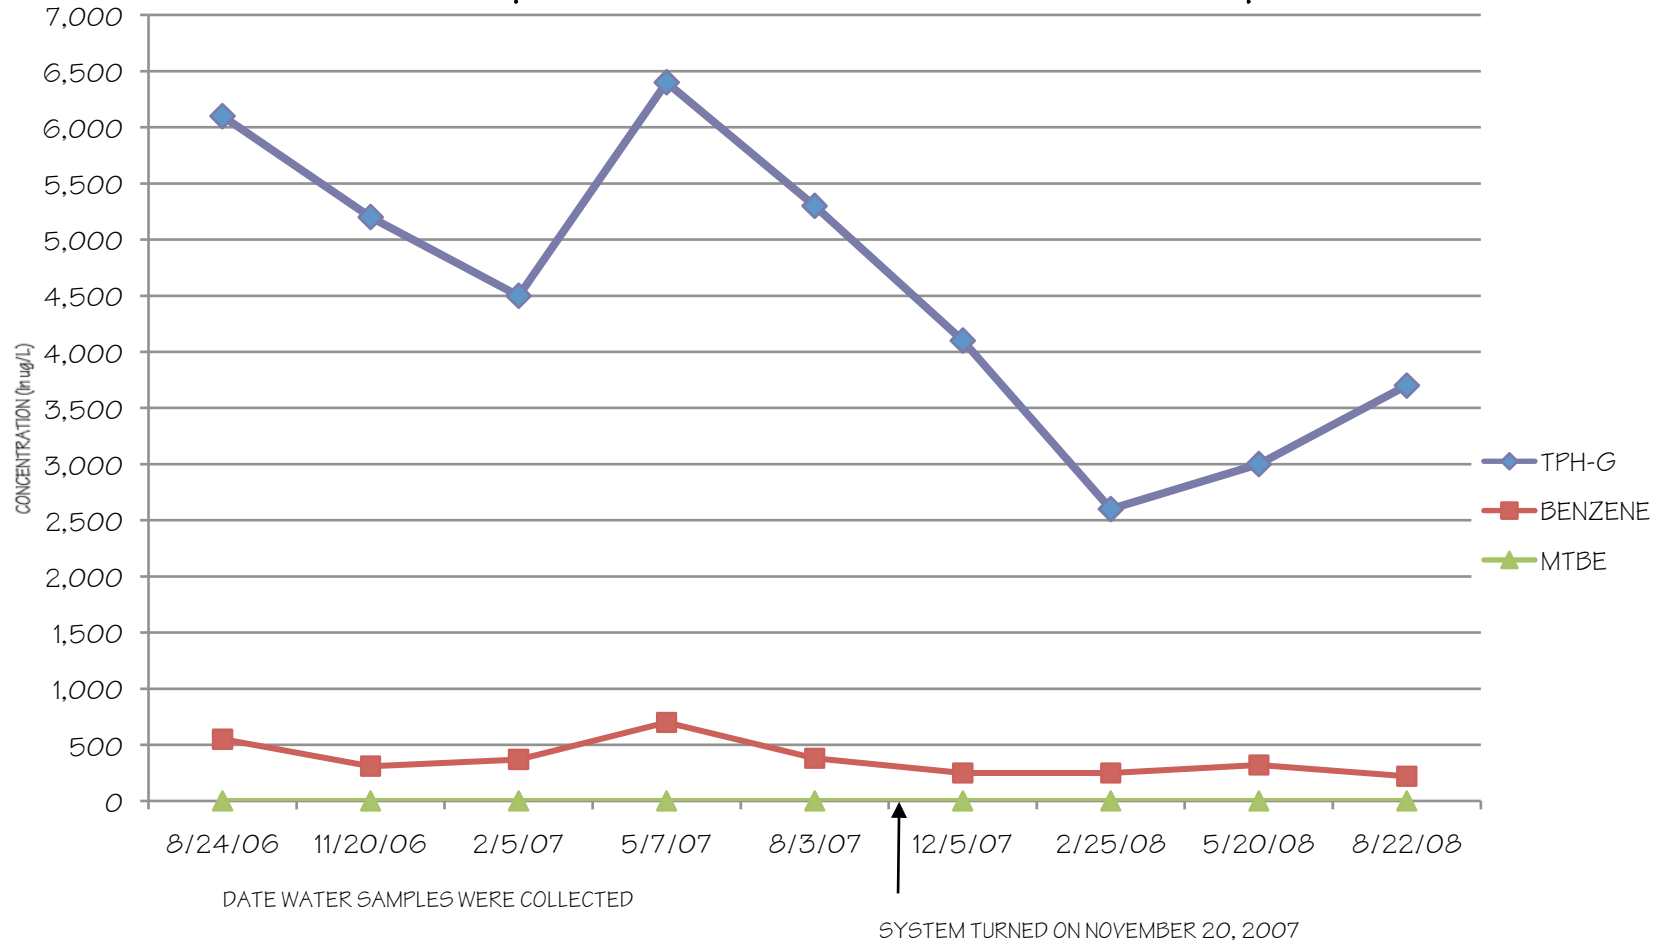
MTBE Concentrations in Monitoring Well MW-9 Since Ozone-Sparging Remediation System Start-Up

- The TPH-G, benzene and MTBE concentrations have shown a fluctuation in MW-9, but are still below historical highs.
- The TPH-G, benzene and MTBE concentrations have shown a fluctuation in MW-10, but are still below historical highs.
