SUBJECT: Former UST Location Investigation for the Kawahara Nursery, 16550
Ashland Ave., San Lorenzo, CA

CHRONOLOGICAL DOCUMENTATION OF FORMER UST LOCATION INVESTIGATION

Photos of UST Location Trenching Excavation Activities

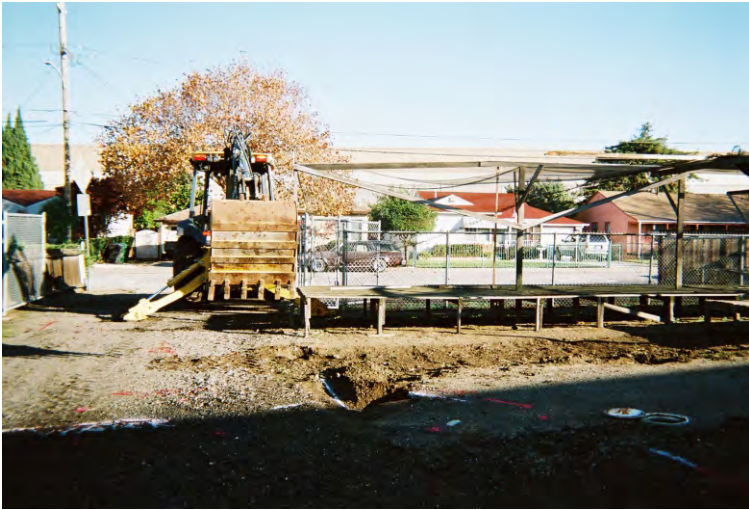
Photo 1 - View North.
Excavation begins at the Lath House adjacent to groundwater monitor well MW-3. Backhoe bucket is 3 feet wide.

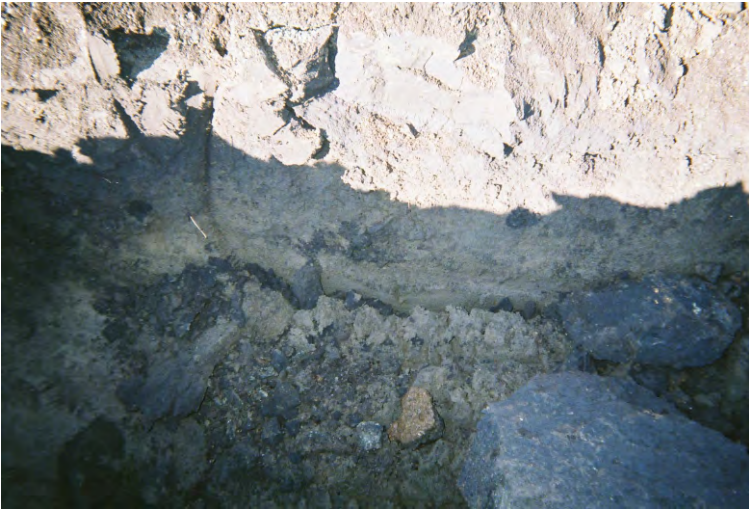
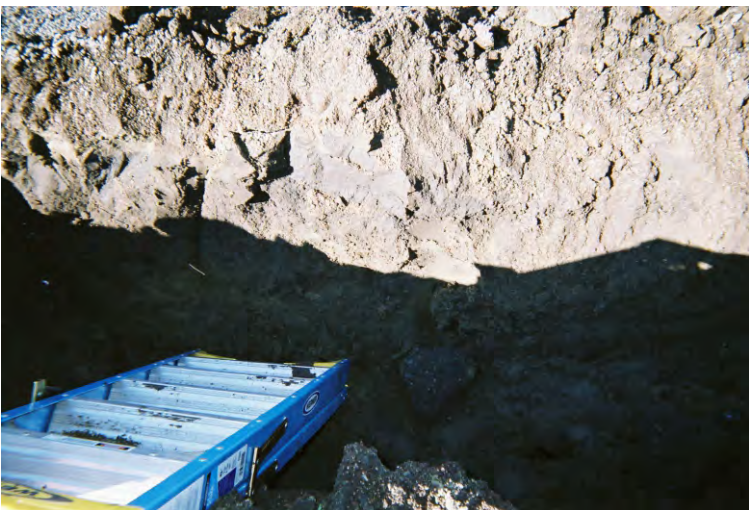
Photos 2 & 3 - View to the west of the north-south trending trench. 0 to 1½ ft bgs is fill composed of vermiculite and ground up bone and red lava rock.

1½ to 2½ ft bgs is a natural silty clay, black, soft and moist. 2½ to >4 feet bgs is a clayey silt, light olive green, soft and moist.

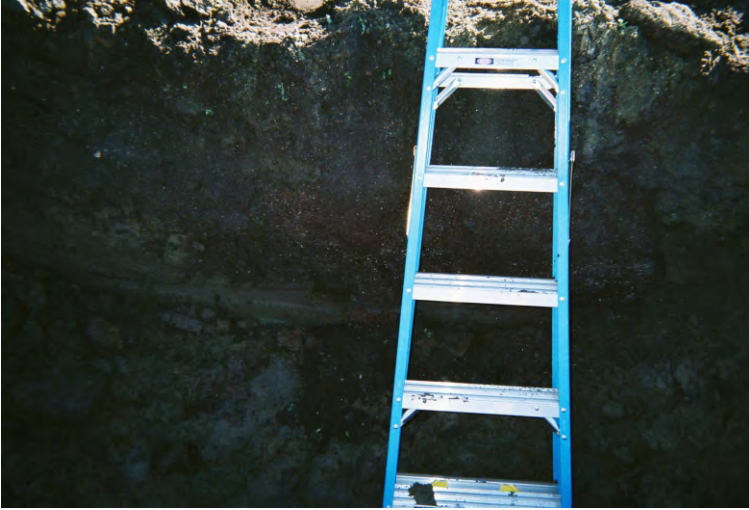
Photos 4 & 5 - View to the east of the north-south trending trench. 0 to 4 ft bgs is fill composed of vermiculite and ground up bone and red lava rock. >4 feet bgs is a clayey silt, light olive green, soft and moist.

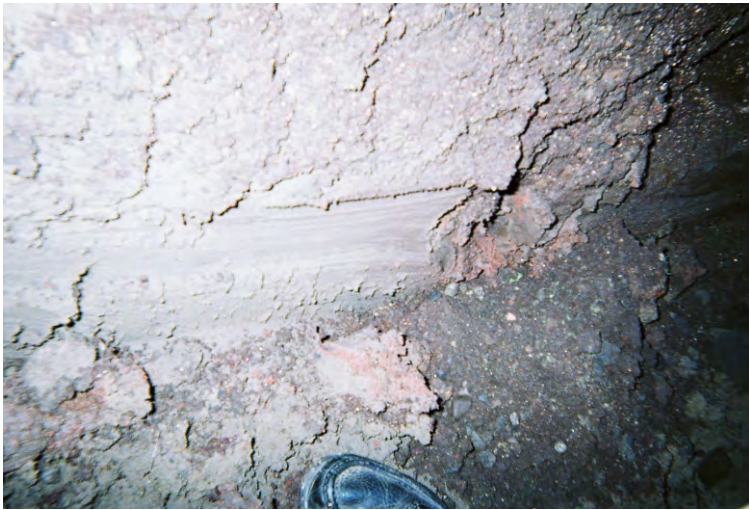
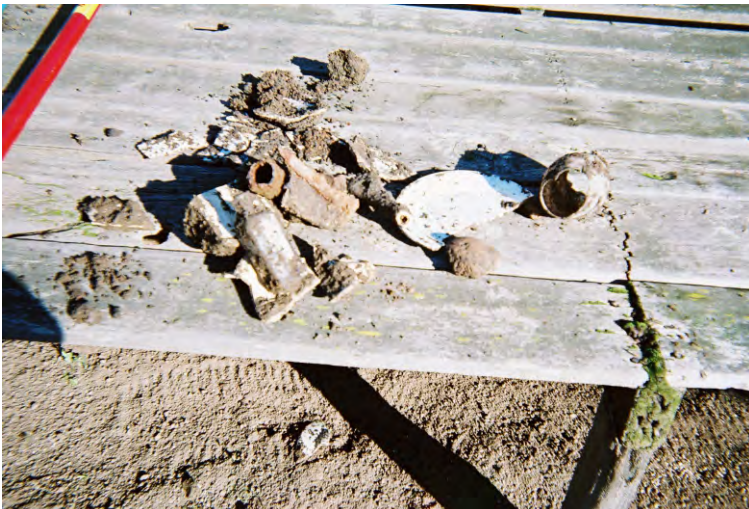
Photo 6 - Fill debris recovered from 1½ feet bgs from the west side of the trench. Debris composed of bottles, railroad spike, metal pipe, and ceramic plate.

Likely, partially, responsible for magnetic anomaly at suspected gasoline UST location.

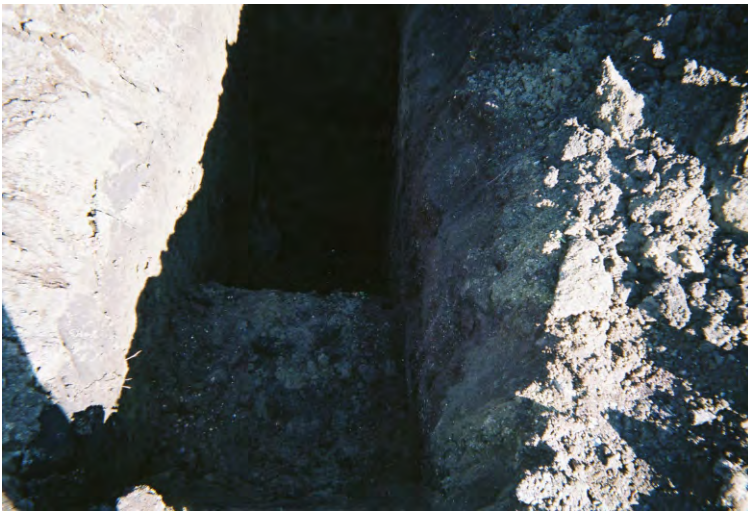
Photo 7 - View to the south of the north-south trending trench. Depth in photo is 7½ feet bgs. Depth reached was 8½ feet bgs. No groundwater encountered. No olfactory or visual evidence of hydrocarbons encountered.

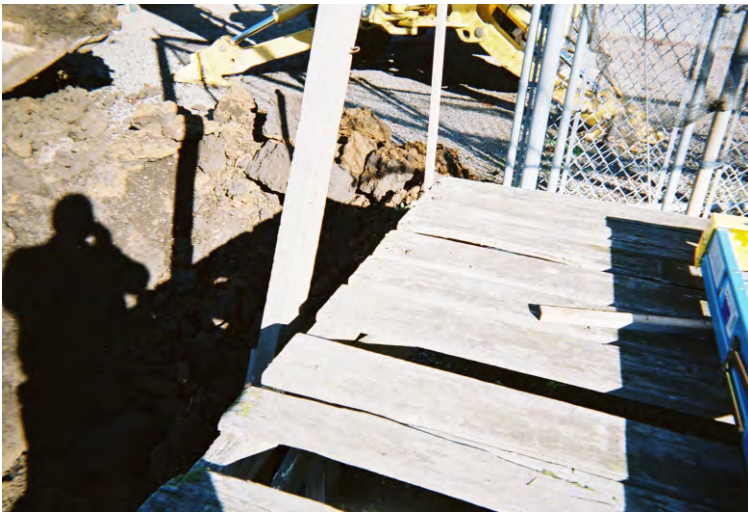
Photo 8 - View to the north of the north-south trending trench of the excavation extension to the north past the fence line.

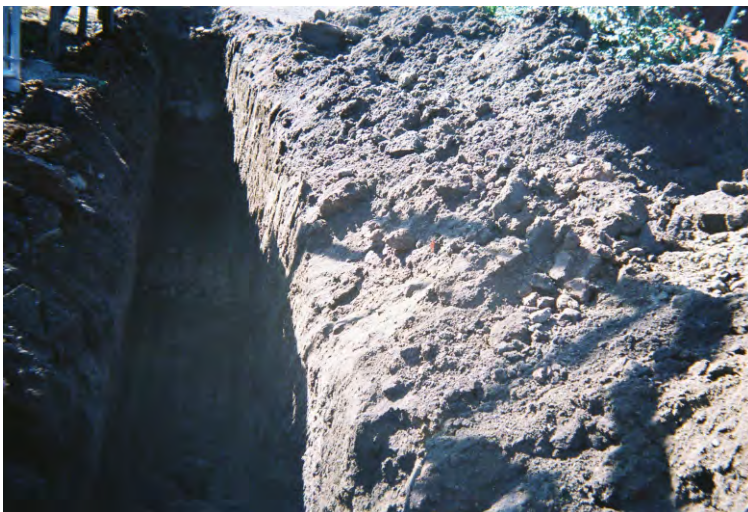
Photo 9 - View to the south of the north-south trending trench extended to the north past the fence line. Depth in photo is 7 feet bgs. Depth reached was 8½ feet bgs. No groundwater encountered. No olfactory or visual evidence of hydrocarbons encountered.

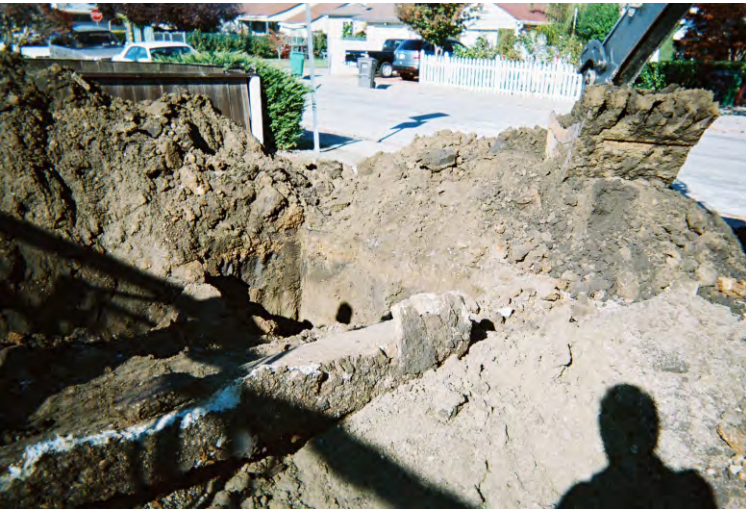
Photo 10 - View to the northwest of the termination of the north-south trending trench and the initiation of a new trench extending to the east.

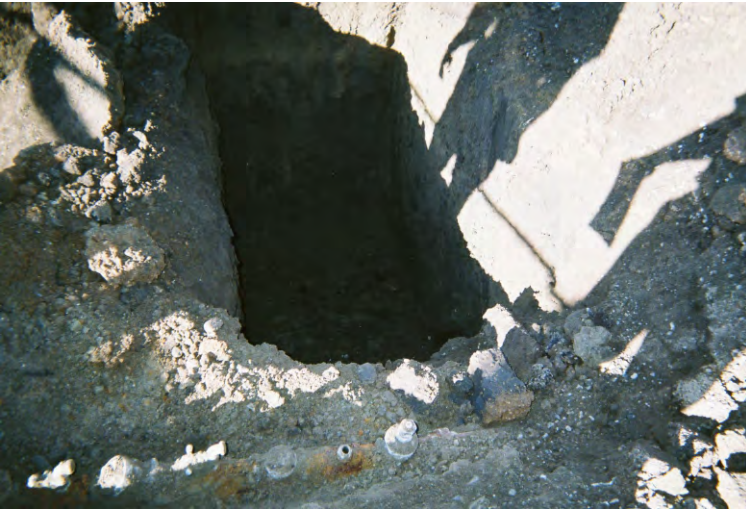
Photo 11 - View to the west of the extended east-west trending trench. See the abandoned water line encountered to the east at the bottom of the photo.

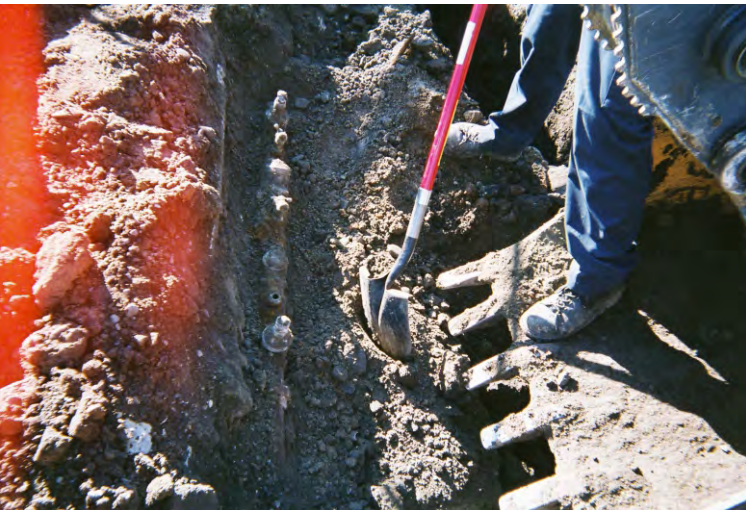
Photo 12 - View to the north of the north-south trending abandoned metal water line. This water line extends to the south and crossed over the top of the former gasoline UST, south of the fence line. This is very likely the cause of the magnetic anomaly identified to the north of the suspected former gasoline UST and north of the fence line.

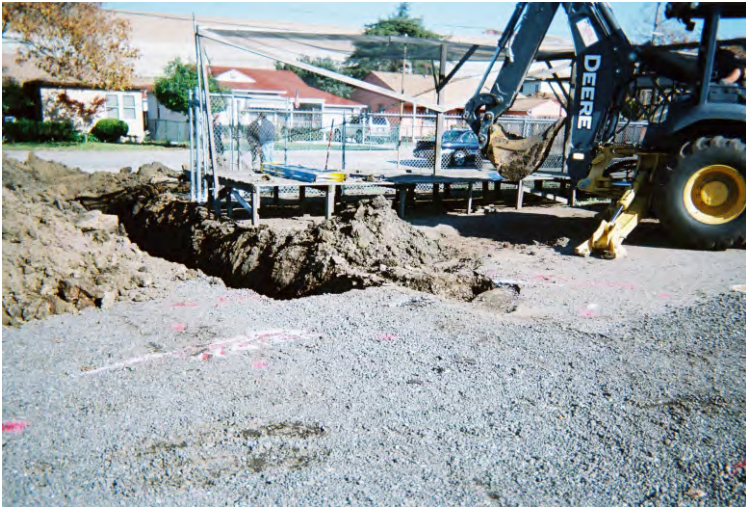
Photo 13 - View to the northeast of the termination of the south end of the north-south trending trench where a new trench was extended to the east at the suspected location of the former gasoline UST.

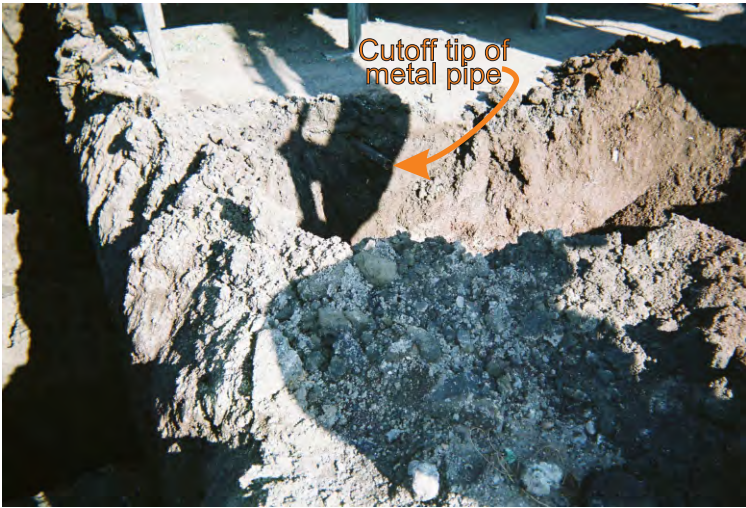
Photo 14 - View to the north of the former gasoline UST trench with cut off metal pipe sticking out of side wall.

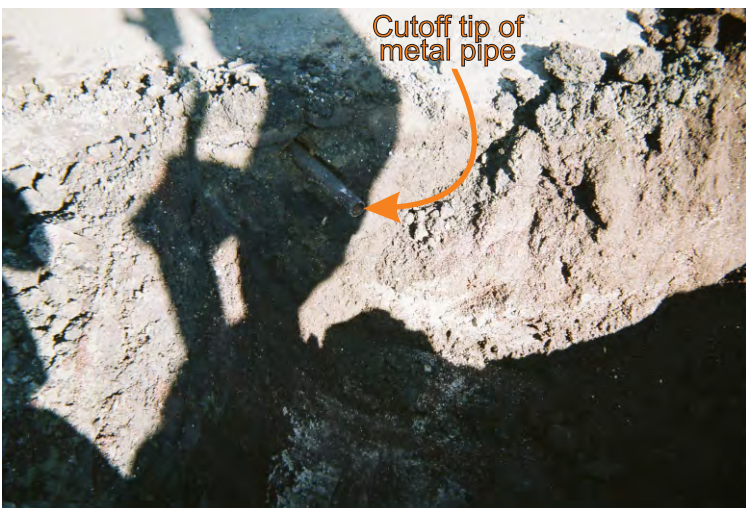
Photo 15 - View to the north of the former gasoline UST trench with cut off metal pipe sticking out of side wall. Notice the reddish colored vermiculite and crushed lava rock potting soil used as fill in the side wall.

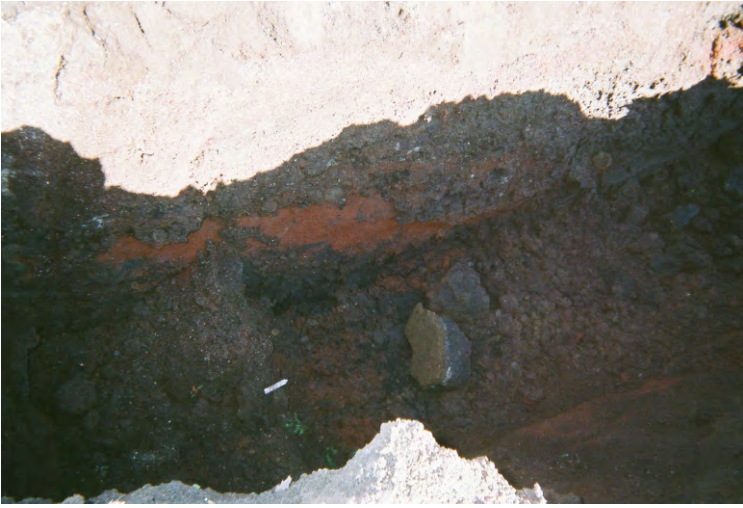
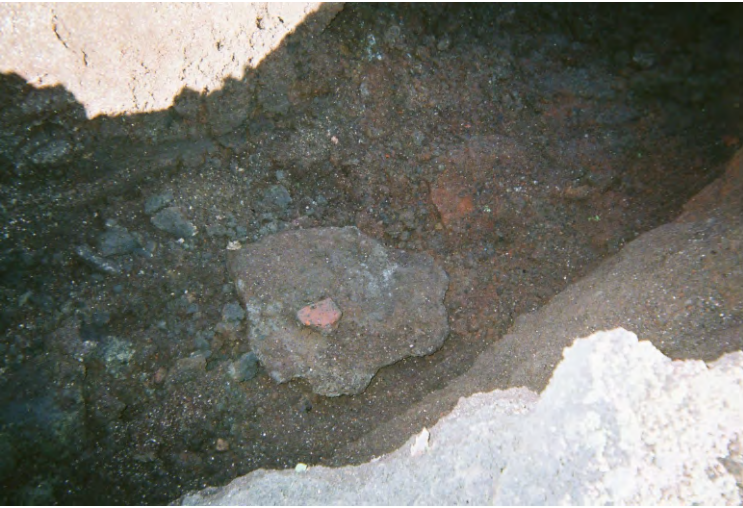
Photos 16 & 17 - View to the north of the north wall of the former UST tank pit. soil layers are composed of 3½ feet of vermiculite fill underlain by a ½ foot thick conglomeritic concrete over a foot of crushed red lava rock that is now seen as a clayey sand (fill 0 to 4½ feet bgs). Photos show trench to a depth of 4½. Trench was excavated to 7½ feet bgs. Below the fill is 2 feet of soft, moist, black clay over 2 feet of firm, moist, green silty clay (natural soil 4½ to 7½ feet bgs).

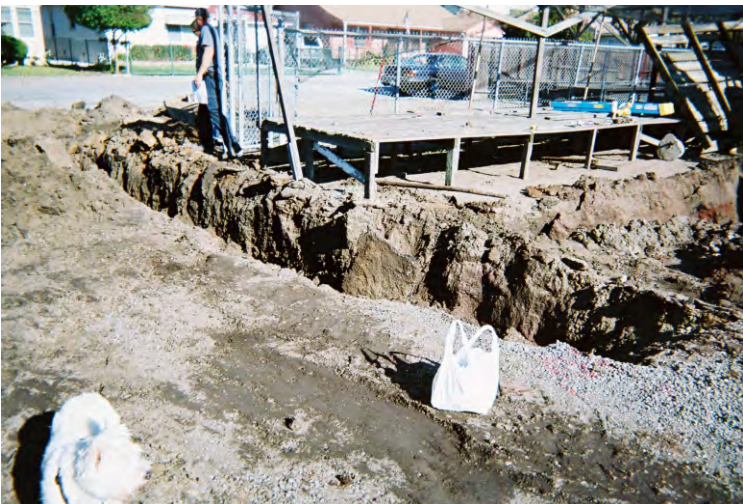
Photo 18 - View to the northeast of the north-south trending trench and the former gasoline UST trench.

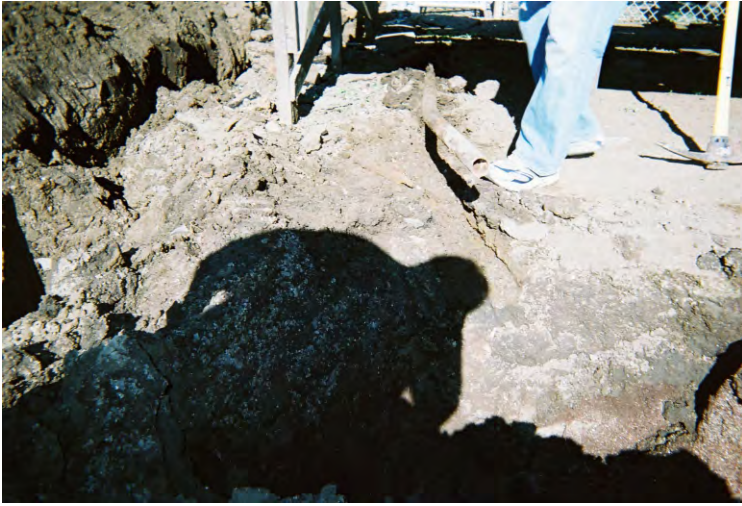
Photo 19 - View to the north of the cutoff metal water pipe.

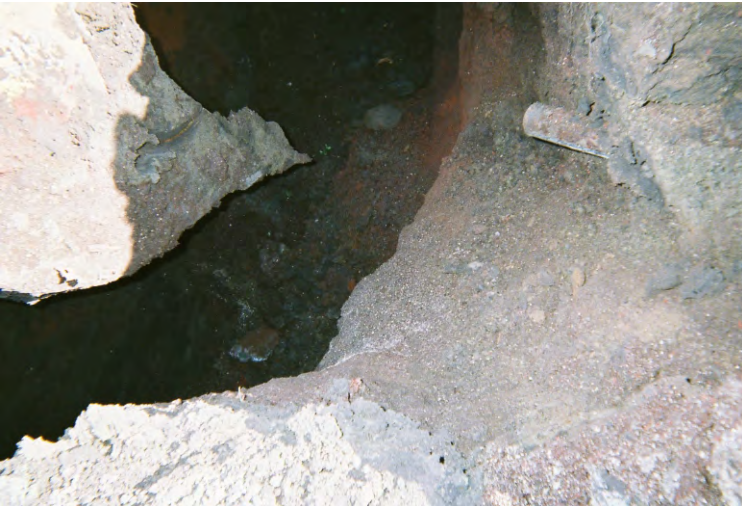
Photo 20 - View to the east of the east-west trending former gasoline UST pit with a cutoff metal water pipe sticking out of the south wall of the trench.

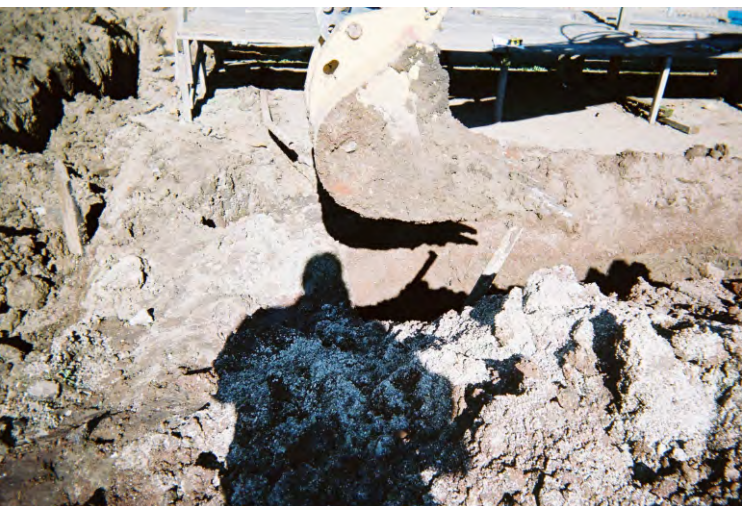
Photo 21 - View to the north of the east-west trending former gasoline UST pit showing the metal water pipe cut out over the trench.

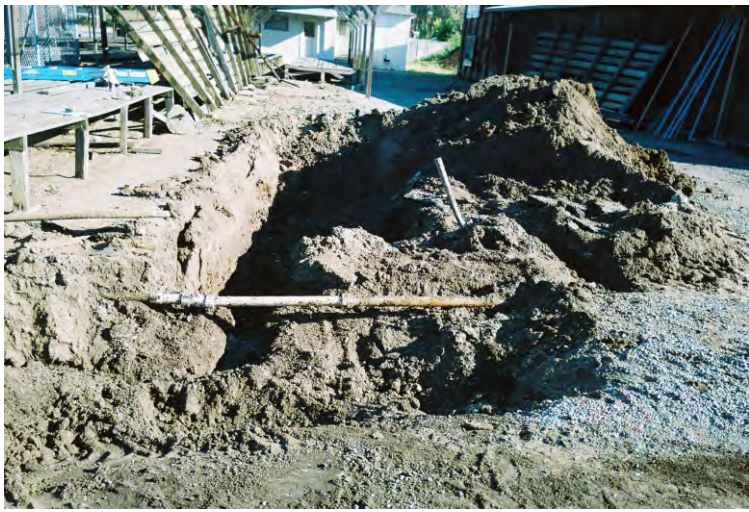
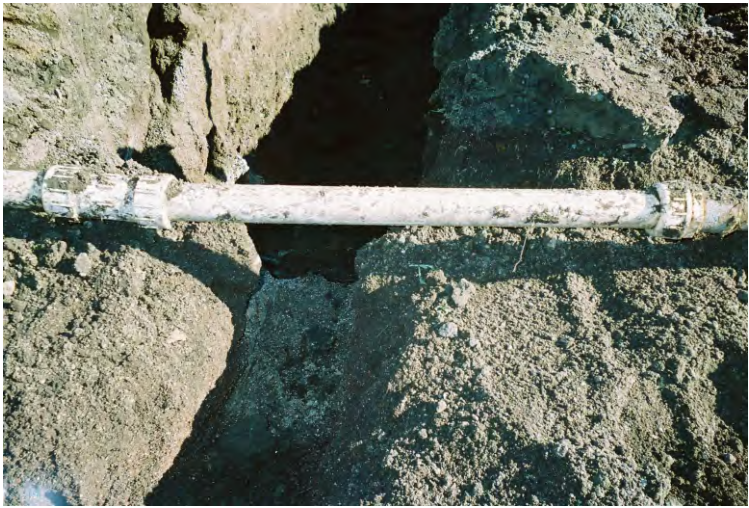
Photos 22 & 23 - View to the east along the former UST pit. A 2nd water pipe was exposed while excavating immediately west of the 1st water pipe discovered. The 2nd water pipe shown is a PVC splice inserted between the previously removed section of a metal water pipe. It appears that both sets of water pipes had their sections cut out to provide access to remove the former UST. Also, the magnetic anomalies identified by the former geophysical survey were likely picking up these metal pipes. Photo 23 shows a closeup of the PVC splice of the water pipe.

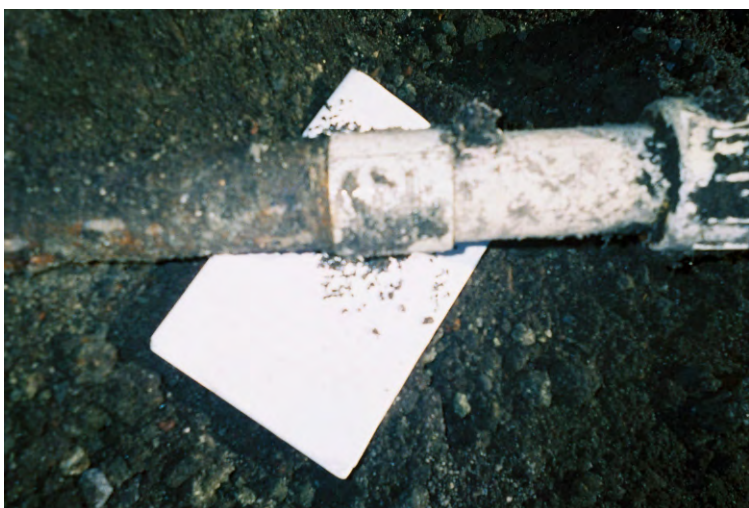
Photo 24 - Closeup of the coupling that connects the cut metal pipe with the PVC splice.

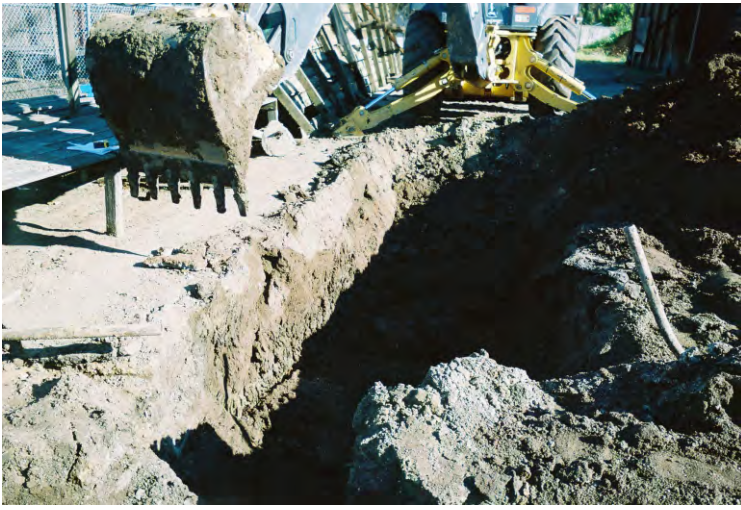
Photo 25 - View to the east along the former UST pit. The north wall of the trench shows the reddish fill soil to a depth of four feet bgs.

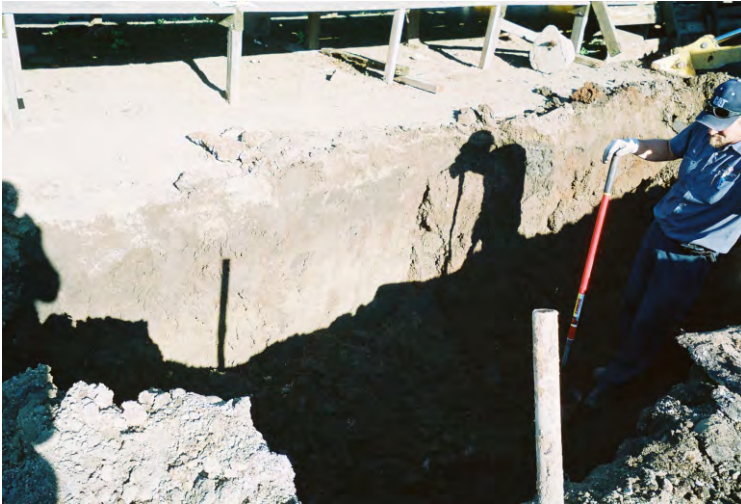
Photo 26 - View to the east along the former UST pit. After the fill, which was shown standing against the sidewall, caved into the bottom of the trench, natural black clay soil was now exposed in the side wall. It appears that the newly exposed side wall is the north wall of original gasoline UST removal pit.

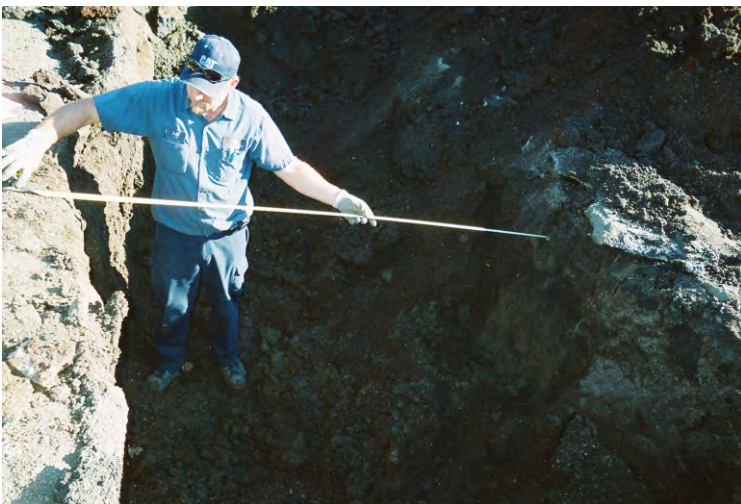
Photo 27 - Width of the original gasoline UST pit is shown to be 7 feet across, and a depth of approximately 4 feet. The olive green clayey silt was observed at the bottom of the trench.
