- 1) Sub-Slab Soil Vapor Sampling Report**
  - 2) Soil and Groundwater Investigation Results**
- P&D 23<sup>rd</sup> Avenue Associates, LLC  
1125 Miller Avenue, Oakland, CA  
Clearwater Project No. CB018H  
ACEH Fuel Case Leak No. RO0000294

## **SUB-SLAB SOIL VAPOR SAMPLING REPORT**

**P&D 23<sup>rd</sup> Avenue Associates LLC  
(Formerly 23<sup>rd</sup> Avenue Partners)  
1125 Miller Avenue  
Oakland, California**

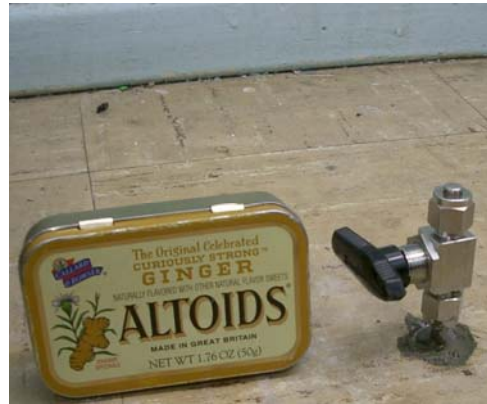
Sub-slab Vapor Probe Diagram (Flush mount and Raised Mount diagrams)

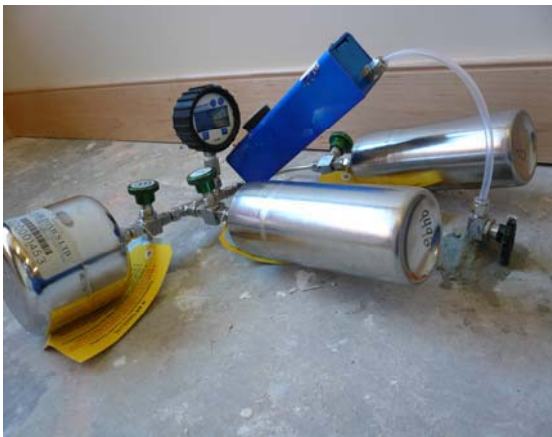
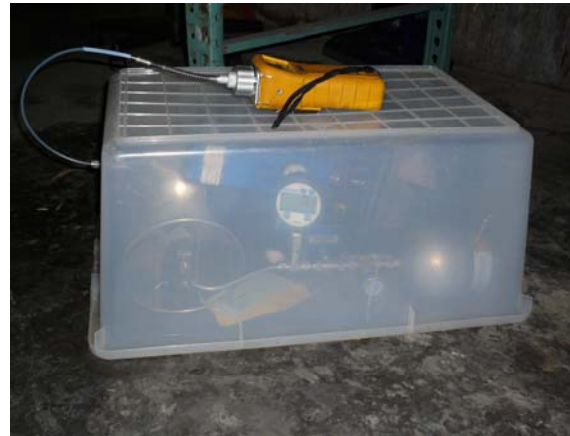
Typical sub-slab sampling manifold and encasement within Shroud with IPA atmosphere.
