SAMPLING REPORT

Call Mac Transportation
461 McGraw Road
Livermore, California 94551
EPA ID Number CAC002567140

Report Completed by: Robert Aragon, P.E., MS

Investigation Date: November 20, 2003

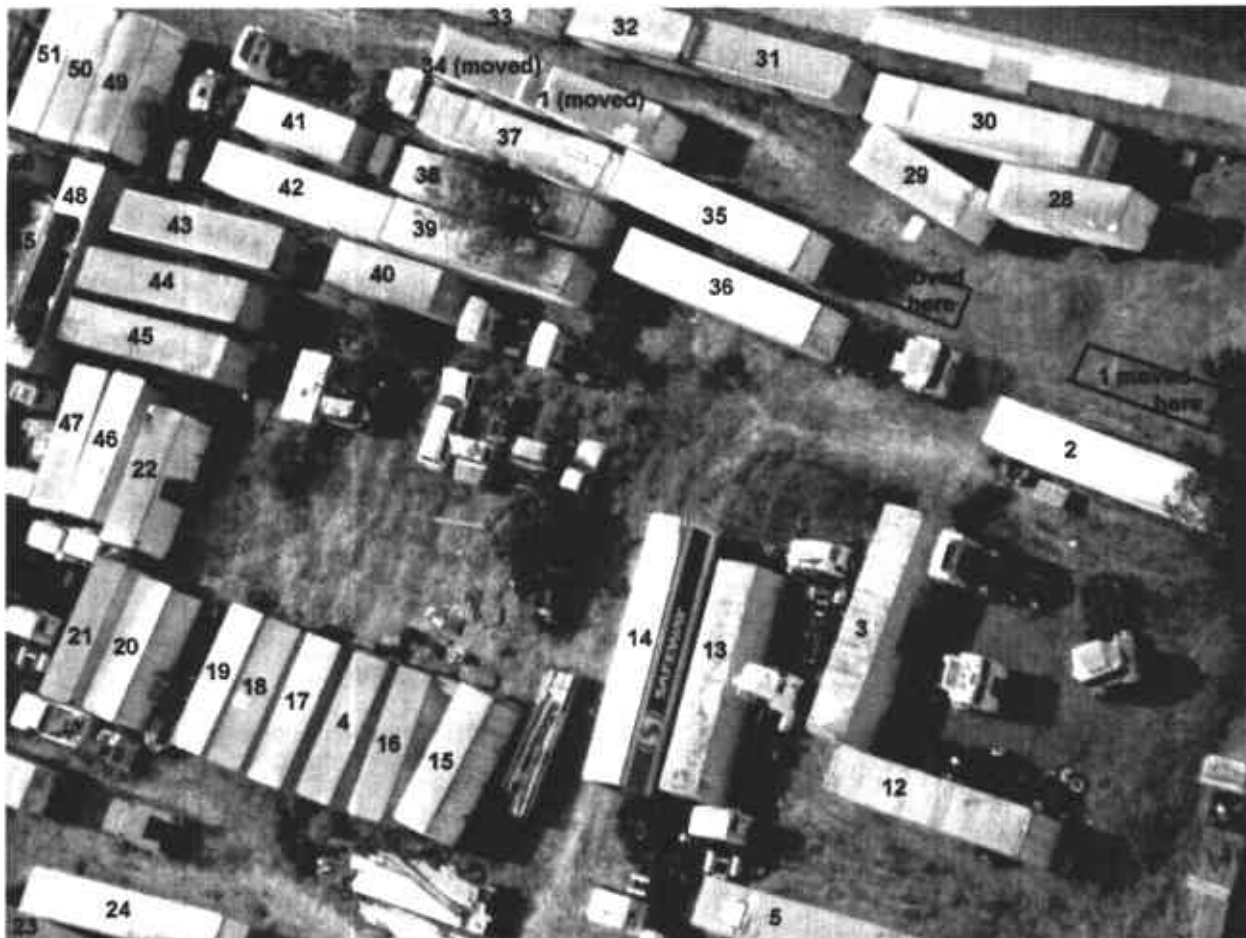
Photo no. 2: Aerial photo with trailers labeled
(photo taken on Oct. 3, 2003).

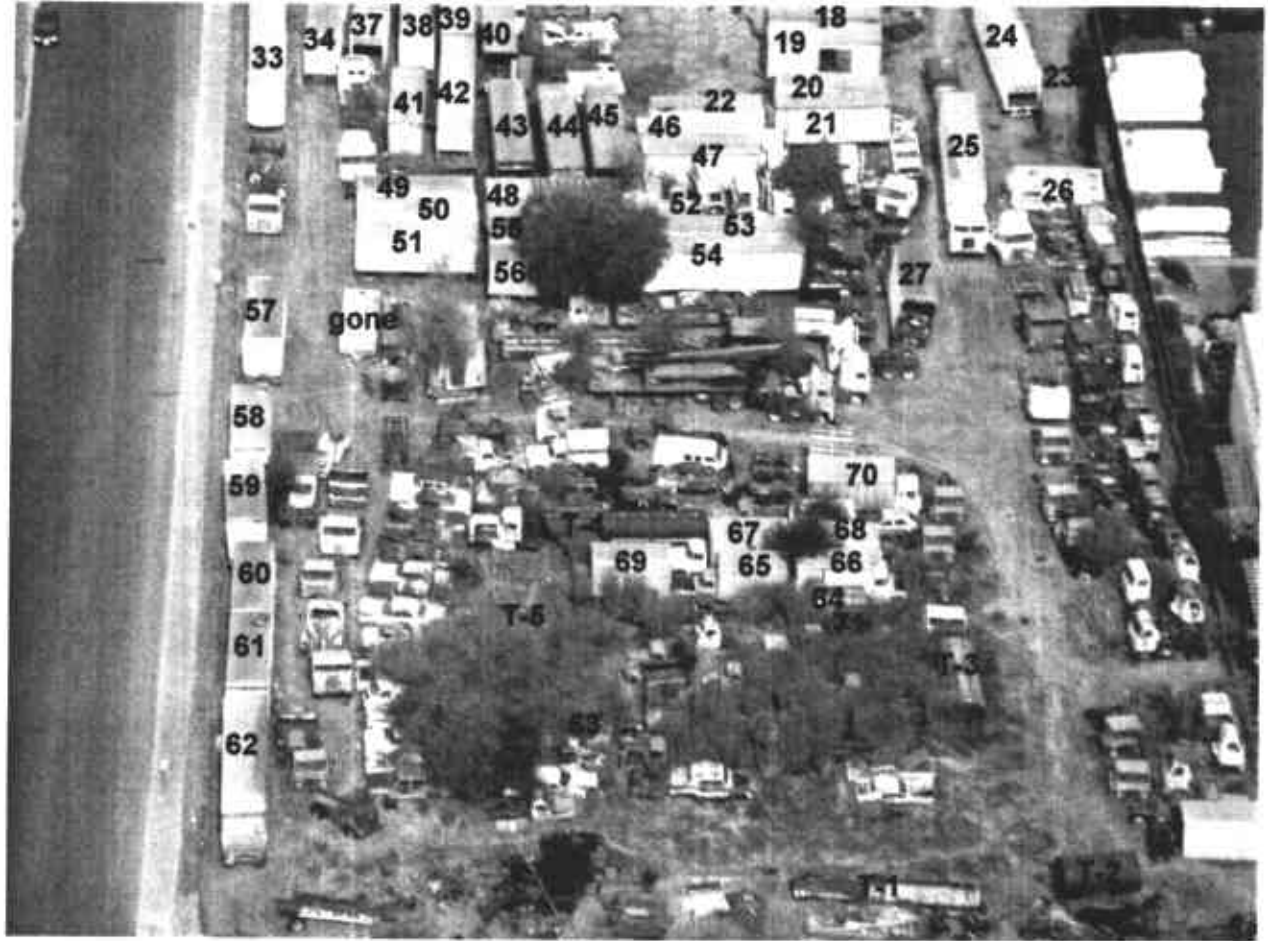
Photo no. 3: Aerial photo looking north with trailers labeled
(photo taken on Oct. 3, 2003).

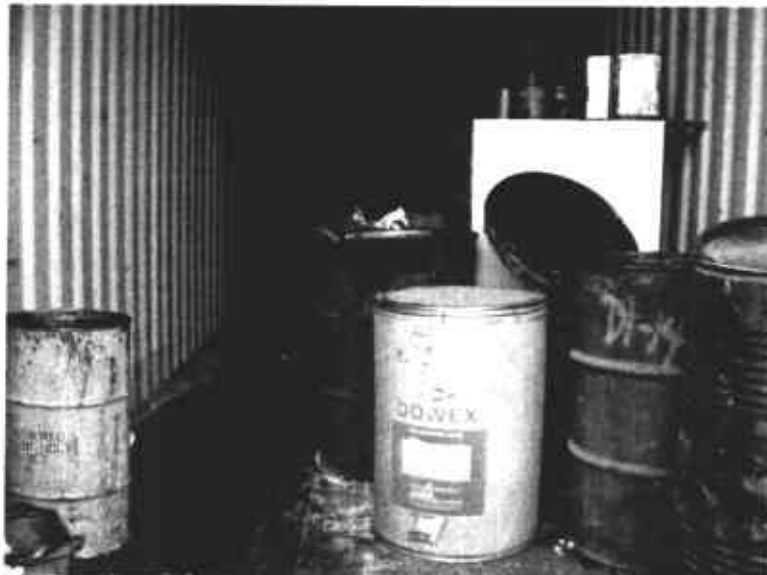
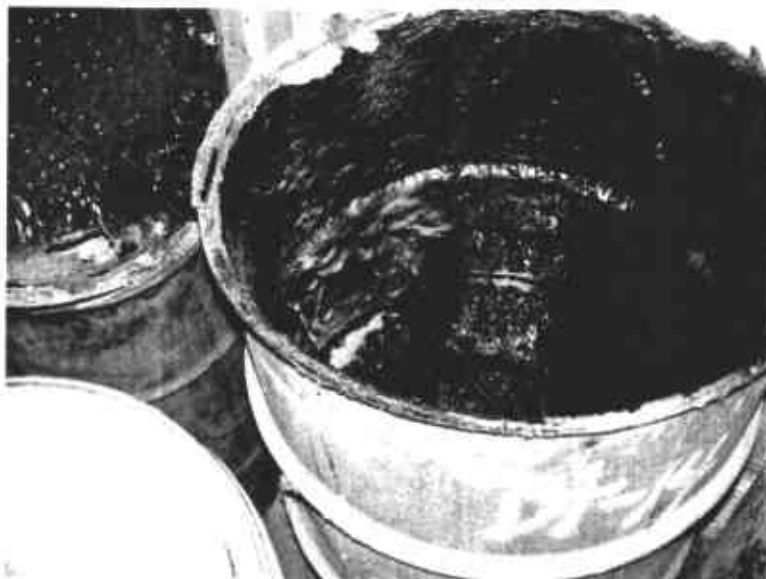
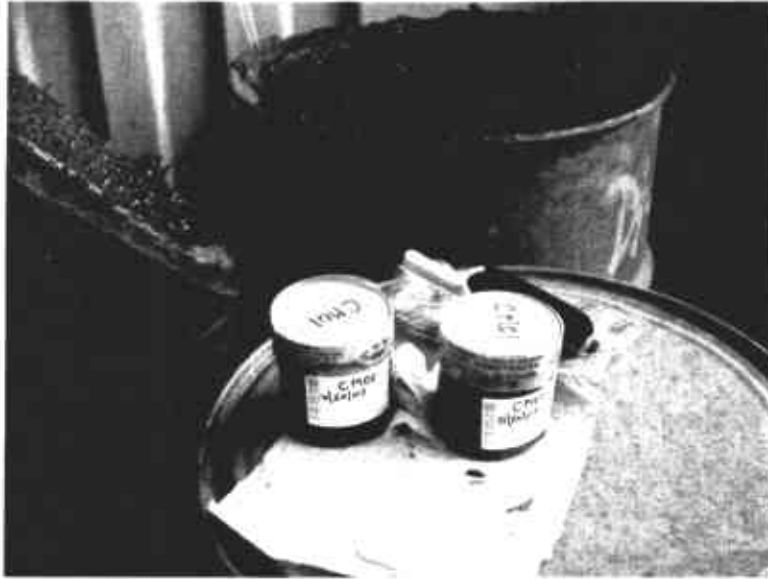
Sample CM01 was taken from a rusty, metal, 55-gallon drum in trailer no. 3. The drum was marked DI-14 and is shown below in photo no. 4. Mr. Pang used a new plastic scoop to collect the sample, which was thick, black material. The drum was two-thirds full and there were three other full 55-gallon drums of the same material in trailer no. 3.

Photo no. 4: Sample CM01 was taken from the drum labeled DI-14.

Photo no. 5: Sample CM01 was taken from this thick dark material inside of the drum.

Photo no. 6: Sample CM01 after it was taken.

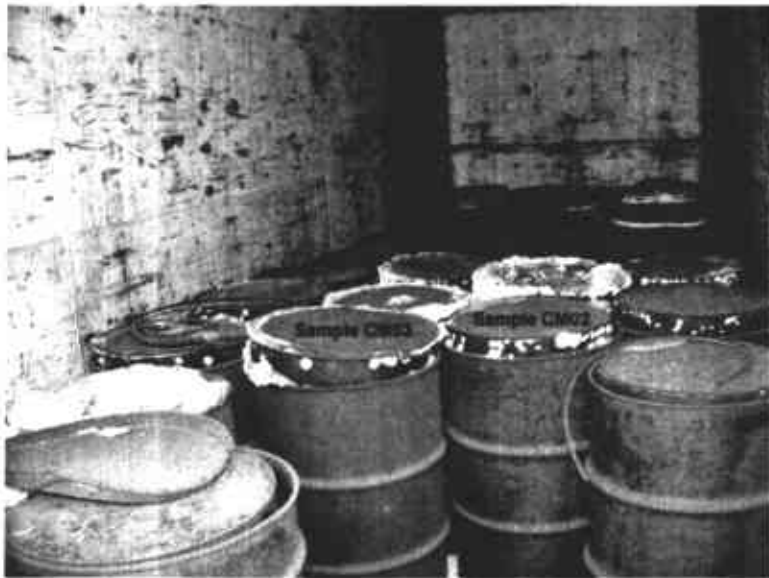
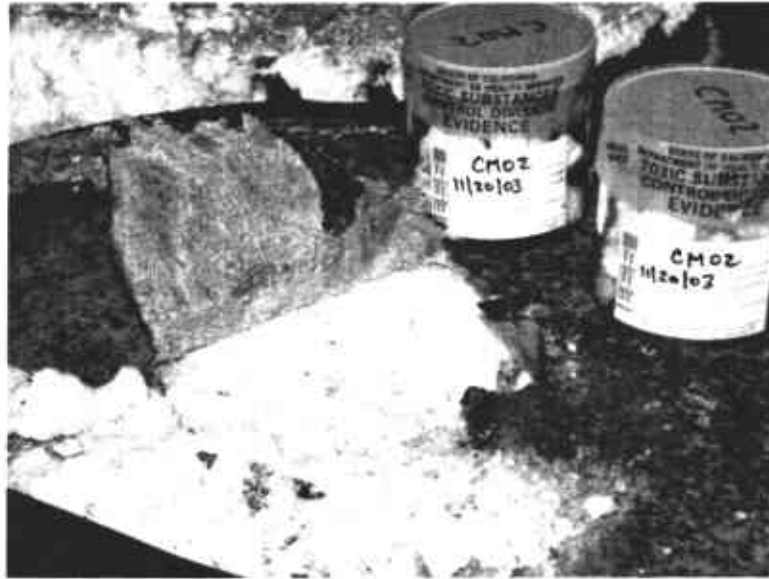
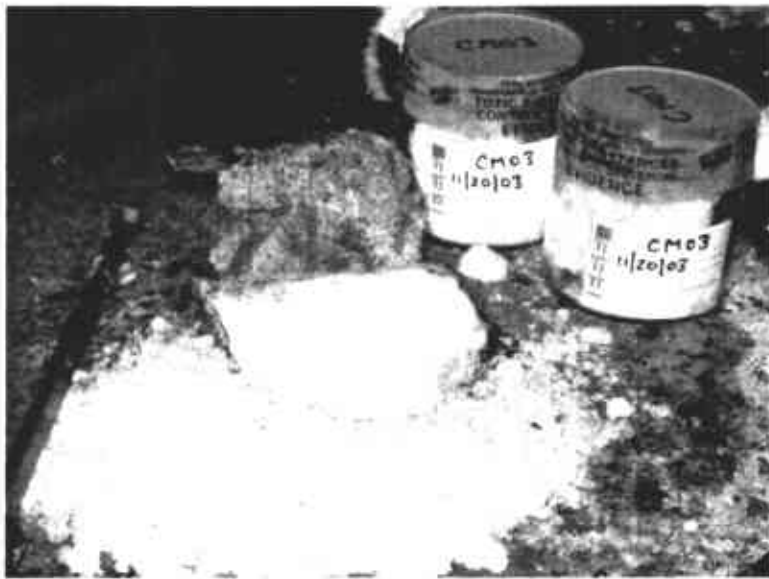
Samples CM02 and CM03 came from two of the 36 rusty drums containing white caustic solids in trailer no. 4 (photo no. 7). All the drums were turned upside down and placed inside 55-gallon drums. All the drums were rusty and deteriorating.

The two drums that the samples were taken from are shown in photo no. 7. We used tools to cut open the tops of the two drums. The white material that has leaked out around the outside of the drums was flaky. The white material inside the drums we cut open was harder material. The samples came from the harder material inside of the drums (photos no. 8 & 9). Mr. Pang broke out pieces of hard material with a screwdriver and put them into the jars using new, clean gloves.

Photo no. 7: Thirty-six 55-gallon drum containing caustic solids inside of trailer no. 4. Samples CM02 and CM03 were taken from the labeled drums.

Photo no. 8: Sample CM02 after it was taken.

Photo no. 9: Sample CM03 after it was taken.

The corrosivity results are dated December 10, 2003 and can be found in Attachment C. Only samples CM02 and CM03, which were solids taken from the drums in trailer no. 4, were analyzed for pH. HML added 20 milliliters (ml) of deionized water to the samples in accordance with EPA method 9040B. The results indicate both the solutions of deionized water and samples CM02 and CM03 had a pH of >13.0. Therefore, in accordance with the California Code of Regulations, Title 22, section 66261.22(a)(3), the drums in trailer no. 4 contain hazardous waste because a representative sample of the waste produced a solution having a pH of greater than 12.5. The 36 drums in trailer no. 4, shown in photo no. 7, contain hazardous waste that exhibits the characteristic of corrosivity.

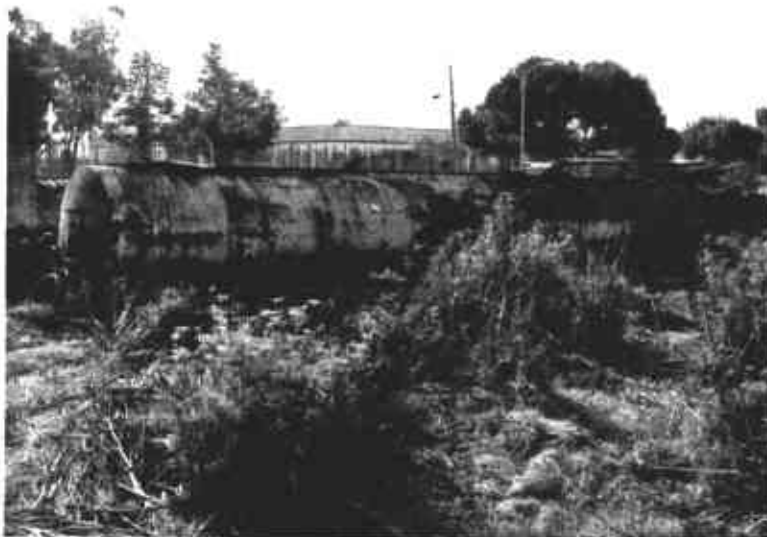
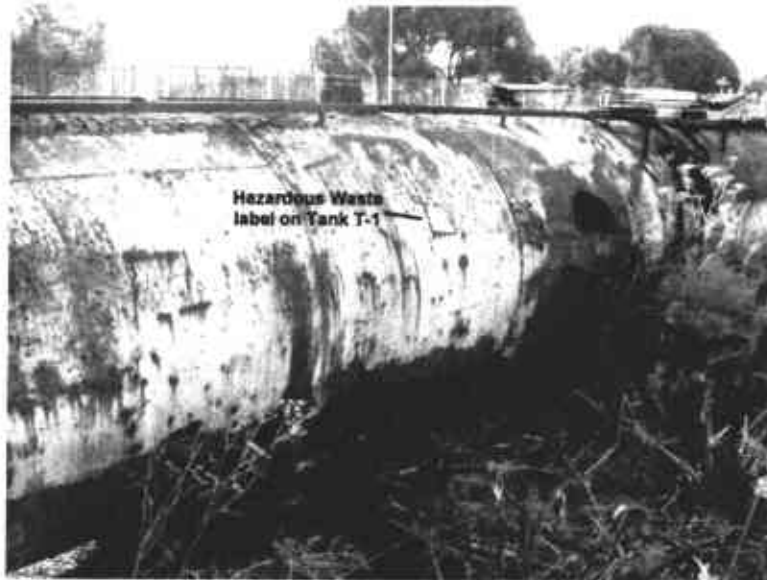
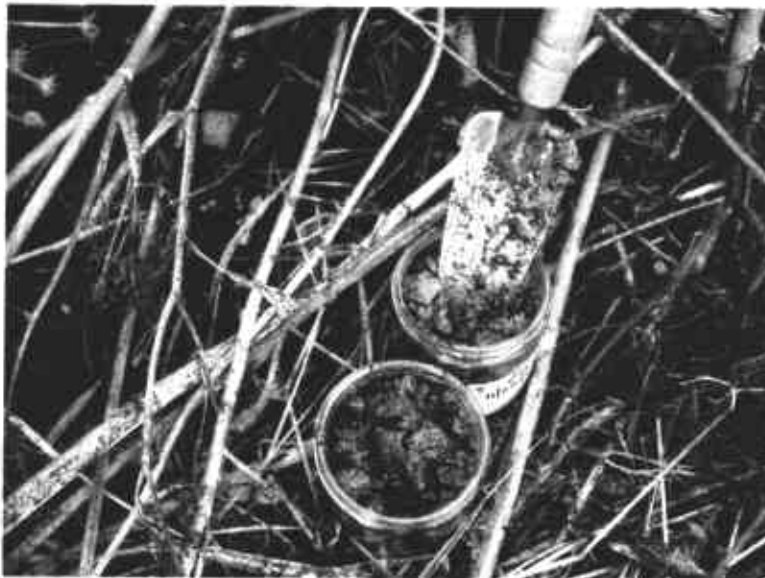
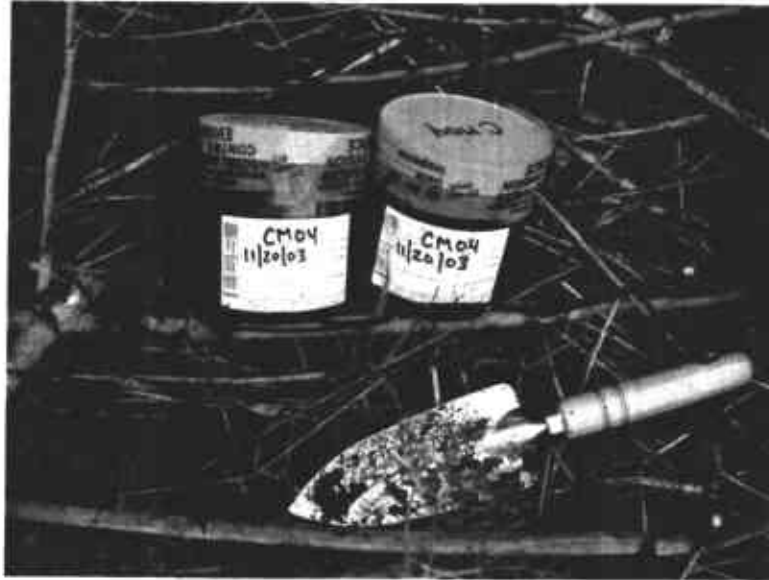
Sample CM04 was taken from tank T-1. The tank is shown in photo no. 10. It had a worn out Hazardous Waste label on it that was not filled out. The label is shown in photos no. 11 and 12. The tank contained solid material that looked like dirt, with a thin black layer on the surface (photo no. 13). It also had some water, possibly rain water, on the surface. It was a little less than half full.

Mr. Pang used a new, clean metal trowel to take the sample from the top few inches of material located near the center of the tank. The sample looked like brown, wet dirt with some of the dark material from the surface included. We used a tape measure to measure the tank. It is 34 feet long and 54 inches in diameter. The height of the material in the tank was 27 inches from the bottom. The surface of the material in the tank is shown in photo no. 13 while the sample is shown in photos no. 14 and 15.

Photo no. 10: Sample CM04 was taken from this tank, T-1.

Photo no. 11: Tank T-1 had a worn out Hazardous Waste label on it.

Photo no. 12: A close-up photo of the Hazardous Waste label on tank T-1.

Photo no. 13: The material inside the tank had a thin dark layer of material on the top.
This photo was taken through the hole in the tank that is shown in photo no. 11.

Photo no. 14: Sample CM04 looked like brown, wet dirt.

Photo no. 15: Sample CM04 after it was taken from inside of tank T-1.

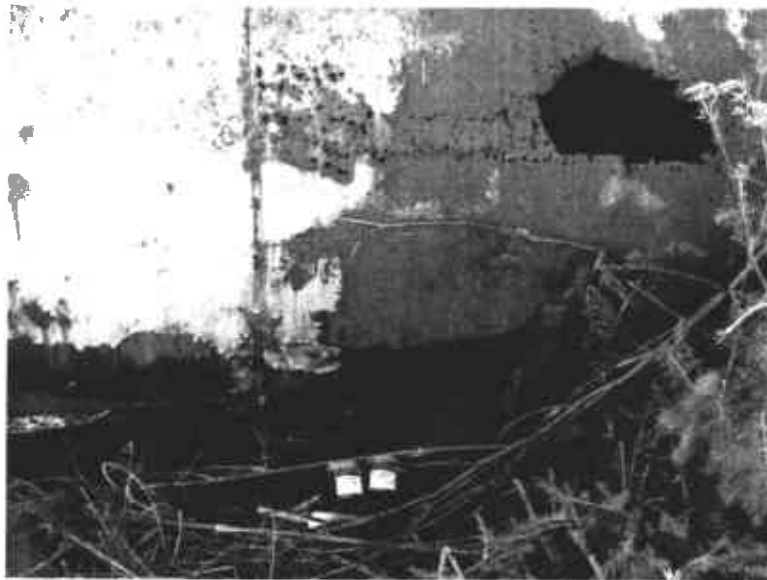
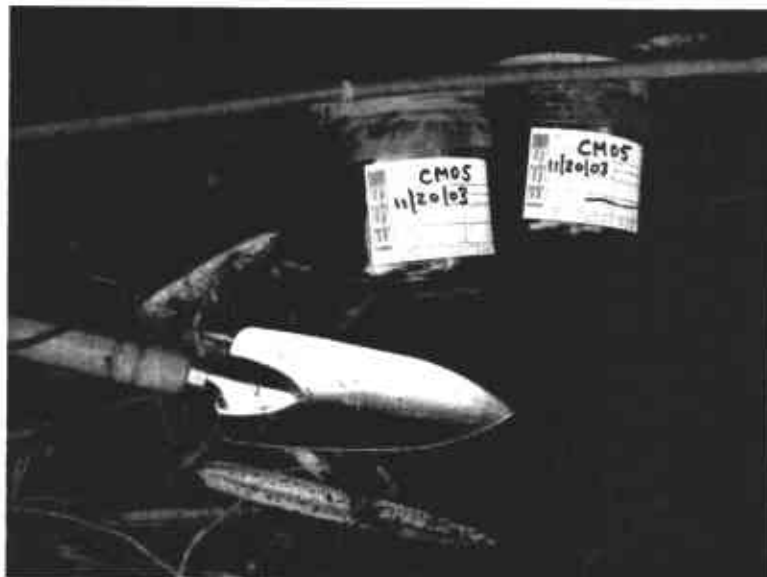
Sample CM05 was taken from the soil under tank T-1. The location is shown in photo no. 16. Mr. Pang used a new, clean metal trowel to dig about two inches into the dark soil and place it into the jars.

Photo no. 16: Sample CM05 was taken from this spot under tank T-1.

Photo no. 17: Sample CM05 after it was taken.

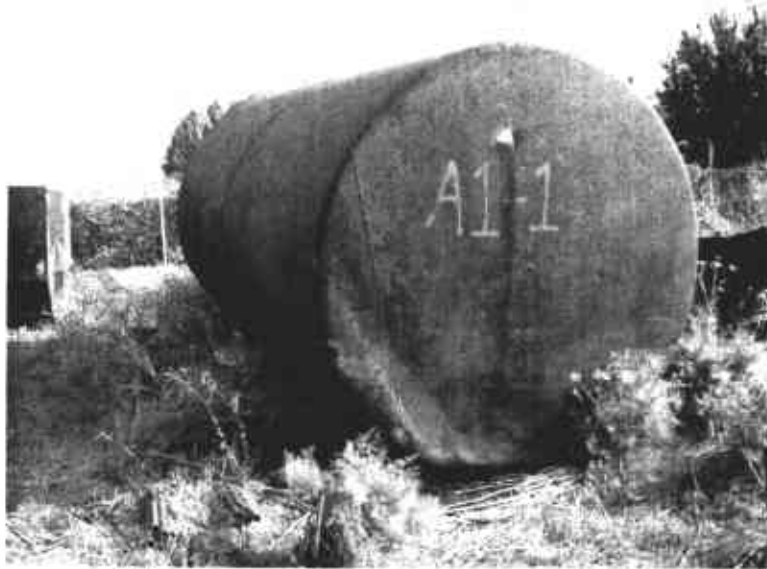
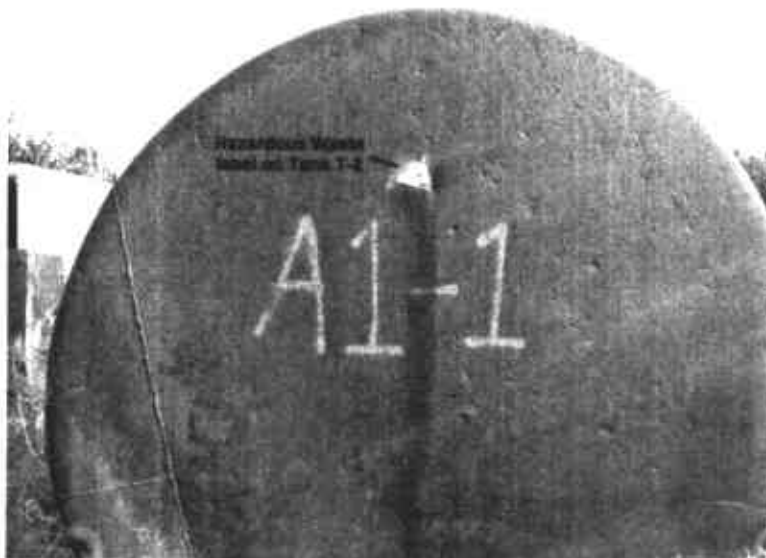
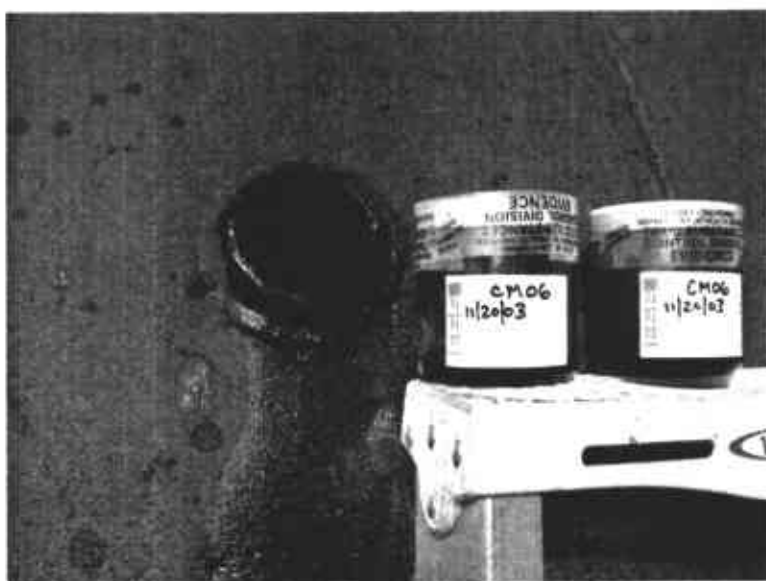
Sample CM06 was taken from the liquid inside of tank T-2, shown in photo no. 18. The tank had a worn out Hazardous Waste label on it that was not filled out. The label is shown in photos no. 18, 19 and 20. Mr. Pang used a new, clean, flexible plastic colliwasa to take the sample. There was approximately six inches of liquid in the tank. The liquid was amber colored and it was contaminated with dirt or some other dark material. The sample is shown in photo no. 21.

Photo no. 18: Sample CM06 was taken from this tank, T-2.

Photo no. 19: Tank T-2 had a worn out Hazardous Waste label on it.

Photo no. 20: A close-up photo of the Hazardous Waste label on tank T-2.

Photo no. 21: Sample CM06 after it was taken.

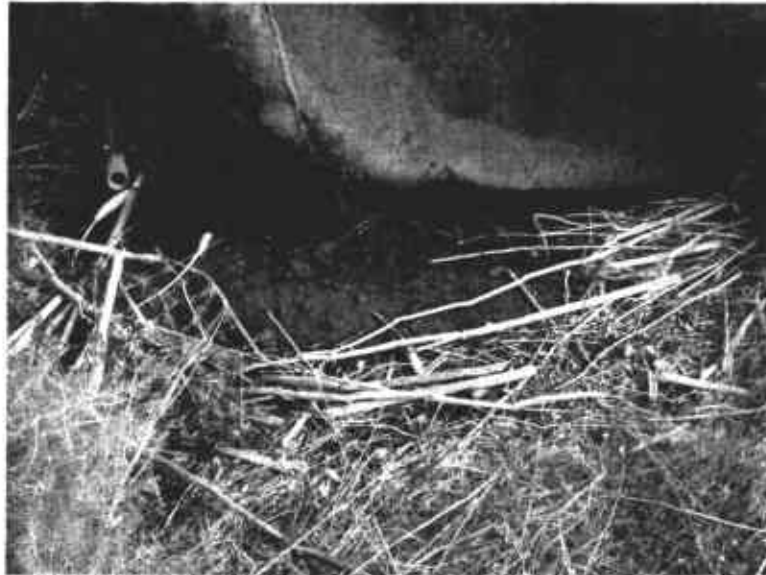
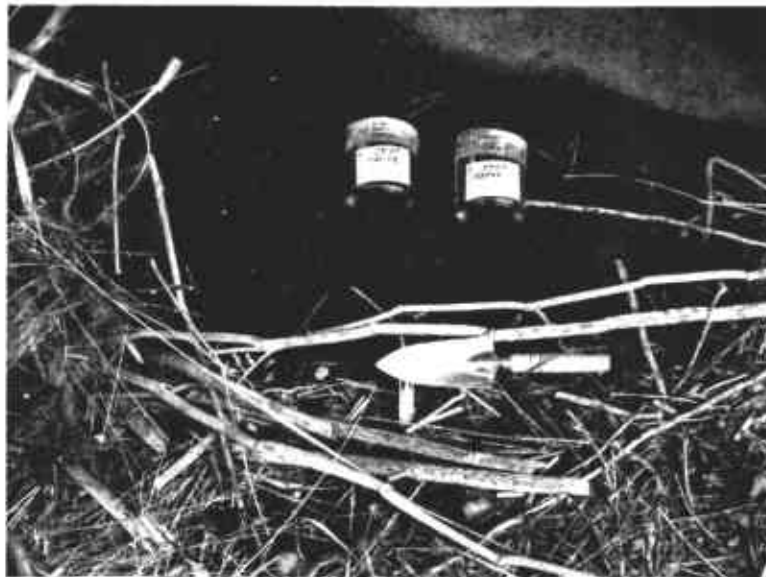
Sample CM07 was taken from some dark soil next to tank T-2. The area is shown in photo no. 22, below, and is near the northwest corner of the tank. Mr. Pang dug down a few inches with a new, clean metal trowel to collect the sample. The soil was dark and appeared to be contaminated with oil.

Photo no. 22: Sample CM07 was taken from this soil next to tank T-2.

Photo no. 23: Sample CM07 after it was taken.

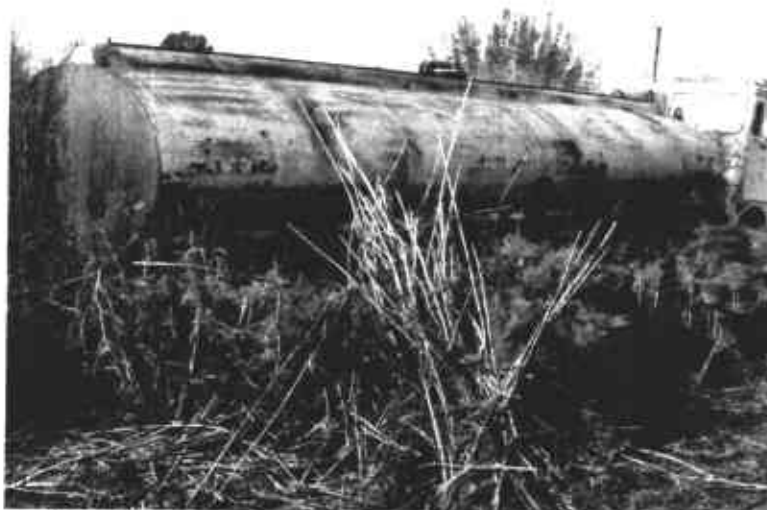
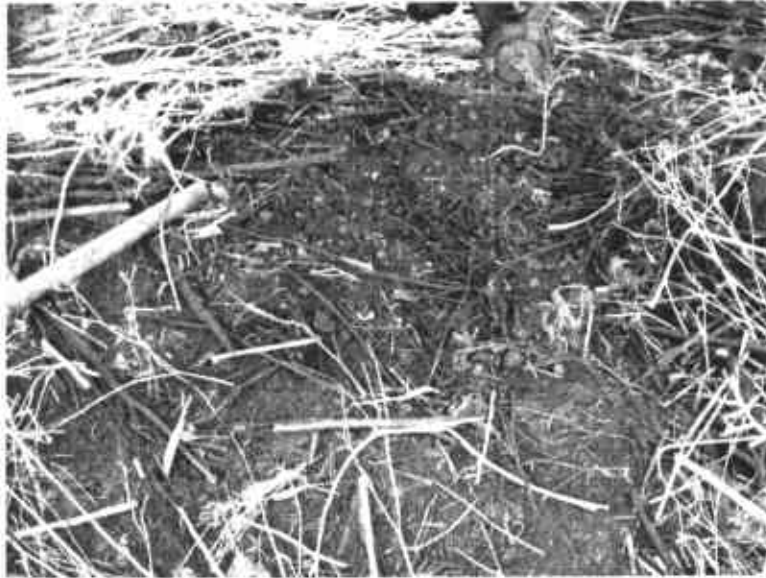
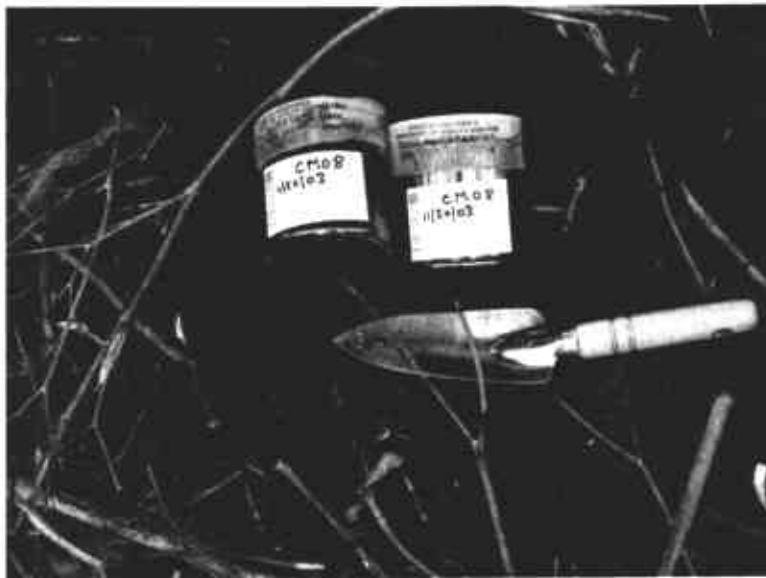
Sample CM08 was taken from the soil directly under tank T-3, which is shown in photo no. 24. Mr. Pang dug down a few inches with a new, clean metal trowel to collect the sample. The soil was dark and appeared to be contaminated with oil.

Photo no. 24: Sample CM08 came from the soil directly under this tank, T-3.

Photo no. 25: The area under tank T-3 where sample CM08 was collected.

Photo no. 26: This photo shows the dirt area before sample CM08 was taken.

Photo no. 27: Sample CM08 after it was taken.

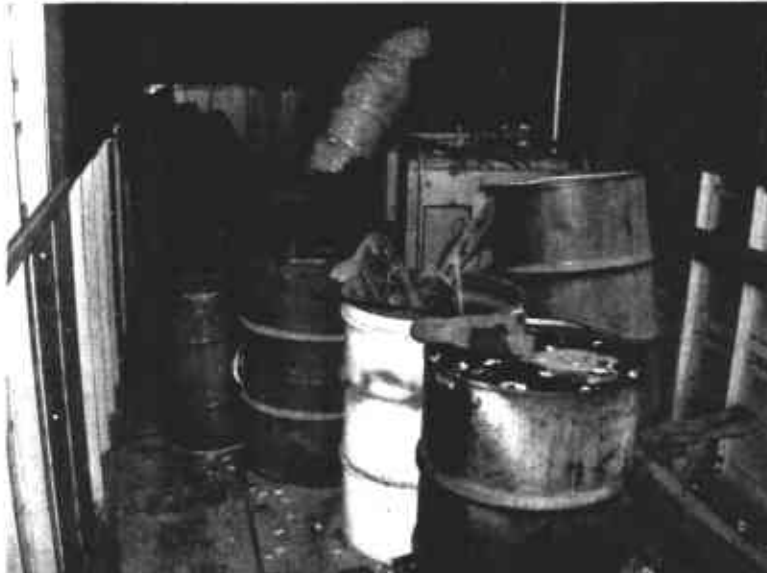
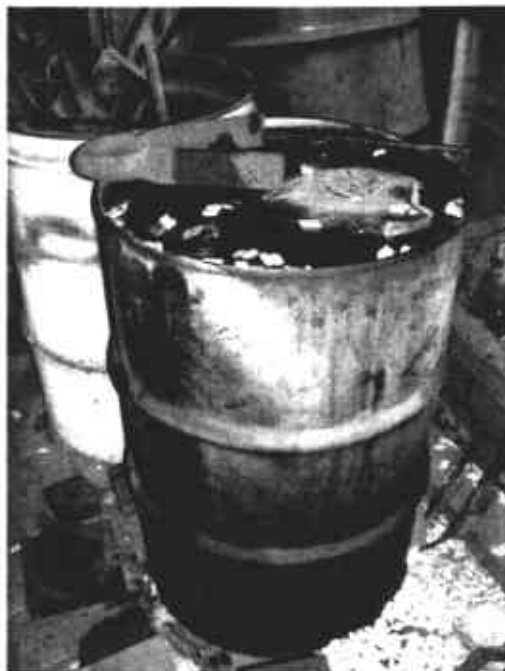
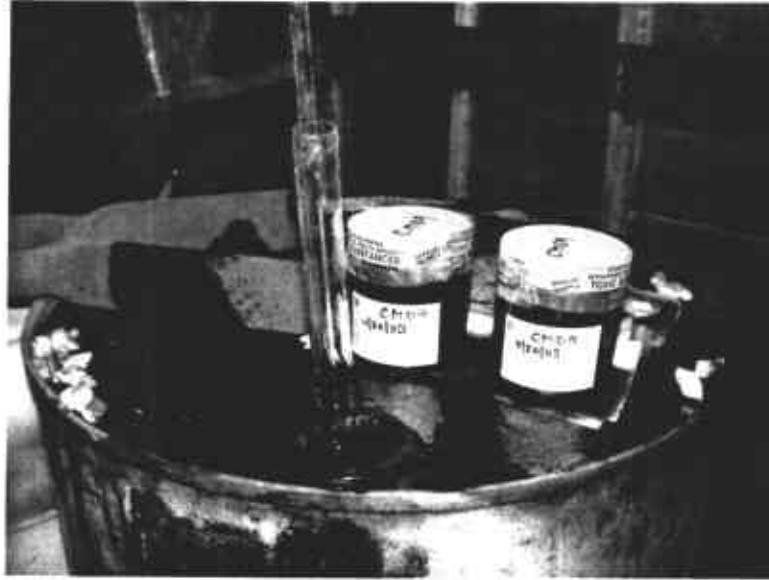
Sample CM09 was taken from a black, metal 55-gallon drum located in trailer no. 55. The drum is shown in the foreground of photo no. 28, below. There were no markings or labels on the drum. The other three 55-gallon drums did not contain chemicals while the smaller green container held product grease. Photo no. 29 is a close-up picture of the drum. Mr. Pang used a new, clean glass colliwassa to take the sample. The sample looked like waste oil and it had a gasoline smell to it.

Photo no. 28: Sample CM09 came from the black, metal 55-gallon drum in the foreground.

Photo no. 29: Sample CM09 was taken from this drum.

Photo no. 30: Sample CM09 after it was taken.

The total metal results are dated December 12, 2003 (Attachment C). The results indicate sample CM09, taken from the 55-gallon drum in trailer no. 55, contained 1920 milligrams per kilogram (mg/kg) of lead. Therefore, in accordance with the California Code of Regulations, Title 22, section 66261.24(a)(2), the drum shown in photo no. 29 contains hazardous waste because a representative sample of the waste exceeds the total threshold limit concentration for lead of 1000 mg/kg. The drum contains hazardous waste that exhibits the characteristic of toxicity.

The WET/soluble metals results are dated December 17, 2003 (Attachment C). It was only necessary for HML to analyze sample CM09 for soluble lead. The results indicate sample CM09 contained 140 milligrams per Liter (mg/L) of lead. Therefore, in accordance with the California Code of Regulations, Title 22, section 66261.24(a)(2), the drum shown in photo no. 29 contains hazardous waste because a representative sample of the waste exceeds the soluble threshold limit concentration for lead of 5.0 mg/L. The drum contains hazardous waste that exhibits the characteristic of toxicity.

The ignitability results are dated November 26, 2003 (Attachment C). Samples CM06 and CM09 were the only samples analyzed for ignitability. HML did not analyze sample CM01 due to its solid matrix. Sample CM06 had a flash point of $>140^{\circ}\text{F}$. Sample CM09, taken from the 55-gallon drum in trailer no. 55, had a flash point of 78°F . Therefore, in accordance with the California Code of Regulations, Title 22, section 66261.21(a)(1), the drum shown in photo no. 29 contains hazardous waste because a representative sample of the waste has a flash point of less than 140°F . The drum contains hazardous waste that exhibits the characteristic of ignitability.

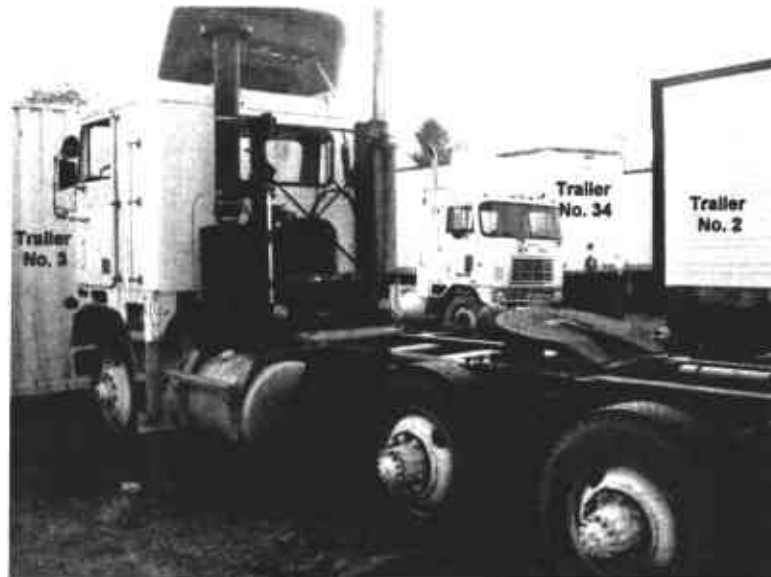
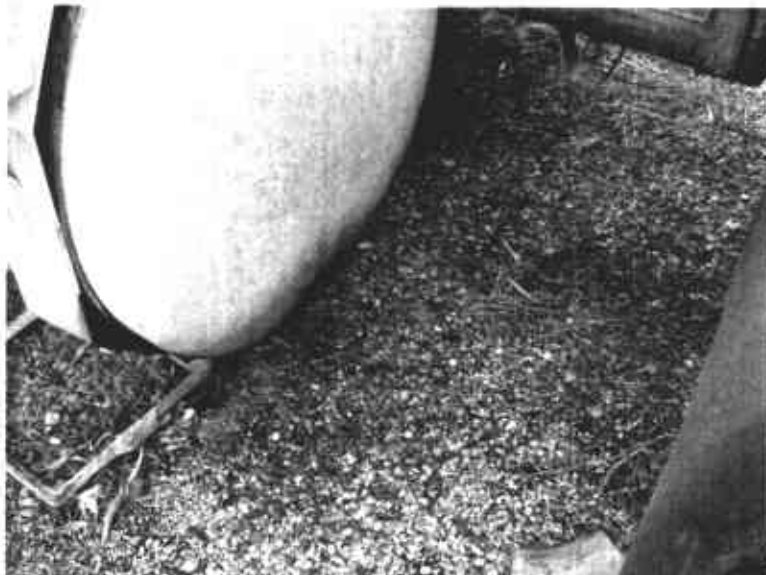
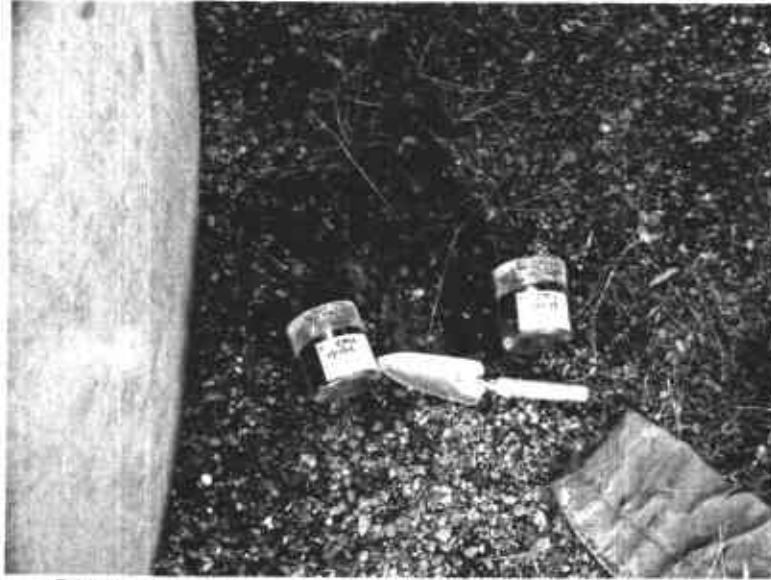
Sample CM10 was taken from the soil directly under the fuel tank on the driver's side of the truck shown in photo no. 31. The truck was north of trailer no. 3 and east of trailer no. 2. Mr. Pang used a new, clean, metal trowel to take the sample, which was dirt and small rocks.

Photo no. 31: Sample CM10 was taken from the soil under the fuel tank on the driver's side of this truck.

Photo no. 32: Sample CM10 was taken from the soil under the fuel tank.

Photo no. 33: Sample CM10 after it was taken.

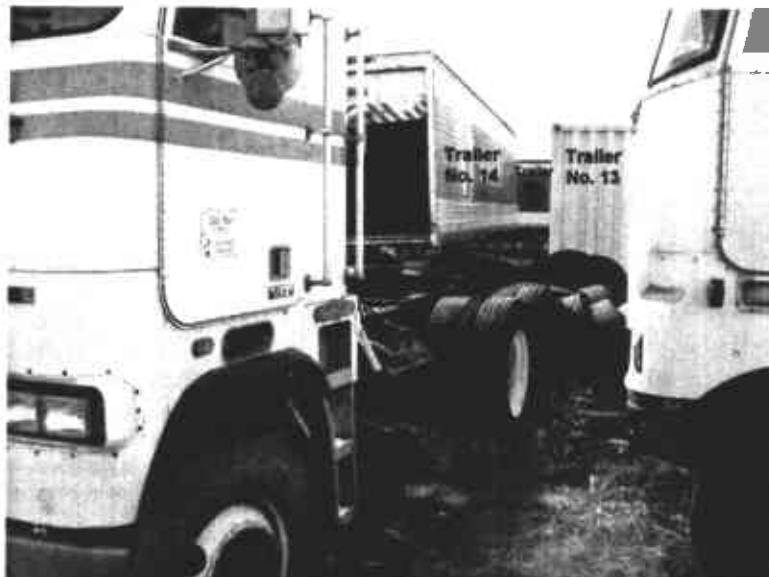
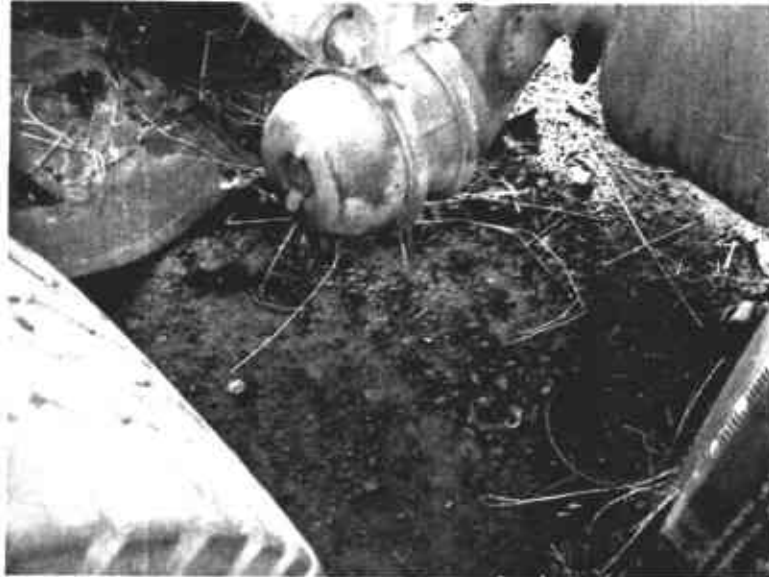
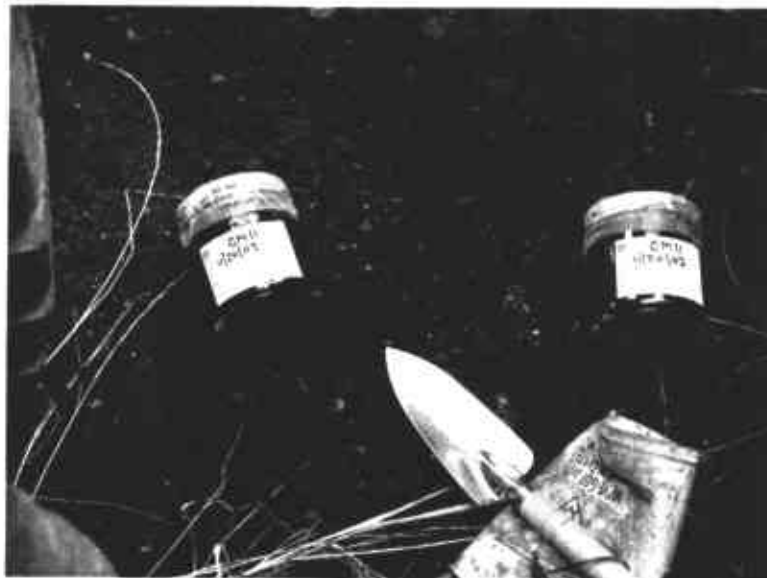
Sample CM11 was taken from the soil directly under the rear axle of the truck shown in photo no. 34, below. The truck was east of trailers no. 13 and 14 and facing east. Mr. Pang used a new, clean, metal trowel to take the sample, which was dark soil that appeared to be contaminated with oil. The soil is shown in photos no. 35 and 36.

Photo no. 34: Sample CM11 was taken from the soil under the rear end of the truck on the left.

Photo no. 35: Sample CM11 was taken from the soil shown here.

Photo no. 36: This photo shows a closer view of the soil that was taken as sample CM11.

Photo no. 37: Sample CM11 after it was taken.

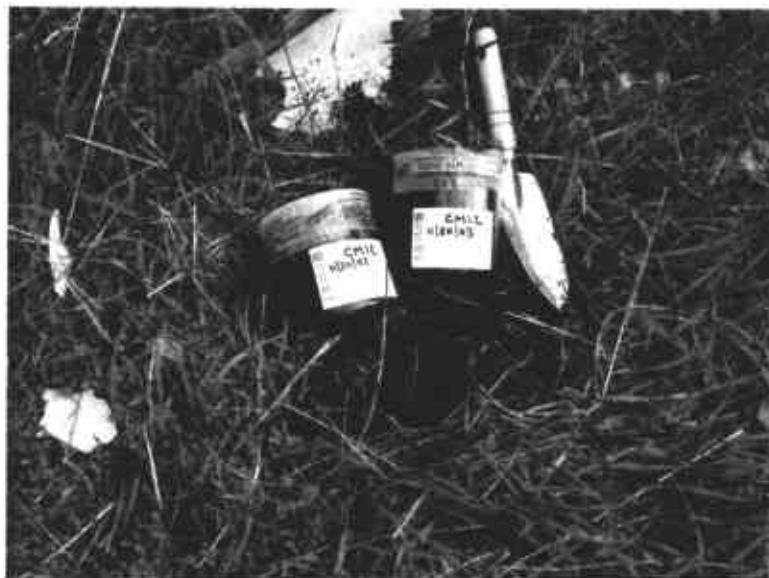
Sample CM12 is a background sample that was taken from soil in an area that we assume will not be contaminated. It was taken just outside the fence on the west side of the property, next to McGraw Road, as shown in photo no. 38. The analytical results from the background sample will be compared to the other soil samples to determine the level of contamination. Mr. Pang dug down a few inches with a new, clean metal trowel to take the sample.

Photo no. 38: Sample CM12 was taken from this spot outside the fence next to McGraw Road.

Photo no. 39: Sample CM12 after it was taken.
