Site Investigation Report

Former BP Service Station #11266
1541 Park Street
Alameda, California
ACEH Case #RO0000318

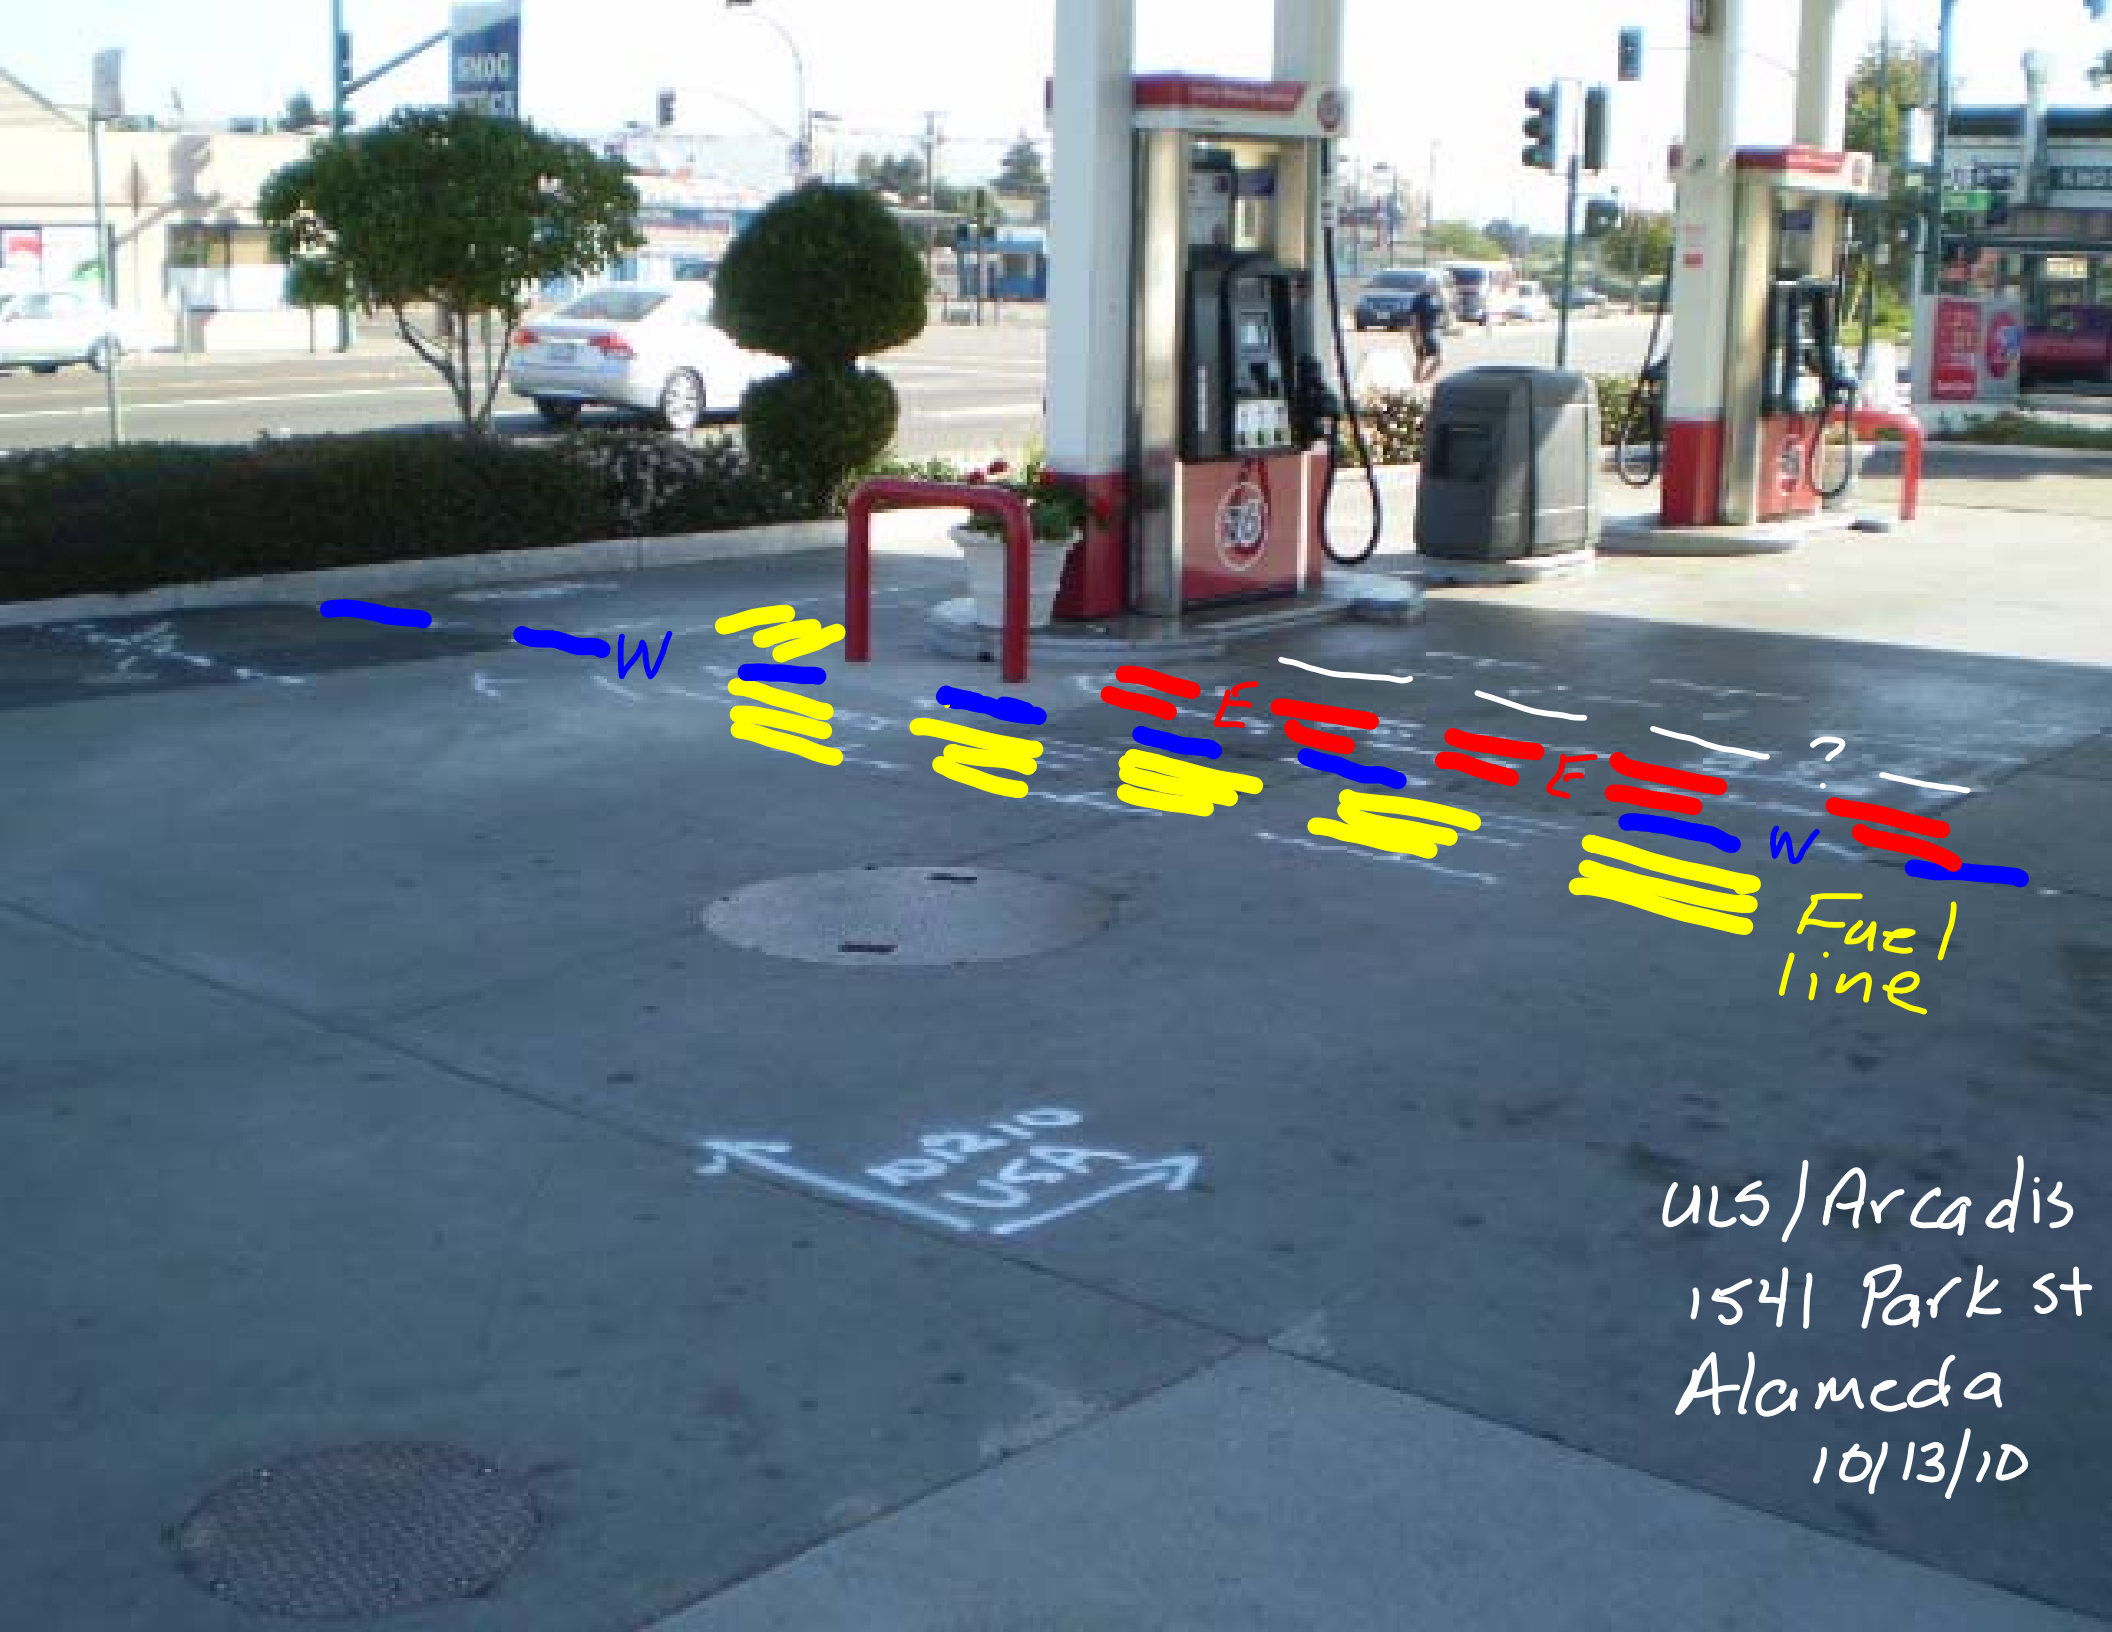
ULS/Arcadis
1541 Park St
Alameda 10/13

* S51, S501 + S52 locations are not viable due congestion of multiple lines trending north-south, including water, fuel and/or vent lines, multiple conduit and unknown GPR response between north and south pumps. (see attached photo edits and GPR profile)

* S502 - Caution advised for water line trending north-south. Extreme caution advised for sewer lateral and cleanout. No visual possible. Evidence of previous markout indicate trend northeast. Caution for fuel lines on north and west of pumps. (see attached photo edits)

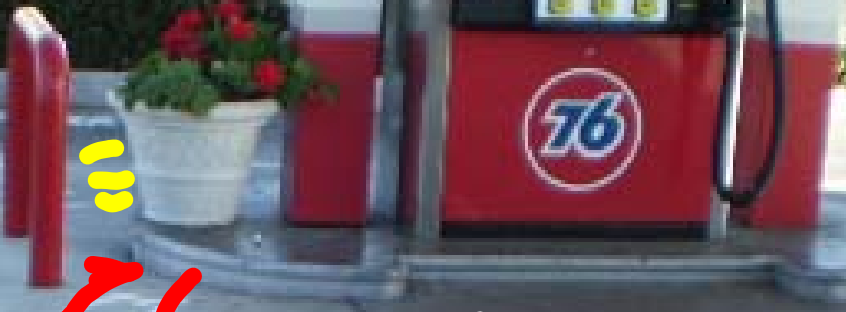
GPR Transect
North to South →
Between north pumps

Fuel | Pump |

Lines

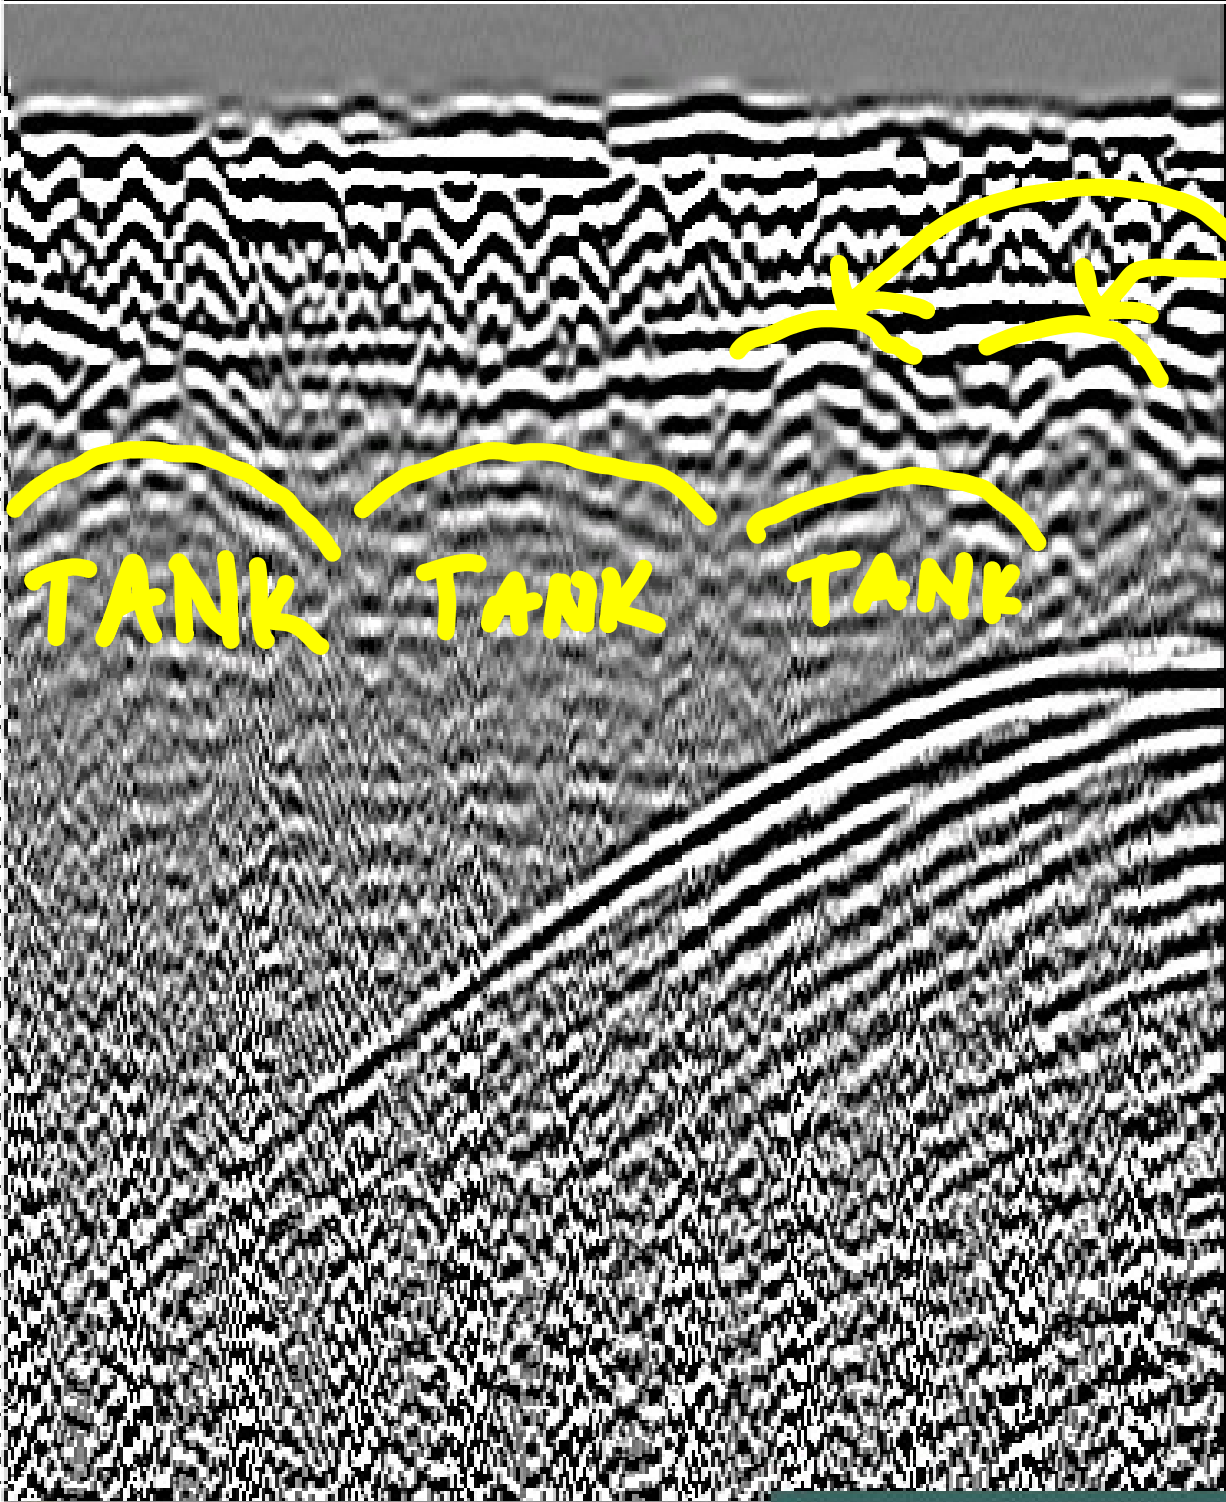
GPR Transect
west → east
over tanks

Fuel lines
and vents?

TANK TANK TANK
