**DENTICI PROPERTY**

**APN#098-0403-012**

**1403 First Street, Livermore, California**

**Phase I Environmental Assessment**

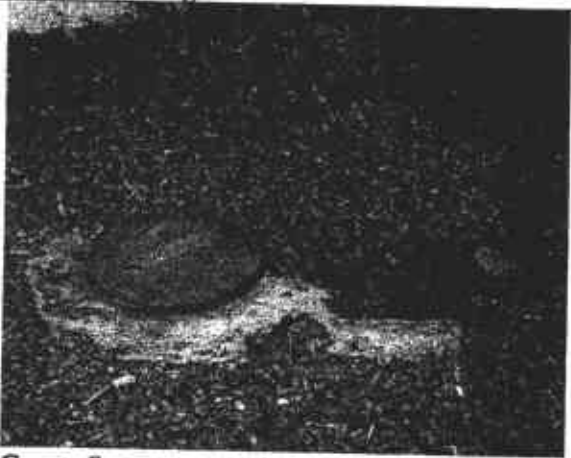
**Grease Separator**

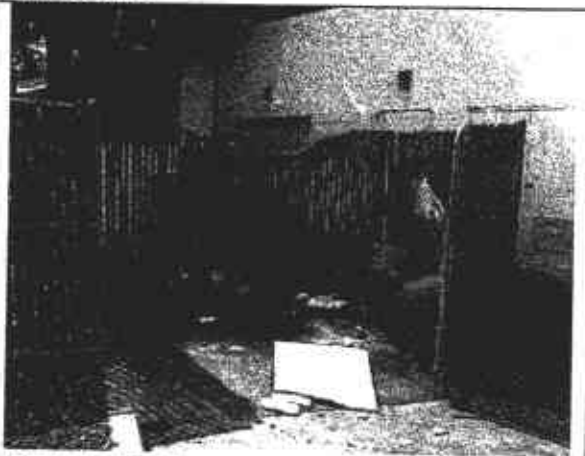
**Dumpster Enclosure**
