SUBJECT: SUBSURFACE INVESTIGATION REPORT CERTIFICATION  
Fuel Leak Case RO 337  
California Linen Supply Company  
989 41<sup>st</sup> Street, Oakland, CA 94608

May 8, 2009  
Report 0304.R16  
RGA Job # CLR20915

SUBJECT: SUBSURFACE INVESTIGATION REPORT  
(GEOPHYSICAL PROFILES 1-3, BORINGS B67- B88, SOIL GAS SAMPLES  
SG6-SG22, POST-EXCAVATION PIT CONFIRMATION SAMPLES (6), AND  
TEST PIT SAMPLES TP1-TP4)  
Fuel Leak Case RO0000337  
California Linen Rental Company  
989 41<sup>st</sup> Street  
Oakland, CA

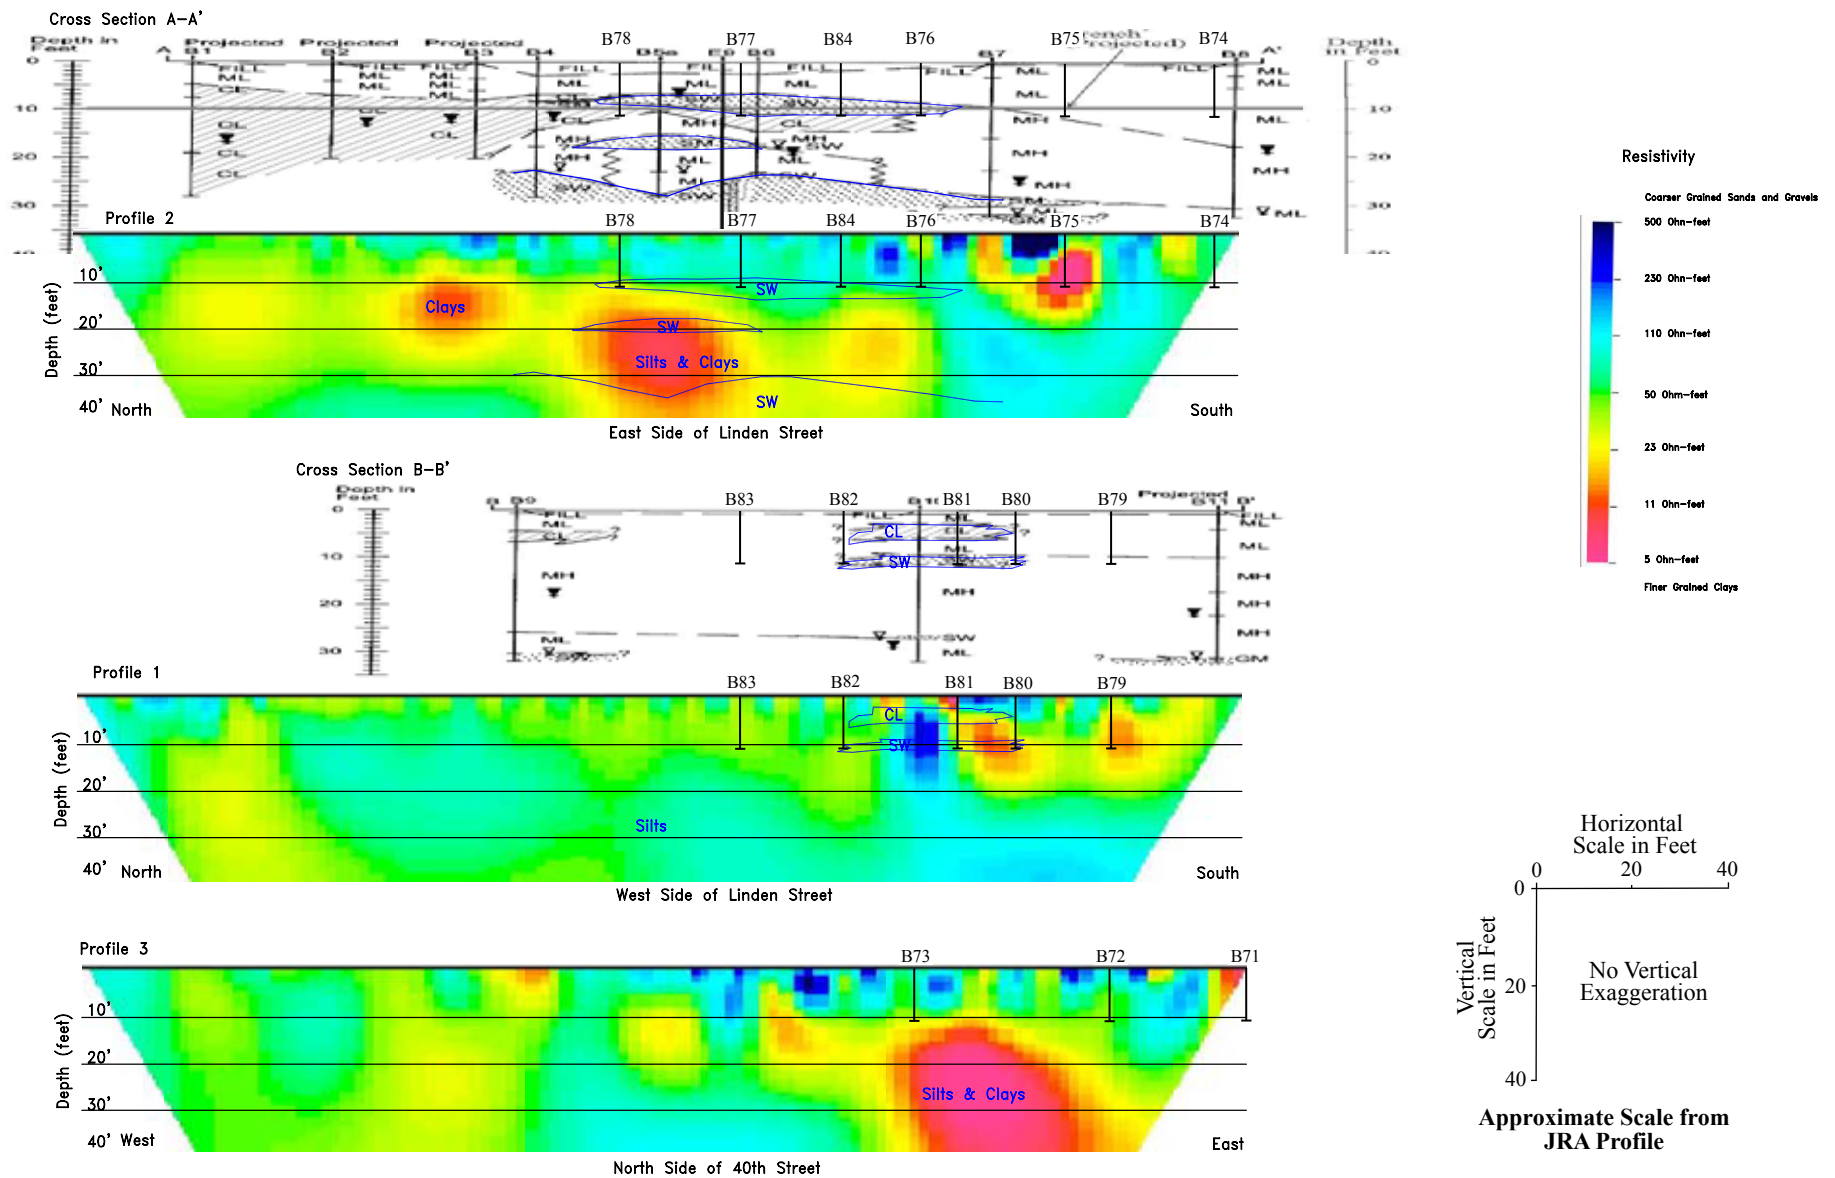
Figure 6  
 Resistivity Profiles with Geologic Cross Sections A-A' and B-B'  
 California Linen Rental Company  
 989 41st Street  
 Oakland, California

Resistivity Profile From  
 JR Associates, 3/27/09

The absence of petroleum hydrocarbons in shallow soil in the boreholes on the west side of Linden Street indicates that the sewer trench in Linden Street (the bottom of the sewer pipe is approximately 10 feet bgs, see Figure 6) is an effective barrier to the westward movement of petroleum hydrocarbons detected in shallow groundwater at B5, B6, B77 and B78. The absence of evidence of petroleum hydrocarbons in the borehole drilled in the sewer trench on the south side of 40<sup>th</sup> Street other than bluish green soil staining between the depths of 8.5 and 9.0 feet in the 9.5 foot deep borehole, and the absence of detectable petroleum hydrocarbons in the soil sample collected from the borehole at a depth of 8.5 feet indicates that detectable concentrations of petroleum hydrocarbons have not migrated as far as the south side of 40<sup>th</sup> Street in the sewer trench.

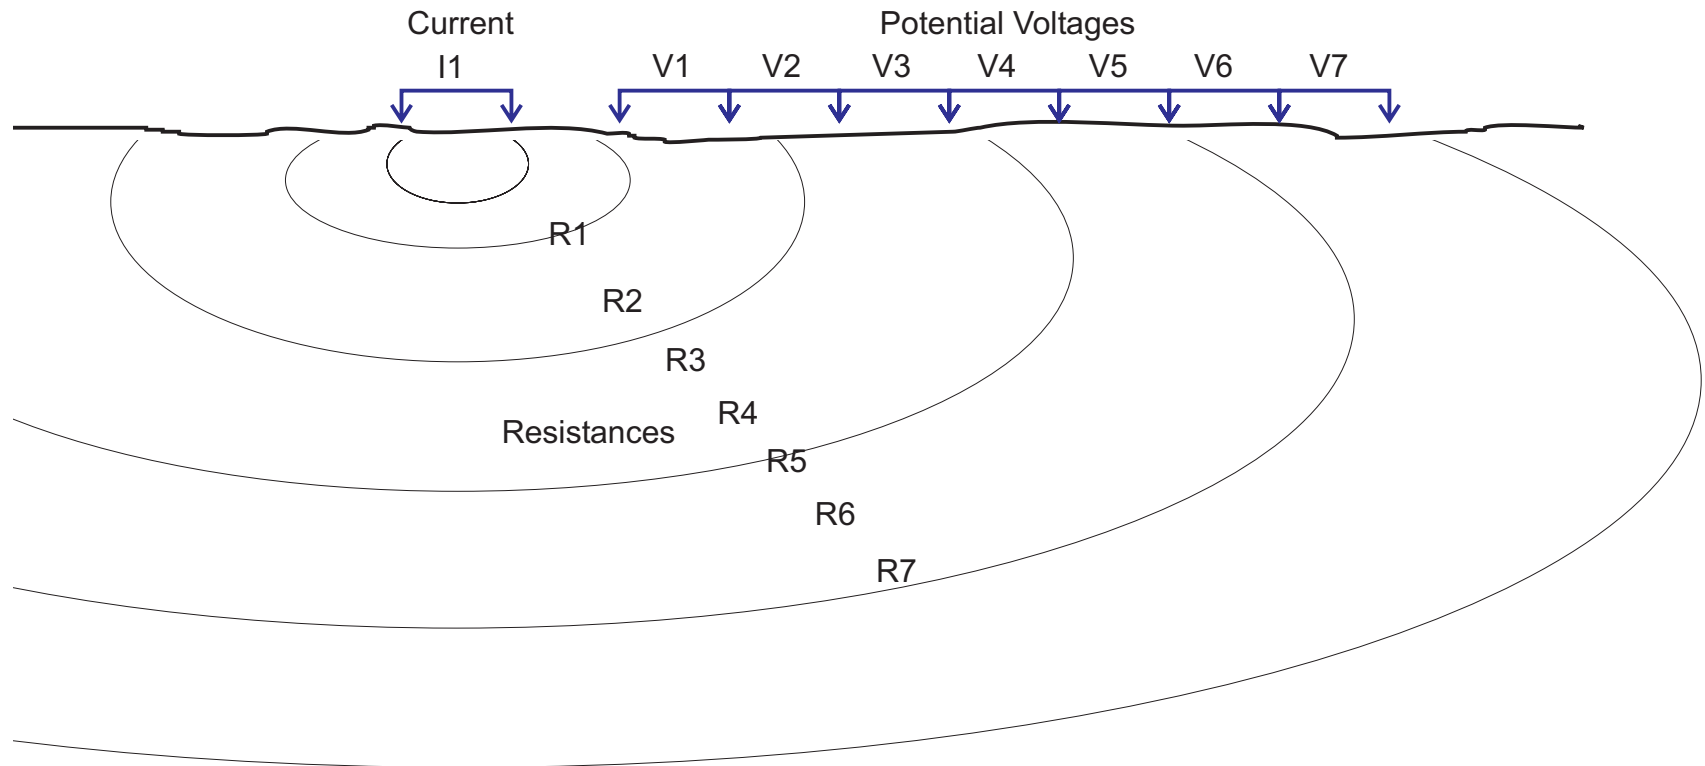
Material	Resistivity (Ohm-ft)
Fresh Bedrock:	> 1000
Weathered Bedrock:	100 to 1000
Coarse Grained:	100 to 1000
Finer Grained:	25 to 250
Clays:	<25

<b>Dipole-Dipole Array</b> Dipole Resistivity Investigation 989 41st Street Oakland, California		
SCALE:	No Scale	DRAWN BY:    J.J.R.
DATE:	3-27-2009	JOB NUMBER:                      111-261-09    REVISED:
<b>J R ASSOCIATES</b> Civil and Environmental Geophysics 1886 Emory Street, San Jose, CA (408) 293-7390		
		DRAWING NUMBER: <b>3</b>

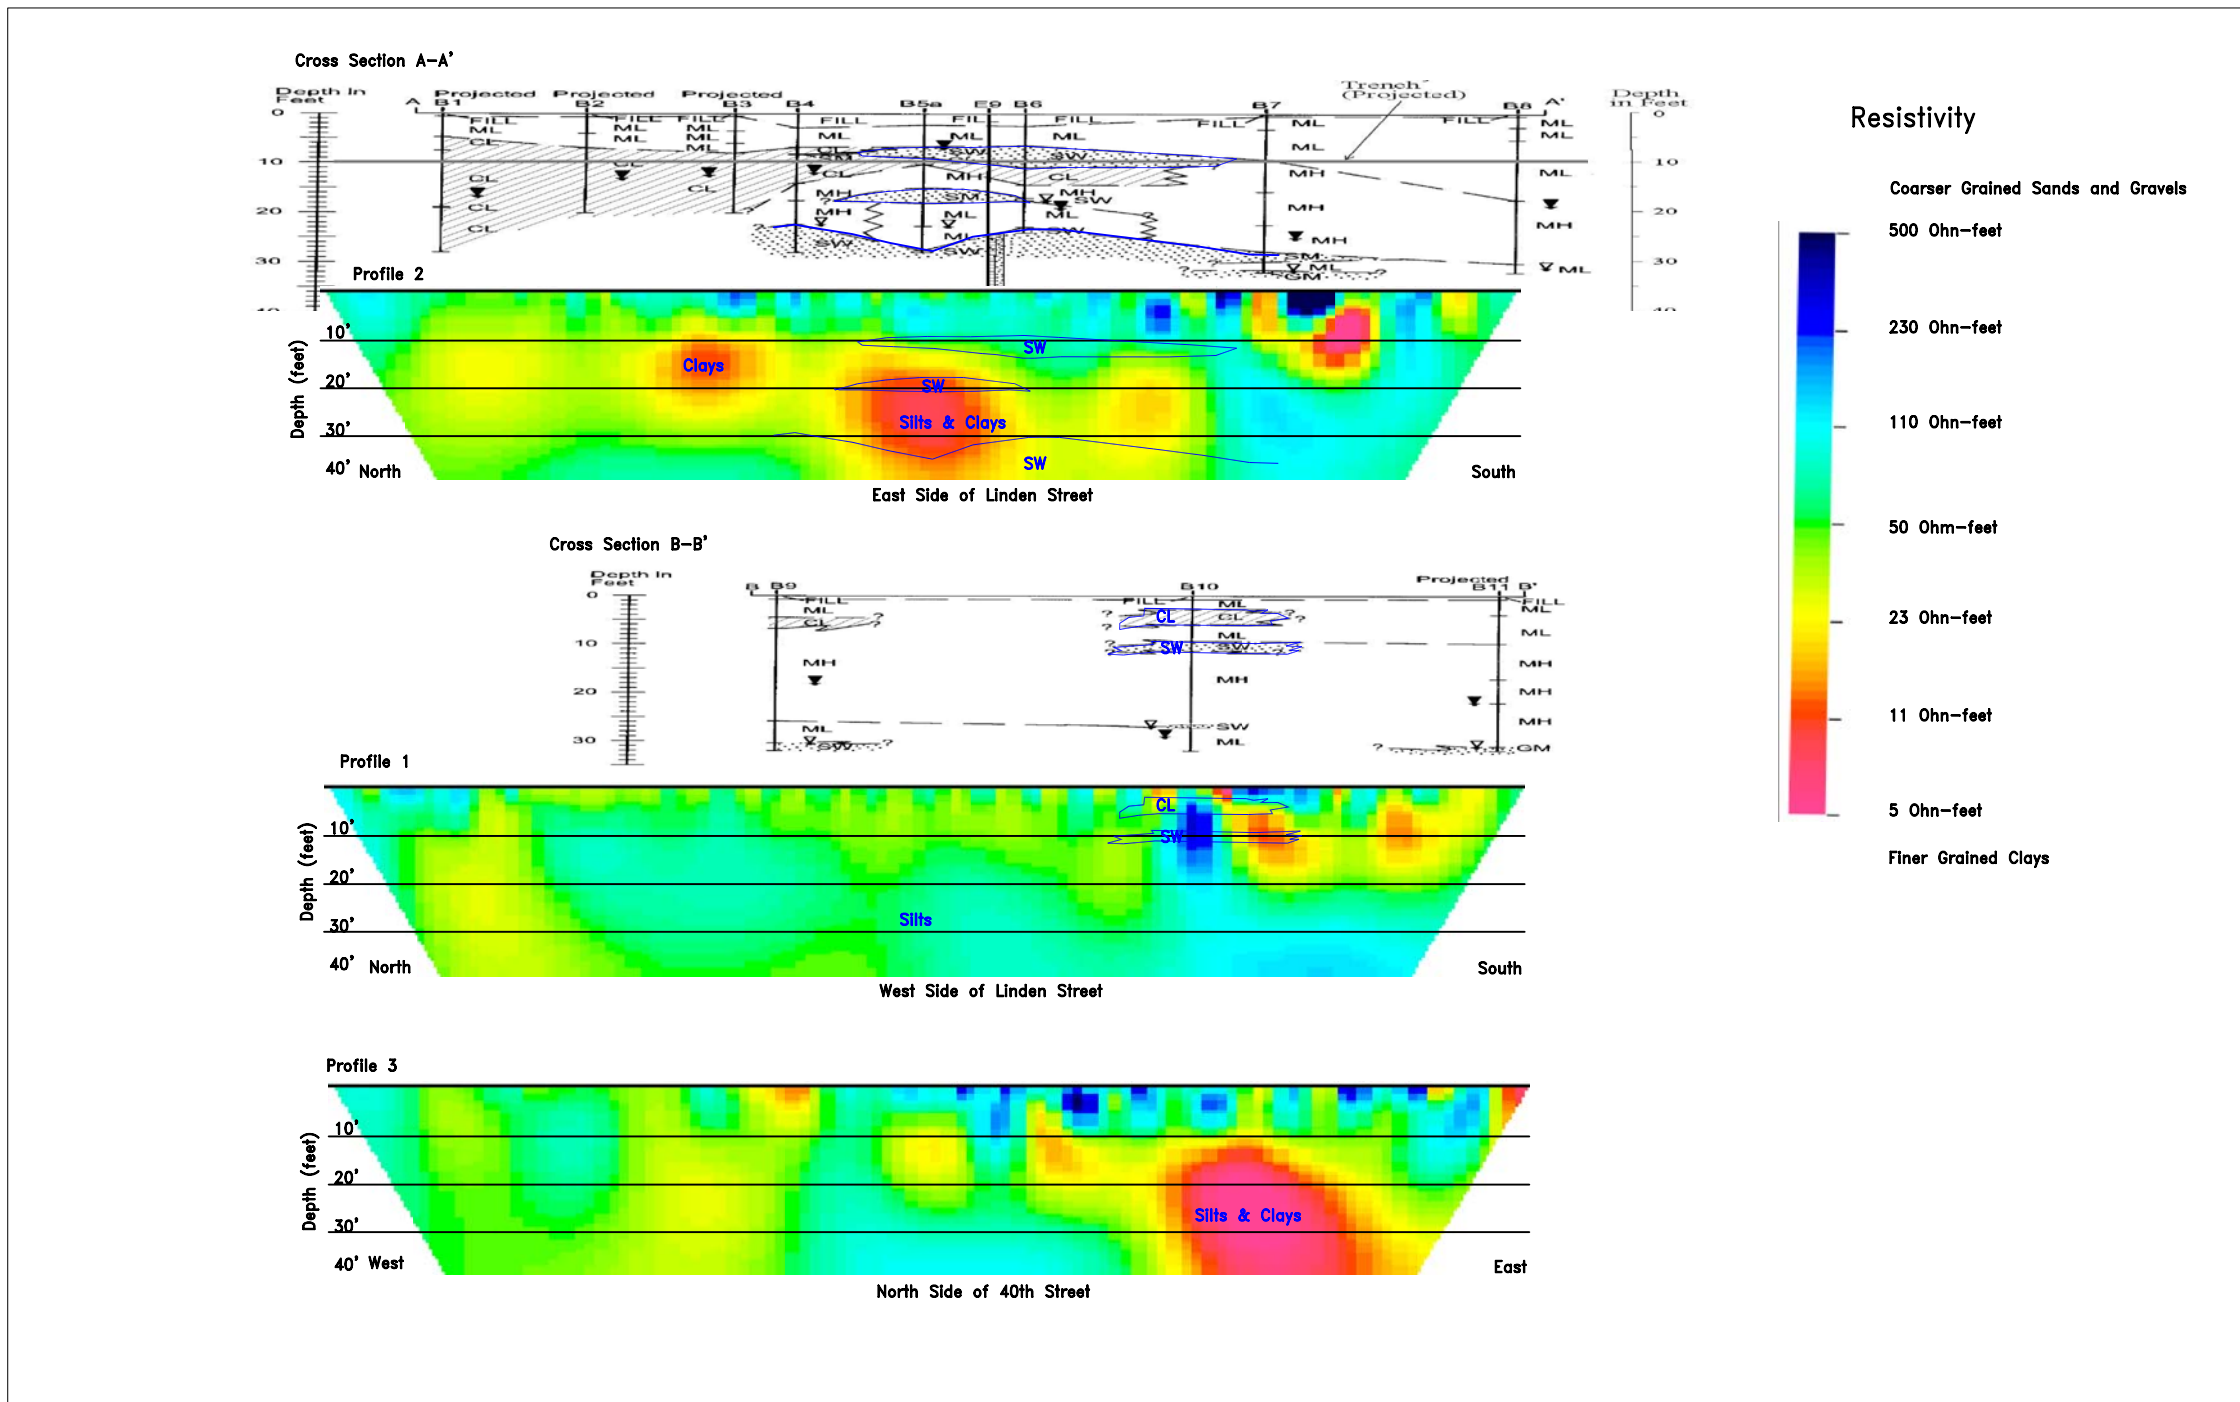
DRAWING NUMBER: 4

Note: Geologic cross sections were provided by RGA Environmental

**Resistivity Profiles Vs Geologic Cross Sections**

The results of the dipole-dipole resistivity profile are shown in Drawings 4 and 5. Drawing 4 illustrates resistivity Profiles 1, 2, and 3 that were collected on the west and east side of Linden Street and along 40th Street respectively. In general, the blue and green areas in the profiles indicate sands to silts and the yellow and pink areas indicate silts to clays. Along with the profiles are geologic cross sections provided by RGA Environmental. Cross Section B-B' paralleled Profile 1 and Cross Section A-A' paralleled Profile 2. The location of the sand beds (SW) found in the geologic cross section was copied onto the profiles to help compare the resistivity values to the known geology. In the middle of Profile 2 there was a conductive zone (shown in yellow and pink) indicative of silts and clay soils that was not found beneath Profile 1. The geologic cross section A-A' indicated sand layers with strong petroleum odors and elevated TPH-G just above the silt and clay zone.

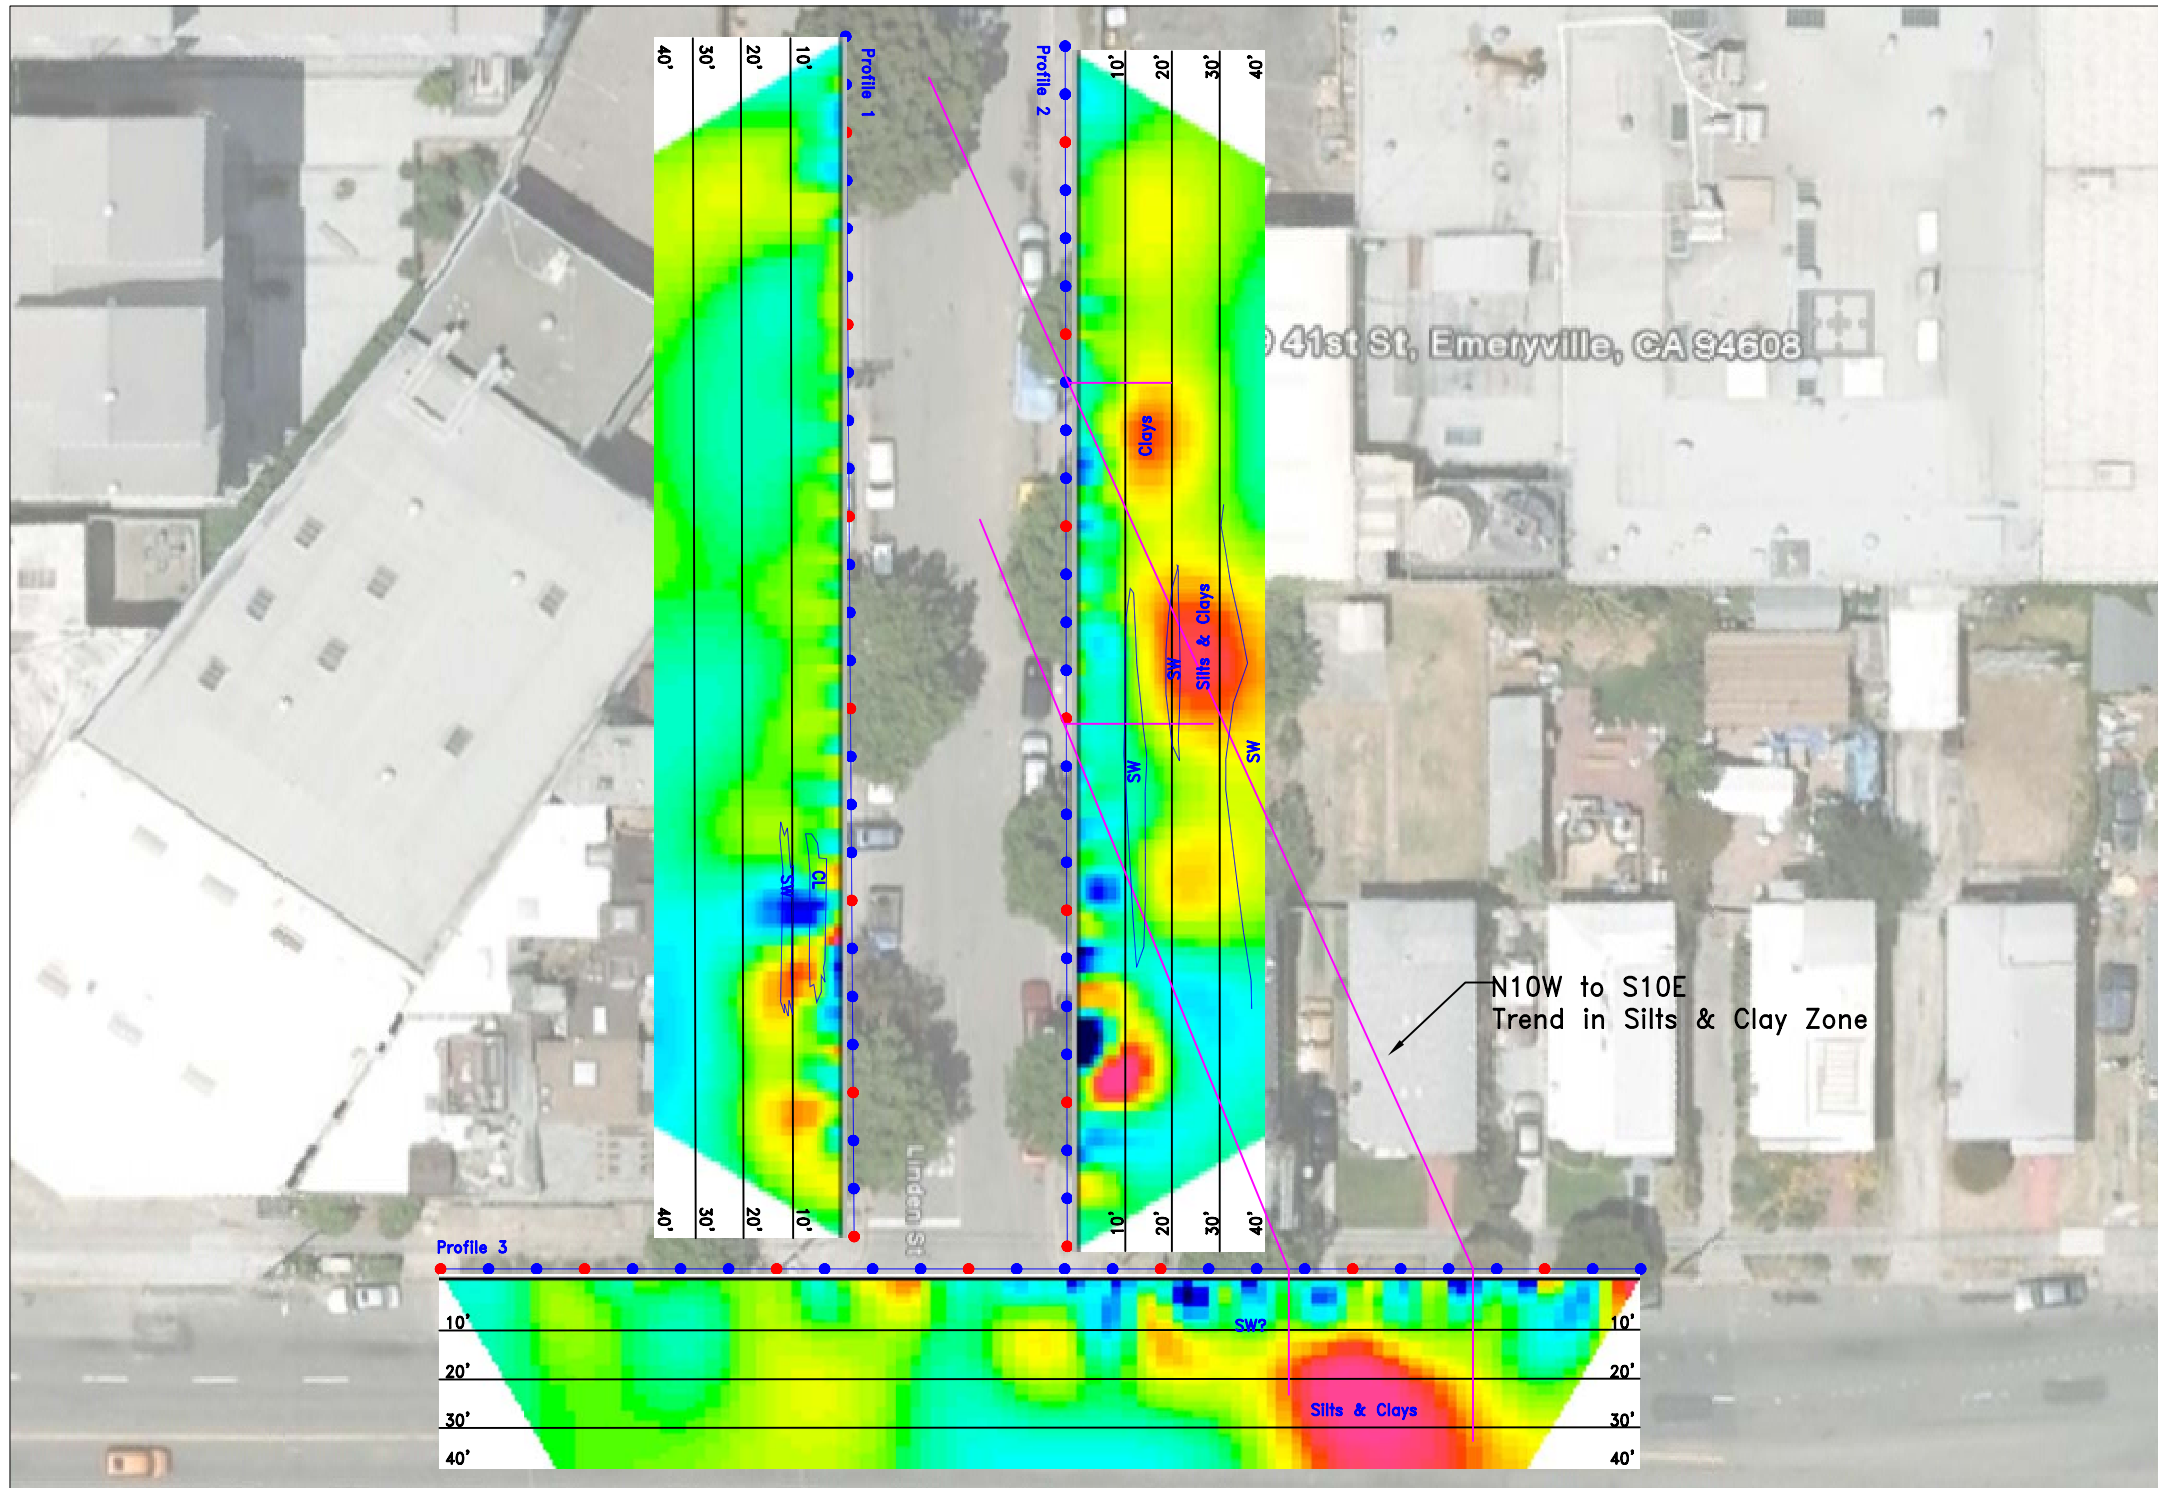
**Resistivity**

Coarser Grained Sands and Gravels

Finer Grained Clays

**Trend in Silts & Clay Zone** Dipole Resistivity Investigation  
989 41st Street  
Oakland, California

Drawing 5 shows the three resistivity profiles superimposed on an air photo. The electrically conductive silts and clay zone found beneath Profile 2 appears to also be under the east end of Profile 3. There appears to be an approximately South 10° East trend to the zone. This suggests there may be a south and slightly east trend to the bedding in the area and would be a reason why the electrically conductive silts and clay zone was not found on the west side of Linden Street. The resistivity data suggest that contaminants may be migrating along bedding that trends in a southerly and slightly east direction. Sampling would be needed to confirm this.
