# **Vapor Intrusion Investigation Report**

**3519 Castro Valley Boulevard  
Castro Valley, California 94546**

**June 26, 2014**

**Project 2762**

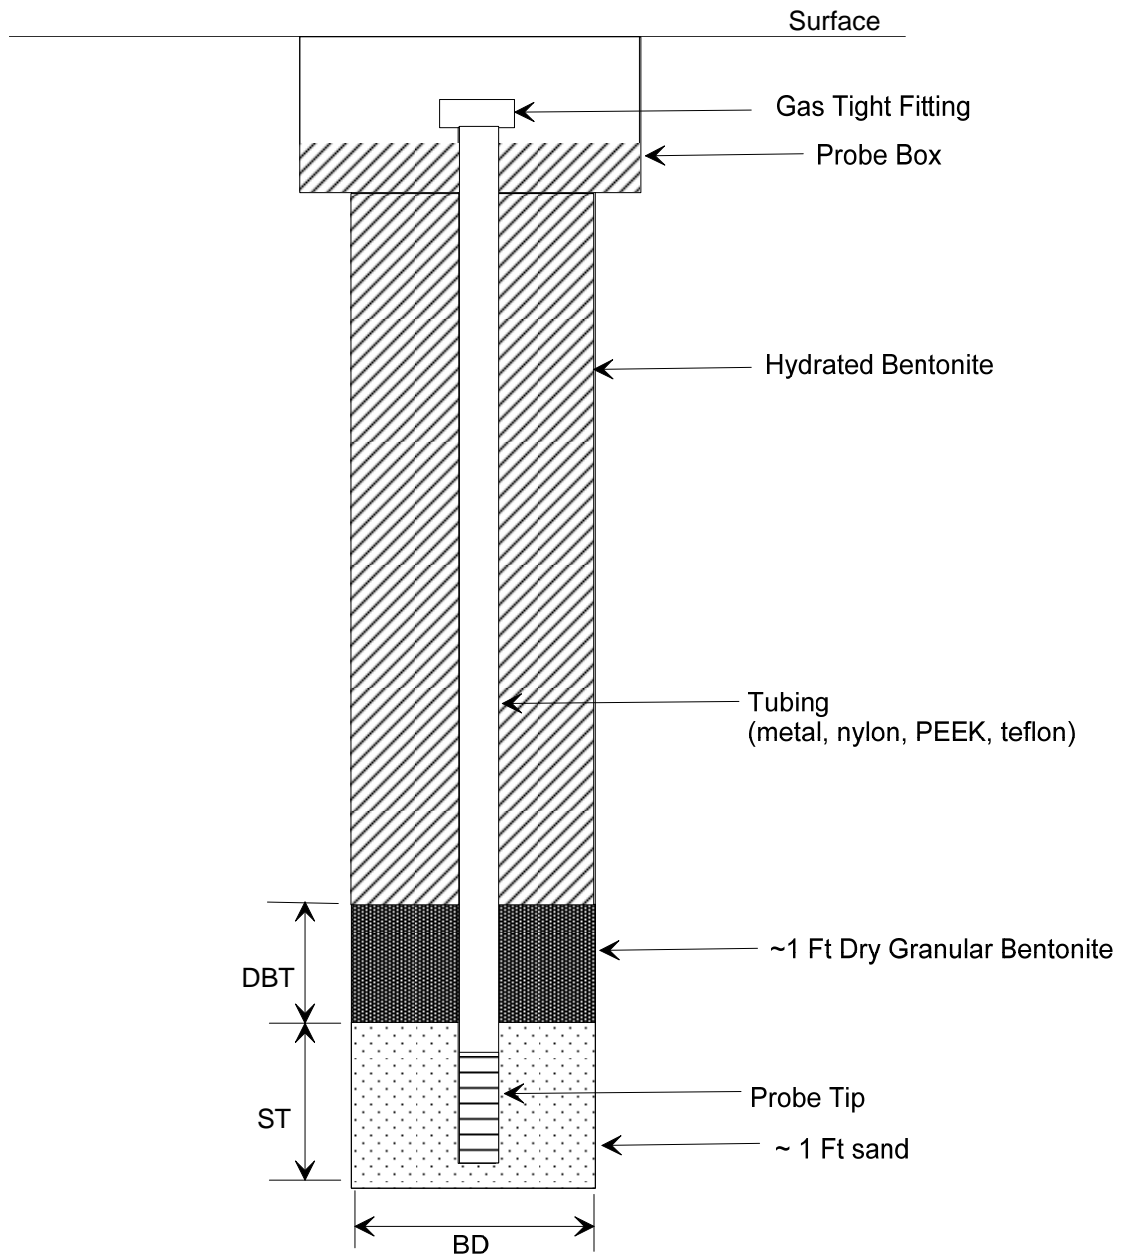
BD = borehole diameter (inches)  
 DBT = dry bentonite thickness (ft)  
 ST = sand pack thickness (FT)  
 PEEK = Polyetheretherketone

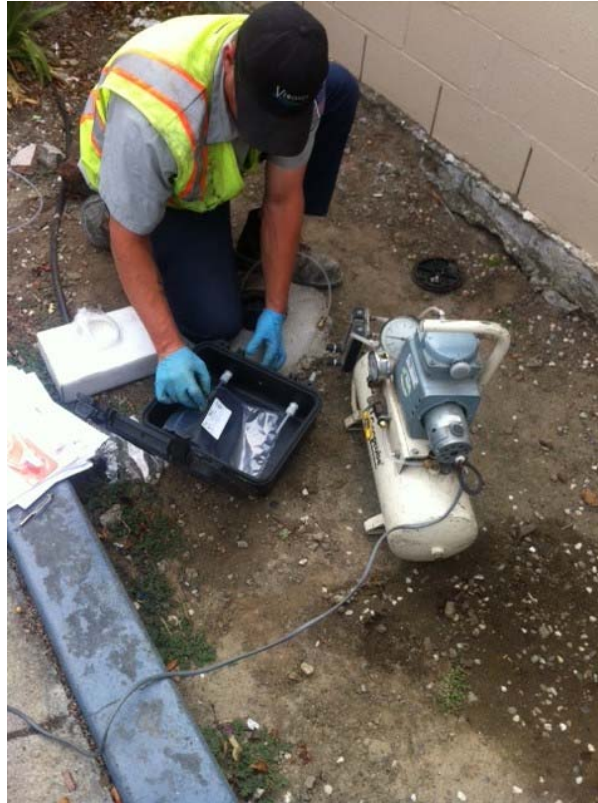
Time: 08:15 Left for site  
08:45 Arrived onsite, Vironex onsite  
H&S meeting + site walk-thru.  
09:00 Set up on SV-2, still water inside  
Time: tubing coming up, so no samples.  
09:50 Set up on SV-4, purged sample of  
~3 purge volumes. Shut-in/leak test good.  
Time: ~~09:50~~ Sampled 10:31-10:32 @ 200 mL/min.  
10:50 Set up on SV-5, purged sample of  
~3 purge volumes. Shut-in/leak test good.  
Time: Sampled 11:33-11:34 @ 200 mL/min  
11:43 Set up on SV-3, purged sample of  
~3 purge volumes. Shut-in/leak test good.  
Sampled 12:08-12:09 @ 200 mL/min.  
Time: 12:20 Set up on SV-1, saw water coming  
up through tubing, so did not sample.  
[12:45-13:45] Lunch  
Time: 13:50 Set up on SSG-3, purged ~30 seconds.  
Shut-in/leak test good. Sampled 14:35-14:36 @ 200 mL/min  
14:50 Set up on SSG-2, purged ~30 seconds.

**Plate 1.** Vironex setting up on SV-2

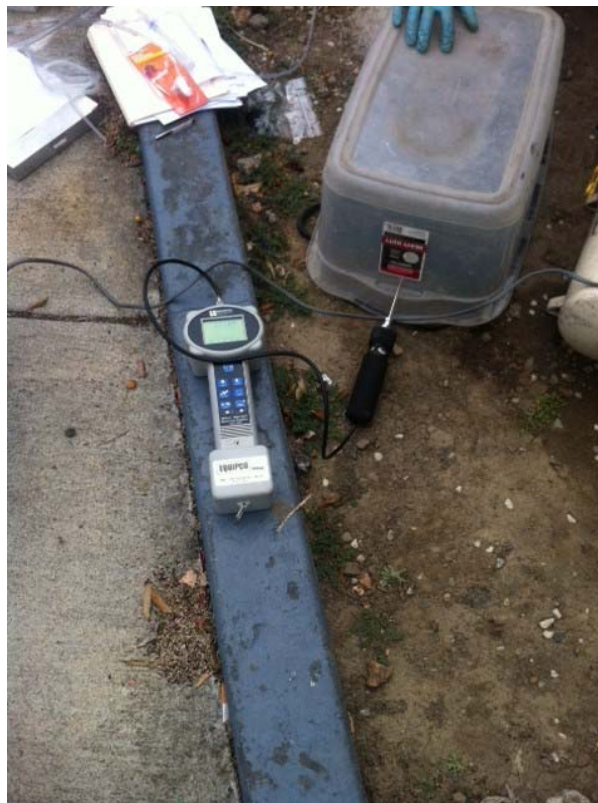
**Plate 2.** Set up on SV-2

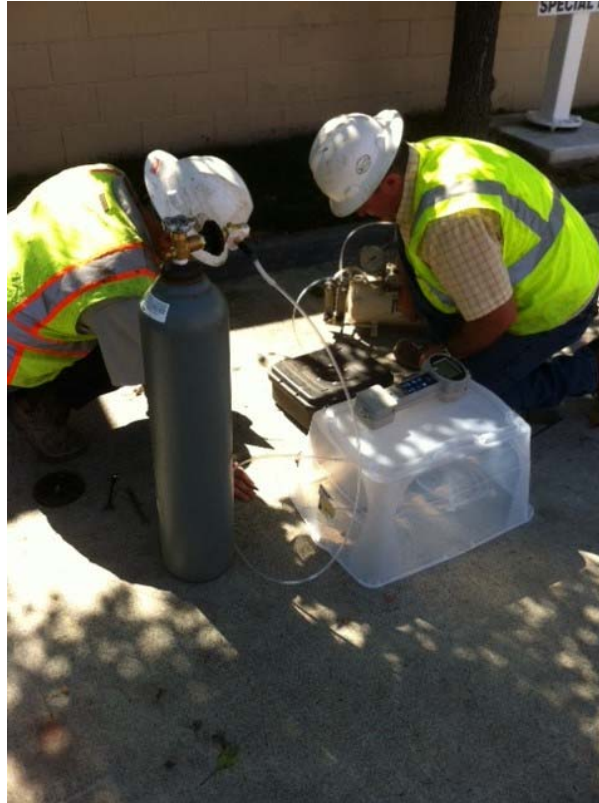
**Plate 3.** Vironex setting up on SV-4

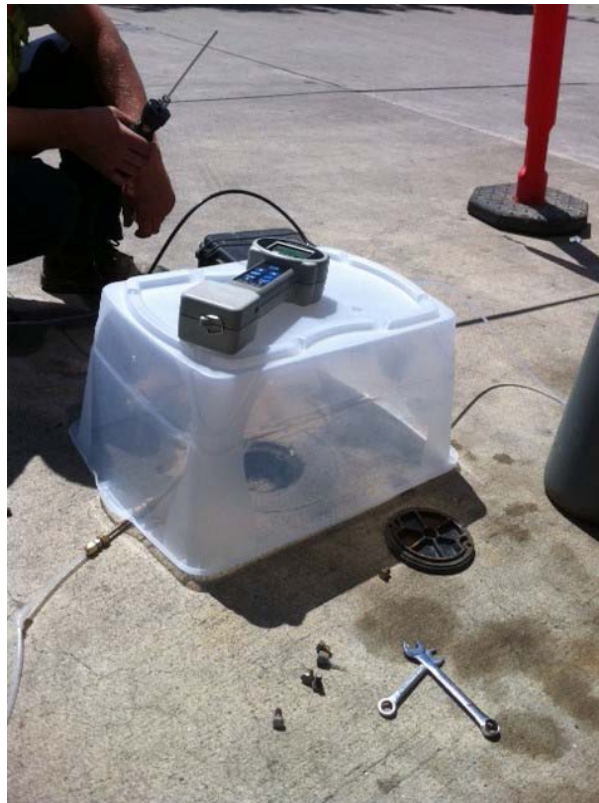
**Plate 4.** Vironex set up on SV-5
