# BLAINE TECH SERVICES INC.

SITE:  
Chevron Service Station No. 93864  
5101 Telegraph Avenue  
Oakland, California

PROJECT:  
Full service station demolition  
with removal of all above ground  
and subsurface installations

## MULTIPLE EVENT SAMPLING REPORT 911010-C-1

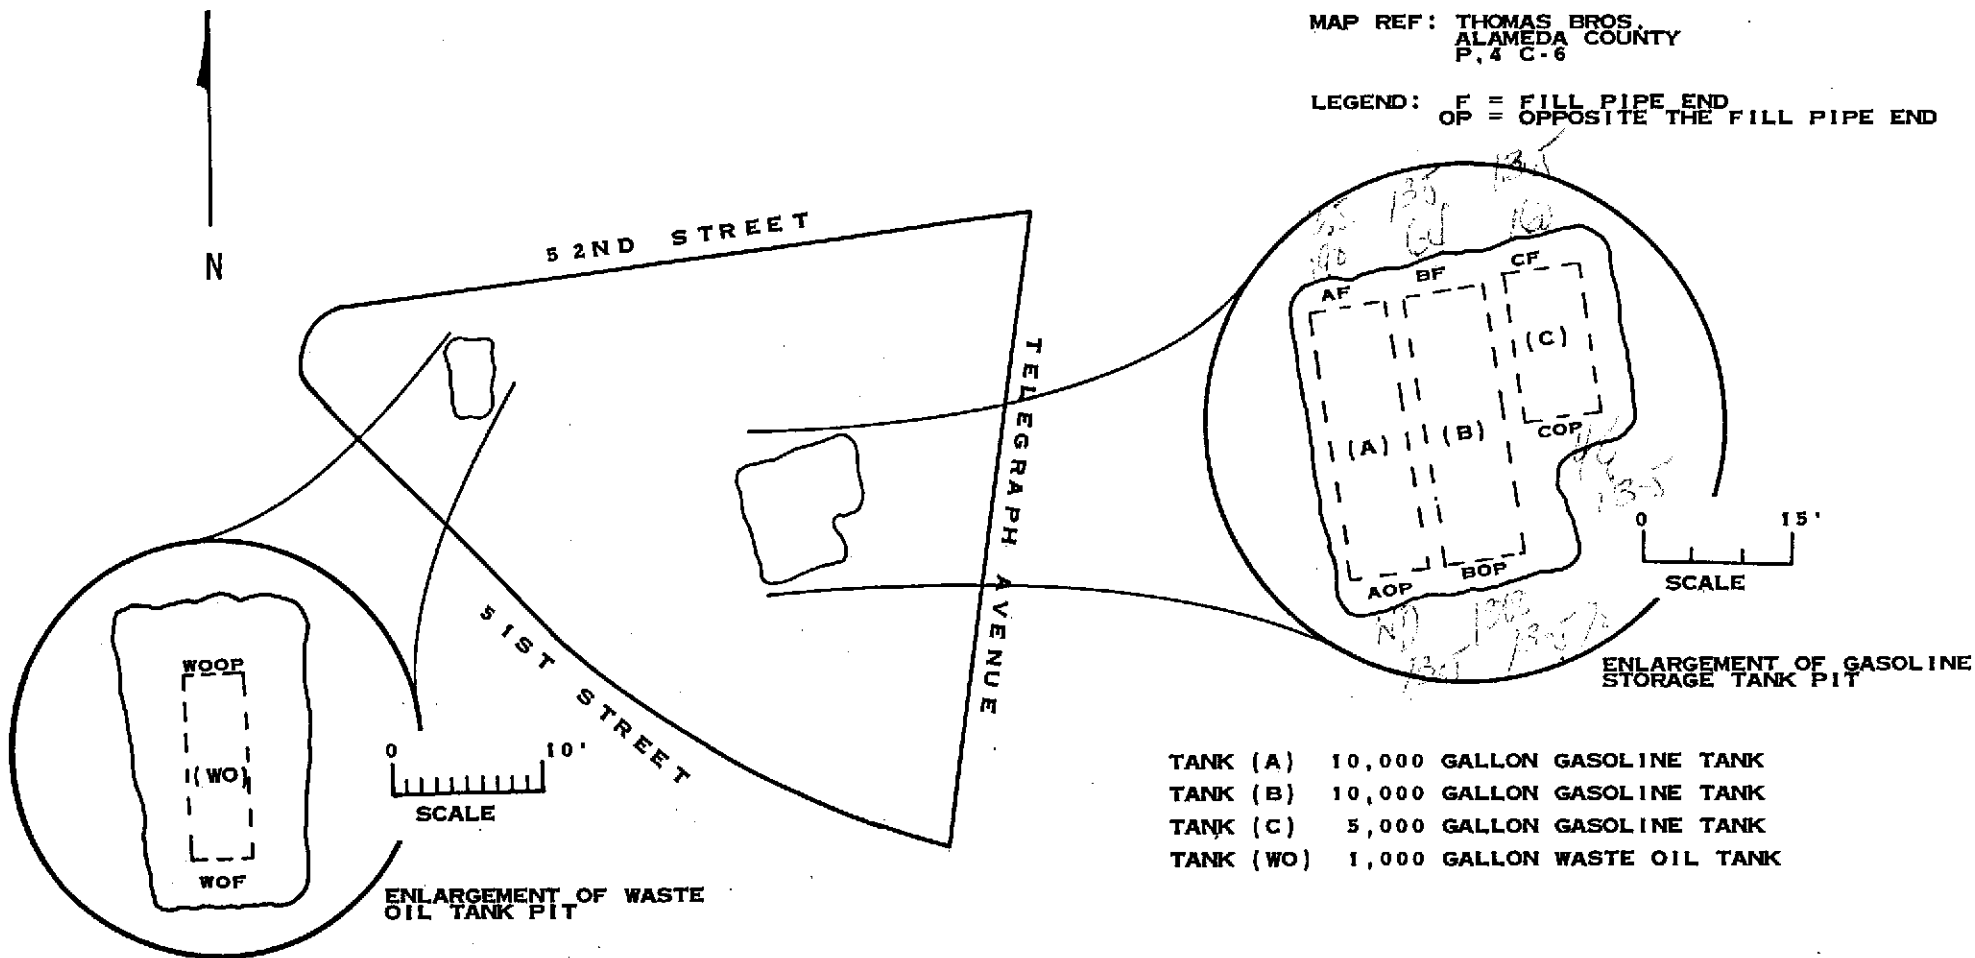
# MASTER SITE DIAGRAM

- TANK (A) 10,000 GALLON GASOLINE TANK
- TANK (B) 10,000 GALLON GASOLINE TANK
- TANK (C) 5,000 GALLON GASOLINE TANK
- TANK (WO) 1,000 GALLON WASTE OIL TANK

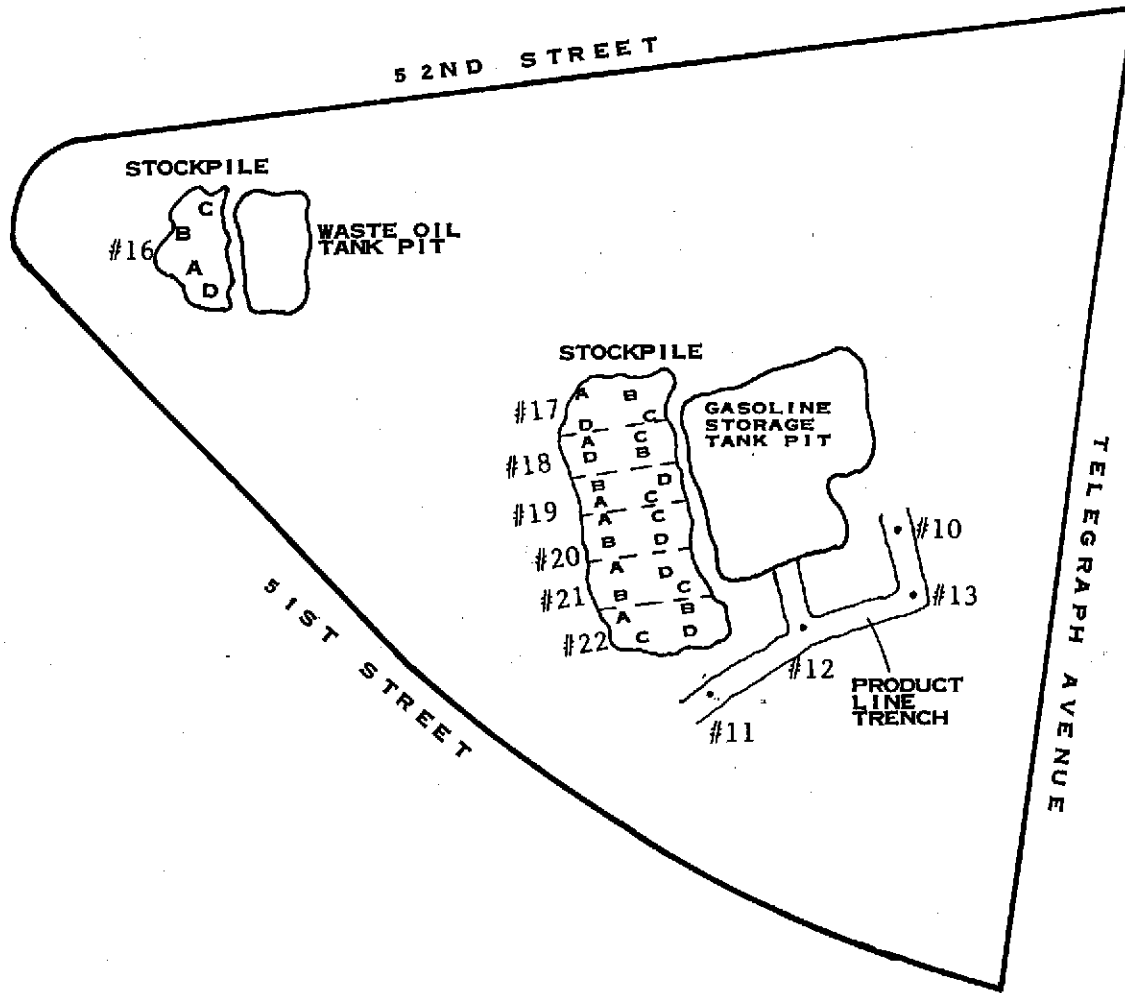
# TANK REMOVAL DIAGRAM

Standard RWQCB interface samples were taken of the native soil at points corresponding to both ends of each underground storage tank. Stockpile samples were also obtained, as were samples of the soil underlying the product line that conducted fuel from the underground storage tanks to the dispenser pumps. The sampling was performed in accordance with the direction of the LIA representative, Ms. Hugo. In the paragraphs that follow, the samples are described in the order in which they were collected:

Sample #1 was a standard interface sample taken at the end opposite the fill pipe of Tank A at a depth of thirteen and a half feet (13.5') below grade.

Sample #2 was a standard interface sample taken at the end opposite the fill pipe of Tank B at a depth of thirteen and a half feet (13.5') below grade.

Sample #3 was a standard interface sample taken at the end opposite the fill pipe of Tank C at a depth of thirteen and a half feet (13.5') below grade.

Sample #4 was a standard interface sample taken at the fill pipe end of Tank C at a depth of thirteen and a half feet (13.5') below grade.

Sample #5 was a standard interface sample taken at the fill pipe end of Tank B at a depth of thirteen and a half feet (13.5') below grade.

Sample #6 was a standard interface sample taken at the fill pipe end of Tank A at a depth of thirteen and a half feet (13.5') below grade.

Samples #7-#9 were sidewall samples taken from the gasoline tank pit. These samples were taken at the request of Ms. Vukelich to confirm the lateral extent of contamination.

Sample #7 was a confirming sample taken from the west sidewall of the gasoline tank pit. The sample was taken at the middle of Tank A at a depth of ten feet (10.0') below grade.

Sample #8 was a confirming sample taken from the northeast sidewall of the gasoline tank pit. The sample was taken at the middle of Tank C at a depth of ten feet (10.0') below grade.

Sample #9 was a confirming sample taken from the southeast sidewall of the gasoline tank pit. The sample was taken near the end of Tank B opposite the fill pipe at a depth of ten feet (10.0') below grade.

Sample #10 was taken of the soil underlying a dispenser pump island at a depth of two feet (2.0') below grade.

Sample #11 was taken of the soil underlying the second of two dispenser pumps at a depth of three feet (3.0') below grade.

Sample #12 was taken of the soil underlying a T shaped fitting in the product line piping at a depth of two feet (2.0') below grade.

Sample #13 was taken of the soil underlying a ninety degree bend in the product line piping at a depth of two feet (2.0') below grade.

Sample #14 was a standard interface sample taken at the end opposite the fill pipe of Tank WO at a depth of eleven feet (11.0') below grade.

Sample #15 was a standard interface sample taken at the fill pipe end of Tank WO at a depth of eleven and a half feet (11.5') below grade.

A review of the analytical results obtained from analyses of the tank removal samples found five areas of the gasoline tank pit and one area in the product line trench that contained unacceptable levels of hydrocarbon contamination.

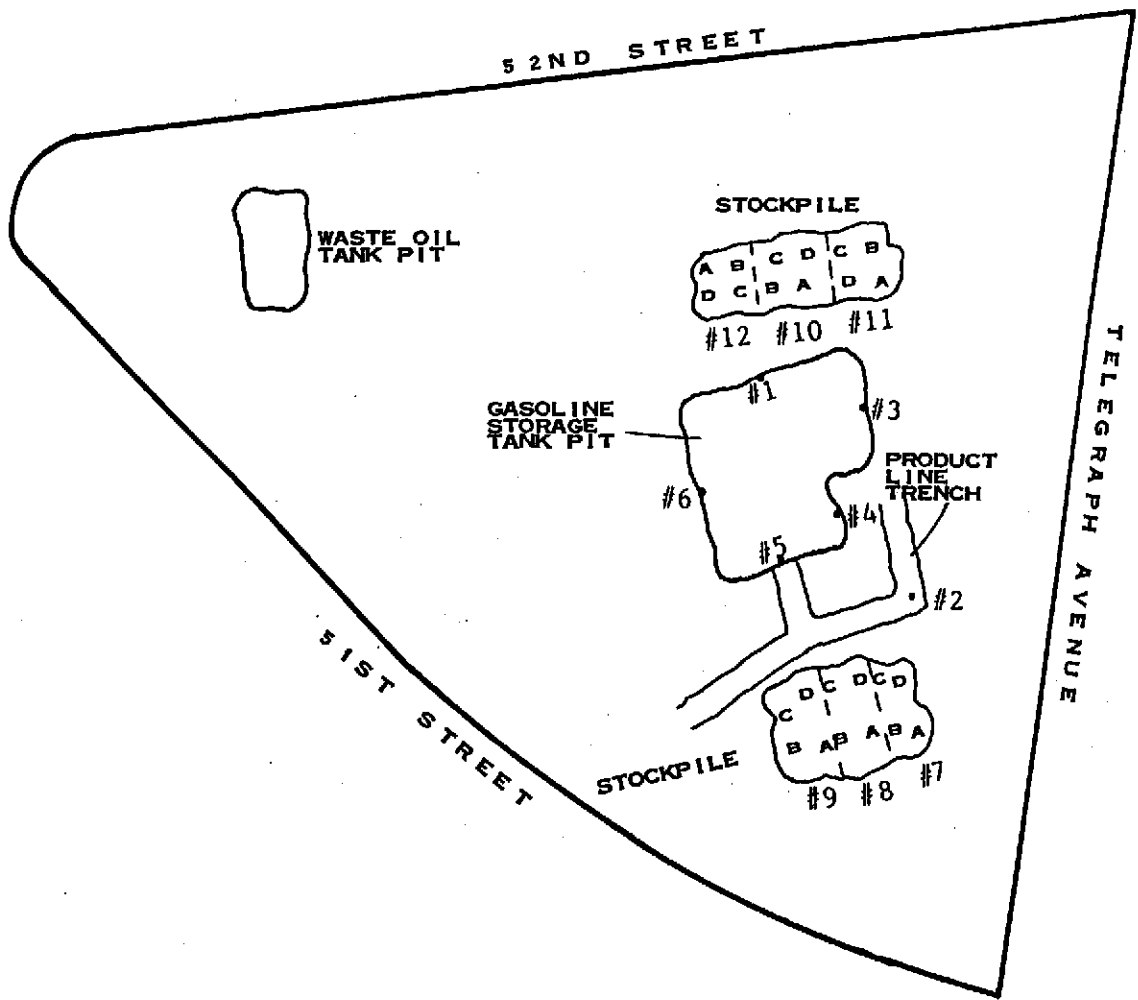
Once the excavation of the tank pit bottom started, old fuel was found to have saturated more than the one to two feet (1.0-2.0') of soil. In an effort to define the depth of the saturation zone, an exploratory trench was put down in the tank pit bottom on the 52nd Street side of the tank pit to a depth of eighteen feet (18.0') below grade. It was found that the old fuel had saturated the soil down to a depth of seventeen feet (17.0') below grade, one and a half to two feet (1.5-2.0') below the level of groundwater. As it was Ms. Vukelich's request to remove the contaminated soil without encountering groundwater, further excavation of the tank pit was halted pending her further directions.

Golden West Builders personnel increased the tank pit depth from thirteen and a half feet to seventeen and a half and eighteen feet (13.5-17.5/18.0') below grade. At that depth, a return to normal soil appearance and coloration was observed.
