Shell-branded Service Station

3790 Hopyard Road
 Pleasanton, California
 Incident #98995842

Vicinity/Area Well Survey Map

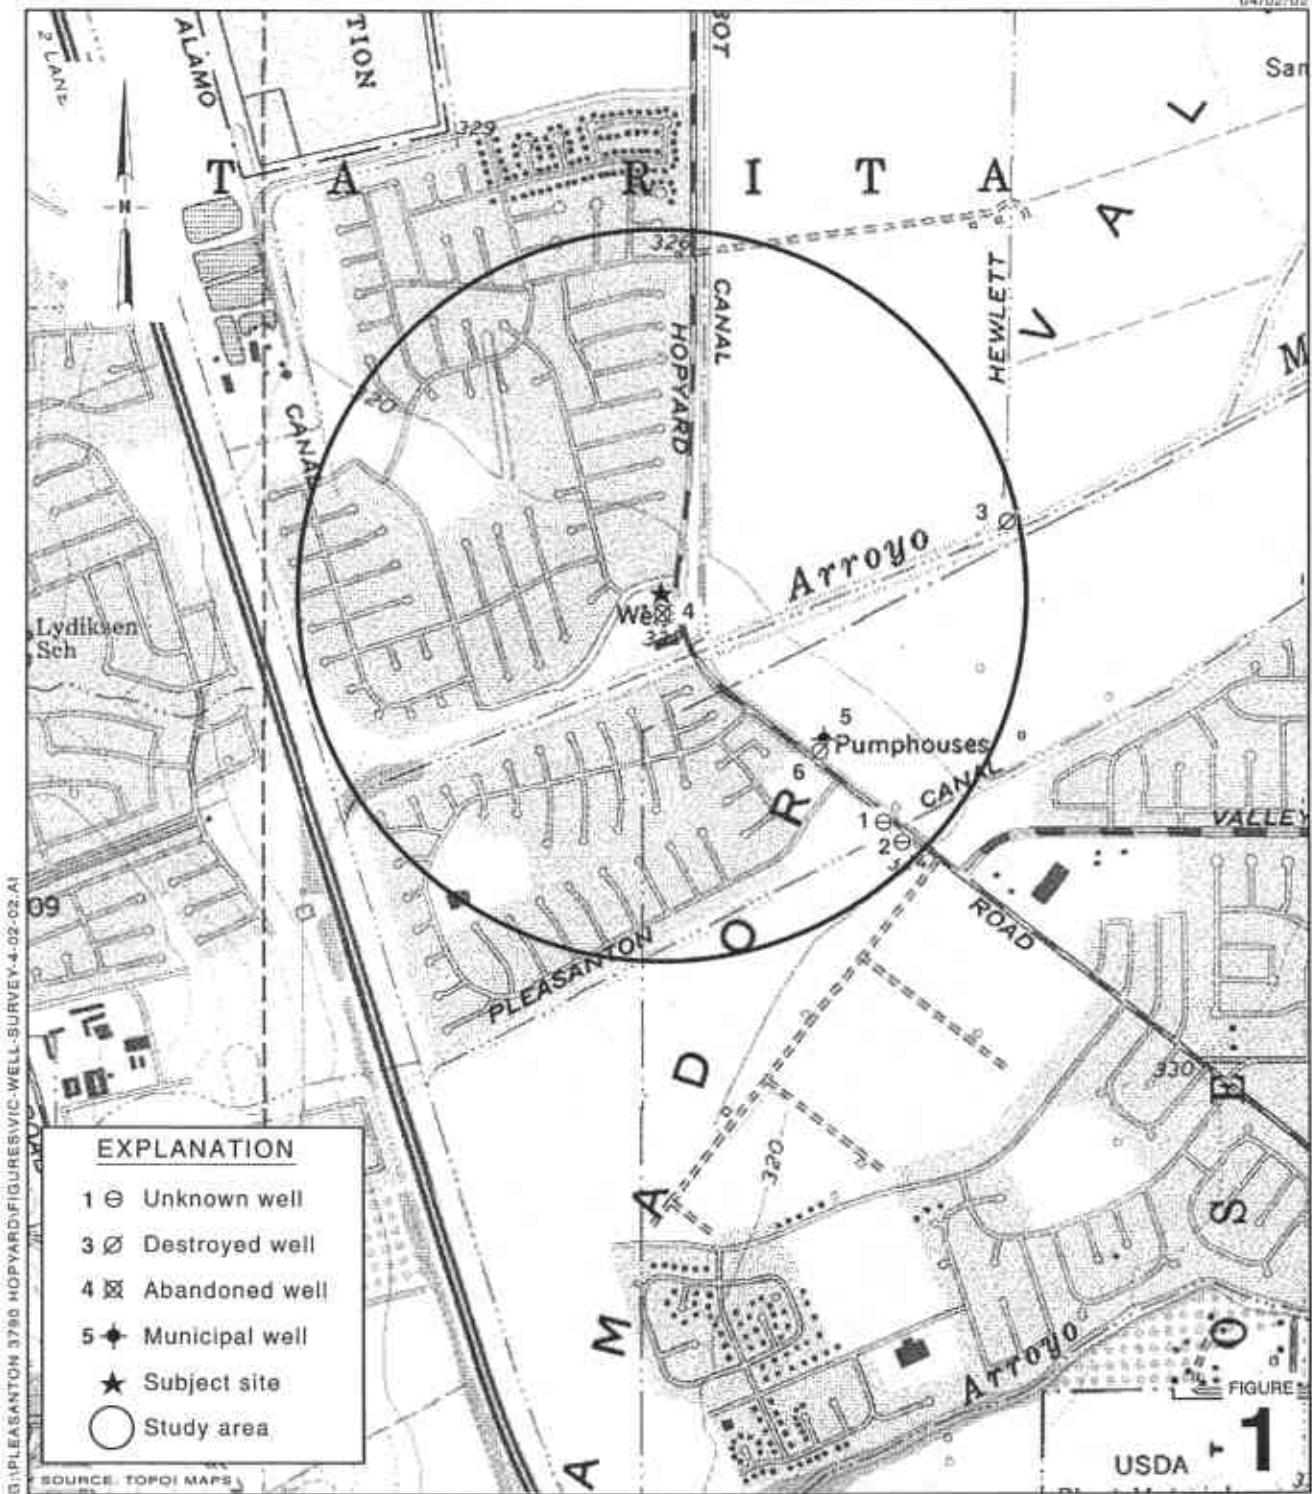
1/2 Mile Radius
