Groundwater and Soil Vapor Monitoring Report

Fuel Leak Case No. RO0000400 and
GeoTracker Global ID T0600100227
Volkswagen Automobile Dealership
2740 Broadway Avenue
Oakland, California

Volkswagen Automobile
Dealership
2740 Broadway Avenue
Oakland, California

Prepared by:
ARCADIS U.S., Inc.
2000 Powell Street
Suite 700
Emeryville
California 94608
Tel 510 652 4500
Fax 510 652 4906

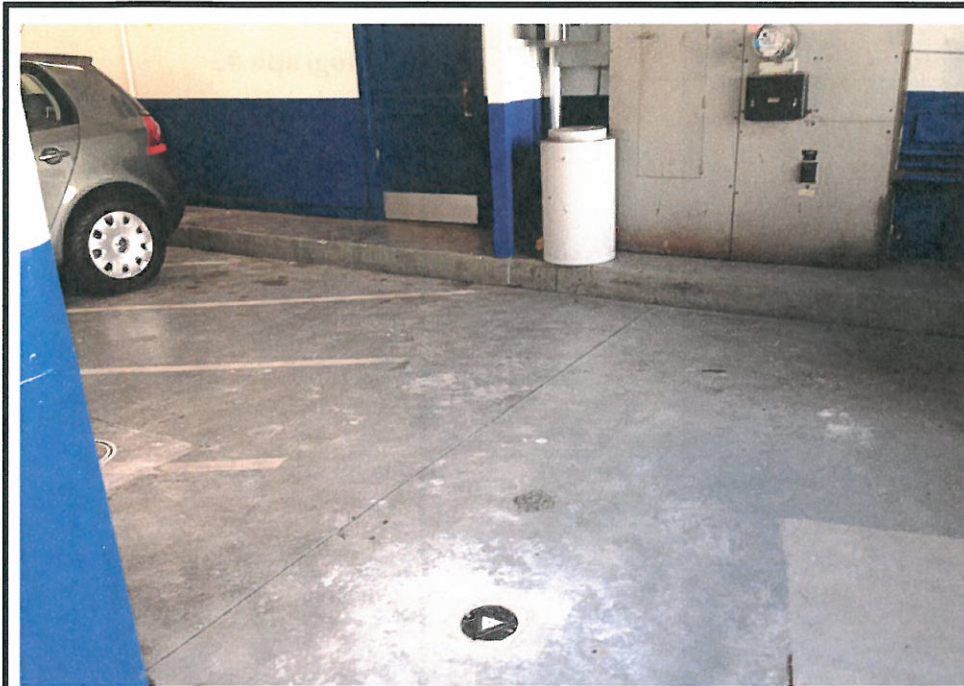
Photograph #1

Description of Photograph:
VW-6 (Christy box) and SS-SV-1
(small dot right of Christy box),
facing west inside service garage.

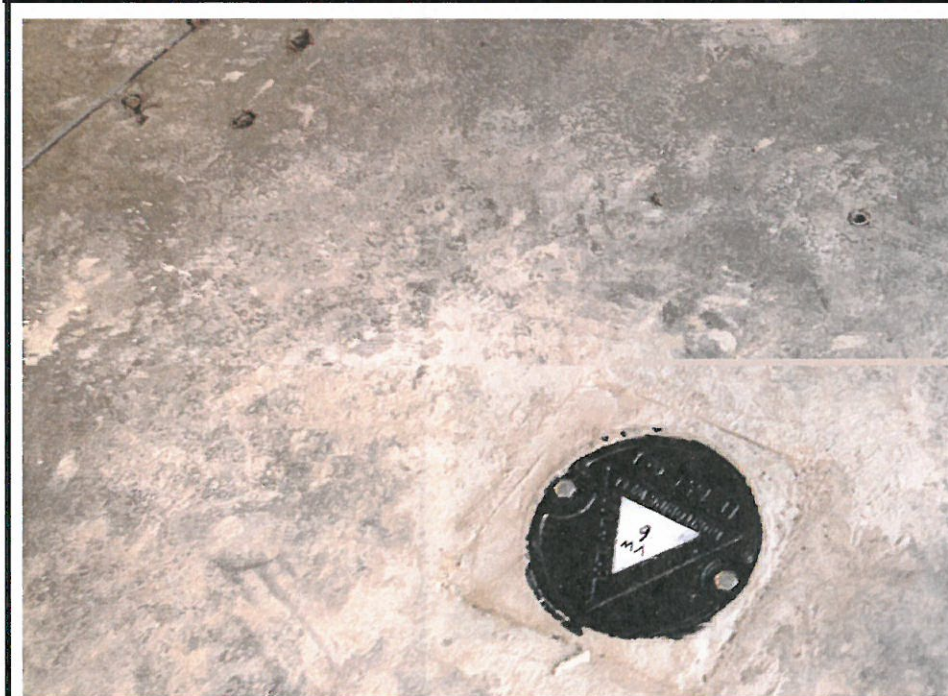
Photograph #2

Description of Photograph:
VW-6 (Christy box) and SS-SV-1
(small dot in top right corner),
facing north inside service garage.
