Subject: Fuel Tank Closure Report

# FUEL TANK CLOSURE REPORT 265 30TH STREET, OAKLAND, CALIFORNIA

HAGSTROM PROPERTIES ORINDA, CALIFORNIA

CCI PROJECT No. 12058-1 (December 1995)

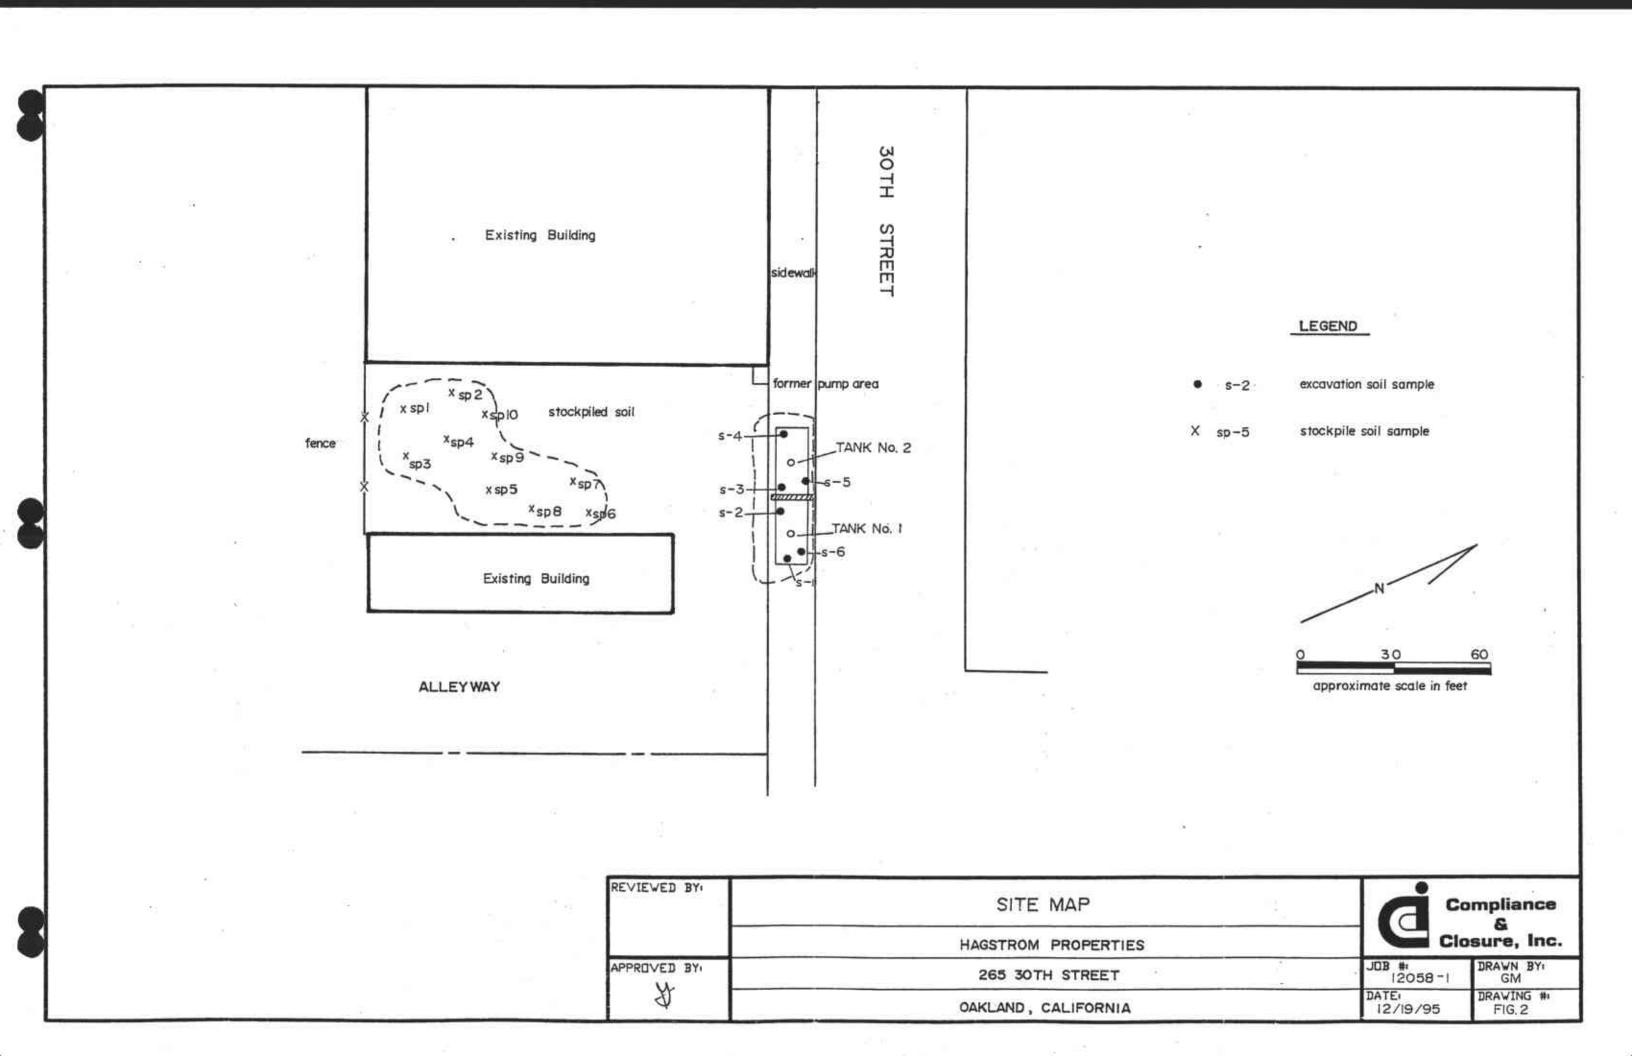
The tank removal was scheduled for the first week in December 1995. Field work to uncover the tops of the fuel tanks began on November 30, 1995. Since the exact size of the fuel tanks was not known, it was assumed that there were at least two 550-gallon fuel tanks under the sidewalk area (Figure 2). After carefully exposing

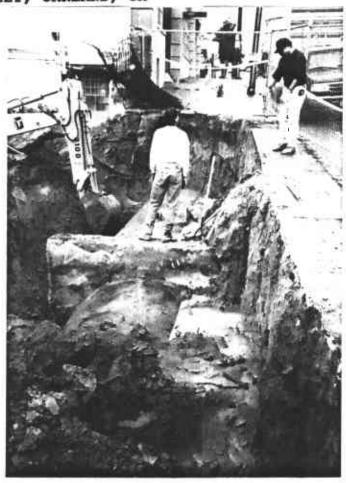
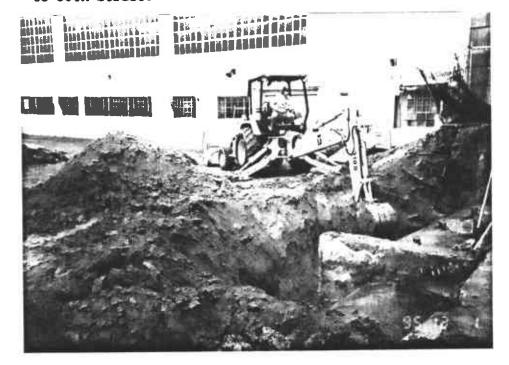
Uncovering top of fuel tanks under sidewalk adjacent to 30th Street.

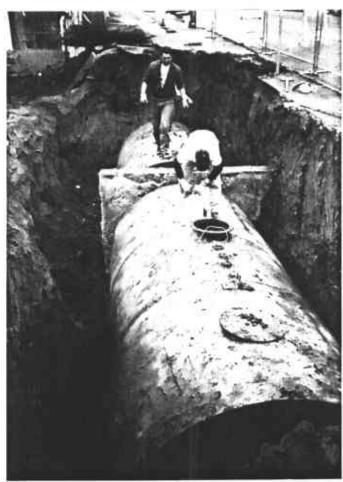
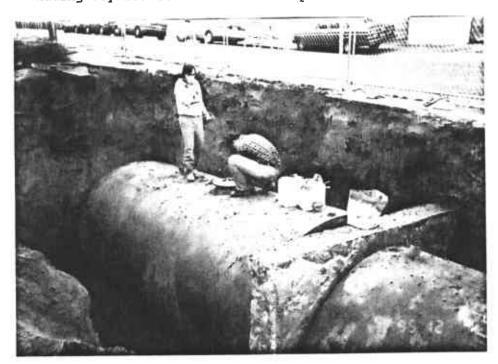
Adding dry ice to the fuel tanks prior to removal

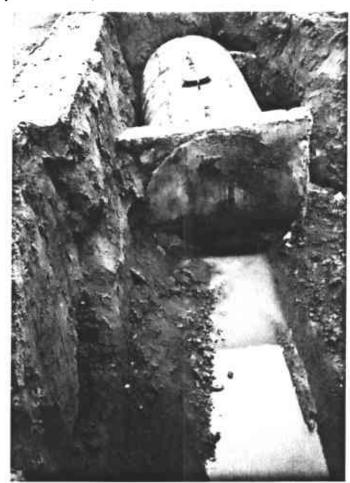
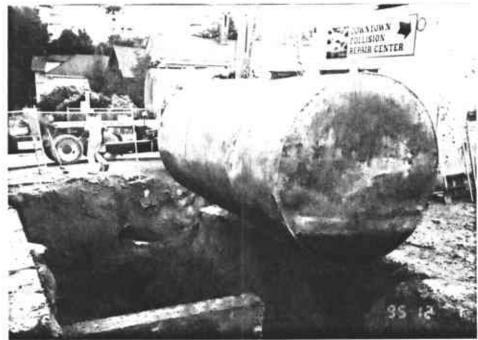
View of Tank No. 1 prior to being removed. Note the concrete separation wall between the two tanks. The separation wall was left in place.

Continued excavation of the two fuel tanks took place on December 4th, 5th and 6, 1995. The clean soil was separated from the soil with suspected petroleum contamination. A large concrete block was uncovered which separated the two fuel tanks. It appeared that the purpose of the concrete block was to separate and hold the two tanks in place. Soil contamination was noted mainly on the central and south sides of the excavation.

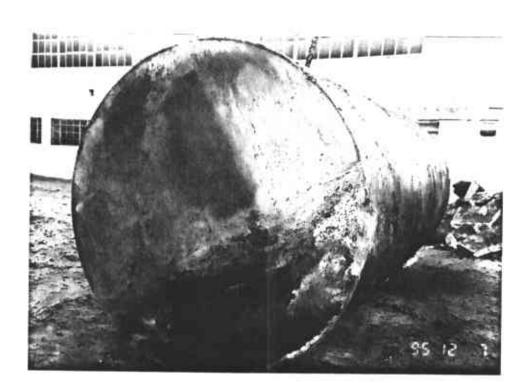
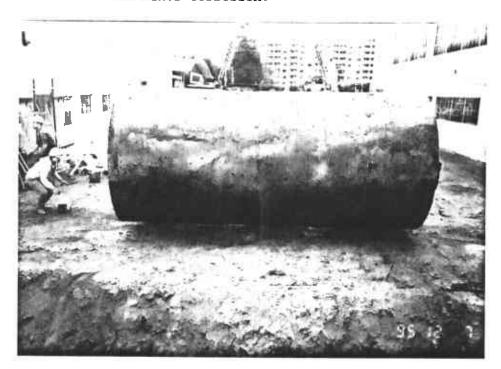
View of removed fuel tank. Tank appeared to be in very good condition with minor corrosion.

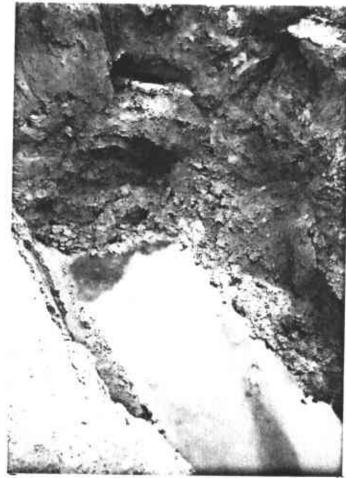
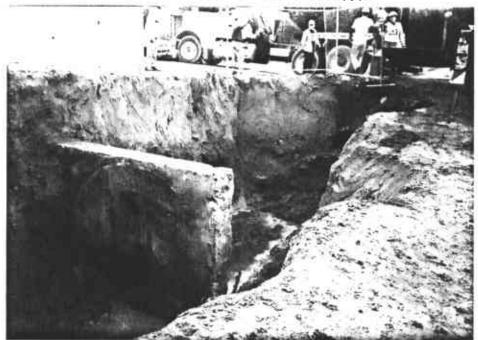
Views of soil contamination on the southwest and southeast sides of the excavation. There was approximately 6-inches of rain water at the bottom of the excavation.

After the tanks were removed, Ms. Madhulla Logan from the Alameda County Health Agency (the County) requested that areas of obvious contamination be sampled from within the excavation prior to over-excavation of those areas. There appeared to be noticeable areas of contamination along the bottom of the excavation and to approximately 3 to 4 feet above the bottom, along the 30th Street side of the excavation. In addition, there was approximately 6-inches of standing water with a heavy sheen at the bottom of the excavation on the southeast side, apparently from recent rain.

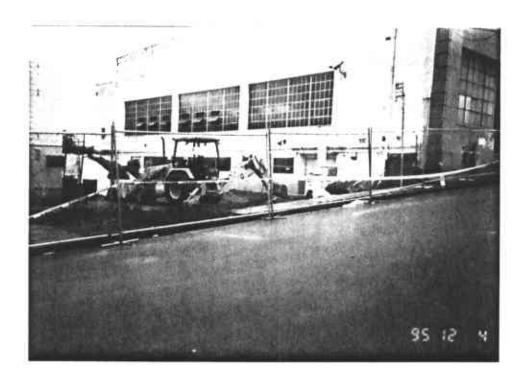
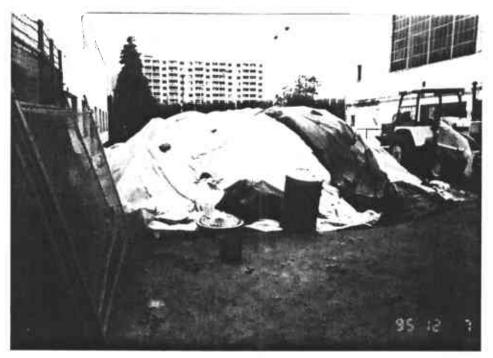
(TOP) - View of the site excavation activity, (Bottom) - View of the stockpiled soil.
