**Transmittal
Results of Additional Investigation
1650 65th Street
Emeryville, California
Fuel Leak Case No. RO0000440
Geotracker Global ID T0600100511**

Submitted herewith for your review is the *Results of Additional Investigation, 1650 65th Street, Emeryville, California* prepared by PES Environmental, Inc.

**Subject: Results of Additional Investigation
1650 65th Street, Emeryville, California
Fuel Leak Case No. RO0000440
Geotracker Global ID T0600100511**

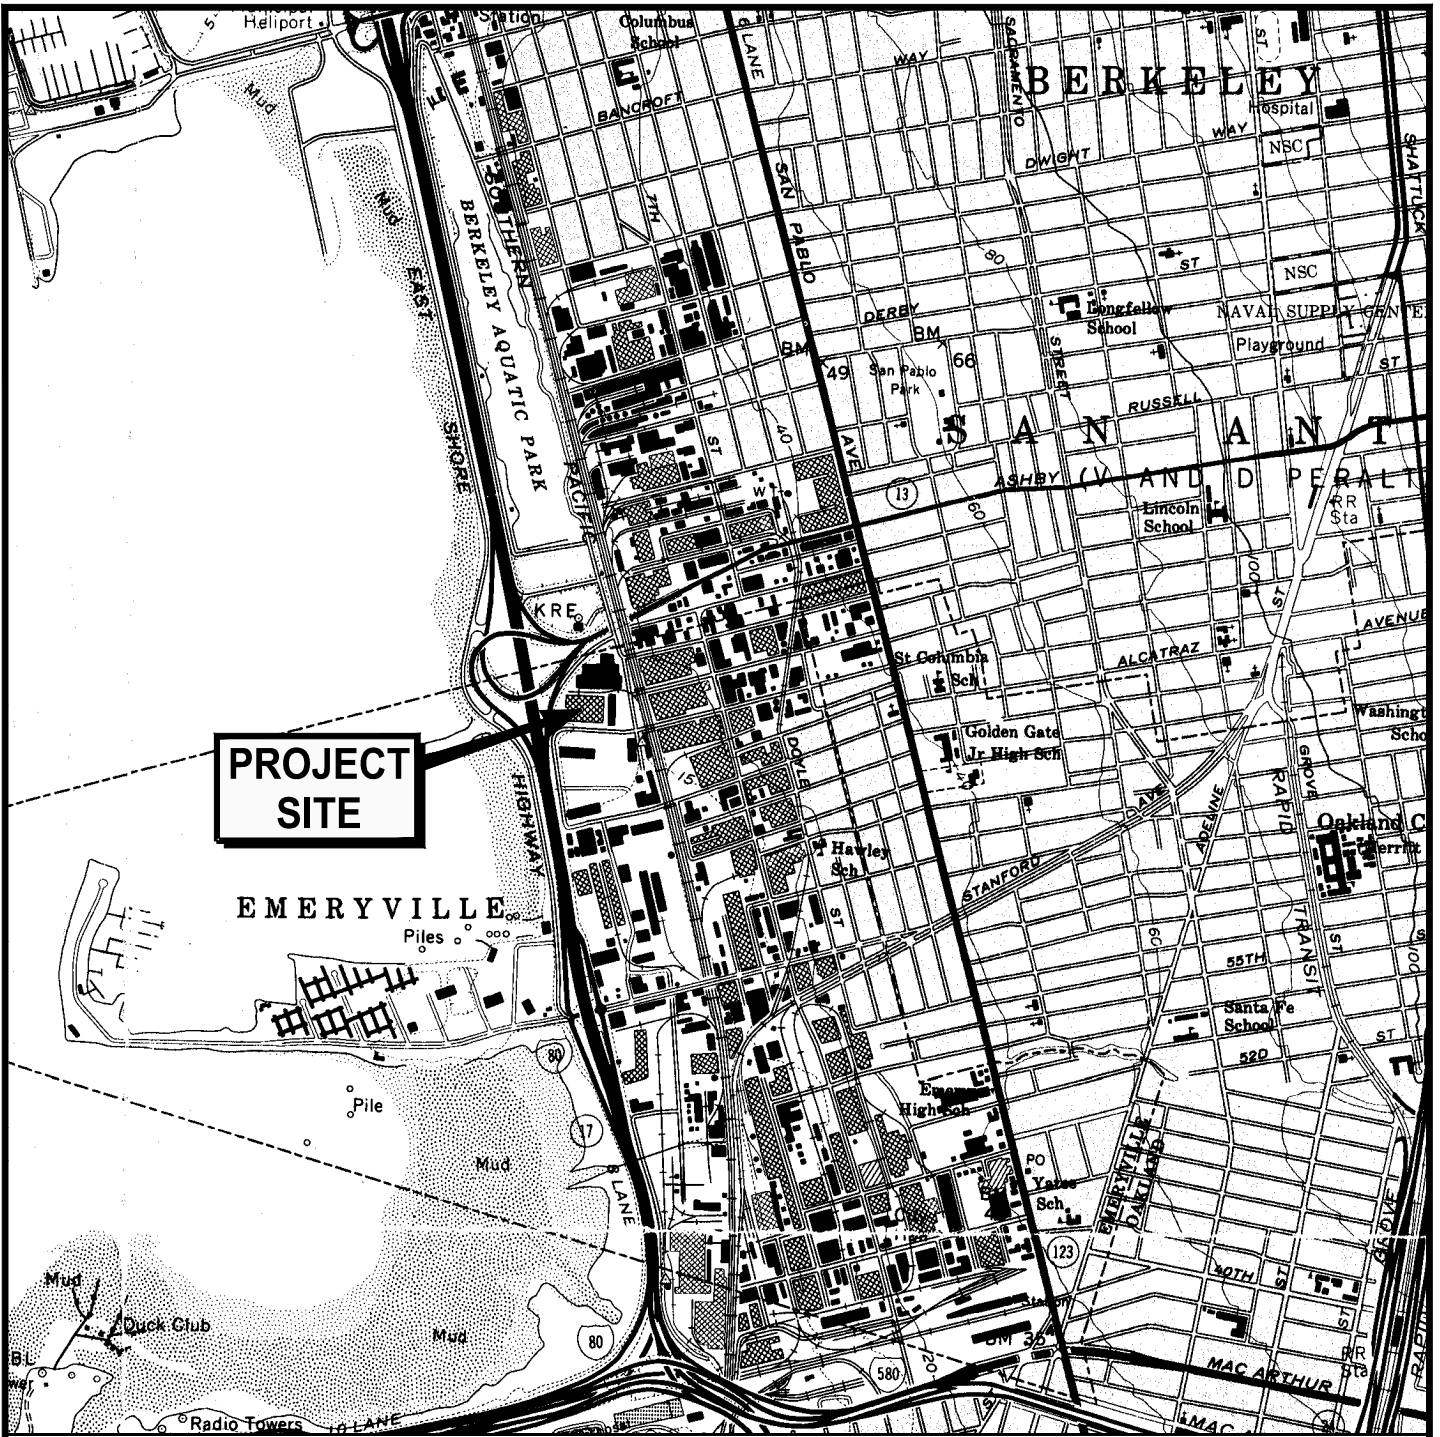
1

This report has been prepared by PES Environmental, Inc. (PES) on behalf of Griffin Capital Corporation (Griffin) as agent for the fee owners to document the implementation and results of focused soil, groundwater, and sub-slab vapor investigations conducted at 1650 65th Street in Emeryville, California (the Site, Plate 1).
