Re: CHEVRON #9-1851
451 Hegenberger Road
Oakland, California
ACEH Case No. 464

Re: **UST Removal Compliance Sampling Report**
451 Hegenberger Road, Oakland, California

On behalf of property owner Mr. Navdeep Singh Grewal, Pangea Environmental Services, Inc., (Pangea) has prepared this *Underground Storage Tank (UST) Removal Compliance Sampling Report* for the subject site. This report describes compliance sampling performed after diesel UST removal with regulatory oversight by the City of Oakland Fire Department (OFD). The compliance sampling was conducted in general accordance with the California Regional Water Quality Control Board's *Tri-Regional Board Staff Recommendations for Preliminary Investigation and Evaluation of Underground Tank Sites* (Tri-Regional Guidelines) dated September 2003. Described below are the project background, compliance sampling, and analytical results.

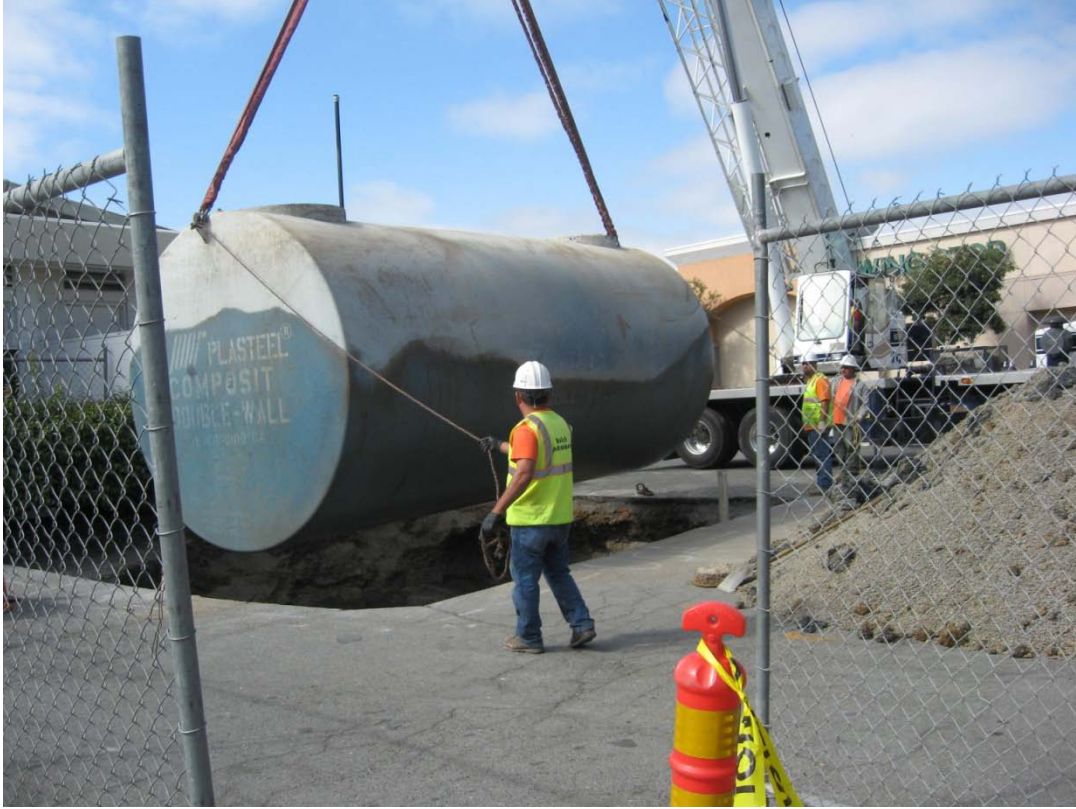
Removal of diesel UST

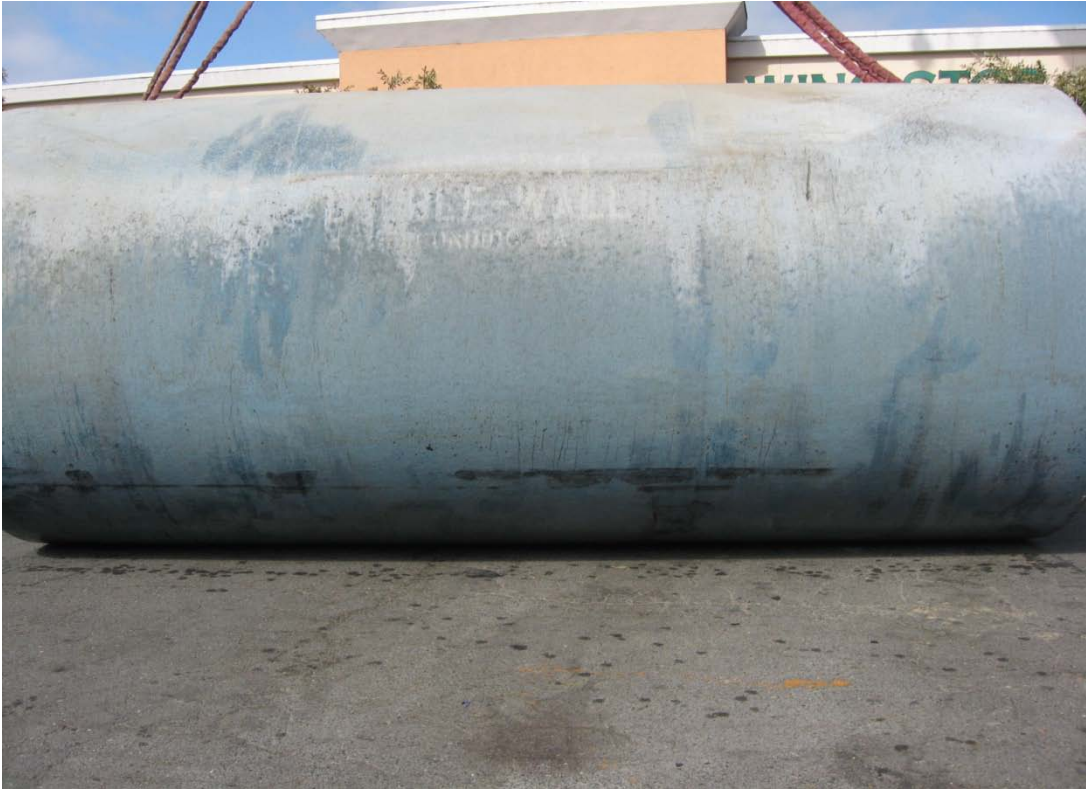
On September 18, 2012, Balch Petroleum Contractors and Builders Inc., (Balch) of Milpitas, California removed a 10,000-gallon diesel UST from the site. The UST removal was observed by Hazardous Materials Inspector Keith Matthews of OFD. UST removal/closure permit information is included in Appendix A. The generator's California EPA ID number is CAL000280379. Limited groundwater was encountered in the UST cavity beneath the bottom of the tank. The final excavation was approximately 15 feet deep at the bottom of the tanks. Photographs of the tank removal are presented in Appendix A. No holes were observed in the UST, which appeared

to be in very good condition. The tank was loaded by Balch and hauled to an appropriate licensed disposal facility. The waste manifest is included in Appendix A.

Diesel UST underside

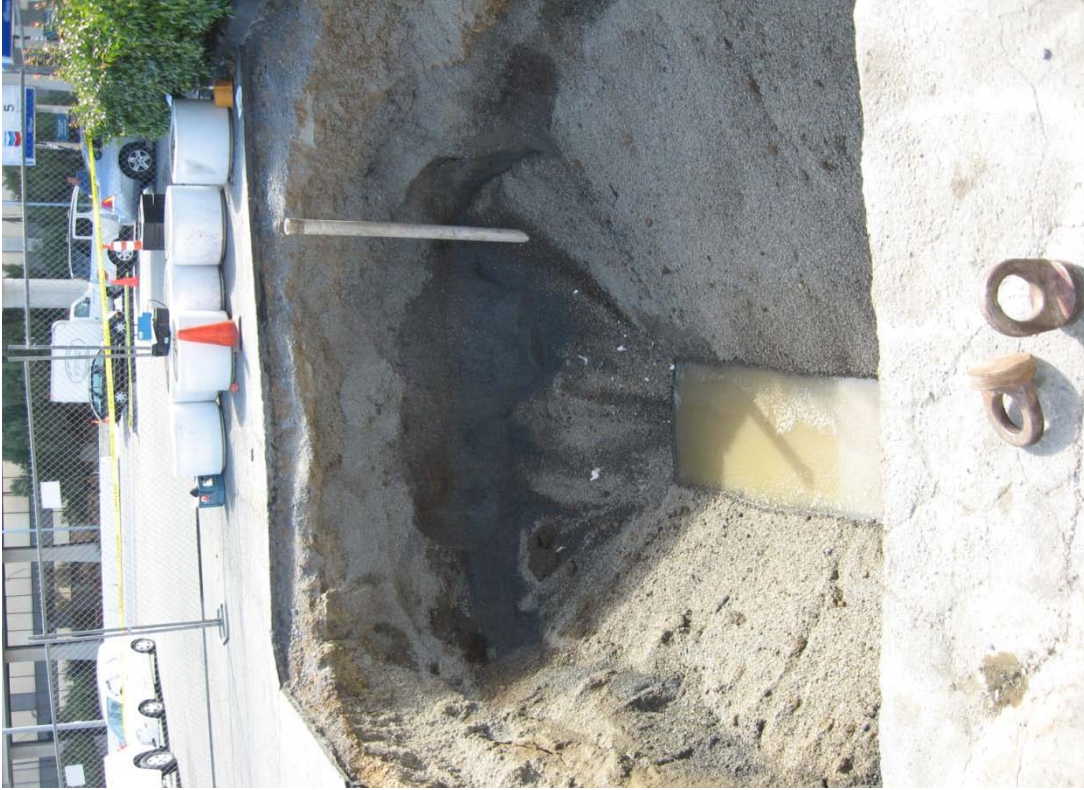
To facilitate UST sample collection, a backhoe was used to collect soil from both ends of the UST. Soil from approximately 6 feet below grade surface (bgs) was lifted to the side of the pit in the backhoe bucket, where a sample was collected. A groundwater sample was collected from the bottom of the pit.

UST cavity

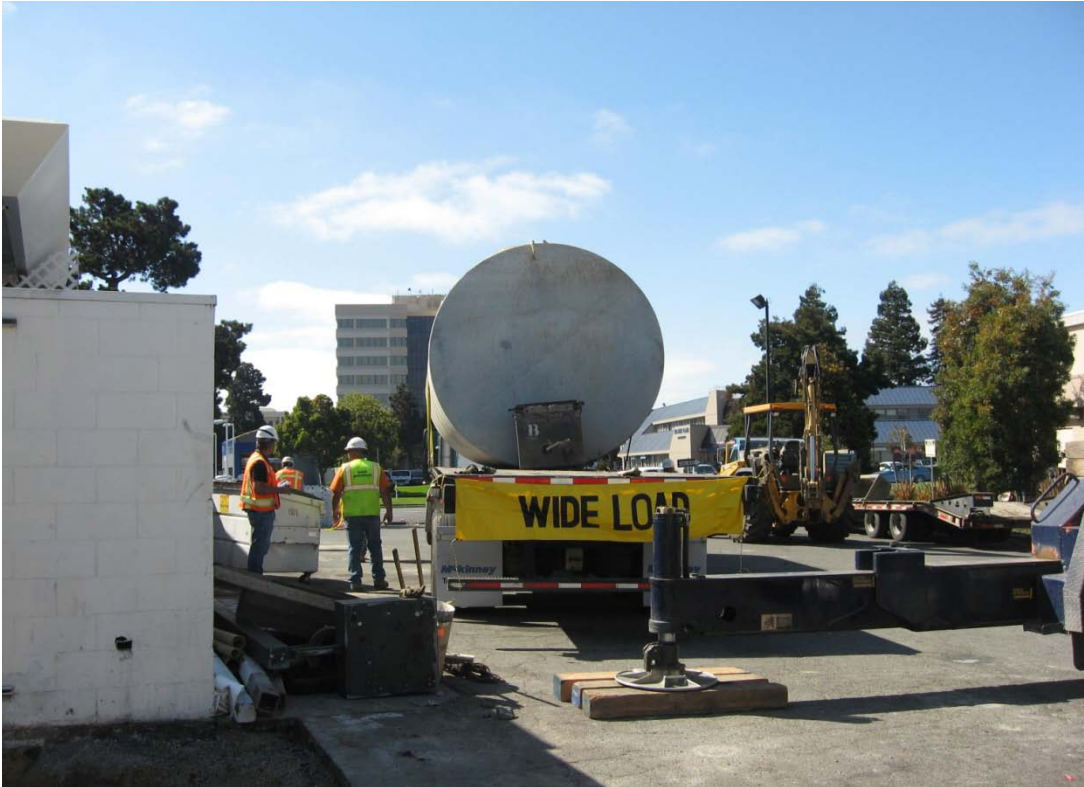
Diesel UST loaded for removal
