REPORT

UNDERGROUND STORAGE TANK CLOSURE

Tanks LF5/6

Project 46591.CL
Ameriflight, Inc.
Oakland Airport, Hanger 2
9171 Earhart Road
Oakland, California 94621

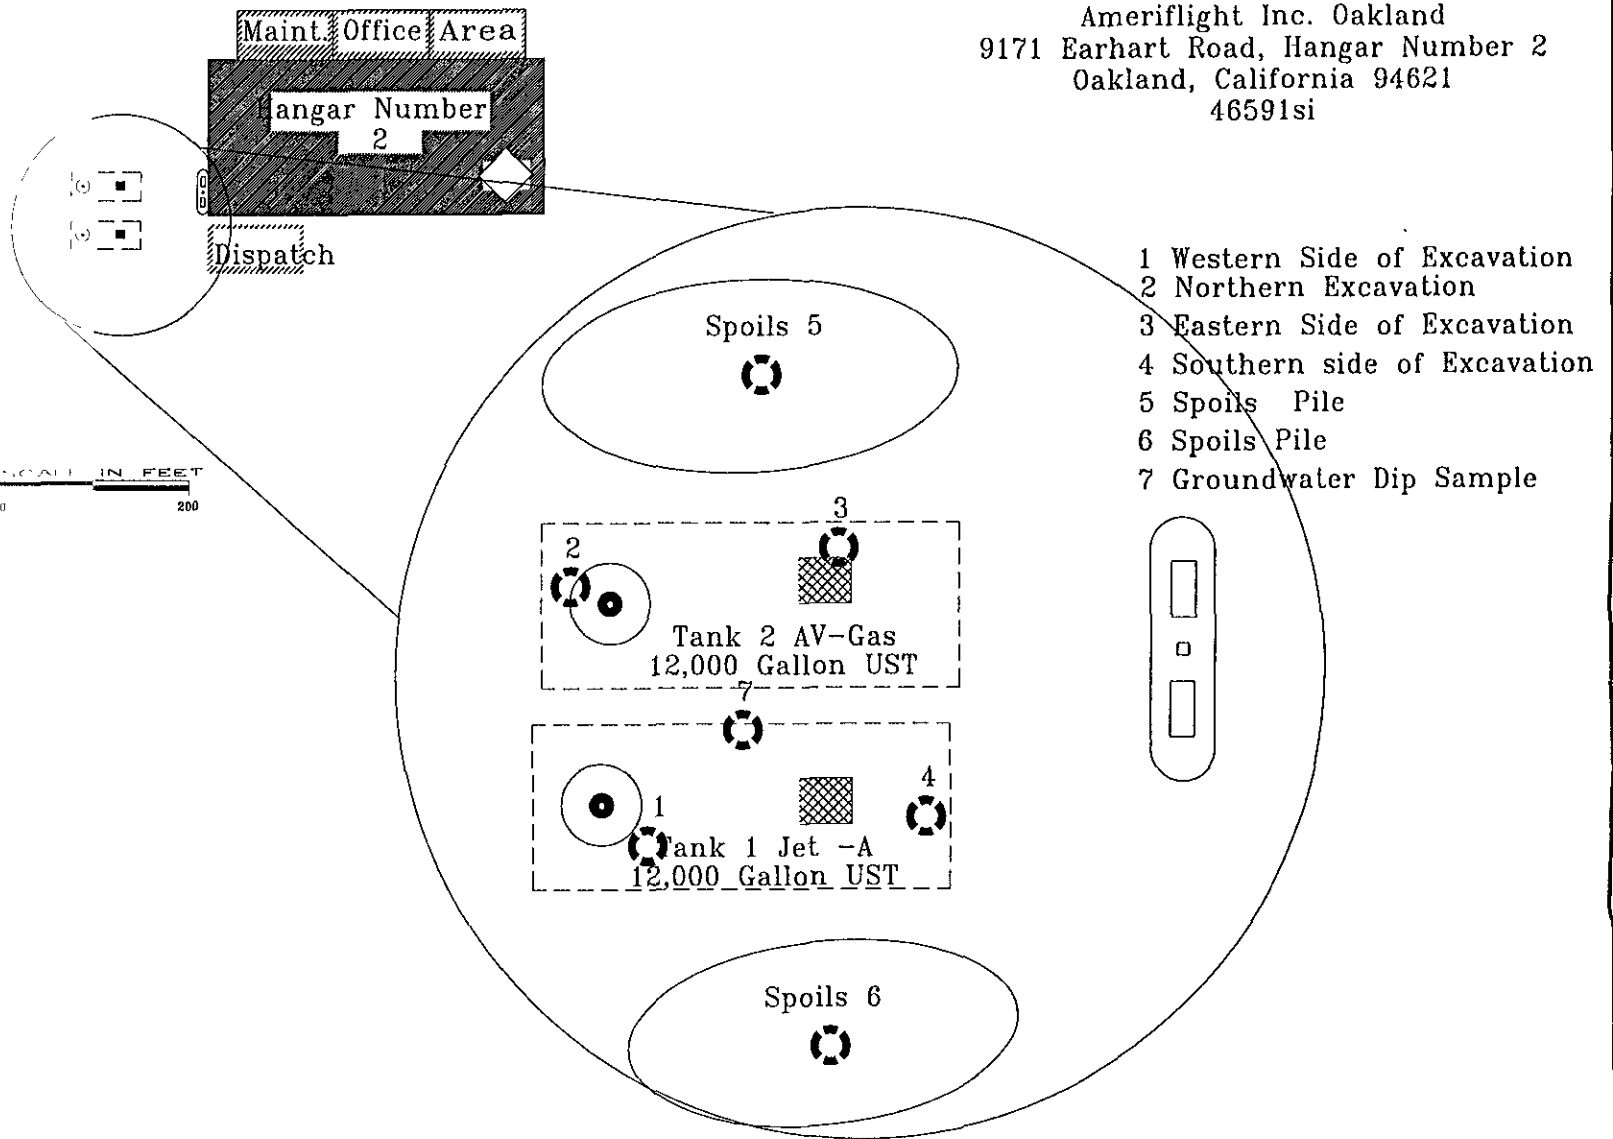
Figure 2 - Site Diagram

- 1 Western Side of Excavation
- 2 Northern Excavation
- 3 Eastern Side of Excavation
- 4 Southern side of Excavation
- 5 Spoils Pile
- 6 Spoils Pile
- 7 Groundwater Dip Sample

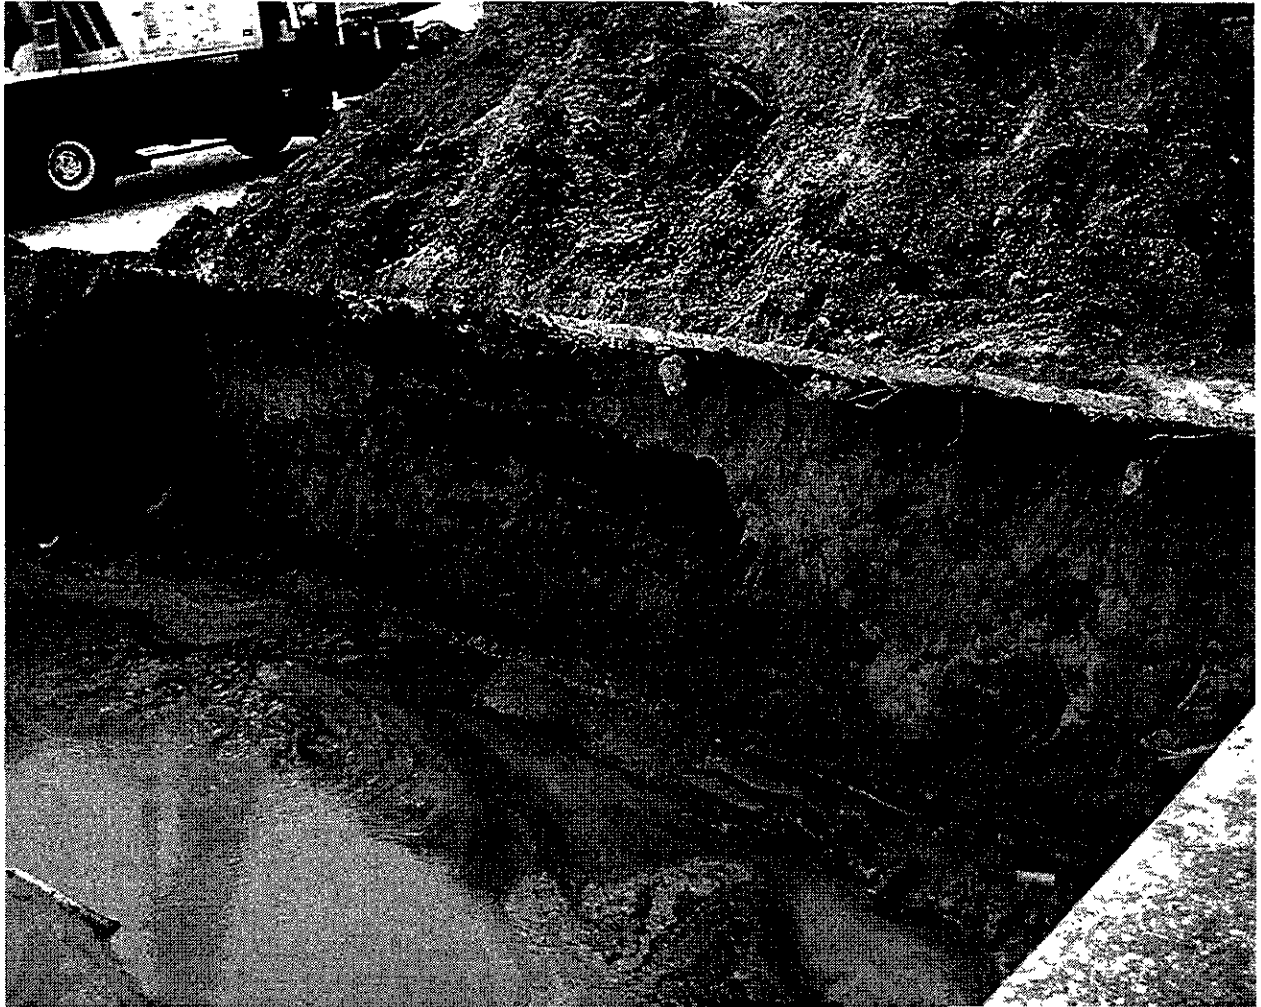
Figure 2 - Waterline of tank excavation shows the change of soil types in the sidewall excavation. Also a froth on the water surface is indicative of organic material breakdown.

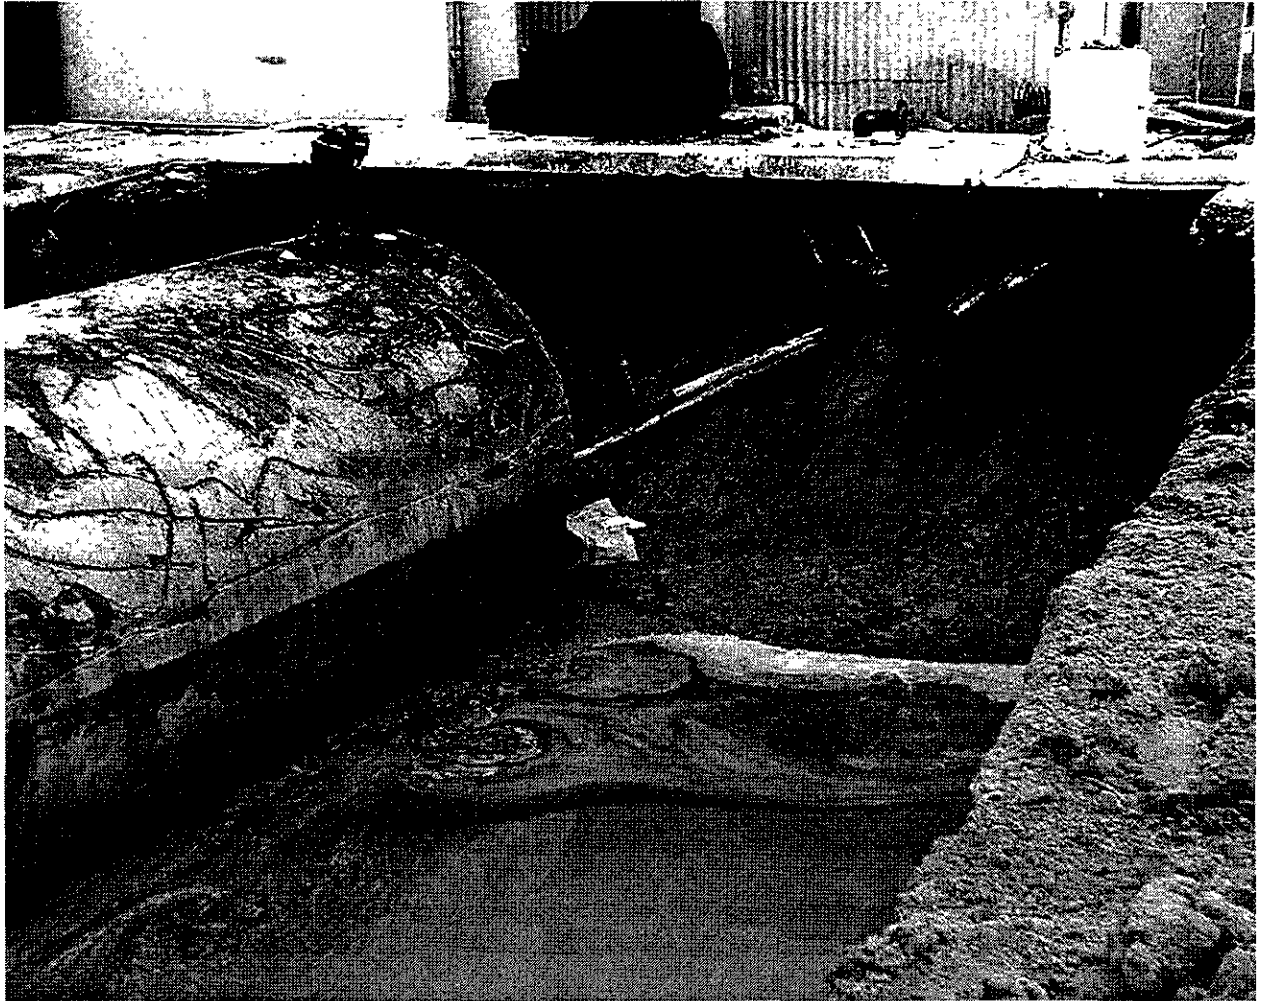
The UST's were removed without incident. The UST's were found to be in good condition with no evidence of failure in either the tanks or associated piping.

Figure 3 - The tanks were in very good condition. The water line on the tank indicates that the water level fluctuated; probably due to tidal action.
