RE: Econo Gas Station
44 Lewelling Boulevard,
San Lorenzo, CA

Subject: Transmittal of letter report No.87044-1 on tank inspection and laboratory analyses of soil samples collected beneath gasoline storage tanks at the Econo gasoline station, 44 Lewelling Boulevard, San Lorenzo, California

GENERALIZED SITE PLAN
Econo Gas Station
San Lorenzo, California

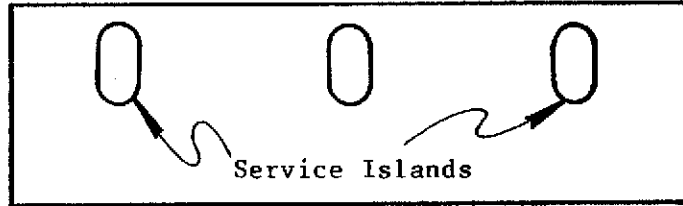
P-2

S-3
S-17- NW

Removed
Underground
Storage Tanks

● Soil Sample Location

The samples were collected from soil at a depth of approximately 14 feet (approximately 4 to 5 feet below the tank bottom). Sample locations are shown on the enclosed Generalized Site Plan. One sample was collected under each end of the three tanks. The six samples were collected by driving laboratory-cleaned brass sleeves into the hoptoe bucket of soil. The sample sleeves were immediately sealed with aluminum foil, plastic caps, and air-tight tape, labeled and placed in iced storage for transport to the analytical laboratory for testing. The Chain Of Custody form for the samples' transferral is included with this letter report.

With the authorization of Kayo Oil Company, a field geologist from Applied GeoSystems returned to the site on April 30, 1987 to observe further excavation in the vicinity of sample S-3 (northwest corner of the tank pit). Soil in the vicinity of sample S-3 was excavated down to the saturated zone. At the interface of the vadose and saturated zone (approximately 17 feet) a sample was collected using the sampling protocol previously described in this letter report. The result of the analysis of sample, S-17-NW, shows total volatile hydrocarbon levels below the 1000 parts per million threshold. Results are presented in Table 2 and on the laboratory Record of Analysis included with this report. Chain of Custody documentation for this additional sample is also included in this report.
