SUBJECT: SOIL SAMPLE COLLECTION REPORT CERTIFICATION
ACEH Case # RO 0000509
Downtown Toyota
4145 Broadway
Oakland, CA

July 28, 2014
Report 0271.R6
RGA Job# PZ35895

SUBJECT: SOIL SAMPLE COLLECTION REPORT
RO # 0000509
Downtown Toyota
4145 Broadway
Oakland, CA

RGA Environmental, Inc. (RGA) has prepared this report documenting the collection of two soil samples (B1-0.0 and B1-2.0) from the planter of the adjacent residential property located at 325 Garnet Street.

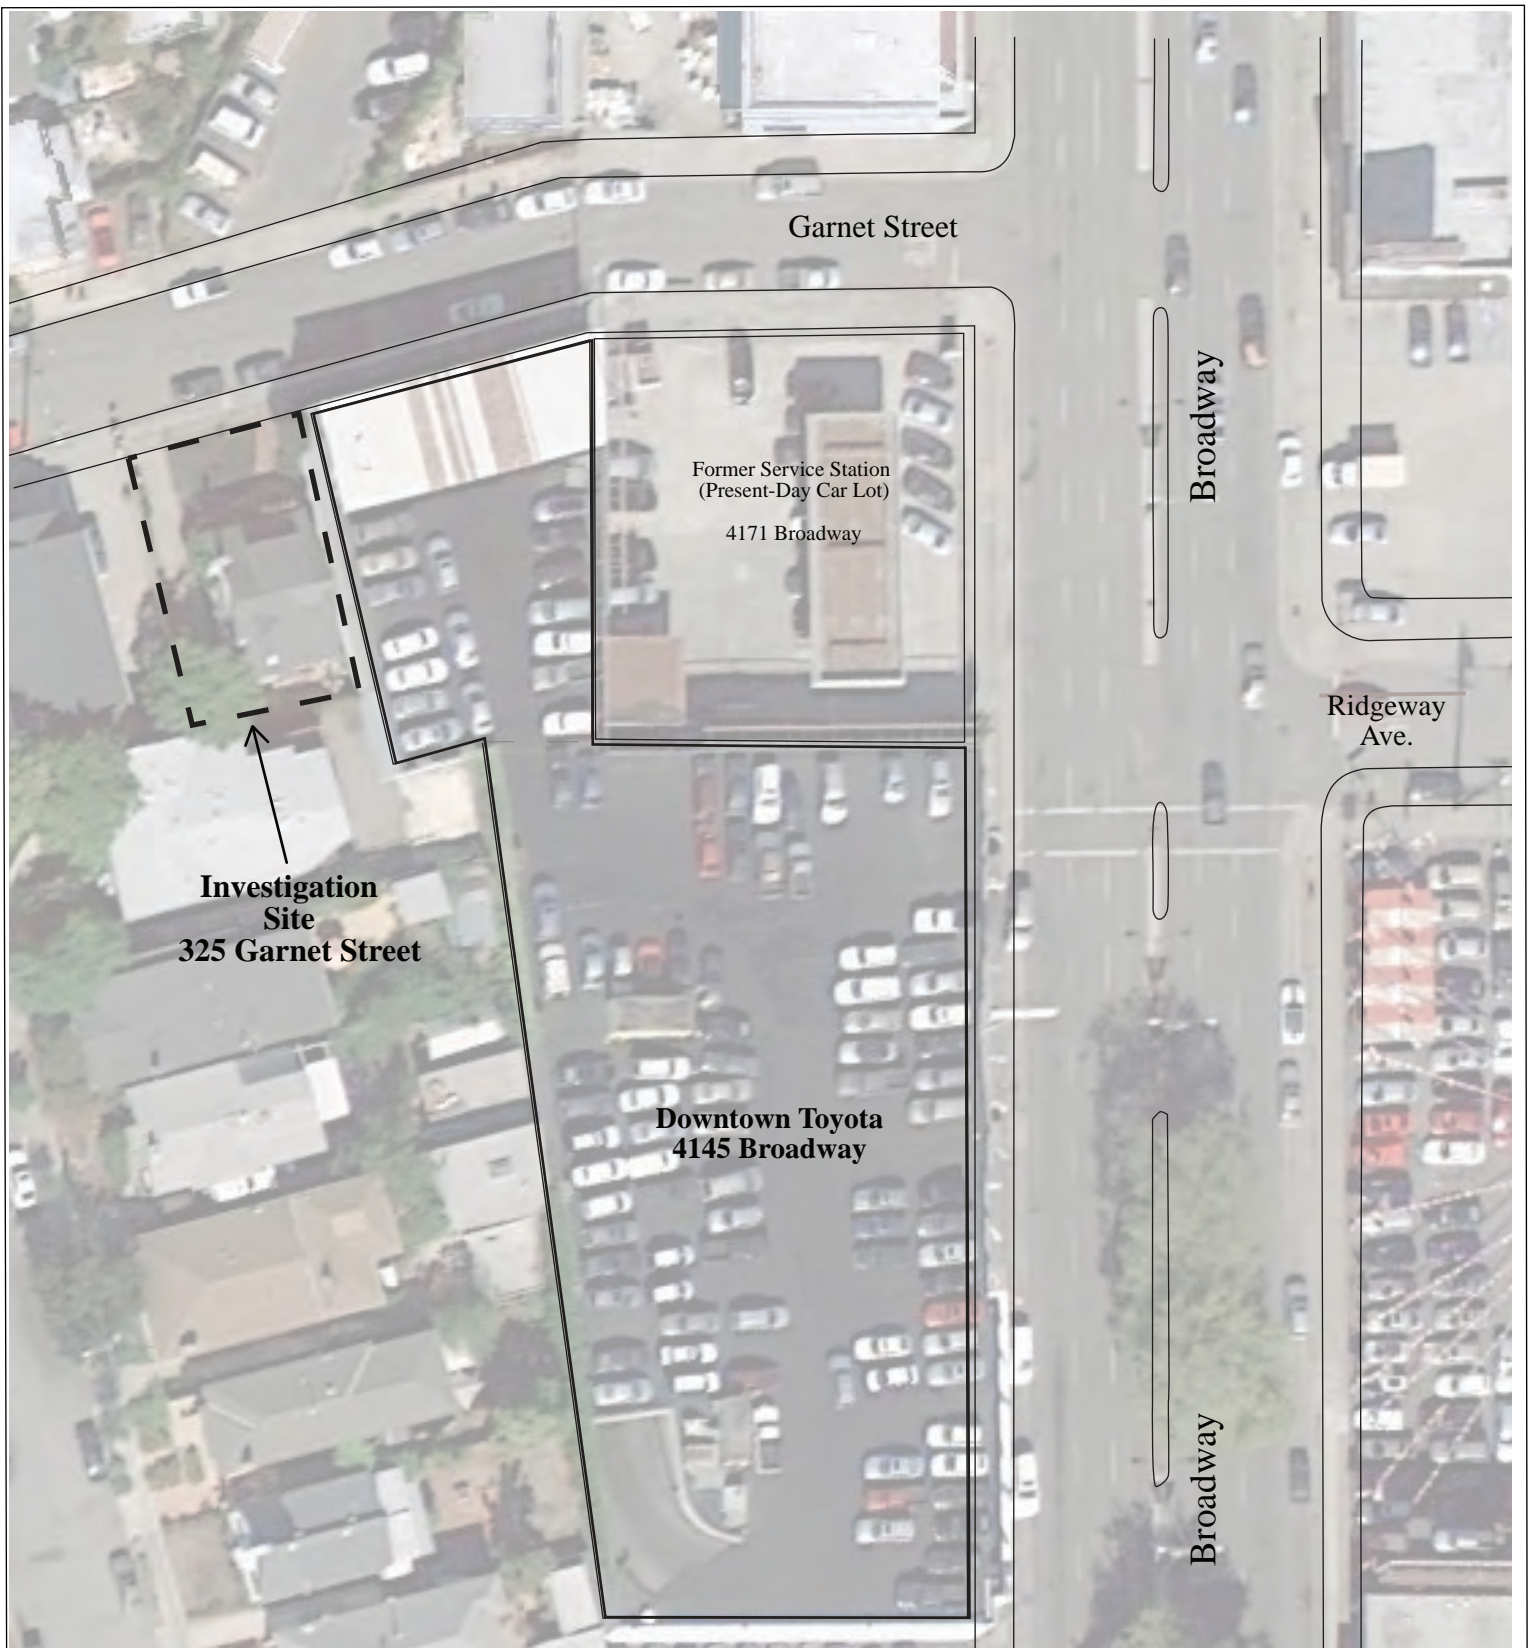
Figure 1
Site Vicinity Aerial Photograph
Downtown Toyota
4145 Broadway
Oakland, California

A Site Vicinity Aerial Photograph is attached as Figure 1, and a Site Plan for 325 Garnet Street is attached as Figure 2. All work was performed under the direct supervision of a professional geologist.
