SUBJECT: REPORT OF SITE ACTIVITIES

UST 18 & 19 SITE

SANTA RITA CORRECTIONAL FACILITY

DUBLIN, CALIFORNIA ESE PROJECT NO. 6595174

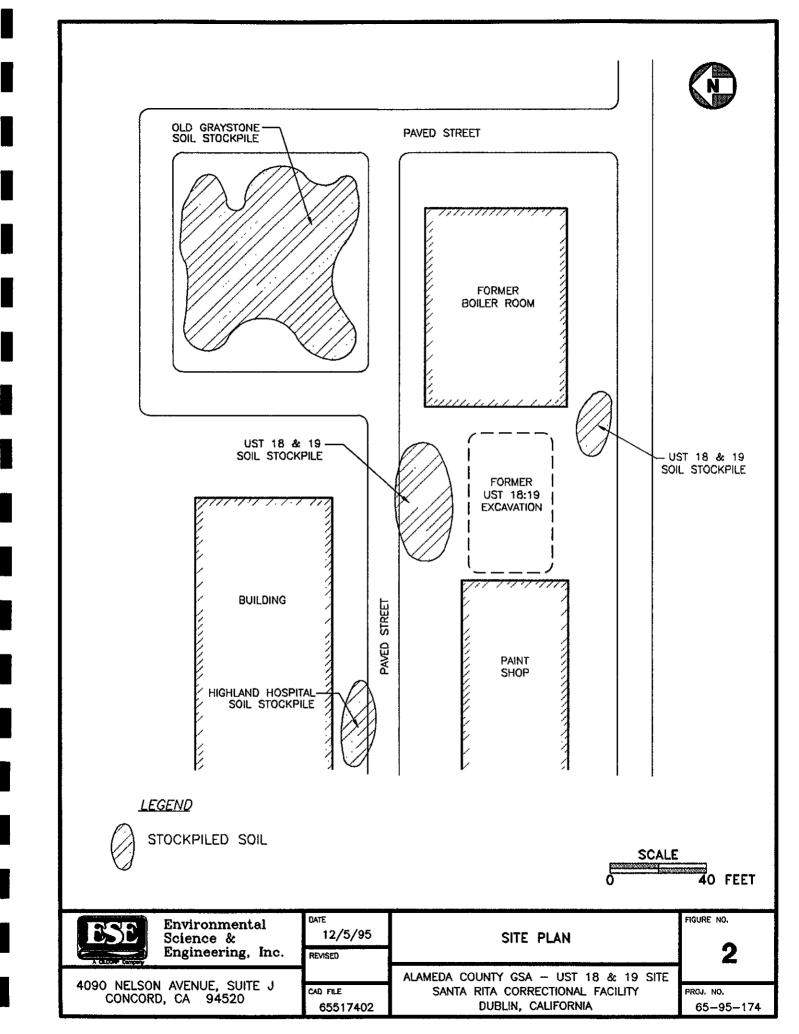
Figure 2 Site Plan

ESE supervised the excavation and removal of two underground storage tanks (USTs) at the subject site on May 13 and 14, 1992 (ESE, 1992a). These USTs were reportedly utilized for the storage of Bunker C fuel oil only. Approximately 160 cubic yards of excavated soil were stockpiled on the north and southwest sides of the excavation (Figure 2 - Site Plan).

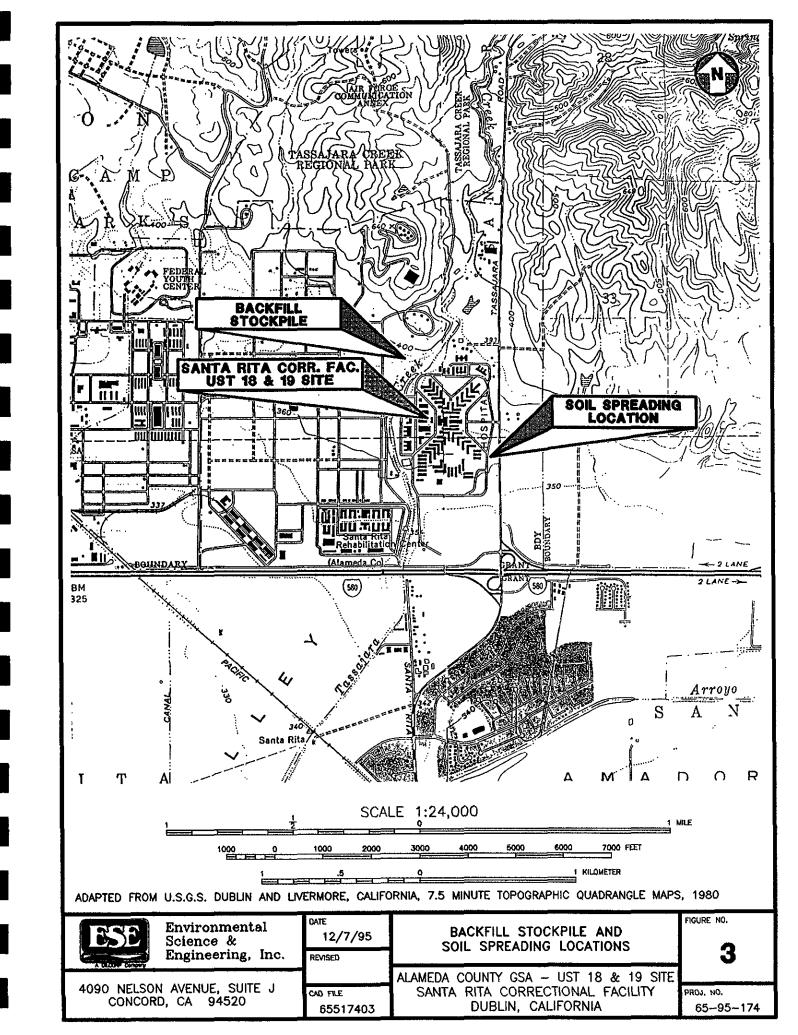
Figure 3 Spreading/Stockpile Locations

The soil was hauled and spread in a commerciaaly zoned area located near the intersection of Gleason Drive and Tassajara Road, as designated by the GSA (Figure 3 - Backfill Stockpile and Soil Spreading Locations). The field was scraped of all gross vegetation prior to receiving soil. ESE then performed a final screening for debris and spread the soil in a six-inch thick layer over the existing grade of the field.

Fill material was obtained from a large stockpile located immediately north of the existing Alameda County Animal Shelter on Gleason Drive (Figure 3). ESE collected representative samples from this soil stockpile on September 24, 1993 and submitted them to McCampbell Analytical of Pacheco, California (a State-certified laboratory) for analysis. No detectable concentrations of TPH-D, TPH-G, O&G, and BTEX constituents were reported in these representative samples (Attachment 3).

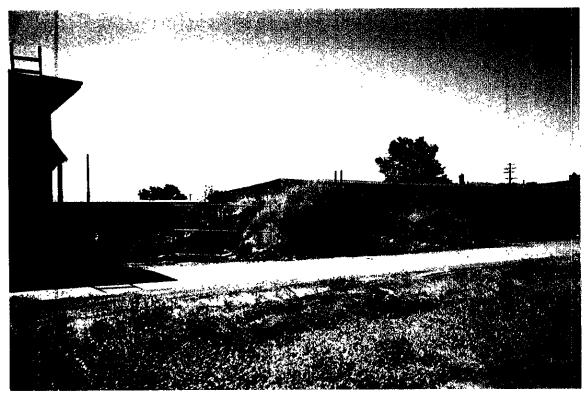
Plate 1 - Viewing toward southwest at UST 18 & 19 soil stockpile bordered on the east and west with security fencing and the south by the UST excavation.

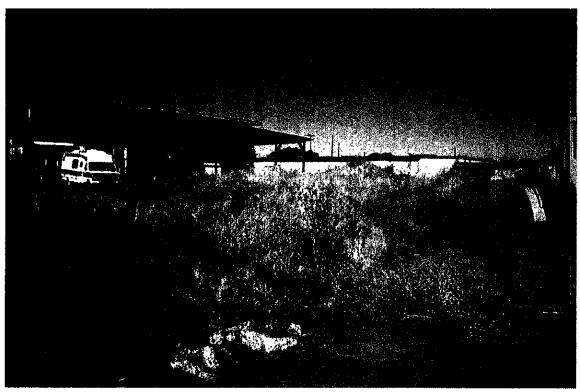
Plate 2 - Viewing toward northwest at Old Graystone soil stockpile prior to loading activities.

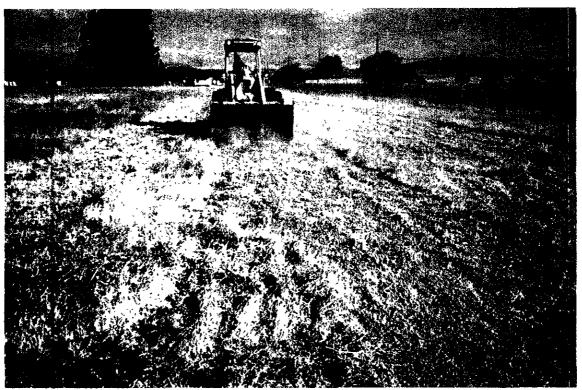
Plate 4 - Viewing toward north at field grade preparation activities.

Tassajara Road is visible to the east side of the plate.

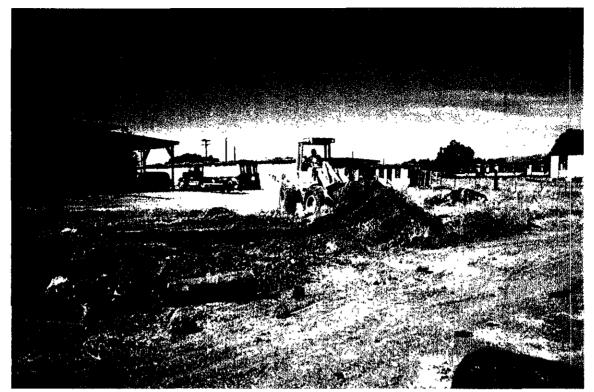
Plate 5 - Viewing toward northwest at loading/hauling of Old Graystone soil stockpile. Note loaded tractor-trailer departing site in background.

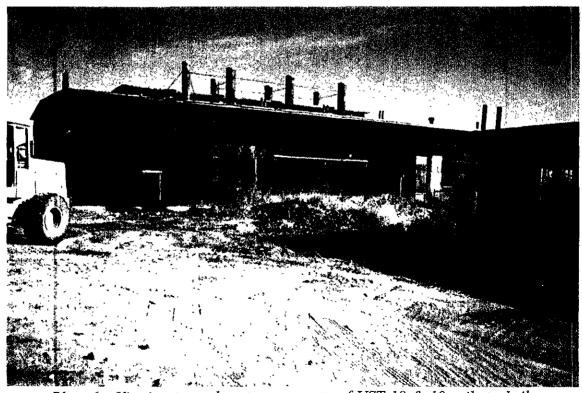
Plate 6 - Viewing toward east at remnants of UST 18 & 19 soil stockpile.

Note Boiler Room building located in background.

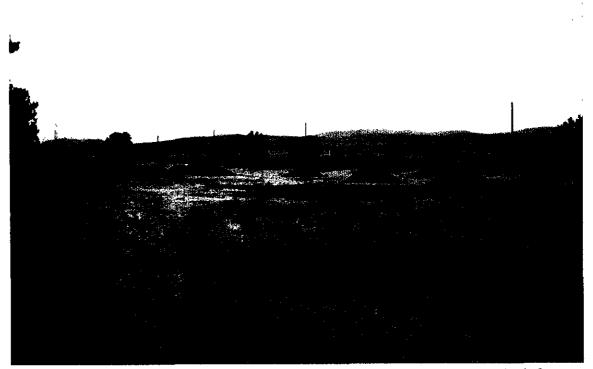
Plate 7 - Viewing toward northeast at truckloads of soil being stockpiled in the receiving field. Tassajara Road is present in the background.

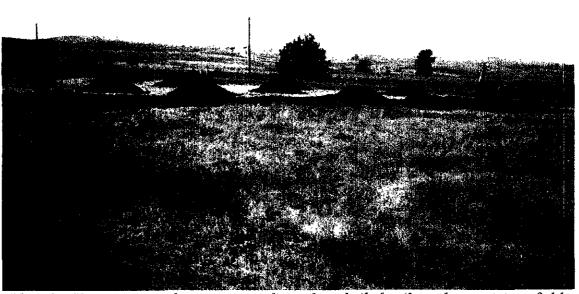
Plate 8 - Viewing toward east at spreading of stockpiled soil on the receiving field.

Final approximate spread soil thickness was six inches.

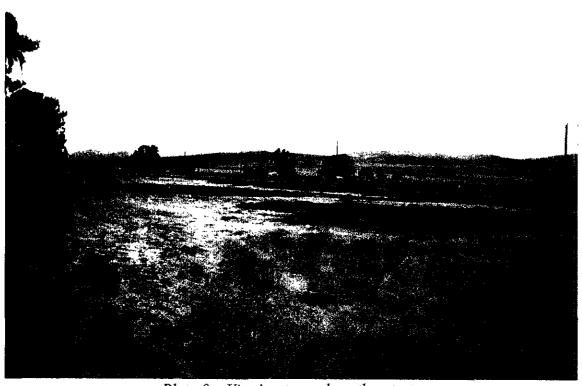
Plate 9 - Viewing toward northeast at receiving field after preliminary spreading of soil.

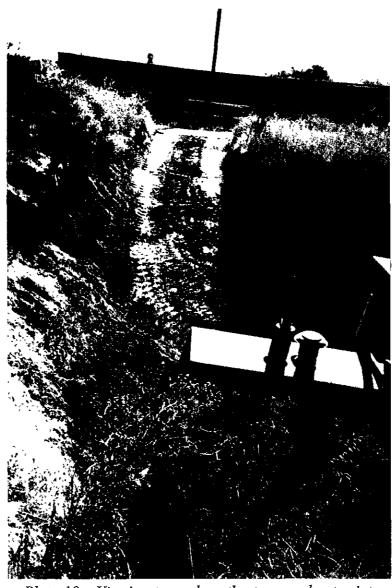
Plate 10 - Viewing toward south at ramped entry into UST 18 & 19 excavation for heavy machinery.

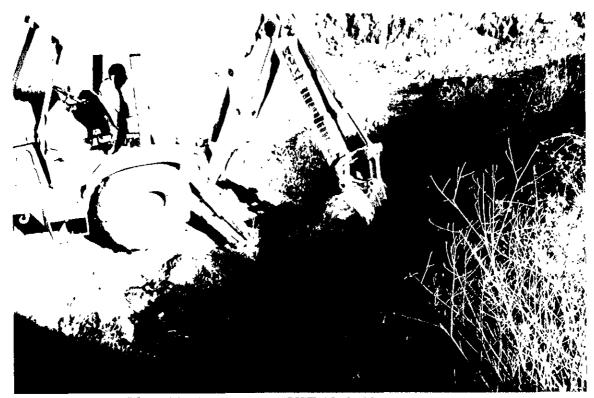
Plate 11 - Viewing into UST 18 & 19 excavation at sidewall preparation activities.

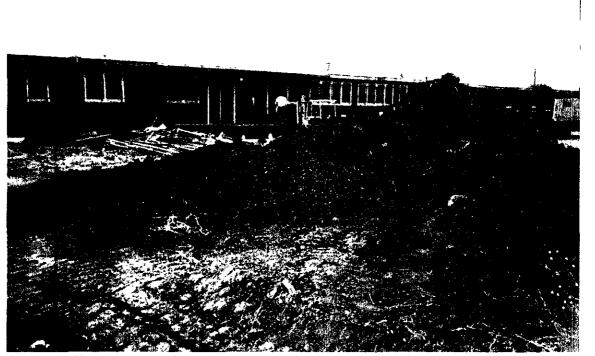
Plate 12 - Viewing toward southwest at stockpile of clean soil imported from a Santa Rita Correctional Facility location behind the County Animal shelter at Gleason Road.

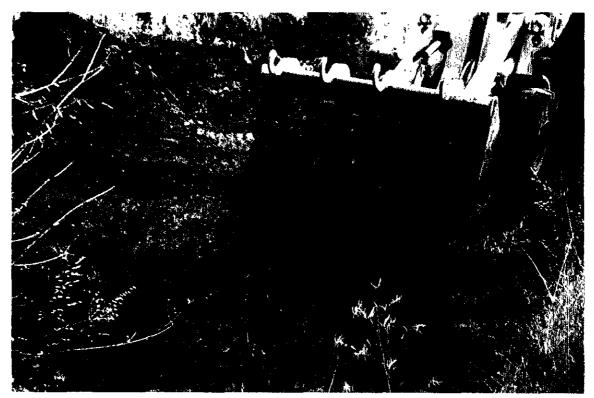
Plate 13 - Preliminary importing of clean soil into UST 18 & 19 excavation by loader.

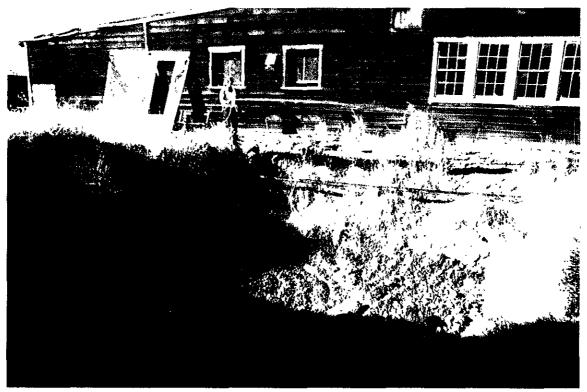
Plate 14 - View toward west at fill hydration activities for obtaining compaction.

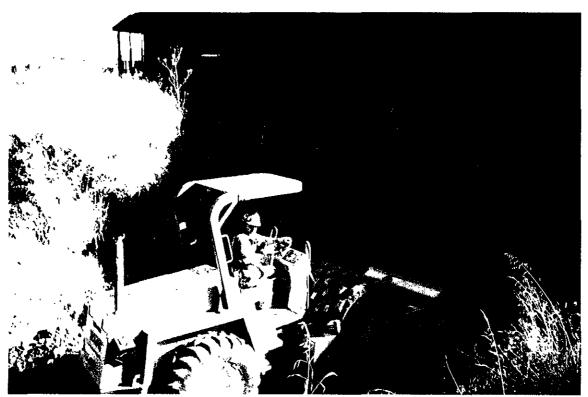
Plate 15 - Viewing into UST 18 & 19 excavation at backfill compaction activities.

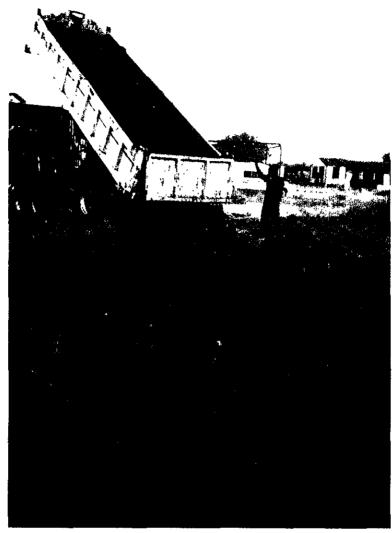
Plate 16 - Viewing toward north at unloading of clean imported fill into the UST 18 & 19 excavation prior to spreading and compaction.

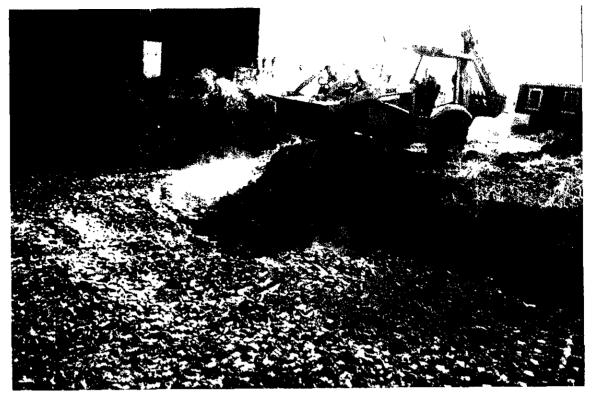
Plate 17 - Viewing toward southeast at surface of hydrated and compacted clean fill material in UST 18 & 19 excavation.

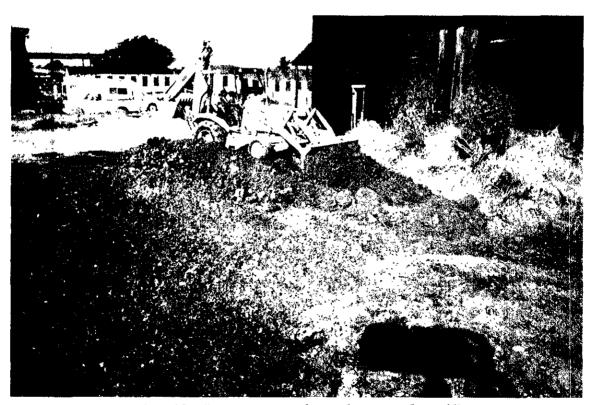
Plate 18 - Viewing towards northeast at clean fill at grade over the former UST 18 & 19 excavation.

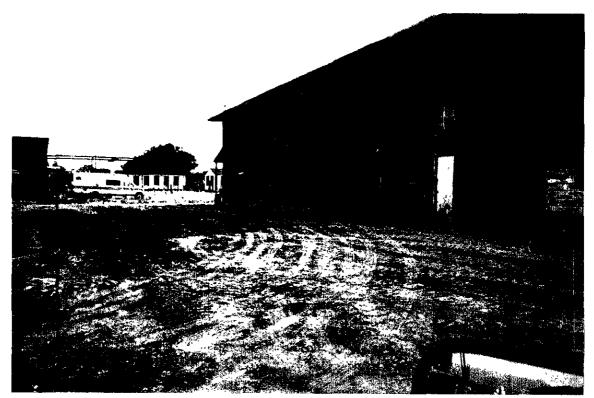
Plate 19 - Viewing toward northeast at final grade over the east portion of the former UST 18 & 19 excavation.

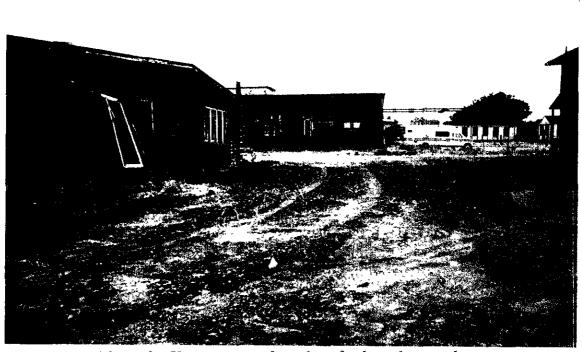
Plate 20 - Viewing toward north at final grade over the west portion of the UST 18 & 19 excavation.
