**PHASE I  
ENVIRONMENTAL SITE  
ASSESSMENT REPORT,  
DUBLIN ELEMENTARY SCHOOL SITE  
DUBLIN, CALIFORNIA**

**PHASE I ENVIRONMENTAL  
SITE ASSESSMENT REPORT  
DUBLIN ELEMENTARY SCHOOL SITE  
DUBLIN, CALIFORNIA**

Kleinfelder Job Number 10-3002-34

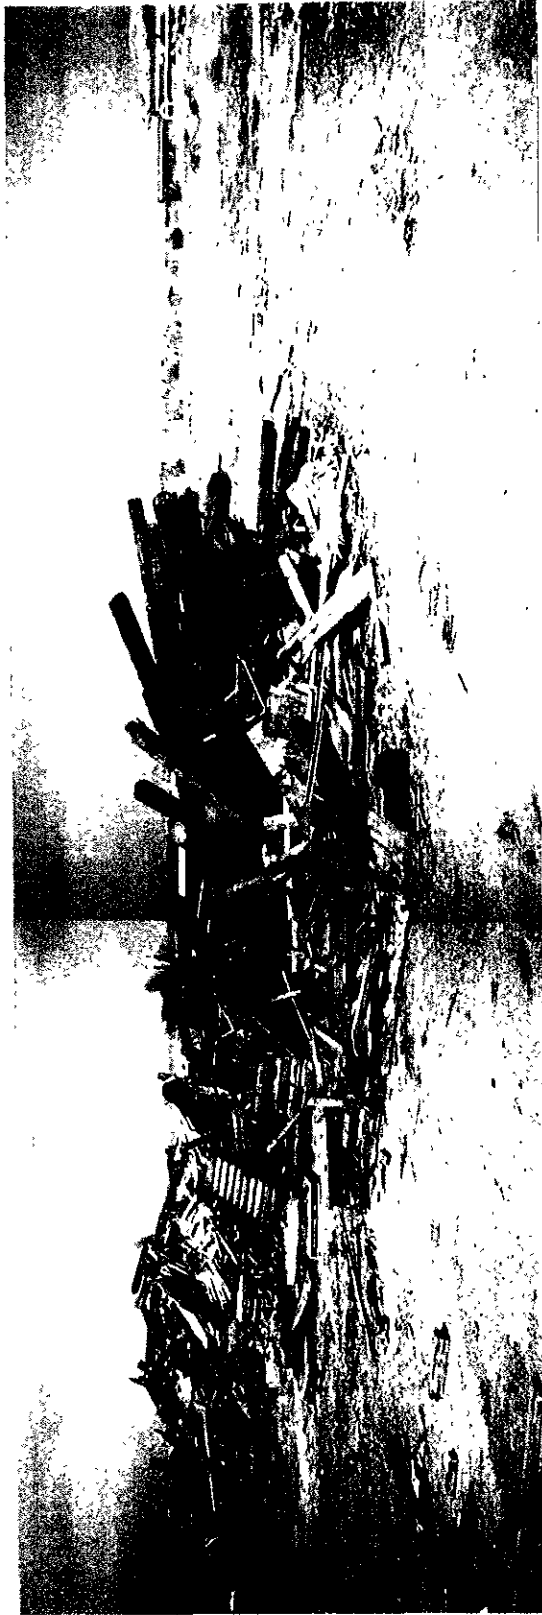
On the southern half of this sector there was more trash, particularly along the southern edge of the school site. Open 55-gallon drums (Photo 4, Plate 4), waste lumber (Photo 3, Plate 4) and other materials appeared to be stockpiled here awaiting disposal. The 55-gallon drums did not contain any liquids, but there was some soil and rubble in most of the drums. There was a truck loading ramp which was likely a remnant of the former military camp. An asphalt-paved area surrounded the loading ramp, but was in poor condition. No staining was noted.

PHOTO 3. Scrap lumber and other debris awaiting disposal.

1. All trash, rubble and other unwanted material should be removed from the site and disposed of properly. All concrete slabs, foundations and structures not to be used in the proposed school should be removed from the site and disposed of properly. Following cleanup of the site, Kleinfelder should make another site visit to look for stains or other evidence of possible soil contamination.

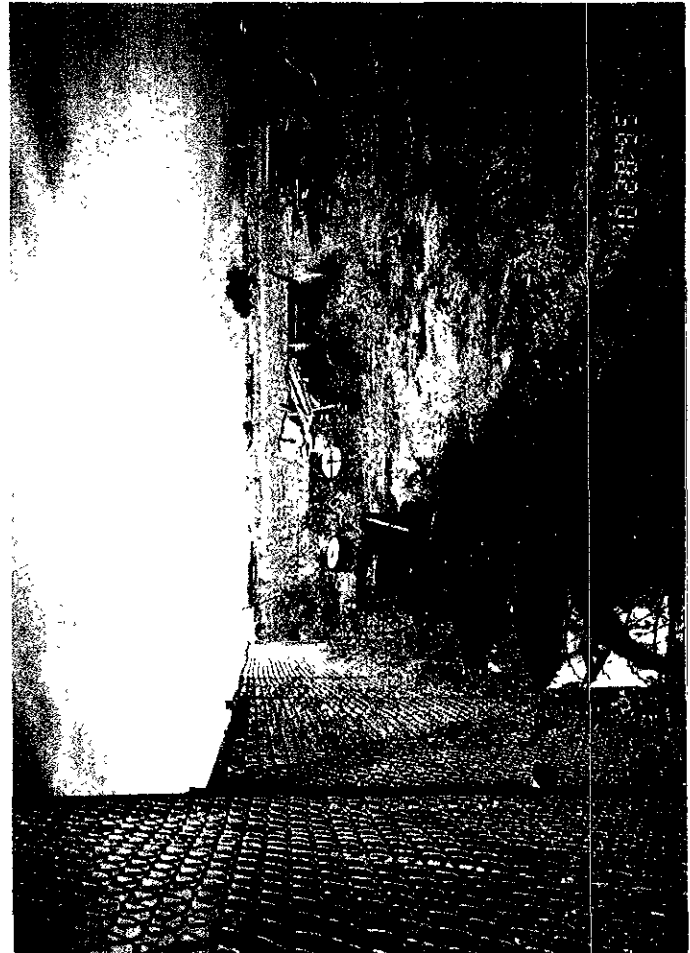
PHOTO 4. Open 55-gallon drums and other debris along southern border of school site

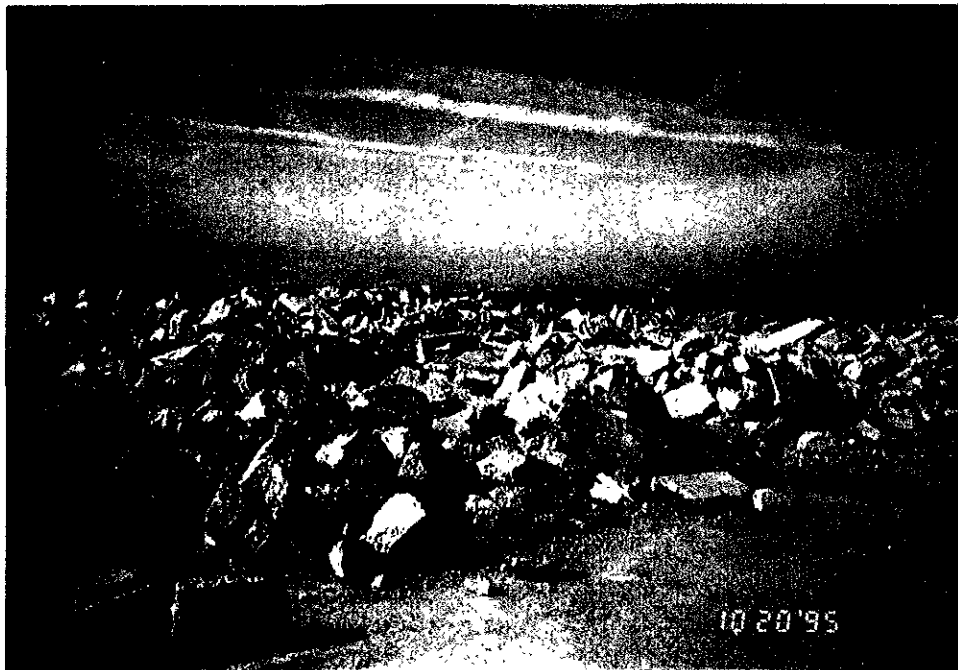
The portion of the school site north of 4th Street and east of Madigan Road was mostly covered by demolition debris, primarily broken concrete (Photo 5, Plate 5). This material extended into other parcels adjacent to the proposed school site.

Under the concrete rubble, the remnants of a building floor and foundation could be seen. At two separate locations on the concrete floor, brass inserts were found that could have marked former locations of filler pipes for underground oil tanks. Both inserts were filled completely with dirt and it could not be determined where they led. There was no noticeable staining around either opening.

PHOTO 5. Broken concrete waste pile at northwest corner of proposed school site.

2. After unwanted concrete structures are removed from the site, a geophysical survey of the entire site (particularly the area northeast of the 4th Street/Madigan Road intersection) should be made to locate any remaining underground storage tanks (USTs), pipelines, etc. If any UST's are found, they should be removed properly.
